# National Transportation Safety Board

WPR23LA149

## **MATERIALS LABORATORY**

Factual Report 24-034

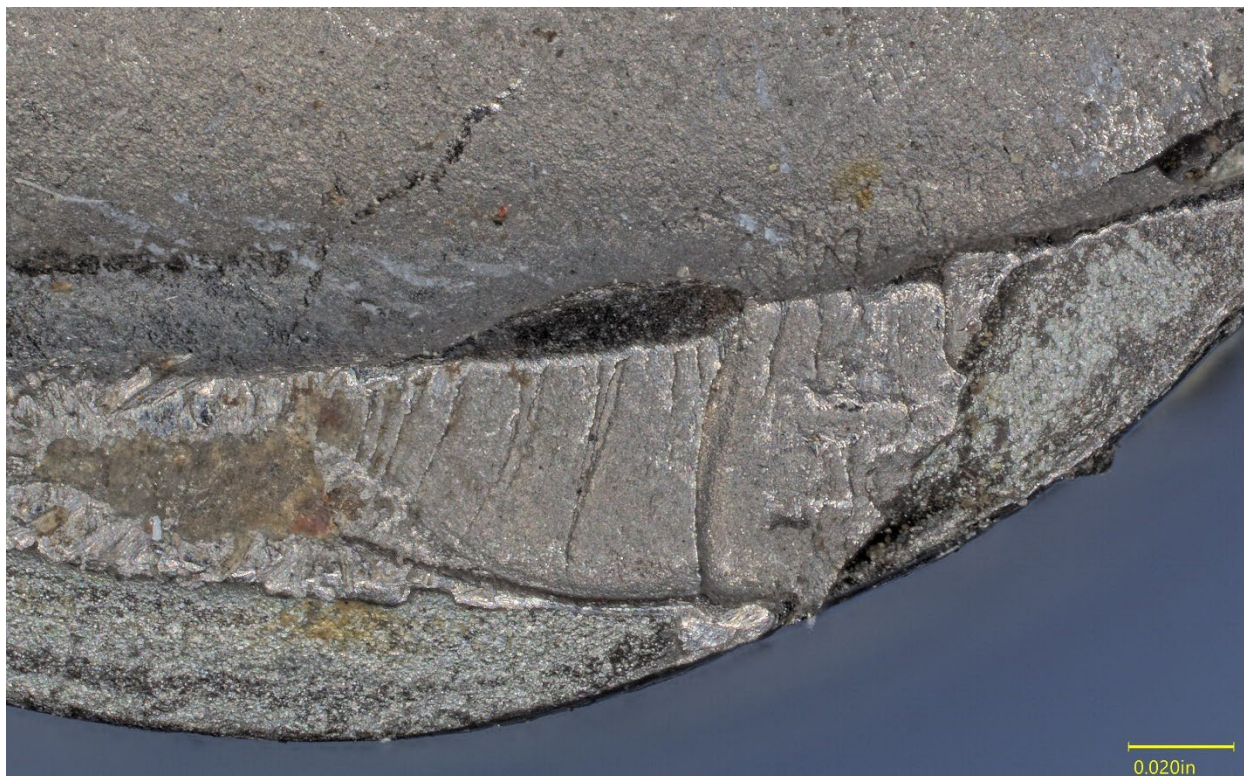
Figures 17 and 18 show the fracture surfaces of Bolts 5 and 6, respectively. Both exhibited several angled thumbnail cracks along the edge, and while Bolt 5 exhibited a shape similar to Bolt 3, Bolt 6 exhibited a larger flatter region. The ridge shape similar to Bolt 4 is shown closer in Figure 19. This feature exhibited coalescing river marks, consistent with crack propagation from the large flatter area (downward in Figure 18). This pattern would be consistent with crack propagation along a different height rather than the two opposite-facing cracks that occurred in Bolt 4. This flatter region exhibited crack arrest marks consistent with propagation from smaller thumbnail cracks on the opposite side in Figure 20.

Figure 19. Closer view of secondary ratchet marks on the end of the Bolt 6 fracture surface.

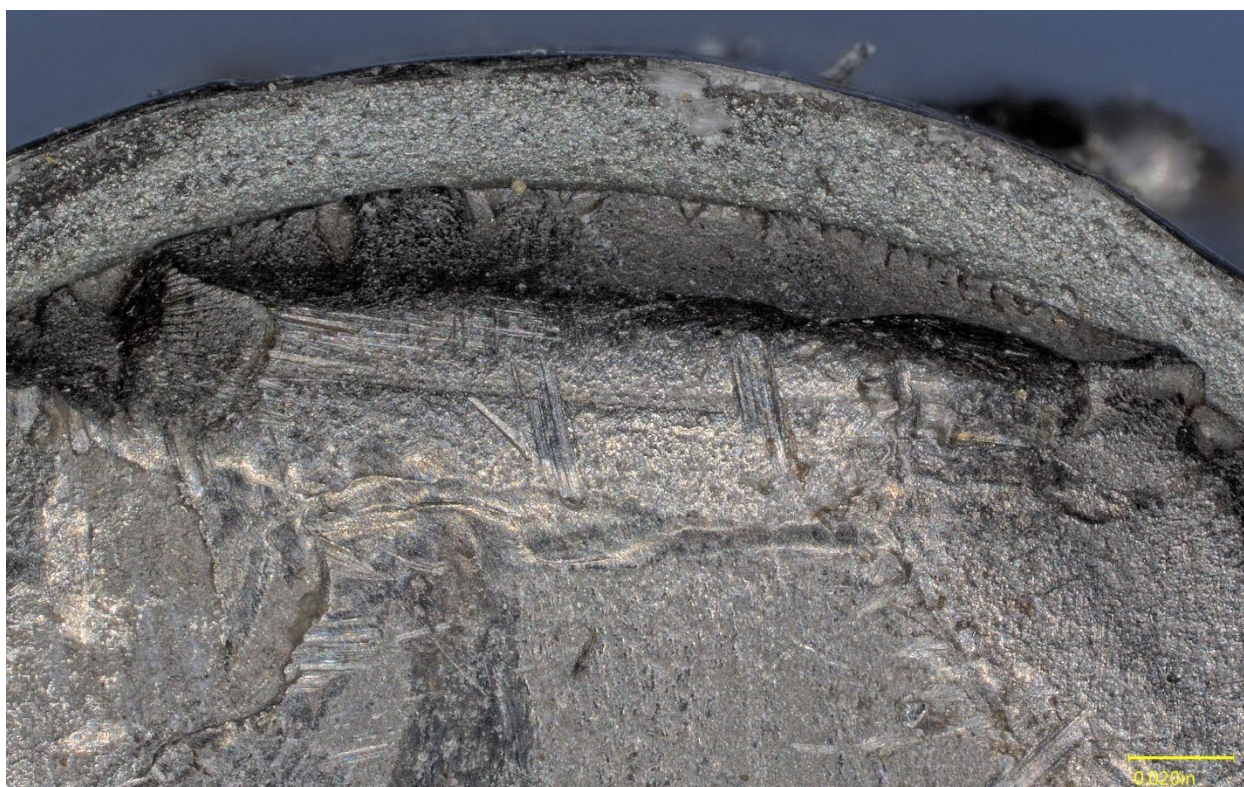
Figure 20. Smaller ratchet marks on the Bolt 6 fracture edge, along with smearing and gouge marks on the surface.

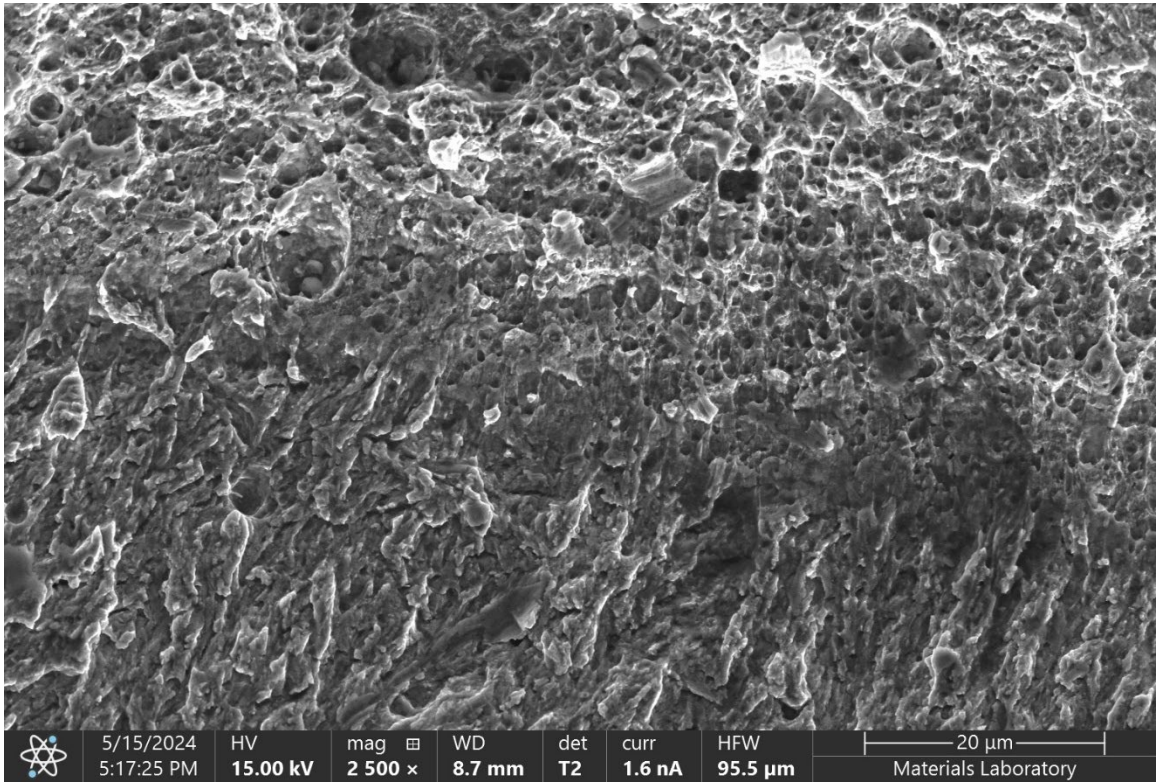
Several bolts were examined using a field-emission scanning electron microscope (SEM). Figure 21 shows the end of the larger flat area of Bolt 4 against the ridge. The figure shows a transition from one fracture mode to another. The area in the lower right exhibited striations consistent with fatigue crack propagation, as shown closer in Figure 22. The upper right area of Figure 20 exhibited dimpled rupture, consistent with overstress fracture, as highlighted in Figure 23. These features were consistent with fatigue crack propagation from opposite thread roots of Bolt 4 until the remaining cross-section of the bolt fractured in overstress, leaving a thin necked ridge.

Figure 21. Secondary electron (SE) micrograph of the end of the fatigue crack on Bolt 4.

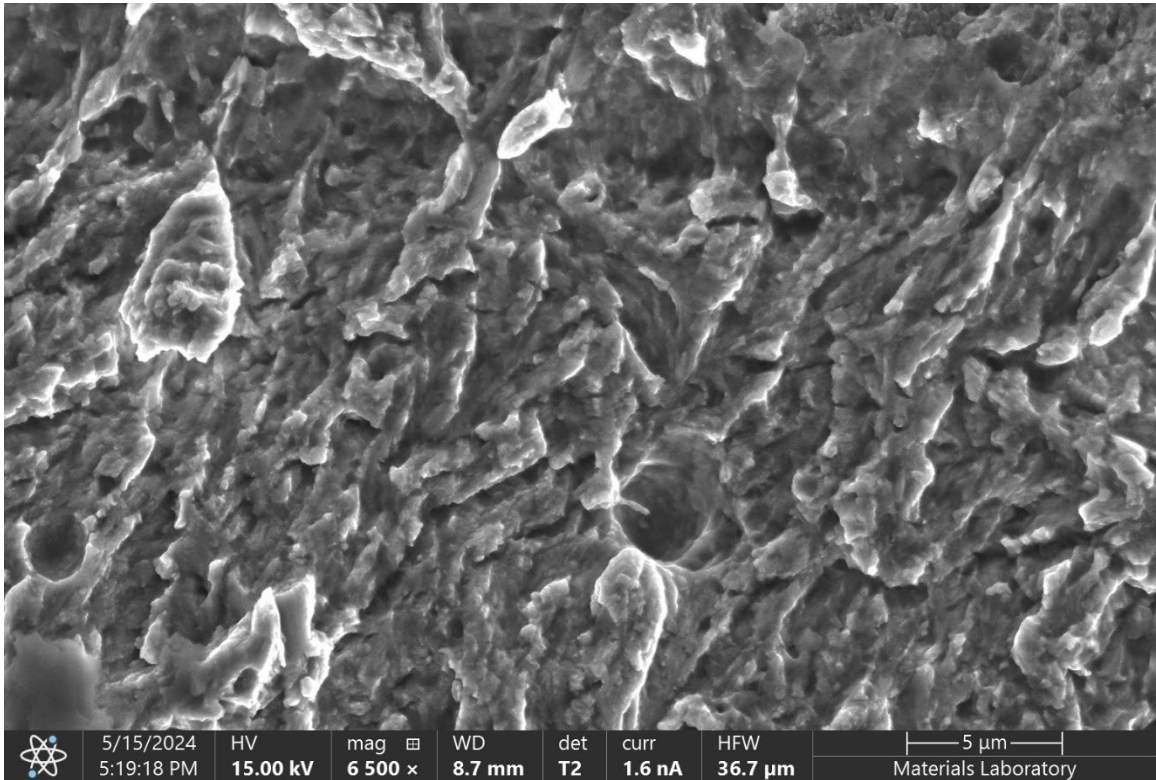
Figure 22. SE micrograph of striations at the end of the fatigue crack in Figure 21.

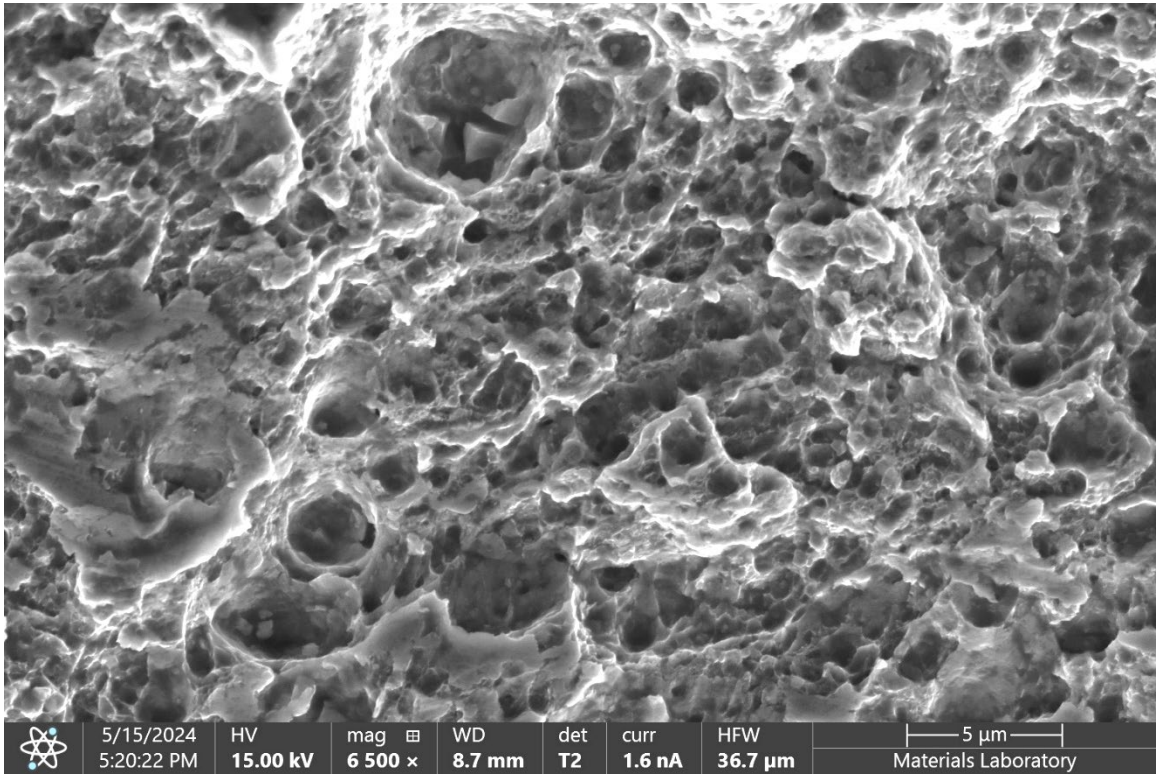
Figure 23. SE micrograph of dimpled rupture outside the fatigue crack in Figure 21.

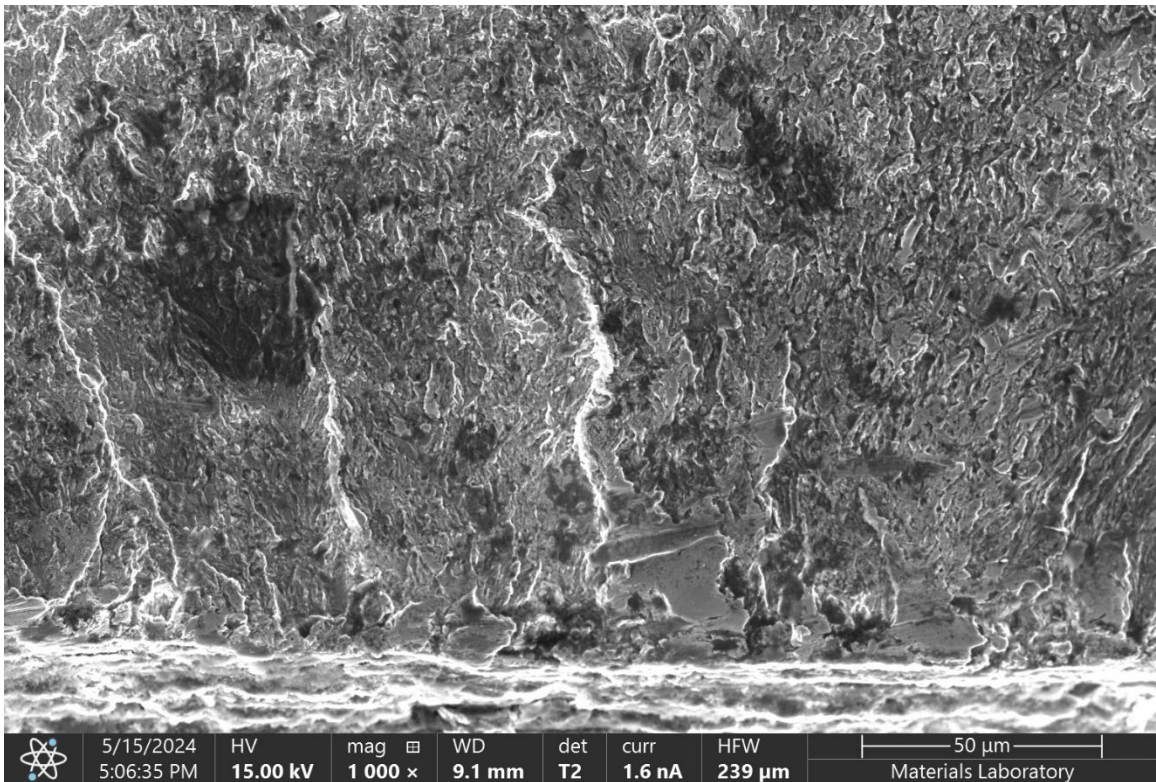
Several fatigue crack initiation sites of Bolt 4 were examined closer, as illustrated in Figures 24 and 25. Each figure shows vertically oriented ratchet marks, consistent with multiple crack initiation sites that coalesced during early crack propagation. Closer views of these areas showed fine fatigue striations, as exemplified by Figure 26.

Figure 24. SE micrograph of multiple crack initiation sites at the Bolt 4 surface edge.

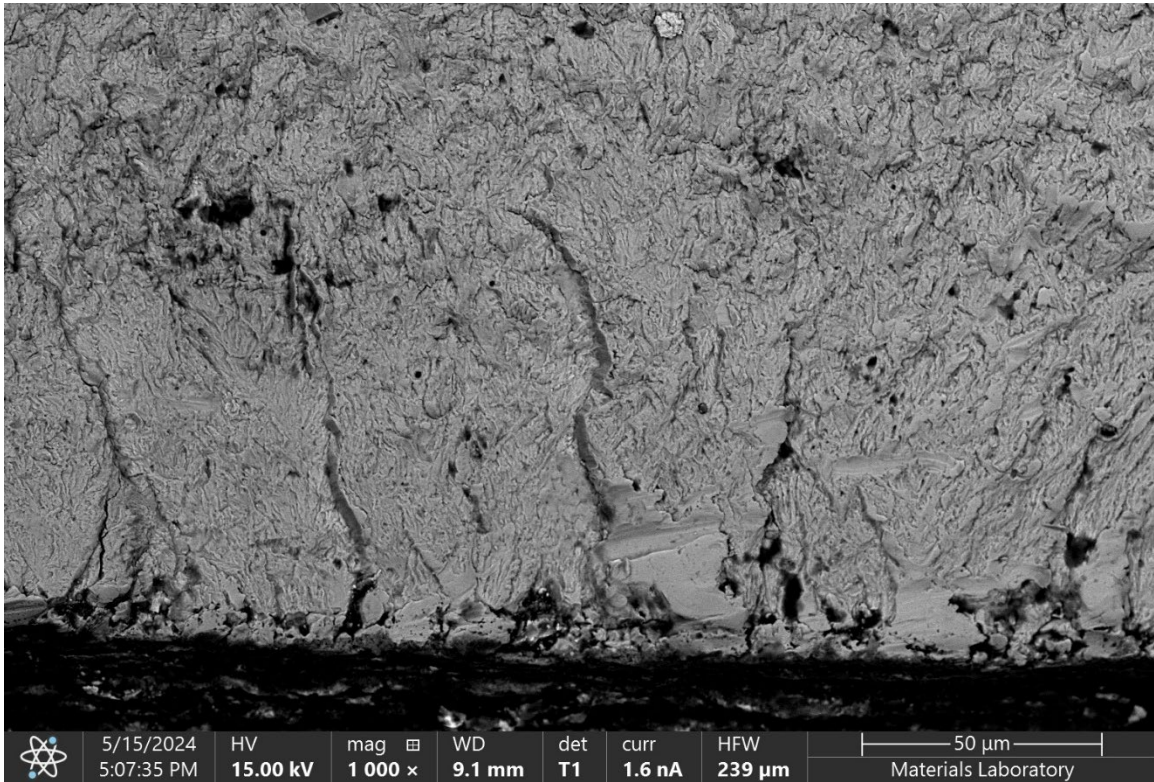
Figure 25. BE micrograph of multiple crack initiation sites at the Bolt 4 surface edge.

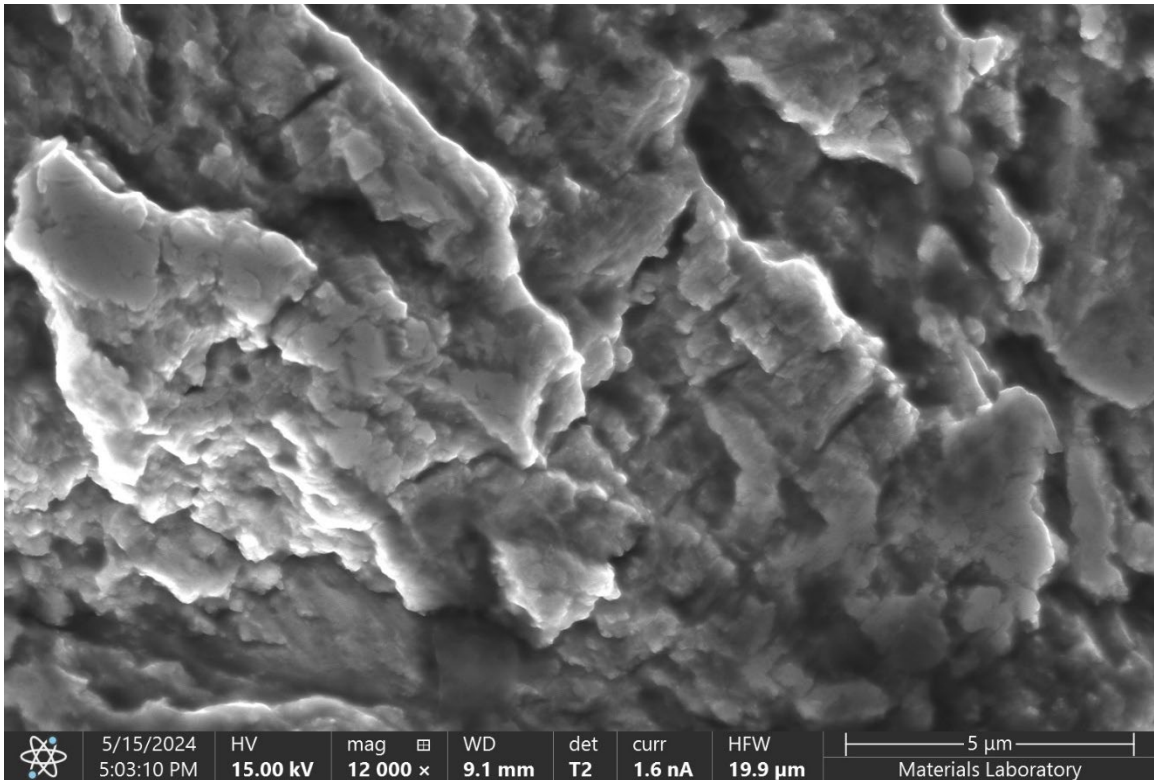
Figure 26. SE micrograph of striations near the initiation sites in Figure 25.

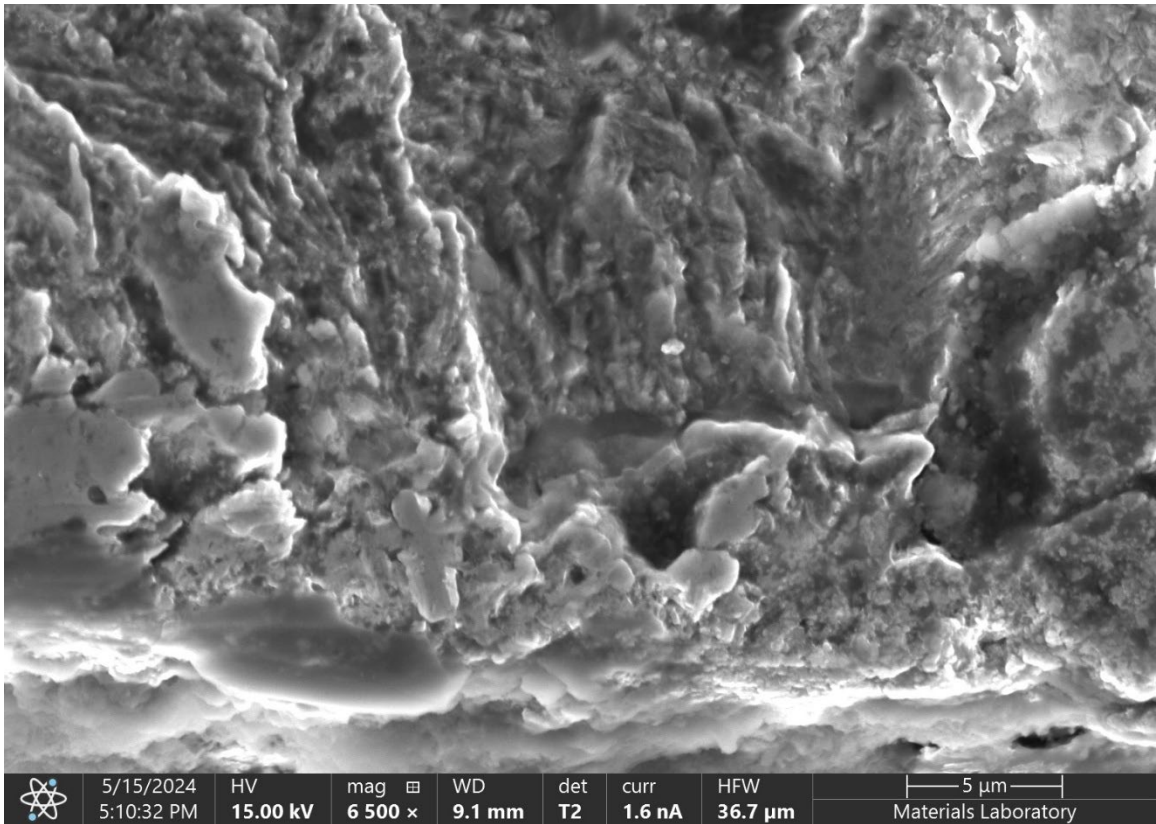
A closer view of the individual crack initiation sites (as shown in Figure 27) did not reveal any corrosion pits or voids. There were some dissimilar materials, as illustrated in the backscattered view in Figure 28, but this was inconsistent with the inclusion of

Figure 27. SE micrograph of a closer view of the center left initiation site in Figure 25.

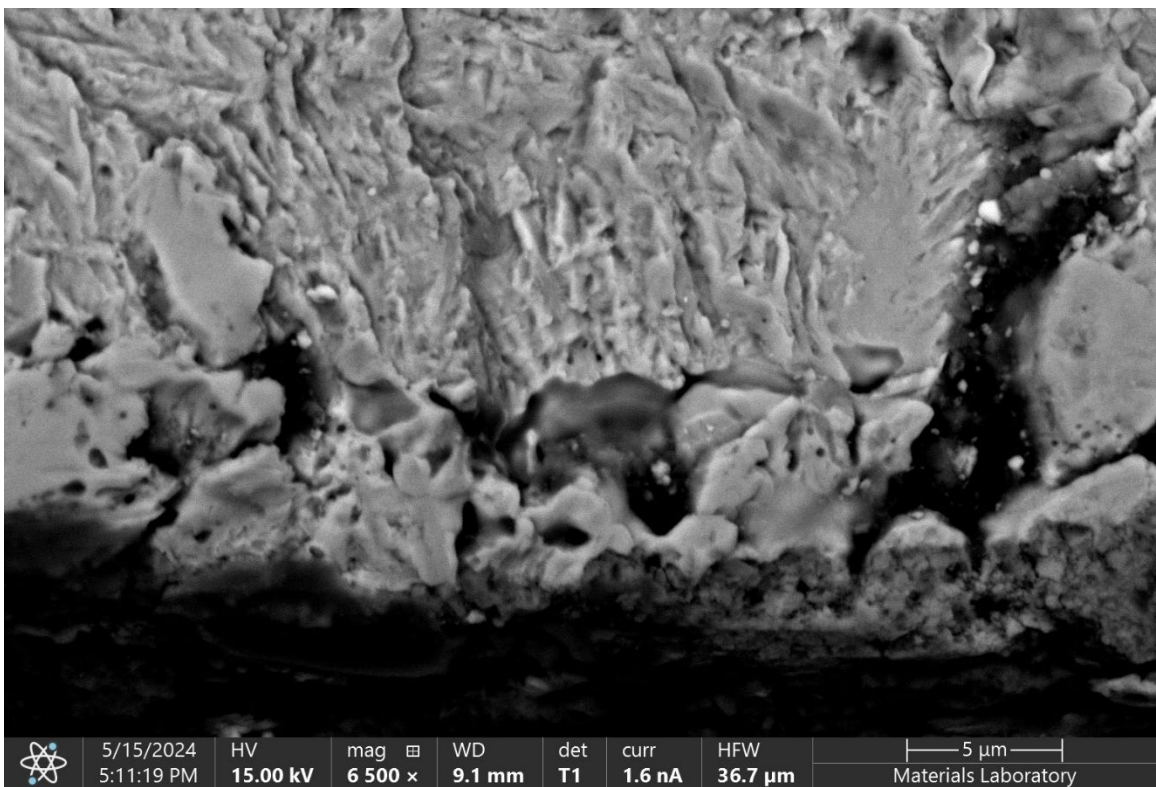
Figure 28. BE micrograph of the fatigue initiation site in Figure 27.

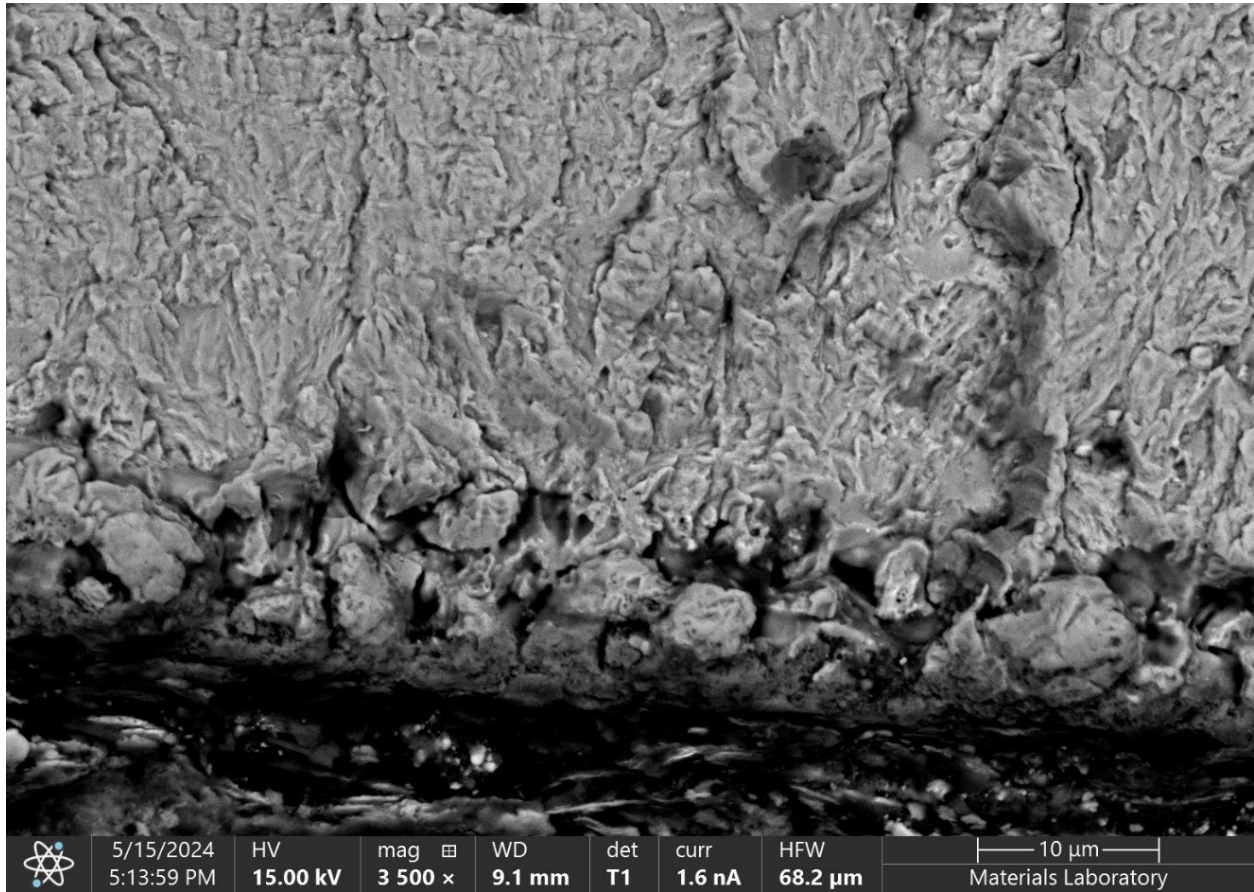
manufacturing.<sup>2</sup> There were some mechanical surface undulations, as exemplified in Figure 29.

Figure 29. BE micrograph of crack initiation sites on the opposite (smaller crack) side of Bolt 4.
