# National Transportation Safety Board

WPR23LA150

## **MATERIALS LABORATORY**

Factual Report 23-046

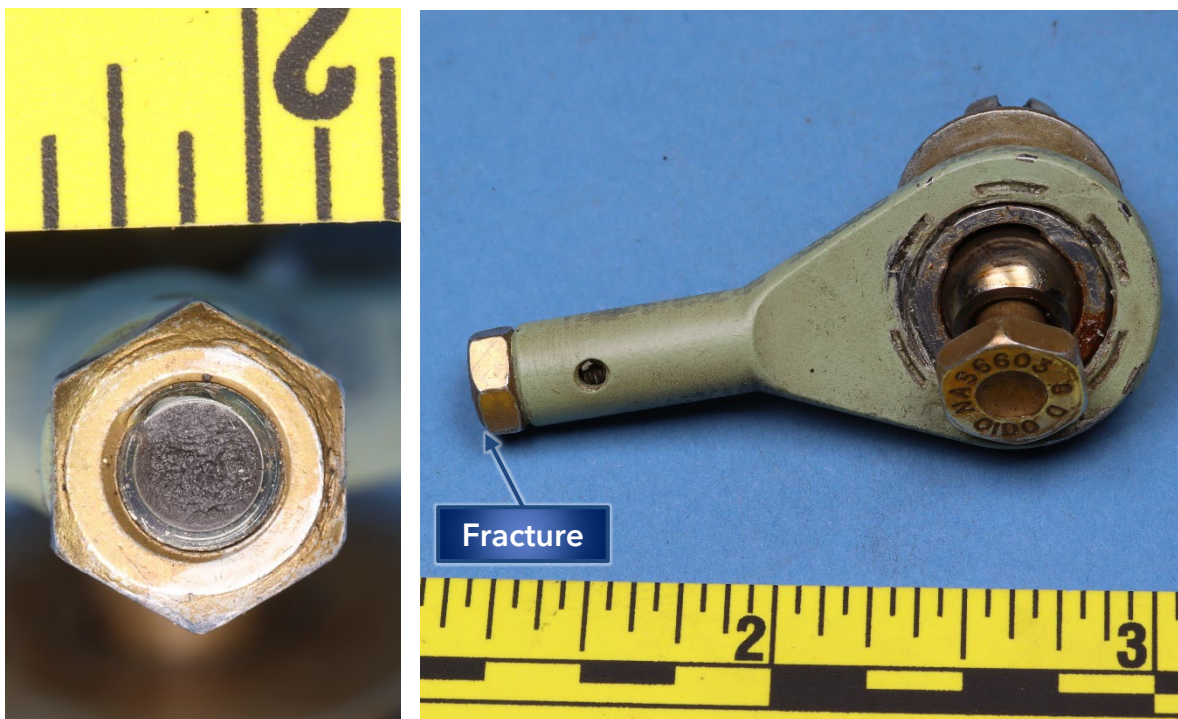
An overall view of the submitted components are shown in figure 1. The fuel control cable input rod was fractured in the threads adjacent to the jam nut on the end fitting as indicated in the right image in figure 1. The input rod threads were visible within the witness hole in the end fitting consistent with sufficient thread engagement.

**Figure 1.** Overall view of the end fitting (right image) and fracture surface of the control cable input rod (left image) as received.

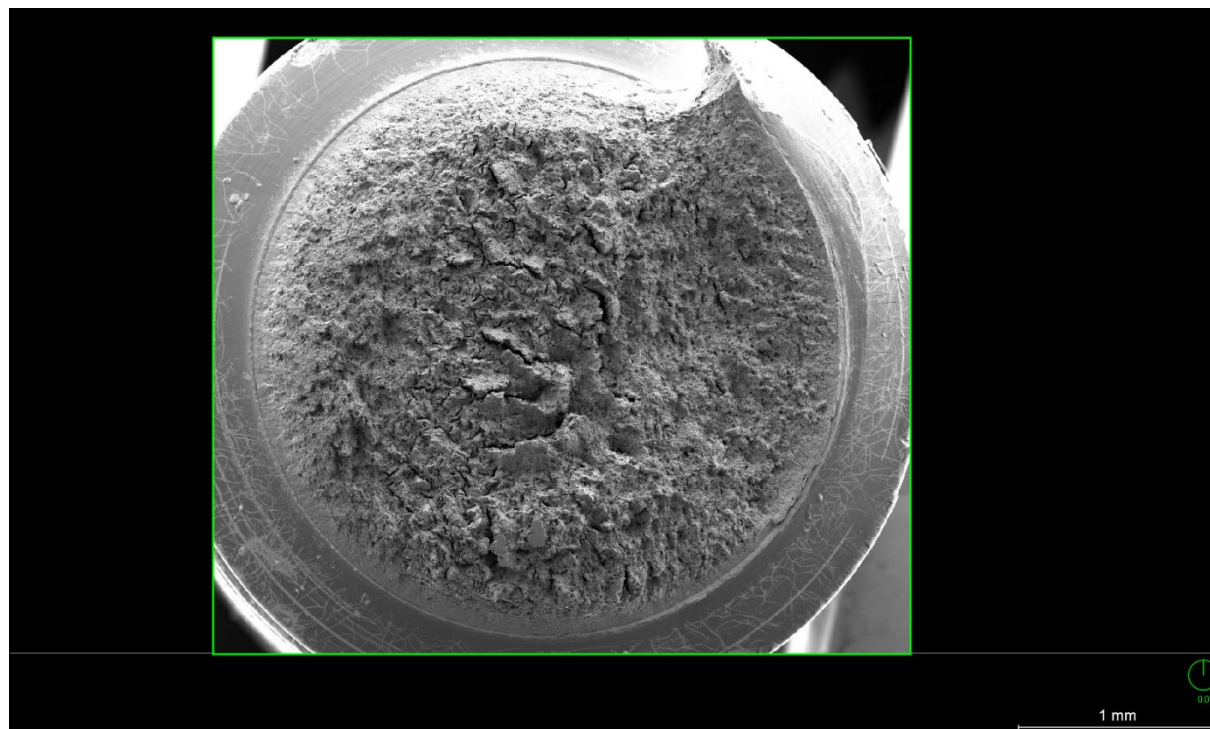
A montage image of the fracture surface stitched together from multiple SEM images is shown in figure 2. Around the edges of the fracture, elongated dimples on a slant angle consistent with a shear lip were observed. In the middle of the fracture, cleavage fracture features were observed intermixed with dimple features such as the area shown in figure 3. Secondary cracks and fissures were also observed intersecting the fracture surface. All features were consistent with overstress fracture with no evidence of progressive fracture.

**Figure 2.** Montage of SEM images stitched together to show an overall view of the fracture surface after cleaning.

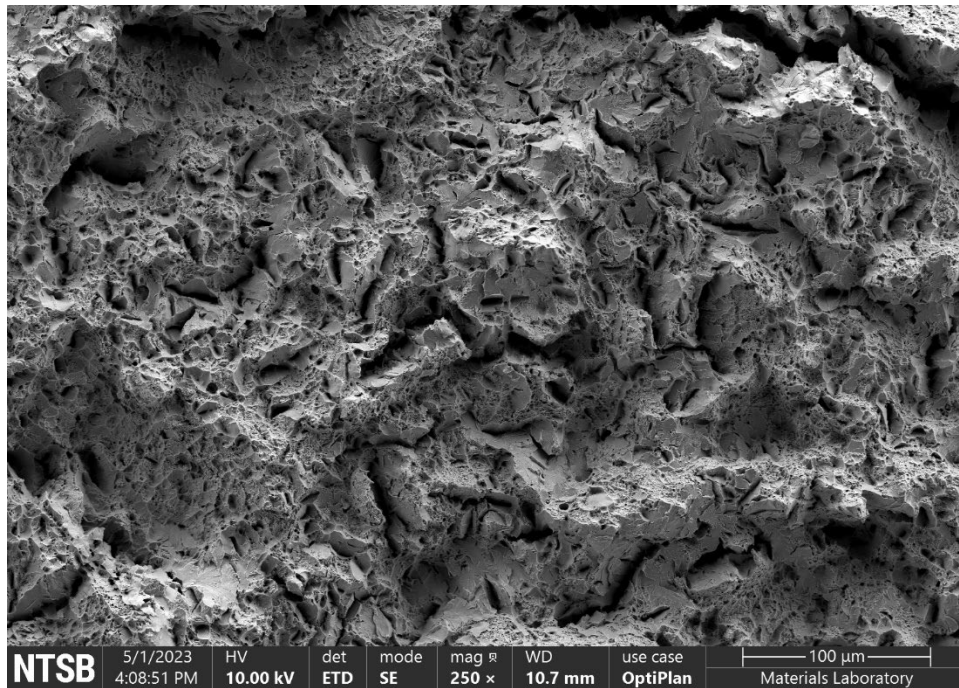
**Figure 3.** SEM image of typical features observed near the middle of the fracture surface.

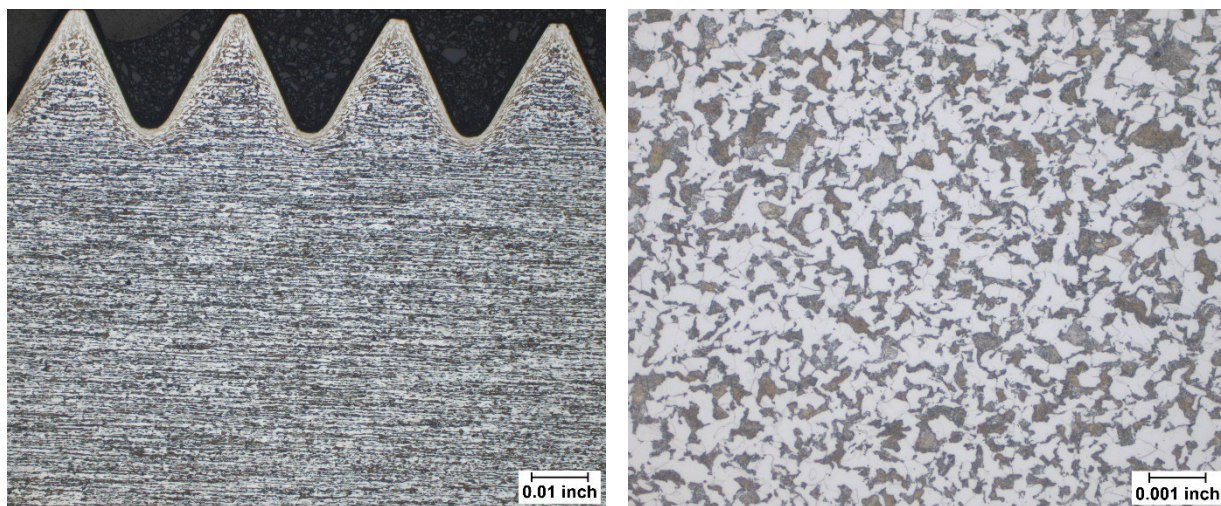
Using a slow-speed abrasive saw, two transverse cuts were made through the input rod piece adjacent to the fracture surface to prepare a transverse metallographic section while preserving the fracture surface. The transverse section was then mounted in a polymer mount along with the remaining threaded end piece, which was mounted lengthwise next to the transverse section. The metallographic specimens were then ground until the polishing plane was close to the middle of the longitudinal section, and the sample was polished and etched using 2% nital. A view of the longitudinal section is shown in the left image in figure 4. The microstructure consisted of ferrite and pearlite that was elongated into a banded structure along the longitudinal axis. The microstructure was deformed around the thread profile consistent with rolled threads. The microstructure in the transverse plane is shown at higher magnification in the right image in figure 4, where the pearlite appears brown, and ferrite appears white.

**Figure 4.** Banded microstructure consisting of ferrite and pearlite with rolled thread profiles observed in the longitudinal cross-section (left image). The ferrite (white) and pearlite (brown) microstructure are shown at higher magnification in the transverse cross-section (right image). Both images are brightfield optical micrographs shown after etching with 2% nital.
