# National Transportation Safety Board

WPR23LA150

## COCKPIT VOICE RECORDER

Specialist's Factual Report

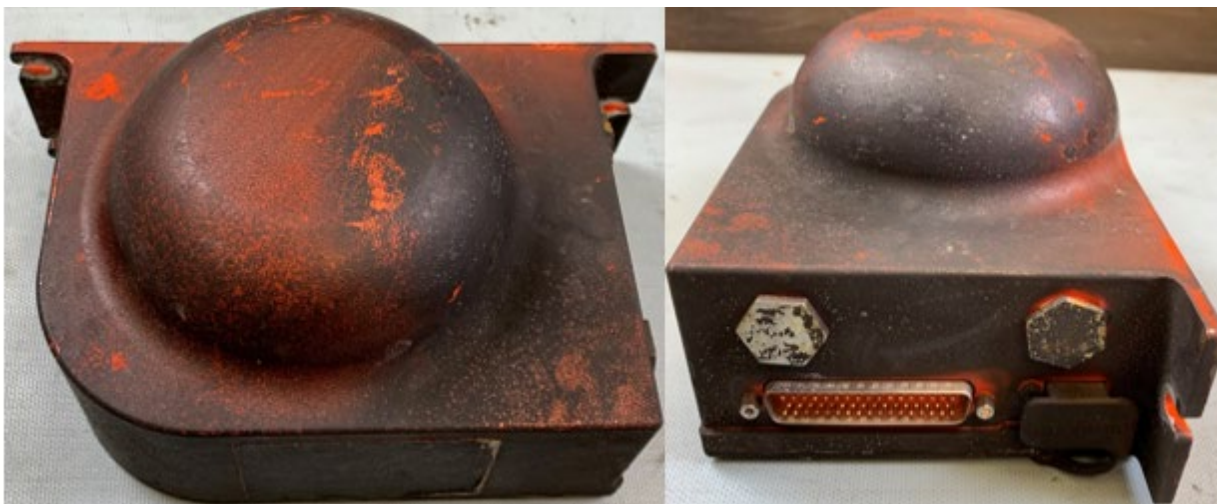
Upon arrival at the laboratory, it was evident that the exterior of the recorder had sustained some heat damage as shown in figure 1. However, the unit was able to mount (connect) to laboratory computers and the audio information was extracted from the recorder normally, without difficulty.

**Figure 1.** Top and side view of the L-3 LDR as received by the NTSB Vehicle Recorder Laboratory.
