# National Transportation Safety Board

WPR23LA154

## **LANDING GEAR EXAMINATION**

Location: Upland, California  
Date: April 16, 2023  
Time: 09:30 PDT  
16:30 UTC  
Airplane: Cessna T337 / N38C

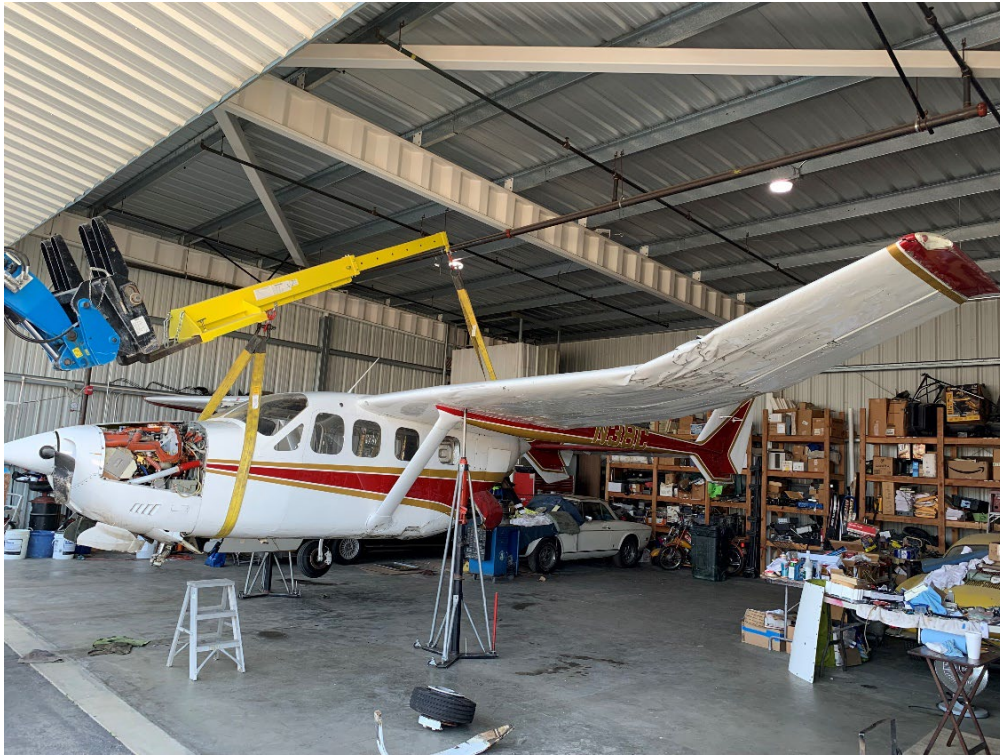
Figure 1. Left wing view

The left wing experienced a significant impact, causing it to bend upwards by approximately 30°, starting from around the midpoint of the wing.

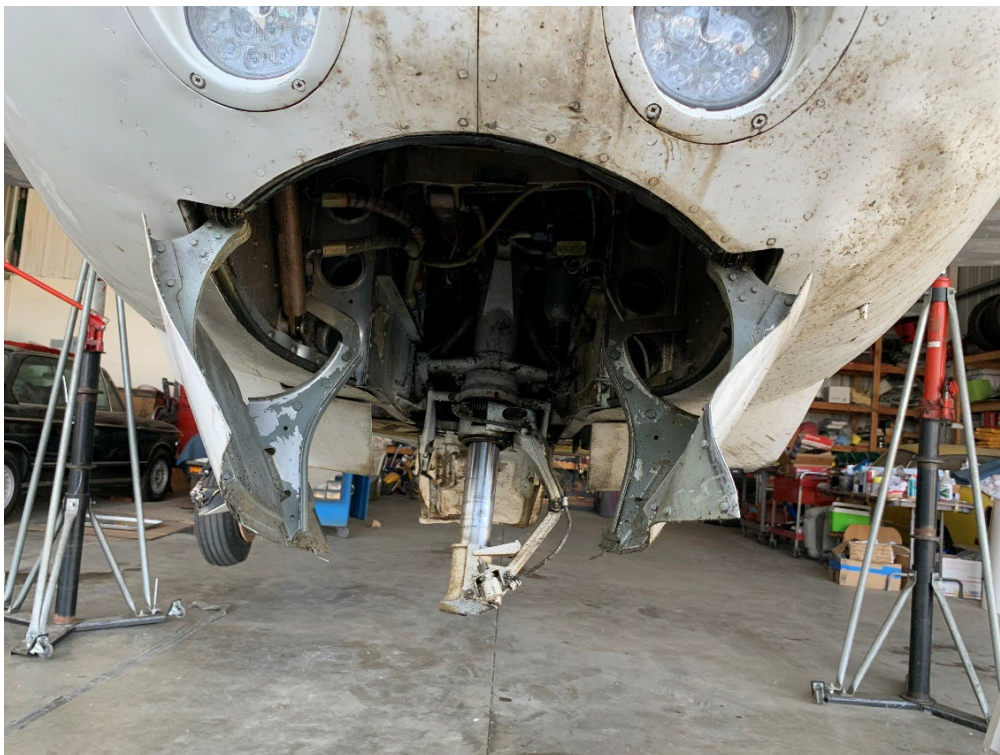
Figure 2. Front landing gear

Prior to the investigative team's arrival at the examination site, the airplane had been placed on jacks and supported additionally by lifting equipment. The landing gear remained in position as when the accident occurred. The nose landing gear was broken and separated in the down and locked position. The left main landing gear was broken and separated in the down and locked position. The right main landing gear was in the down and locked position in an undamaged condition. Both main landing gear doors were opened.

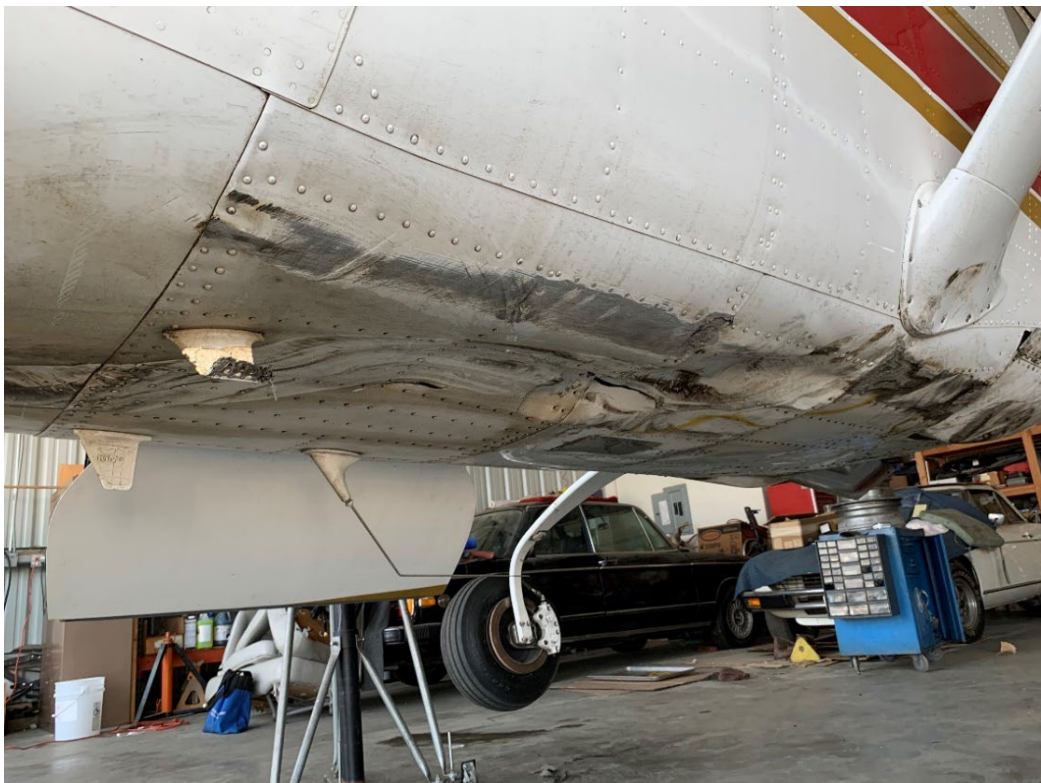
Figure 4. Bottom view

The bottom of fuselage was substantially damaged.

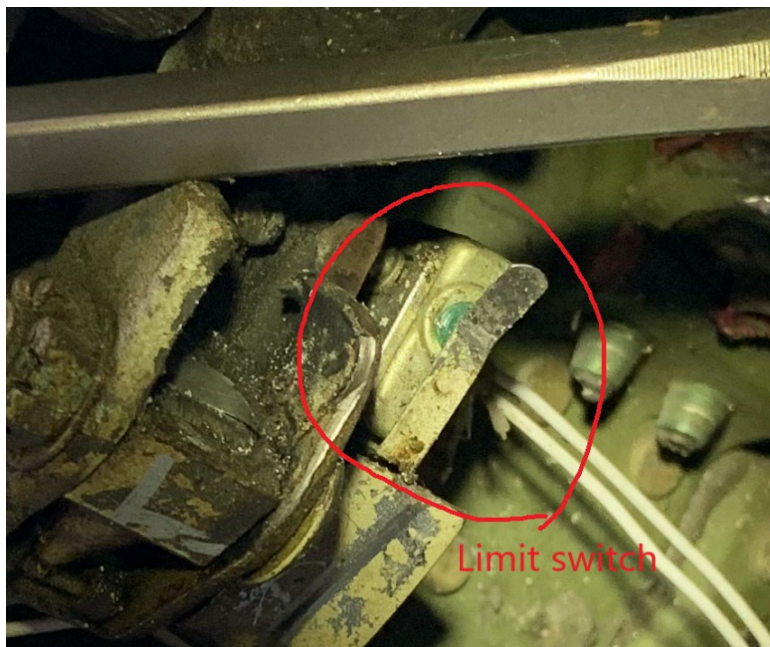
Figure 5. Left landing gear limit switch

The examination of the landing gear system was conducted at the airplane owner's hangar, located in Upland, California. During the examination, it was tested and verified that for the main landing gear doors to close, all three limit switches must be in the closed position. This allows the valves to appropriately direct hydraulic pressure to the door actuators, enabling the doors to be closed. The examination revealed that out of the three limit switches, the left one was not functioning properly.

During the examination, the landing gear system was cycled multiple times through gear extension and retraction to test each landing gear. An issue was observed with the failure of the main landing gear doors to close properly. While individually testing each limit switch through visual inspection and isolating them one by one, all components operated as expected, except for the left limit switch, which was identified as defective.

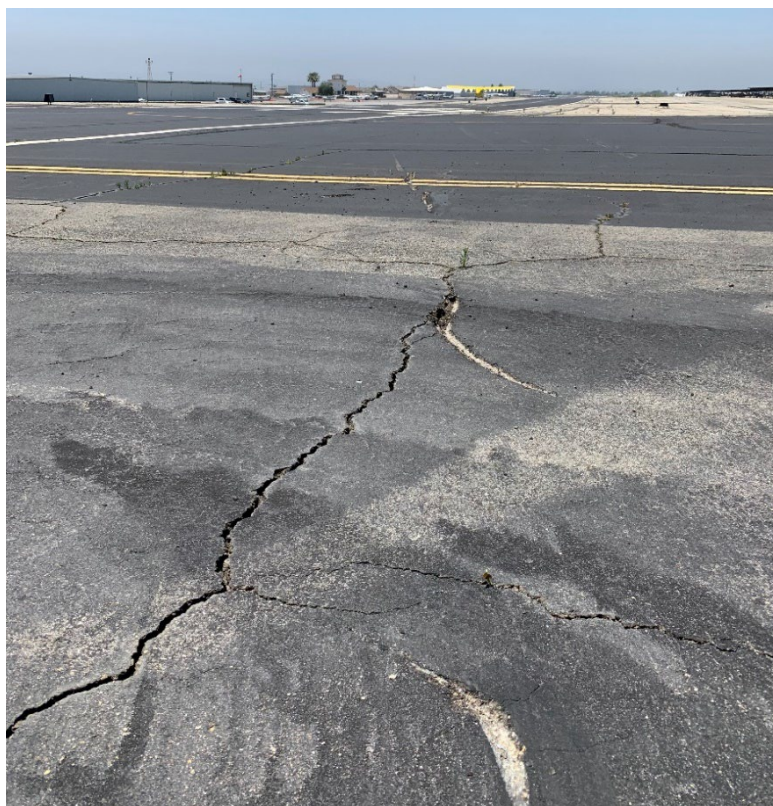
Figure 6. Impact site view

After examining the landing site, it was discovered that the airplane had impacted the asphalt surface short, and to the right of the runway threshold, leaving forceful impact marks in the surface.
