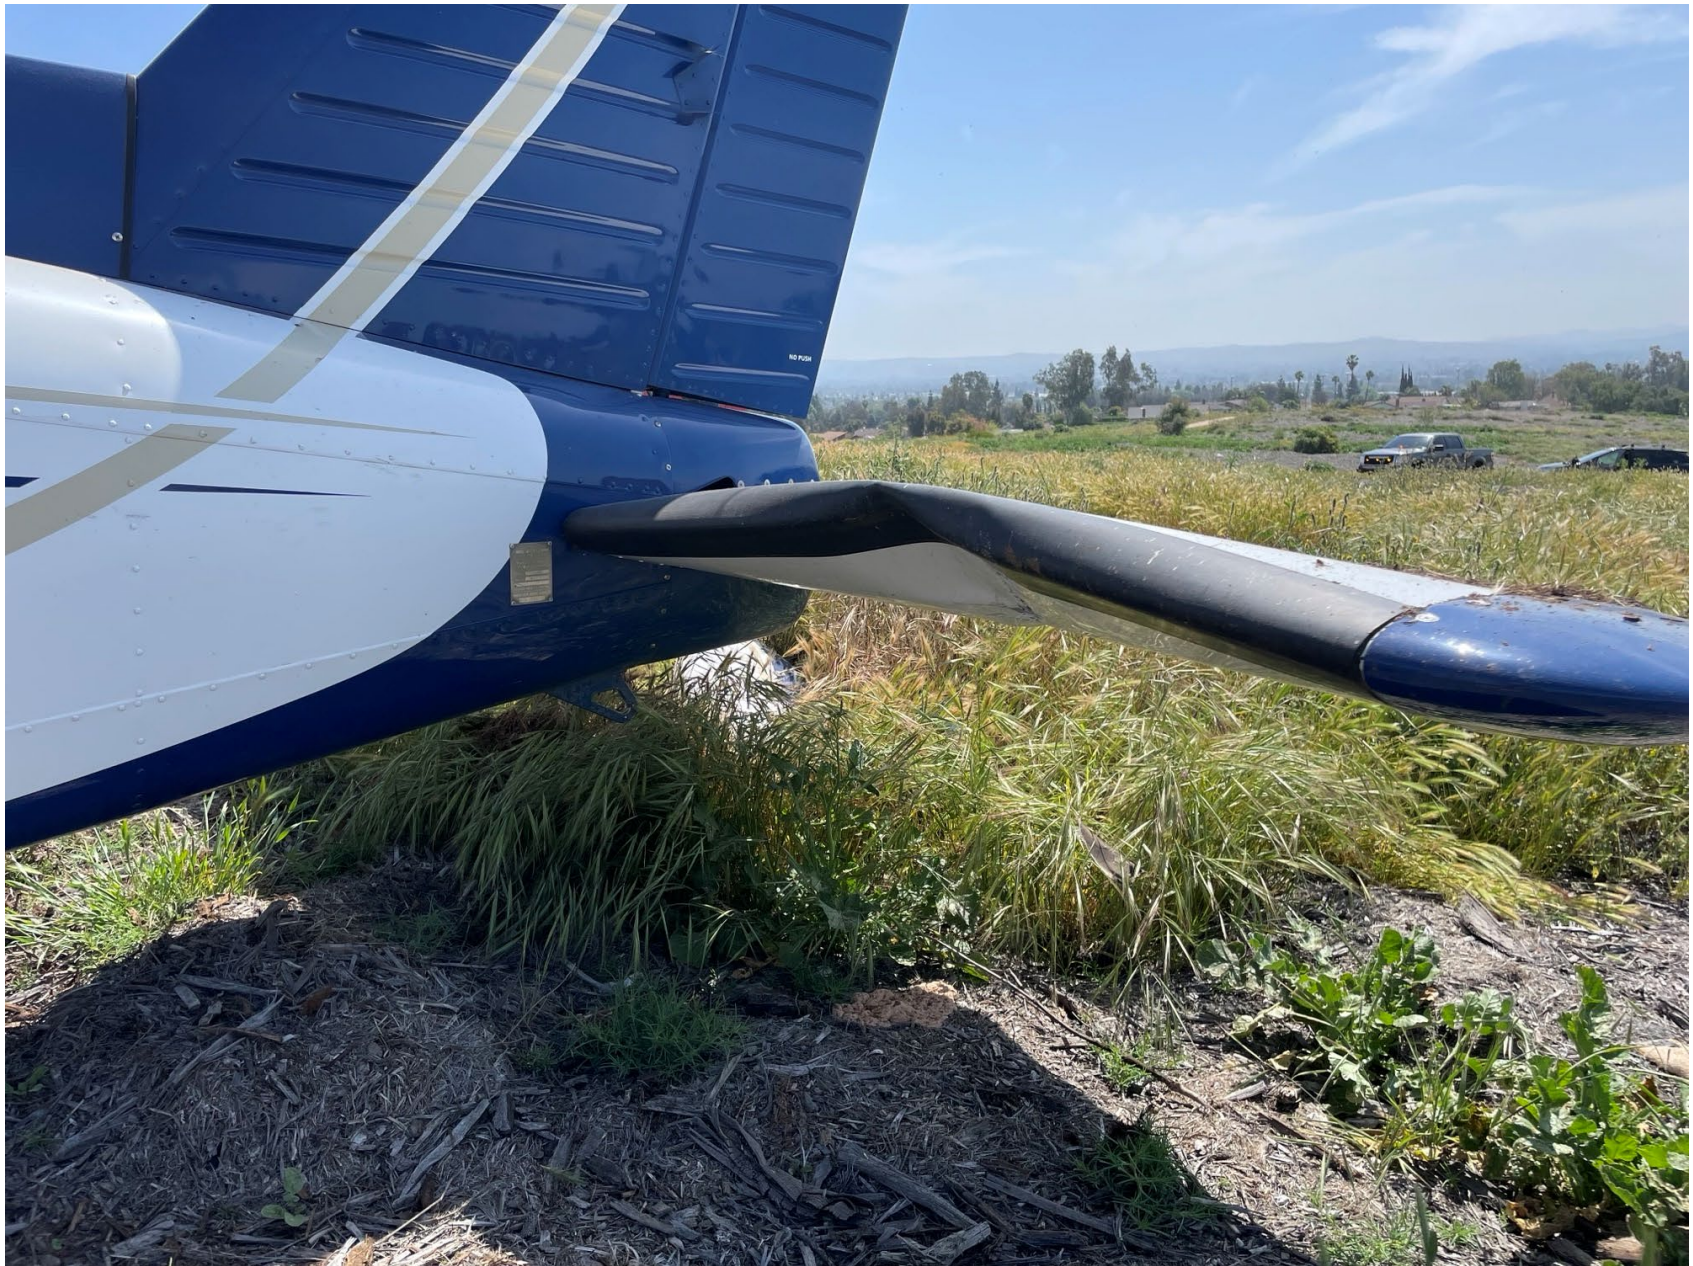
**Photo 1 – View of damage to stabilator. (photo courtesy of LEO)**

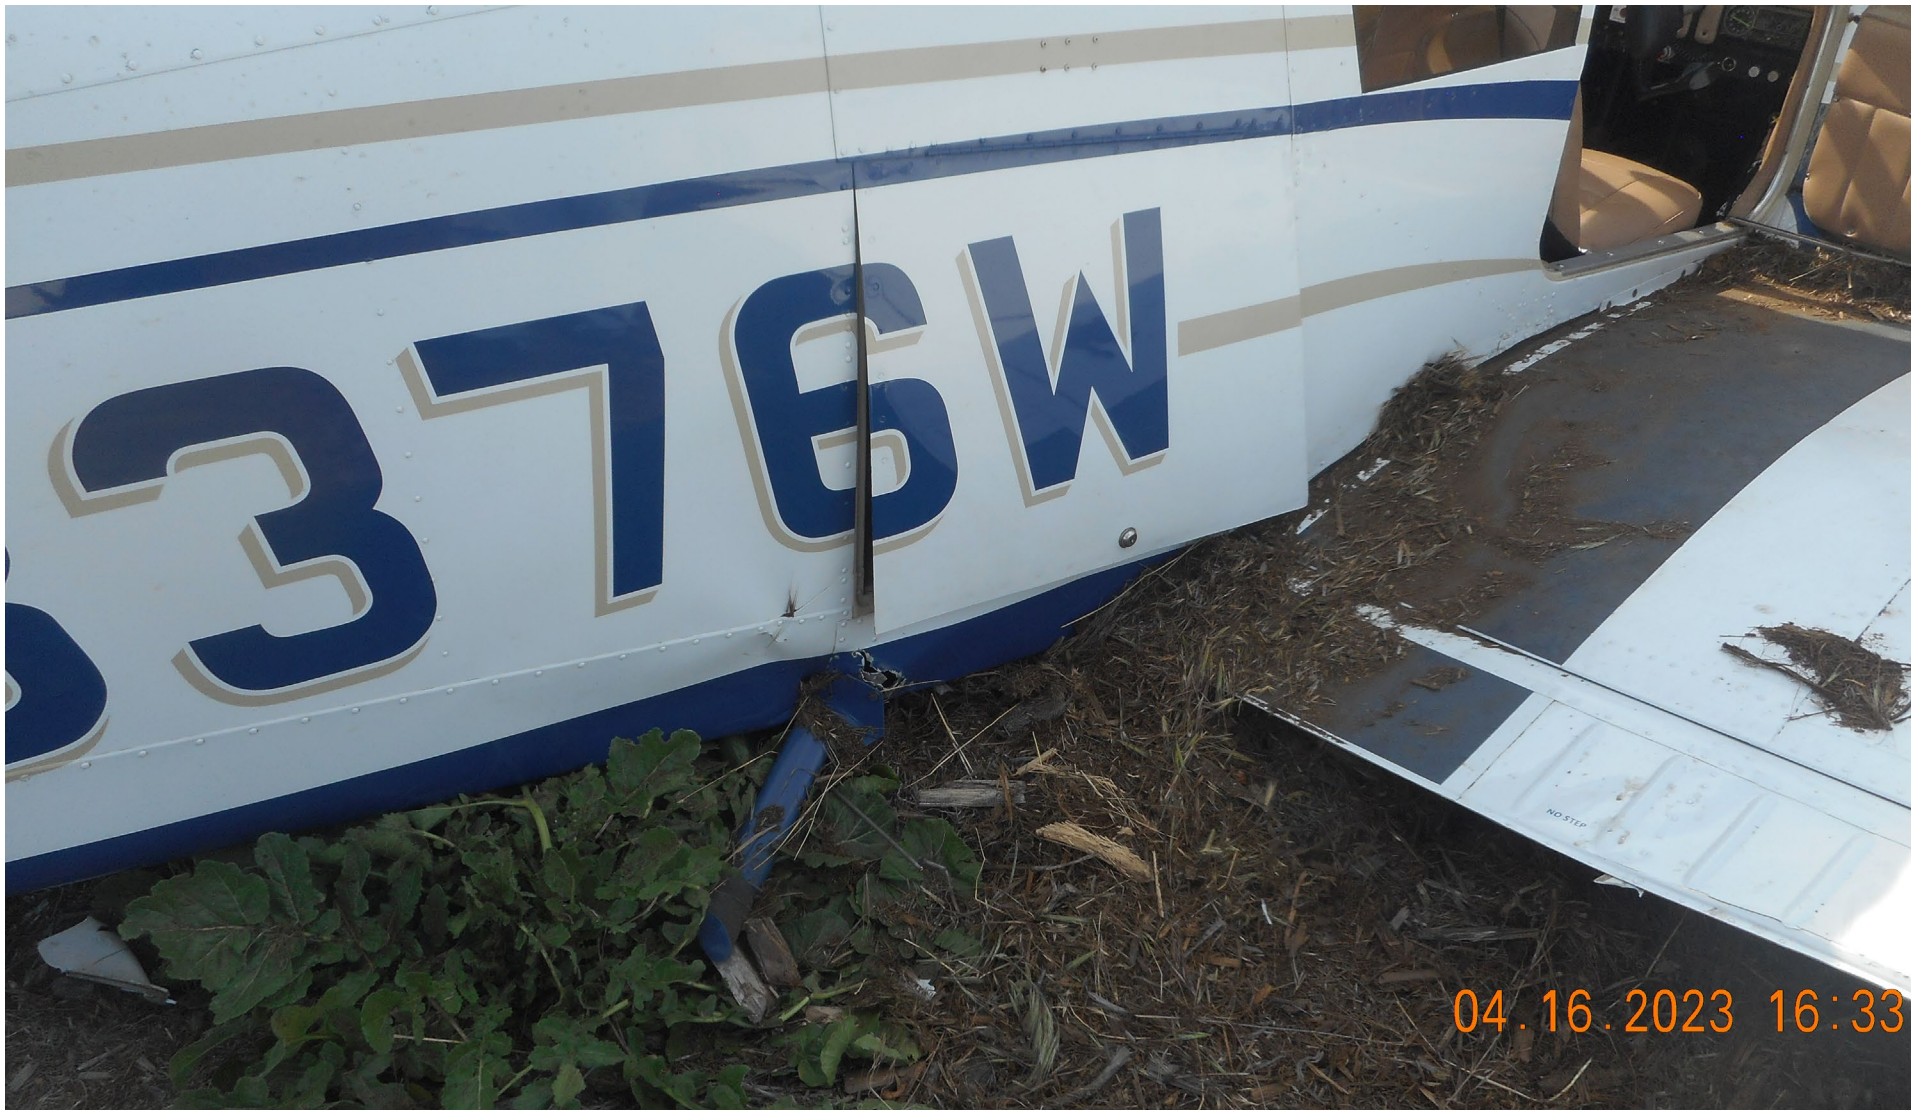
**Photo 2 – View of damage to fuselage. (photo courtesy of LEO)**
