# National Transportation Safety Board

WPR23LA156

## **AIRFRAME AND ENGINE EXAM**

Location: Riverside, CA  
Date: April 16, 2023  
Time: 1010 mountain daylight time  
Airplane: N8376W, Piper PA-28-180

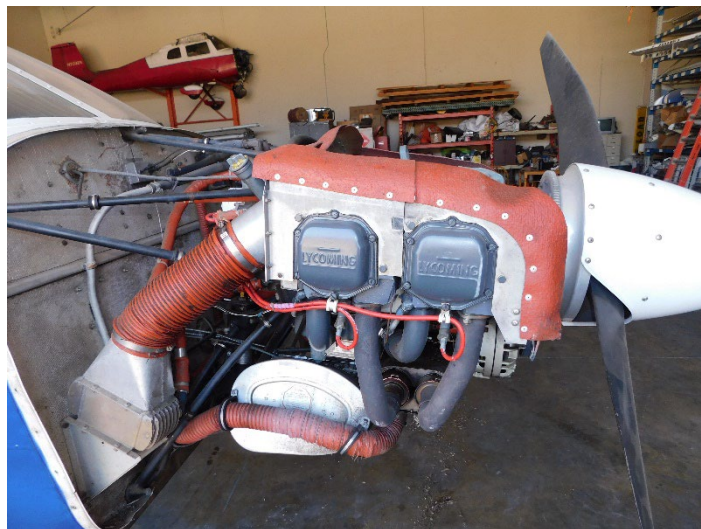
The engine remained attached to the airframe via the engine mount. The bottom of the engine mount was crushed upward and aft. All engine accessories remained attached to the engine. All fuel lines remained connected and secure to their respective fittings. Throttle cable continuity was established from the throttle control to the carburetor throttle control arm. Throttle arm travel was observed from stop to stop, via actuation of the throttle control. Mixture control continuity was established from the mixture control lever to the carburetor mixture control arm. Mixture travel was observed from stop to stop, via actuation of the mixture control lever. The mixture control cable was attached to a portion of the engine mount that was bent, which placed tension on the cable. Carburetor heat cable continuity was established from the carburetor heat lever to the air intake box.

**Figure 1: View of the recovered engine.**

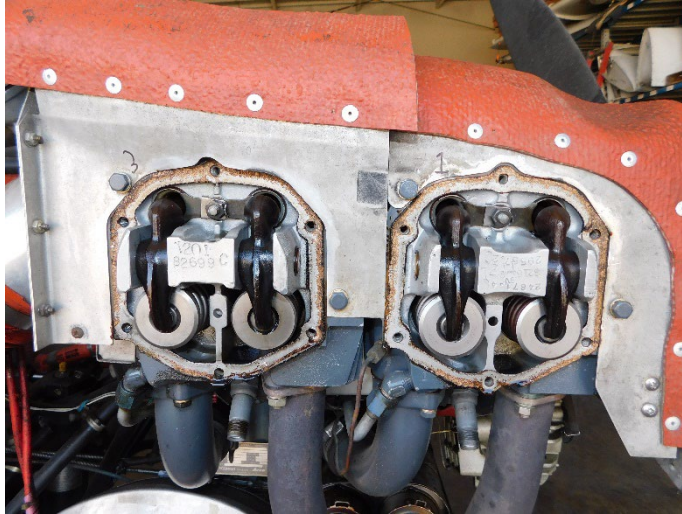
The upper spark plugs, and rocker box covers were removed. The propeller was rotated by hand and rotational continuity was established throughout the engine and valve train. Spark was observed on all spark plug ignition leads. Equal movement of all the intake and exhaust valve lifter arms was observed when the crankshaft was rotated. Thumb compression was obtained on all four cylinders.

**Figure 2: View of nos. 1 and 3 cylinders with rocker box covers removed.**
