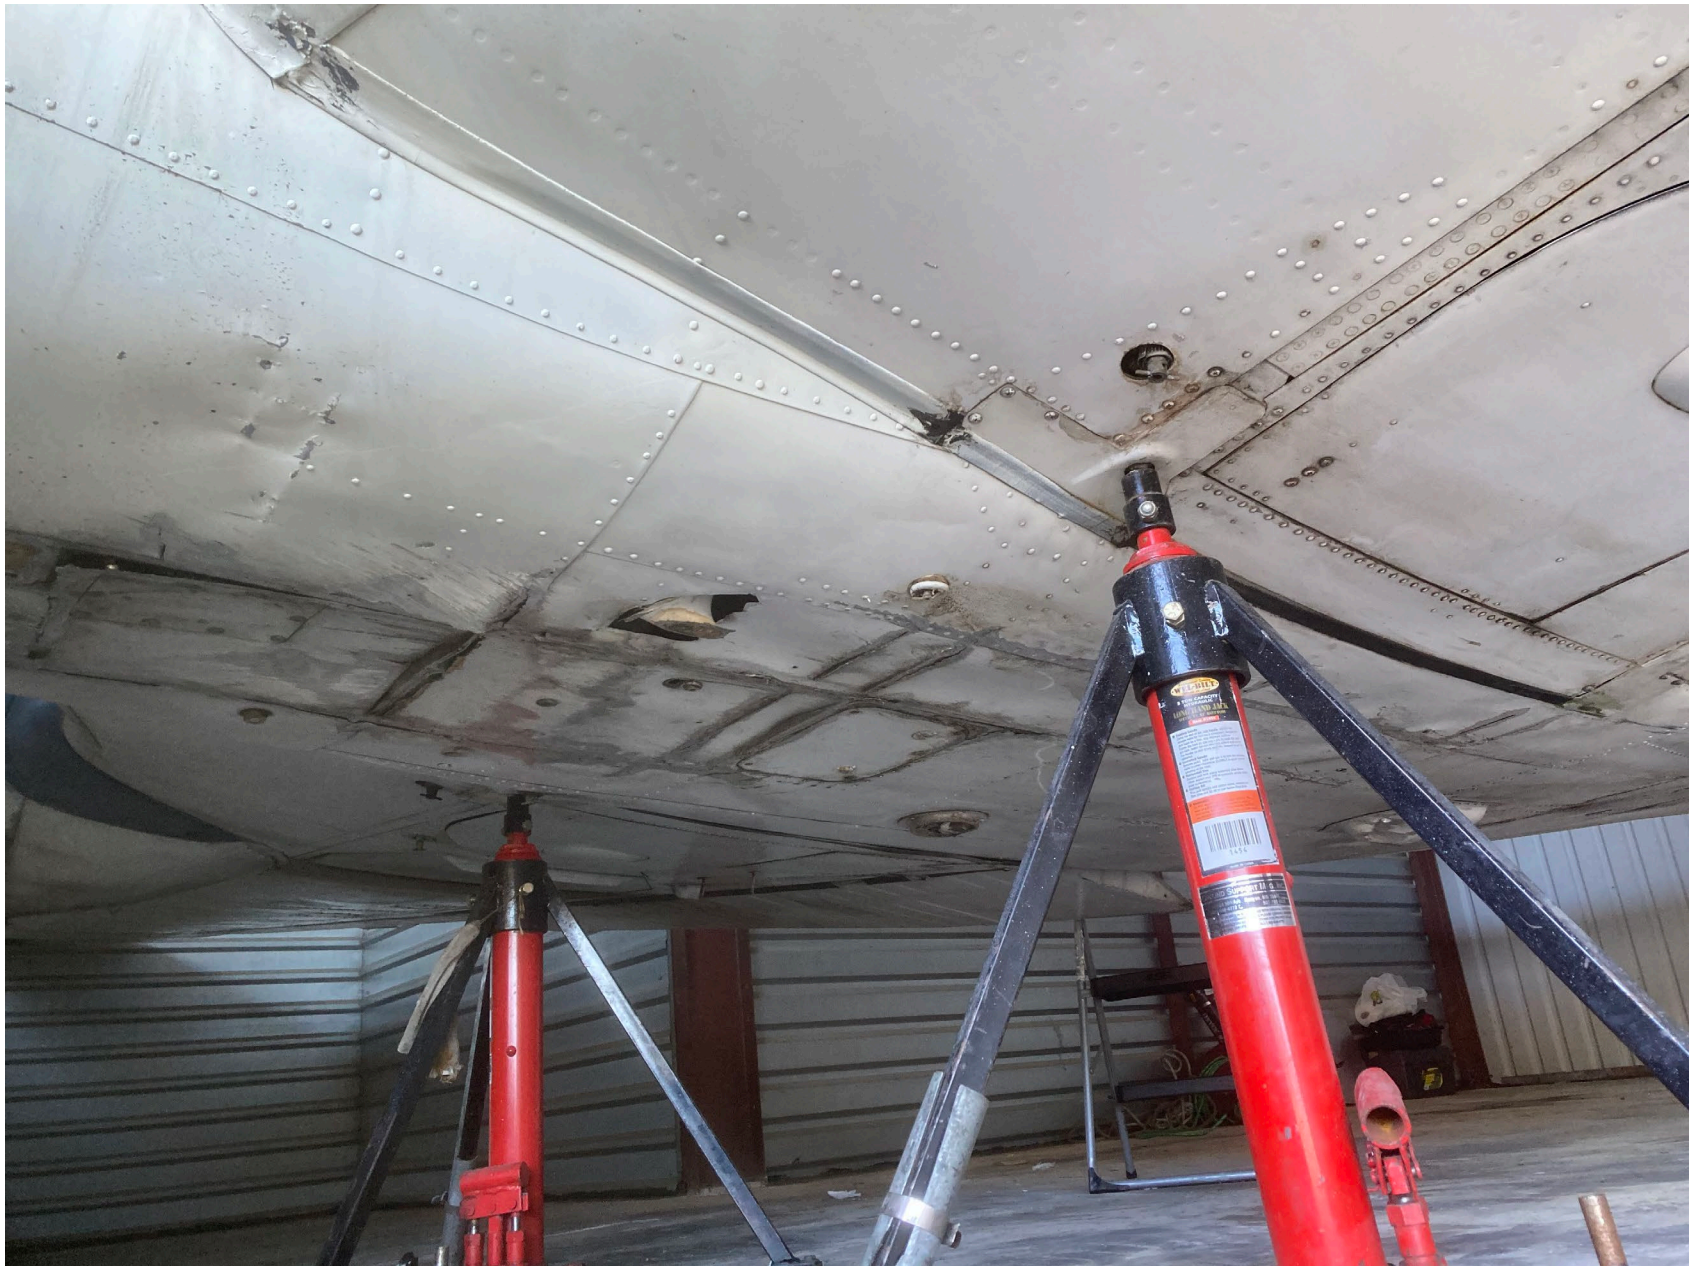
**Photo 2 – Damage to the Lateral Wing Spar Carry-Through Structure (Courtesy of Pilot)**
