Tealeye Cornejo  
Air Safety Investigator (Field)  
AS-WPR

**Date:** June 27, 2023

**Subject:** WPR23LA175, Borescope Photographs

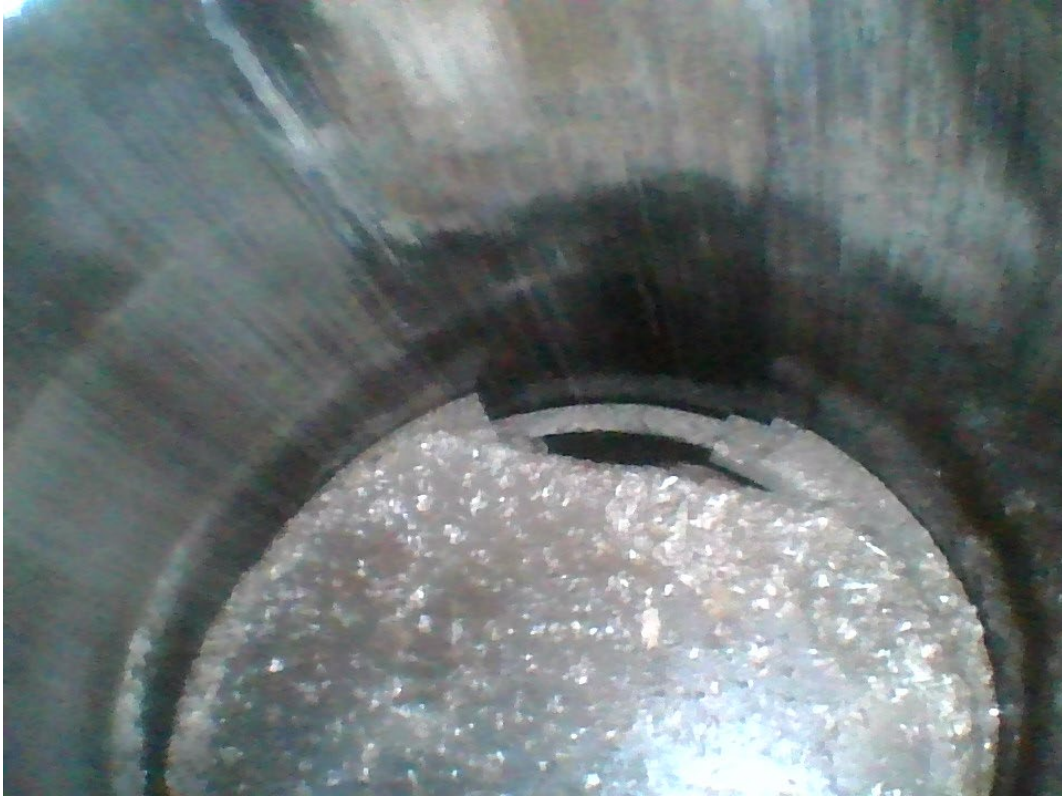
The cylinders from both engines were borescoped with parallel scrape marks on the interior of the cylinder barrels and corresponding scuff marks on the sides of the pistons. The aluminum alloy piston faces were eroded/melted away.

The damage to the rear engine prevented it from rotating and the engine-to-magneto timing could not be established. The No 5 cylinder was borescoped before removal.

*Figure 1: View of the No. 5 cylinder rear engine*

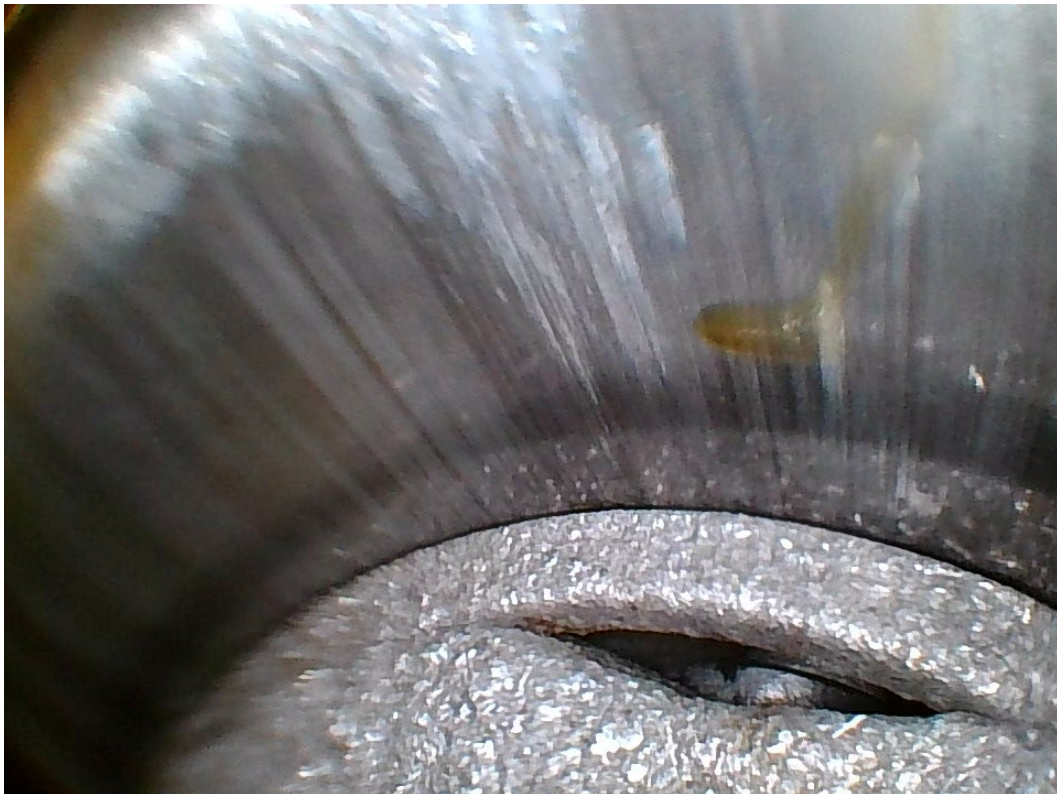
The front engine was able to be manually rotated, with mechanical continuity established. The engine-to-magneto timing was not established due to impact damage. The spark plugs for the front engine were removed and exhibited signs of an engine running lean.

*Figure 2: View of the No. 1 cylinder front engine*
