Tealeye Cornejo  
Air Safety Investigator (Field)  
AS-WPR

**Date:** June 28, 2023

**Subject:** WPR23LA175, Engine Examination

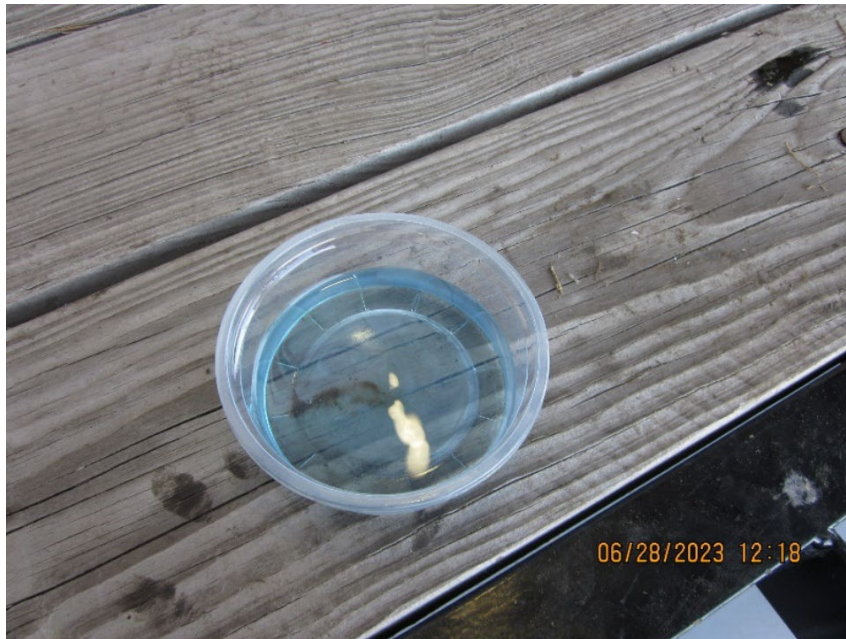
A sample of fuel was obtained from the rear airframe fuel filter. The liquid was blue in color, consistent with 100LL. No debris was observed in the fuel sample.

*Figure 1: View of fuel from rear airframe fuel filter*

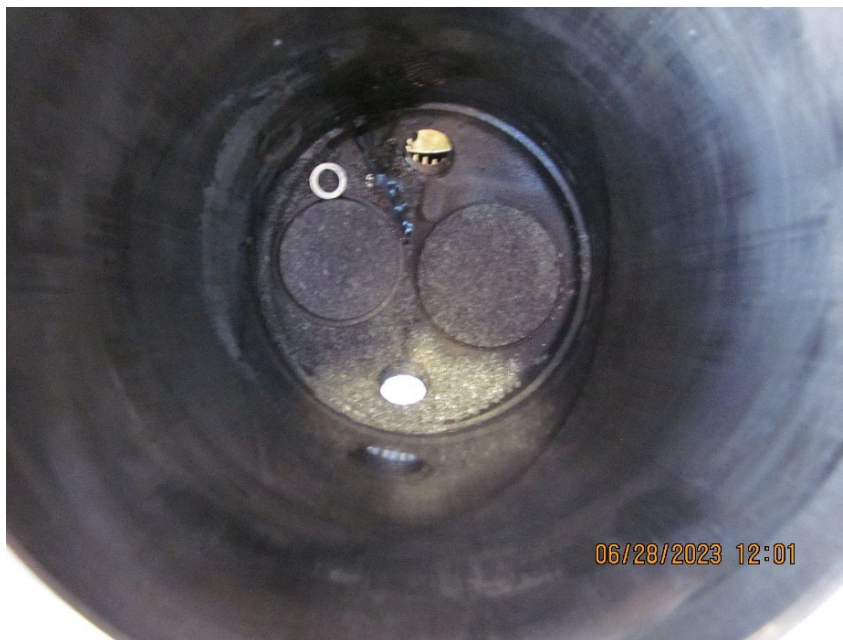
*Figure 2: Internal View of the No. 4 cylinder*

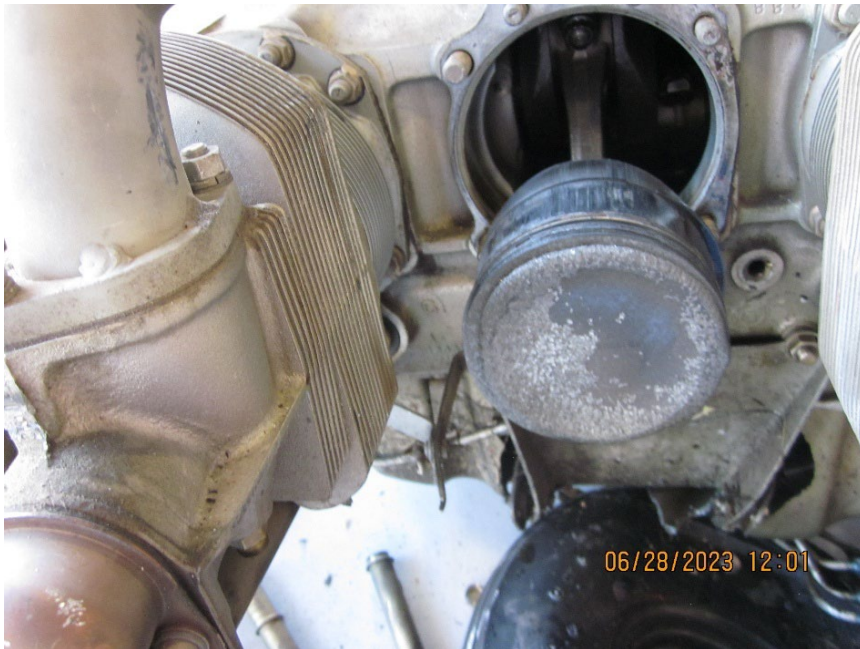
Inspector Hanson provided oversight for the engine inspections. He reported no evidence of any mechanical damage was observed to the engine cases. The cylinders for both engines were removed. All the piston faces were melted as well as being able to see wrist pins. Each engine was lubricated.

*Figure 3: Top View of the No. 4 piston*

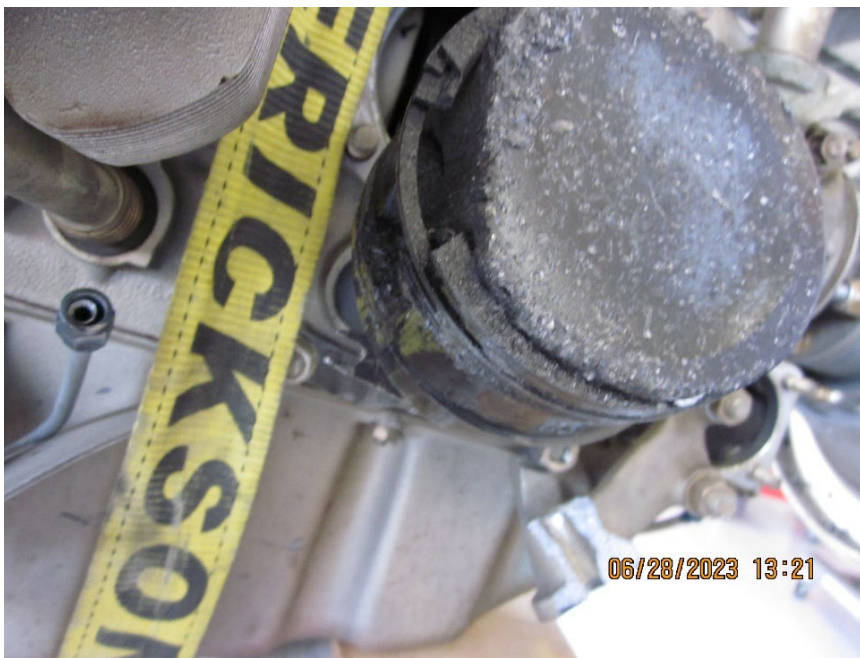
*Figure 4: Side View of No. 5 Piston*

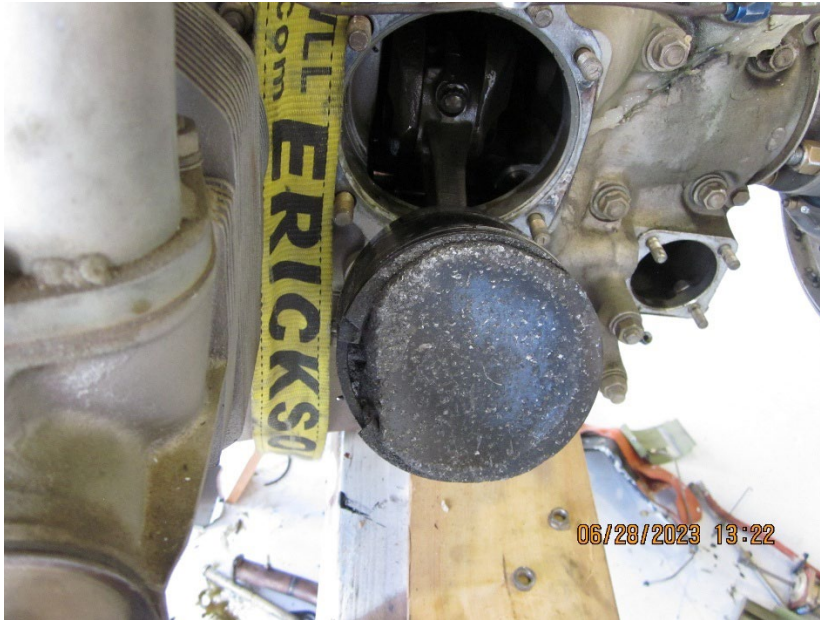
*Figure 5: Front View of the No. 5 Piston*

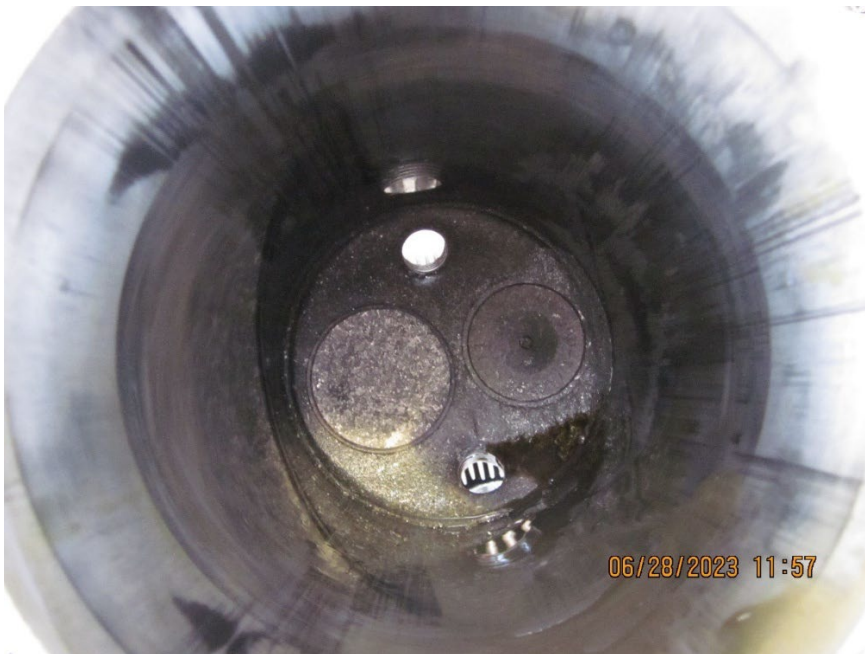
*Figure 6: Internal View of No. 1 cylinder barrel*

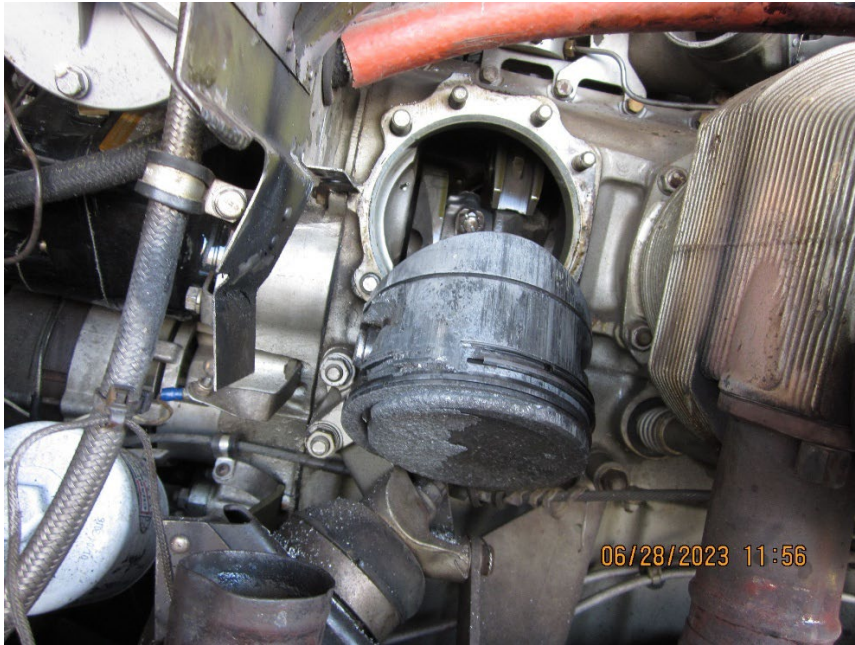
*Figure 7: Side View of No. 1 Piston*

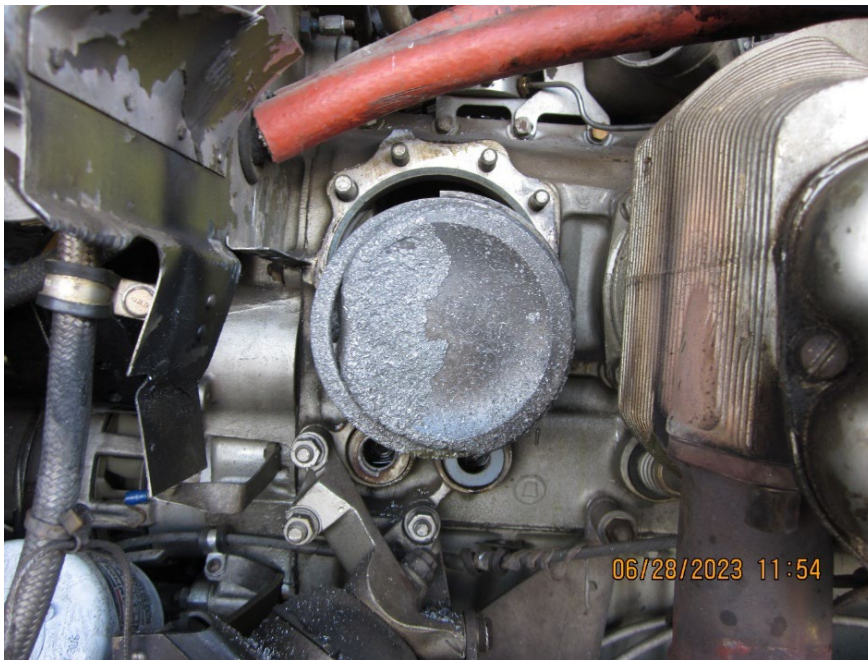
*Figure 8: Front View of No. 1 Piston Face*
