# National Transportation Safety Board

WPR23LA177

## **AIRFRAME AND ENGINE EXAMINATION REPORT**

Location: Pasco, Washington  
Date: 5/3/2023  
Time: 1835 (L)  
Airplane: Cessna 210M / N177CF

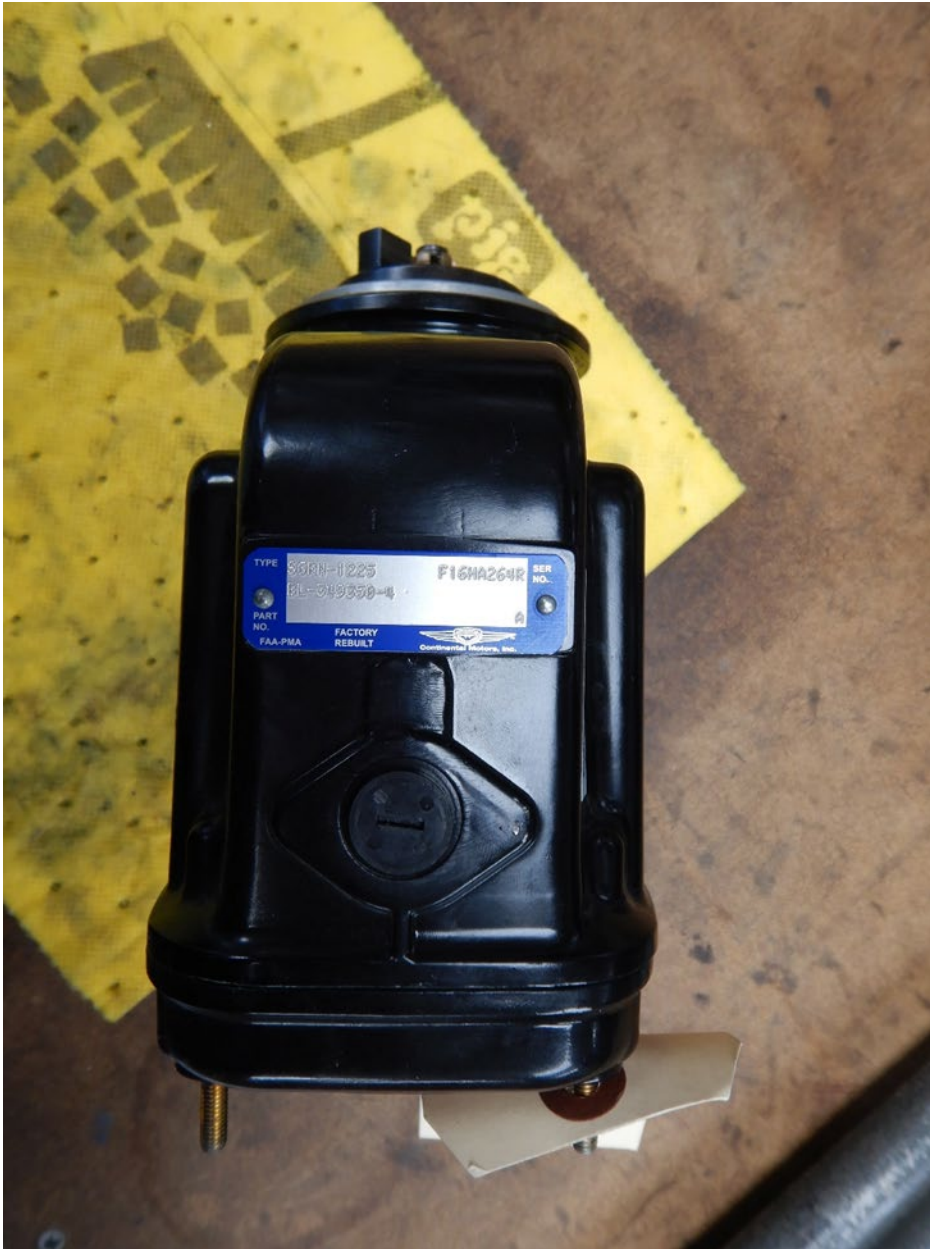
**Figure 1. Magneto F16HA264R**

The IIC travelled to AES to provide overwatch of the magneto examination. The magnetos were removed from storage and photographed. The caps and leads were not shipped with the magnetos. Both magnetos were in good condition with no impact damage.

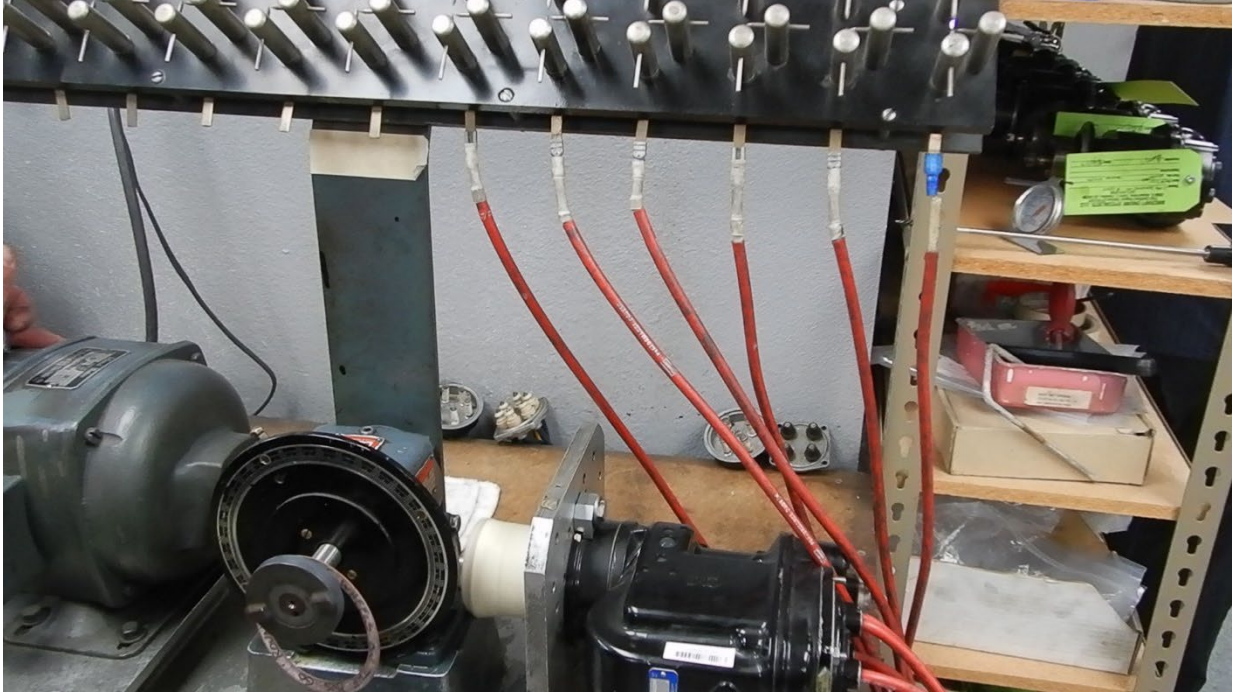
**Figure 3. Magneto F16GA384R on test bench.**

- Both magnetos exhibited correct timing.
- Both magnetos performed normally when installed onto a magneto test bench.
- Both magnetos were operated at speeds from 400 to 2,500 RPM.

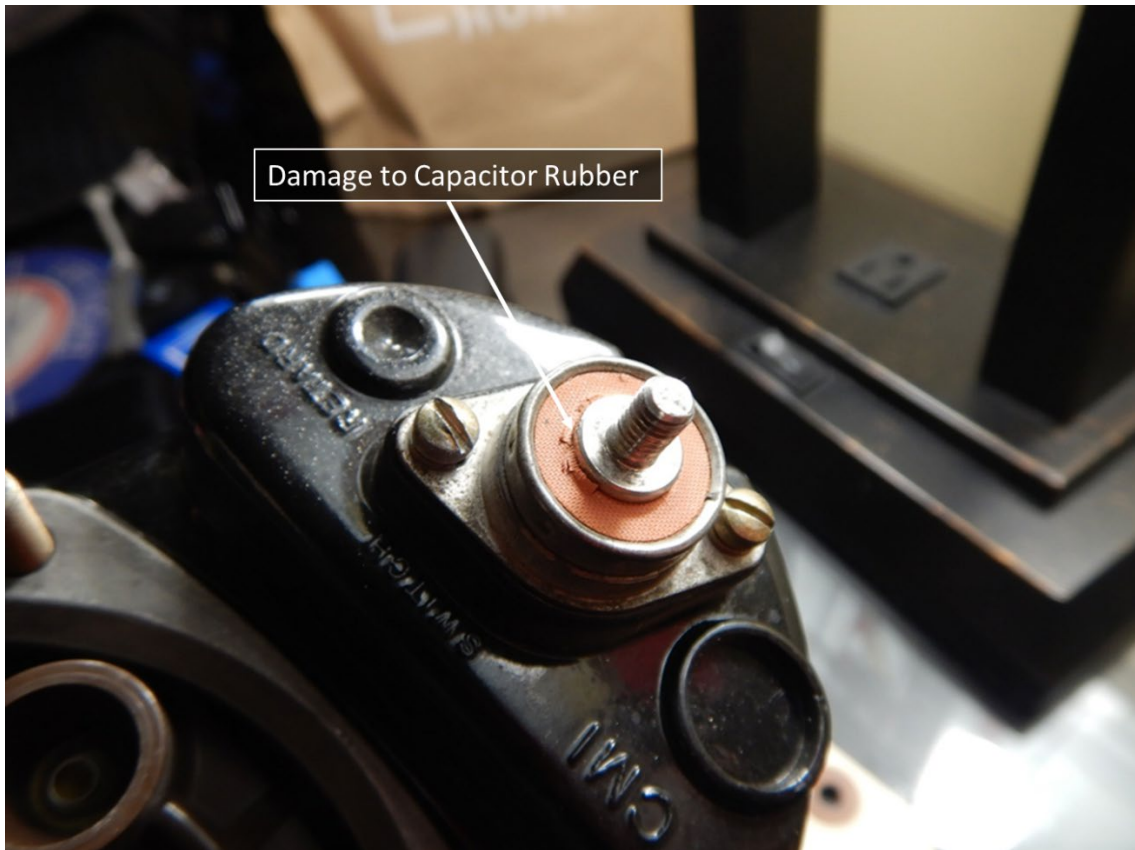
Examination revealed that both capacitor studs exhibited torn rubber insulation, consistent with over-torque of the capacitor studs; however, the studs were not damaged.

**Figure 5. Torn rubber at the capacitor stud, F16HA264R**

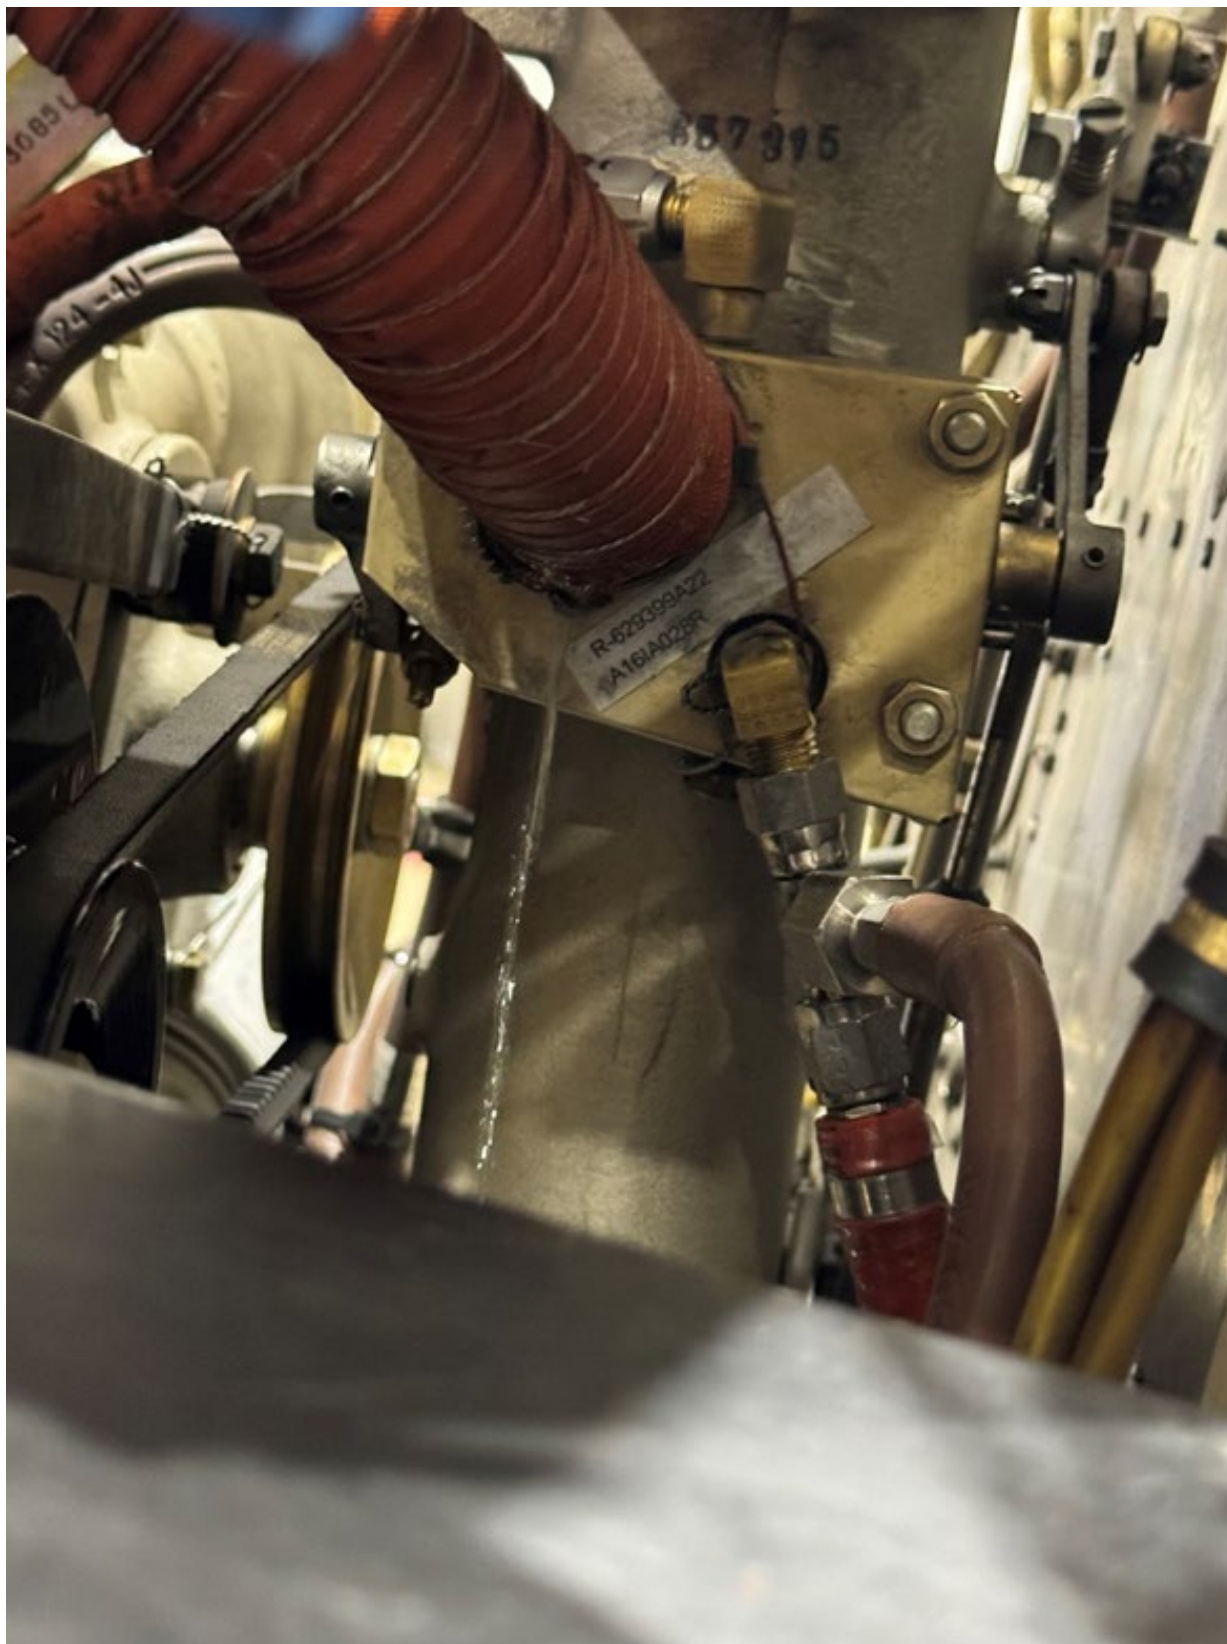
The airplane was moved outside to facilitate a test run. The engine was primed utilizing the airframe boost pump prior to start. Multiple attempts to start the engine resulted in the engine running briefly for about 2 to 3 seconds before losing power. Fuel began to puddle under the aft area of the engine.

The airplane was moved back into the hangar, and all six fuel injector lines were disconnected from the injector nozzles. Cups were placed under each injector nozzle, and the airframe fuel pump was turned on. Some fuel was observed expelling from each injector line. Fuel was observed leaking from the fuel servo outlet line on the fuel servo side. The line was moved by hand and became instantly disconnected from the fuel servo fitting. No additional anomalies were noted with the examination of the airframe or engine.

**Figure 7. Fuel leaking from the fuel servo outlet line.**

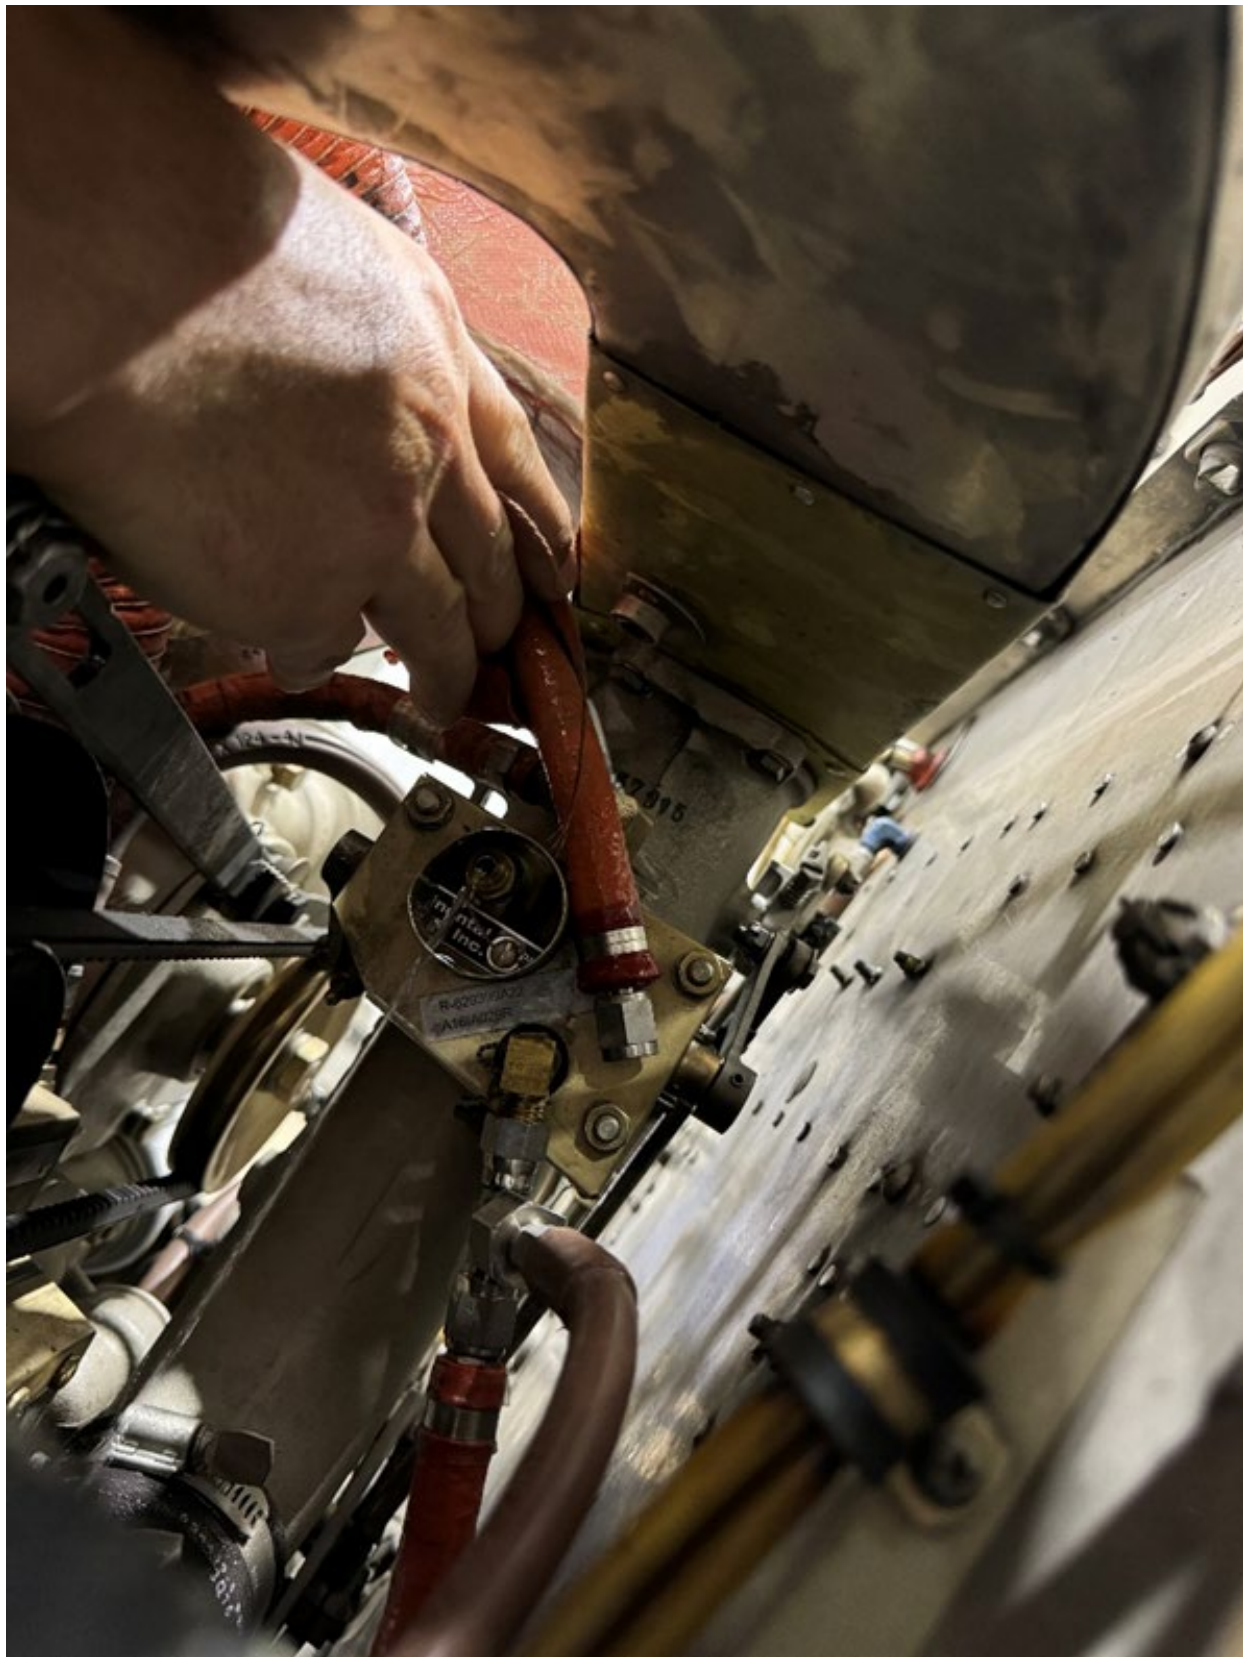
**Figure 8. The fuel servo outlet line pulled away from the fuel servo.**
