# National Transportation Safety Board

WPR23LA177

## **AIRFRAME AND ENGINE EXAMINATION**

Location: Pasco, Washington  
Date: May 3, 2023  
Time: 1835 Pacific daylight time  
Airplane: Cessna 210M, N777CF

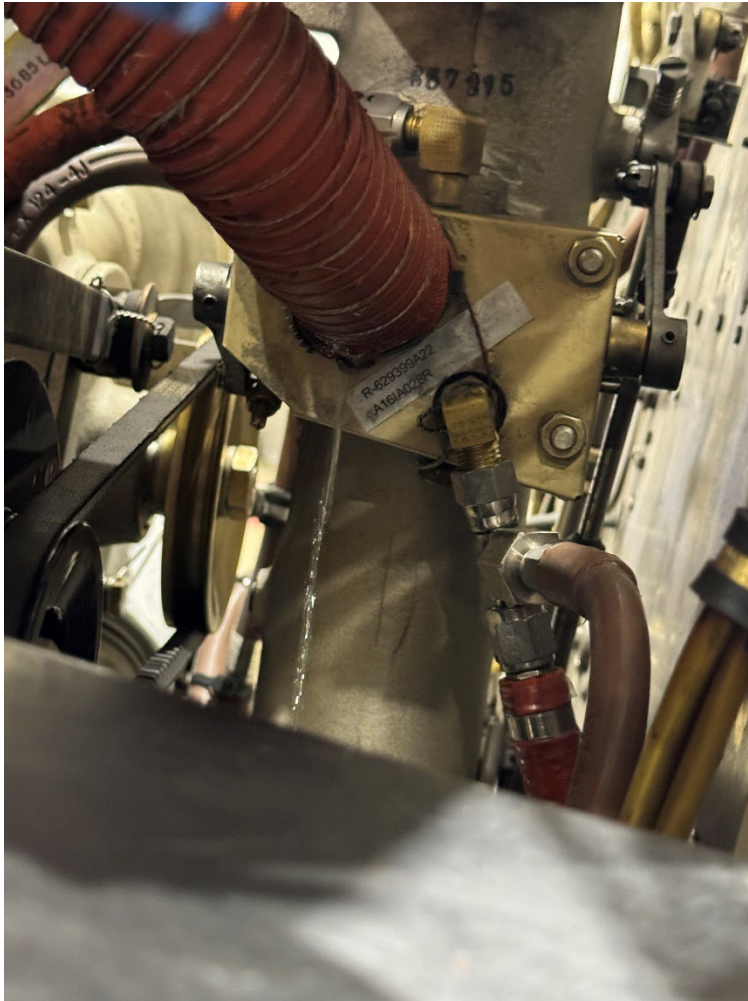
The airplane was moved back into the hangar, and all six fuel injector lines were disconnected from the injector nozzles. Cups were placed under each injector nozzle, and the airframe fuel pump was turned on. Some fuel was observed expelling from each injector line. Fuel was observed leaking from the fuel servo outlet line on the fuel servo side. The line was moved by hand and became instantly disconnected from the fuel servo fitting. No additional anomalies were noted with the examination of the airframe or engine.

**Figure 1: Fuel leaking from the fuel servo outlet line.**

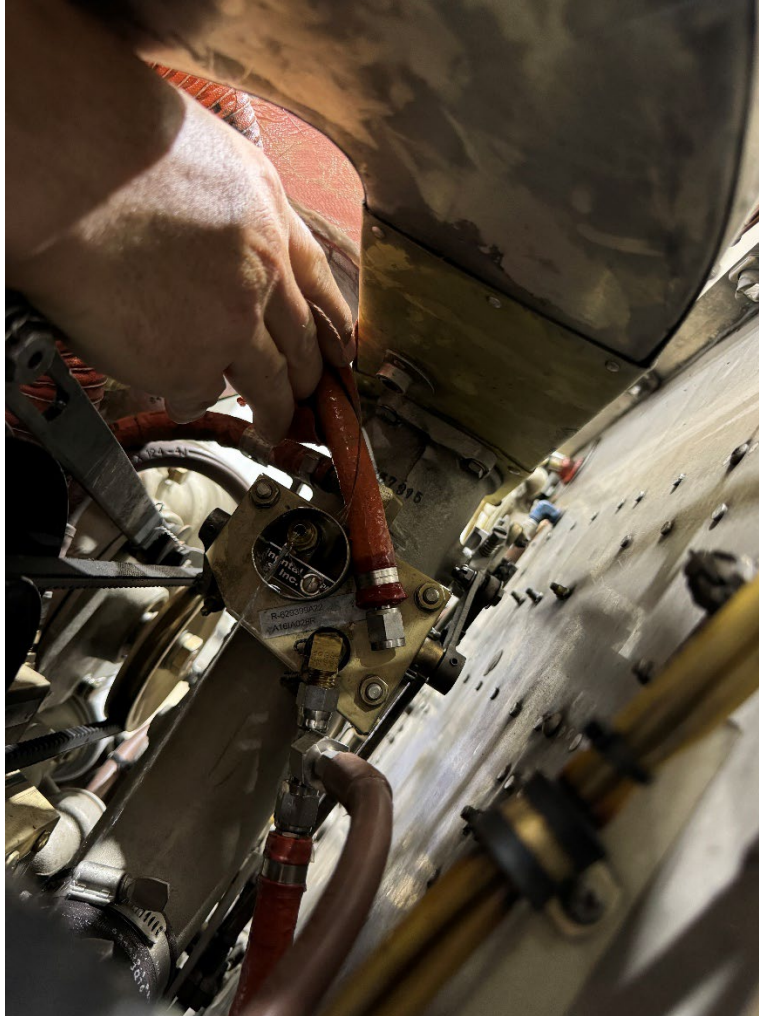
**Figure 2: The fuel servo outlet line pulled away from the fuel servo.**

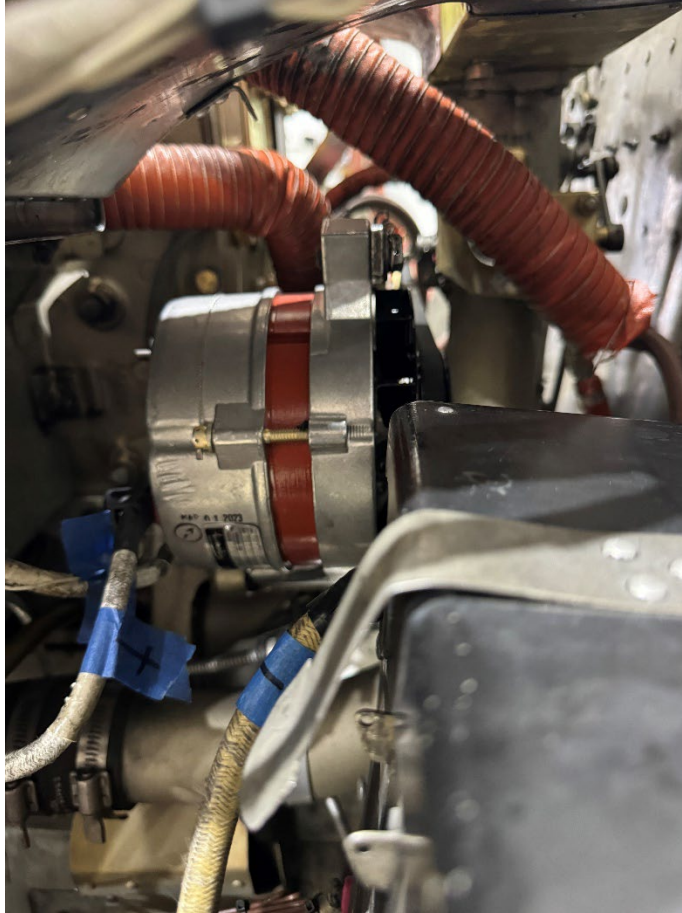
**Figure 3: View of the area of the alternator and battery box, with the fuel servo outlet fuel line in view.**
