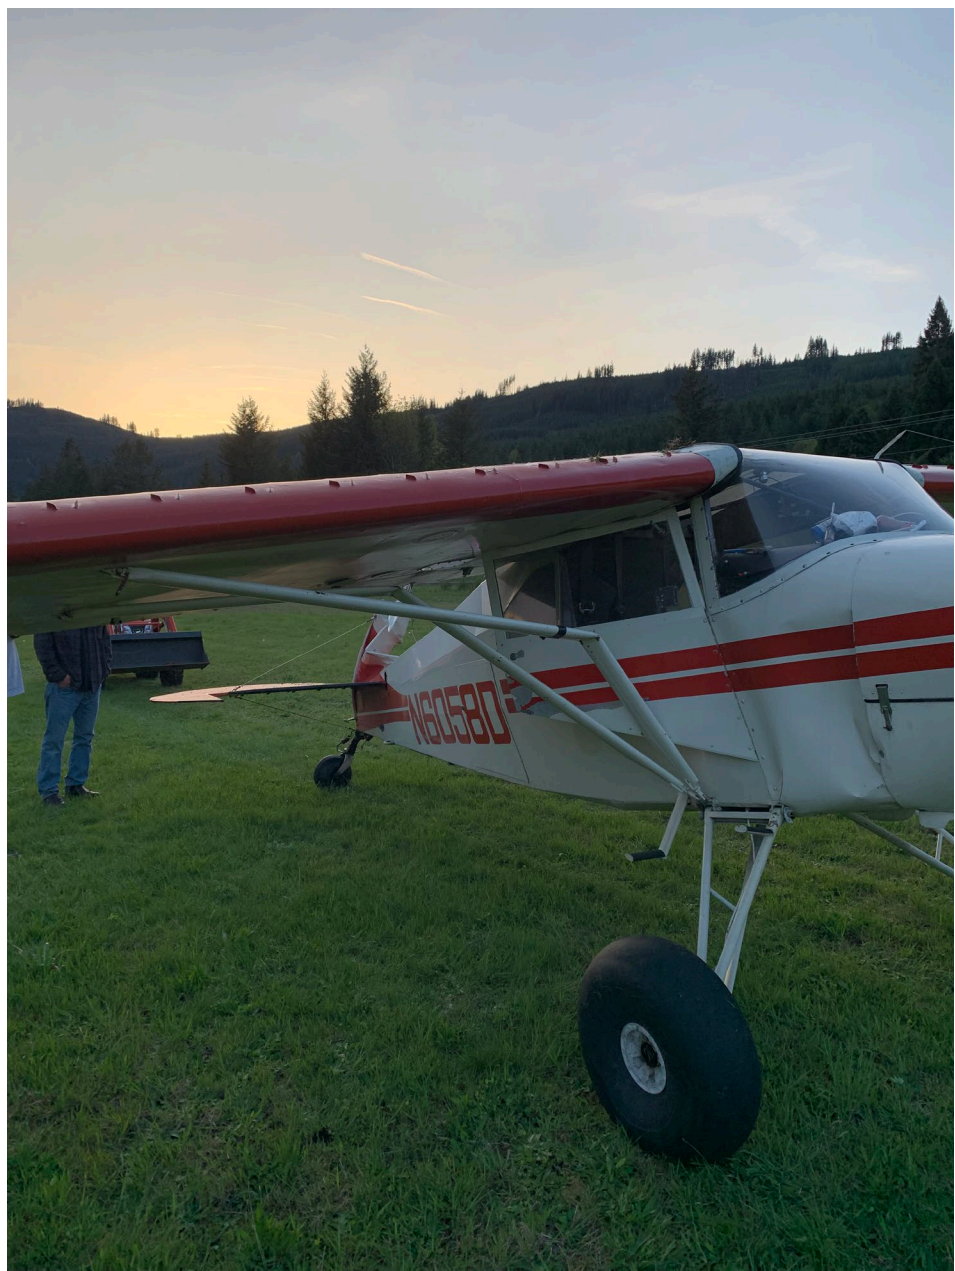
**Photo 1 – View of damage to right wing strut (courtesy of pilot)**

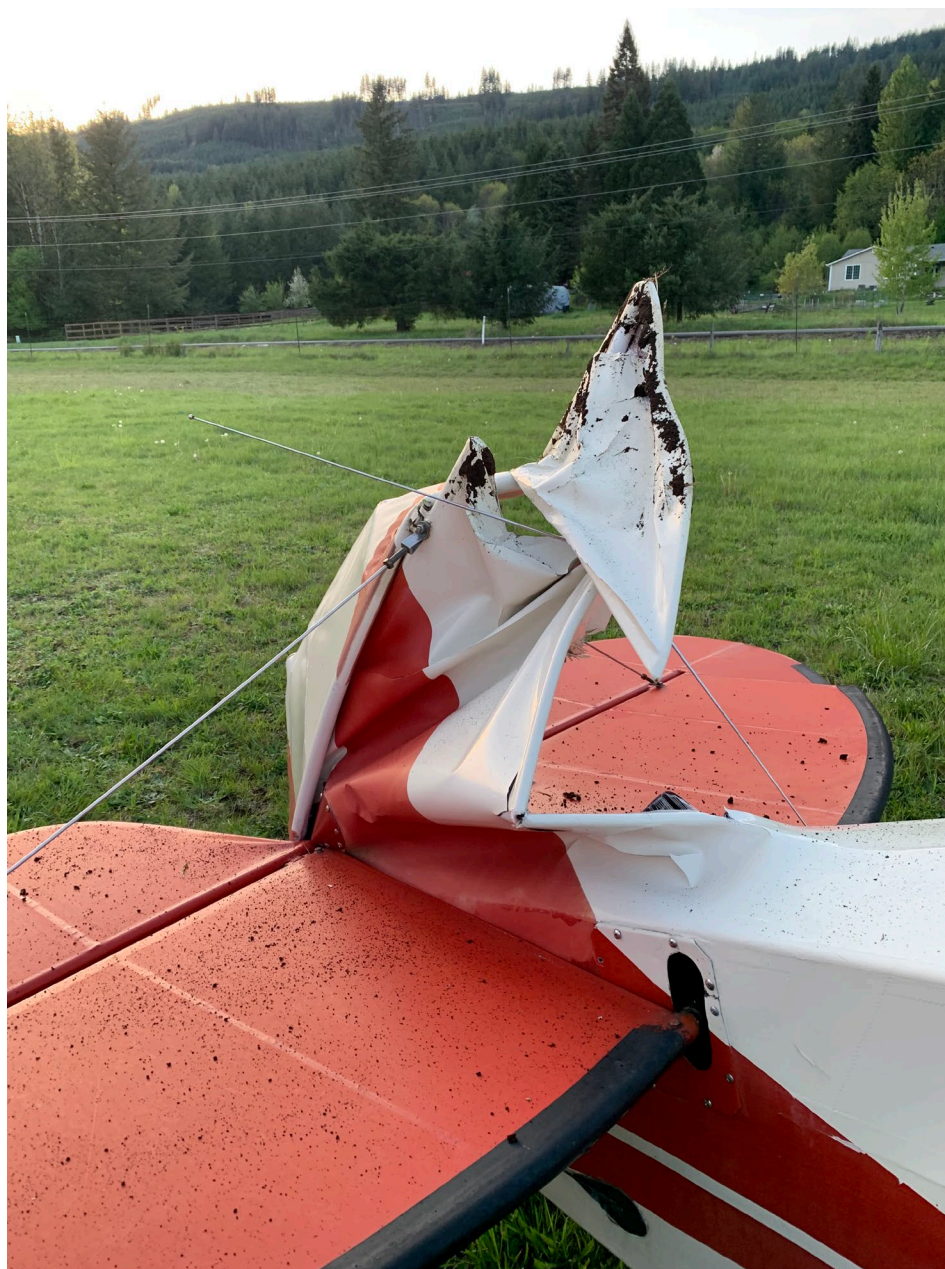
**Photo 2 – (View of damage to vertical stabilizer and rudder (courtesy of pilot))**
