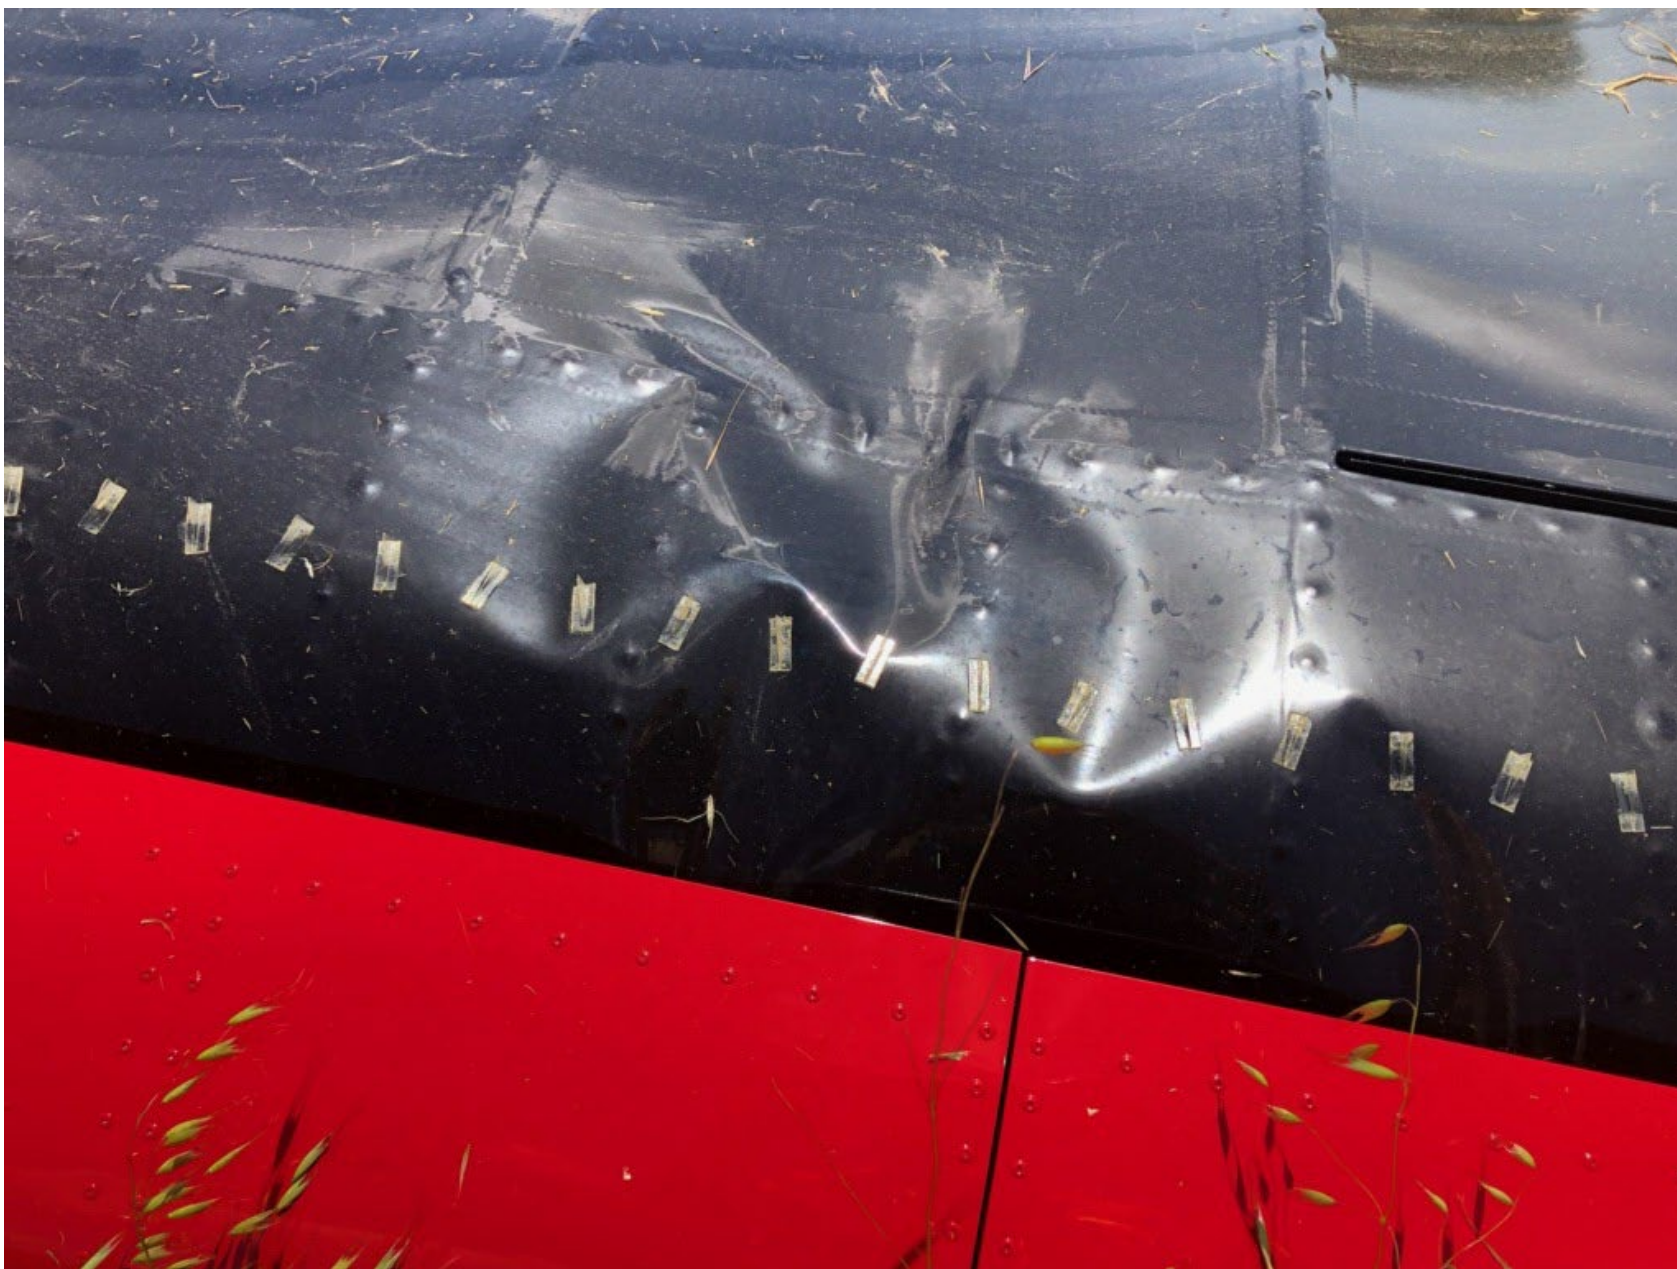
**Photo 1 – View of substantial damage to left wing (provided by LEO)**

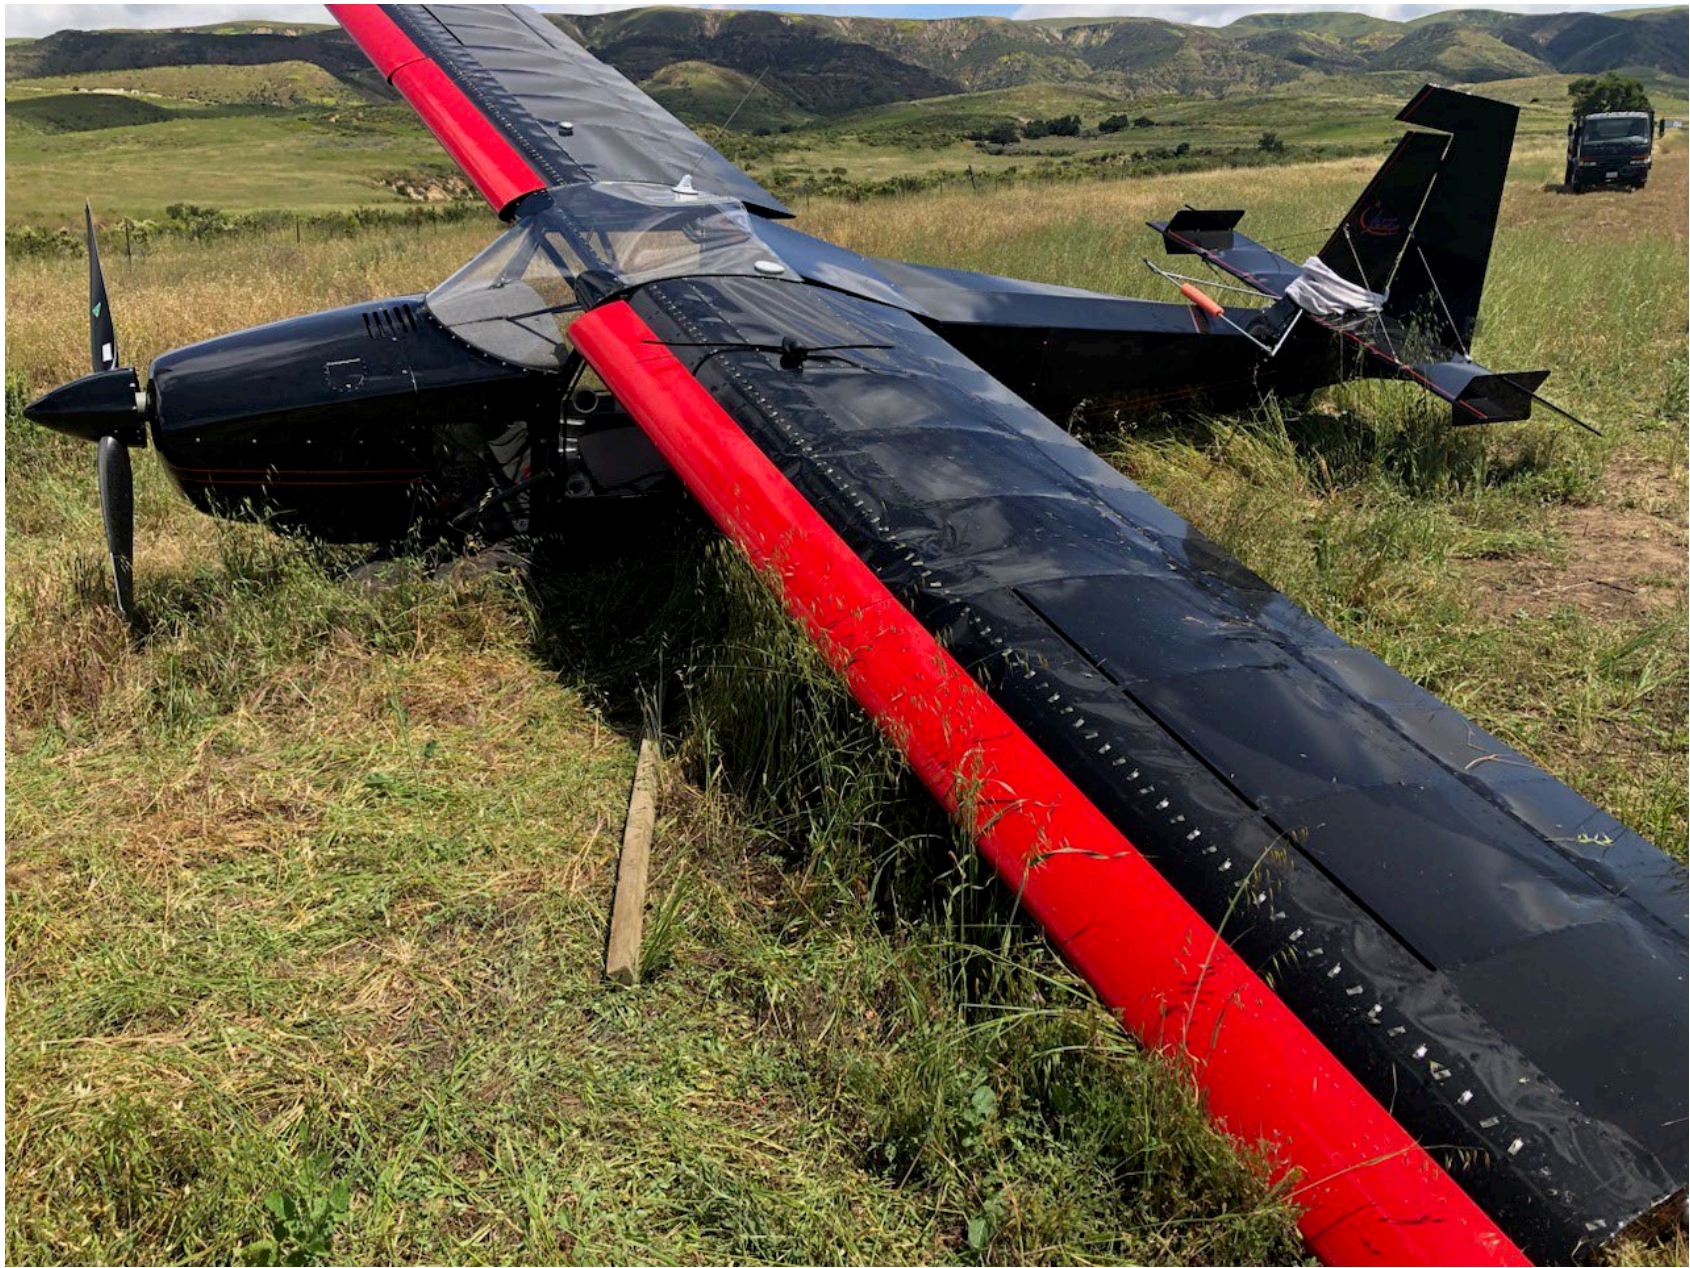
**Photo 2 – View of airplane for reference (provided by LEO)**
