# National Transportation Safety Board

WPR23LA184

## **MATERIALS LABORATORY**

Factual Report 23-068

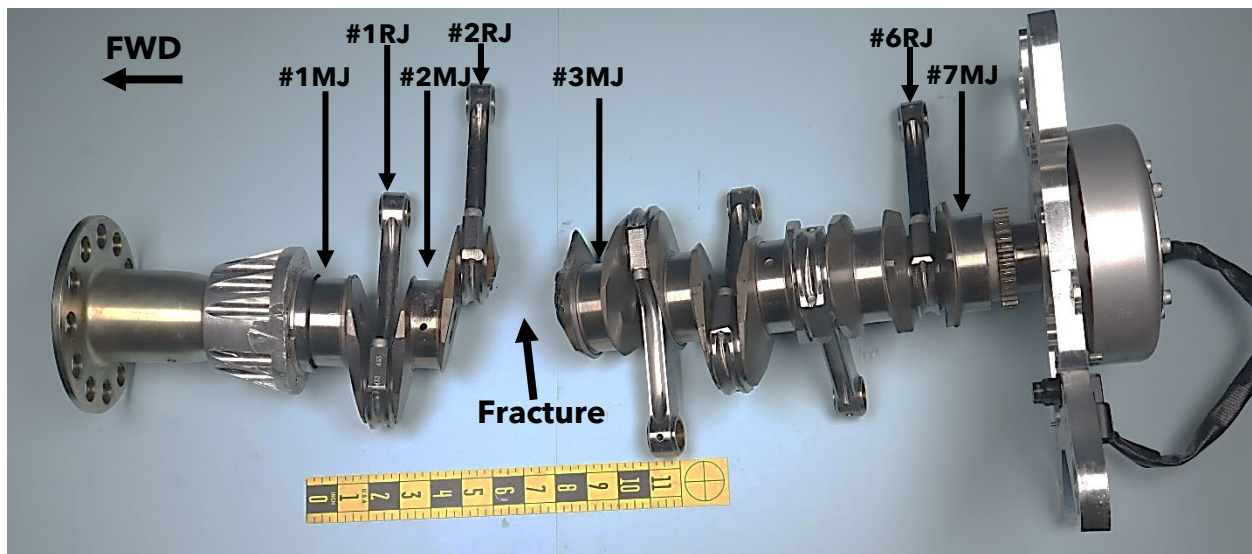
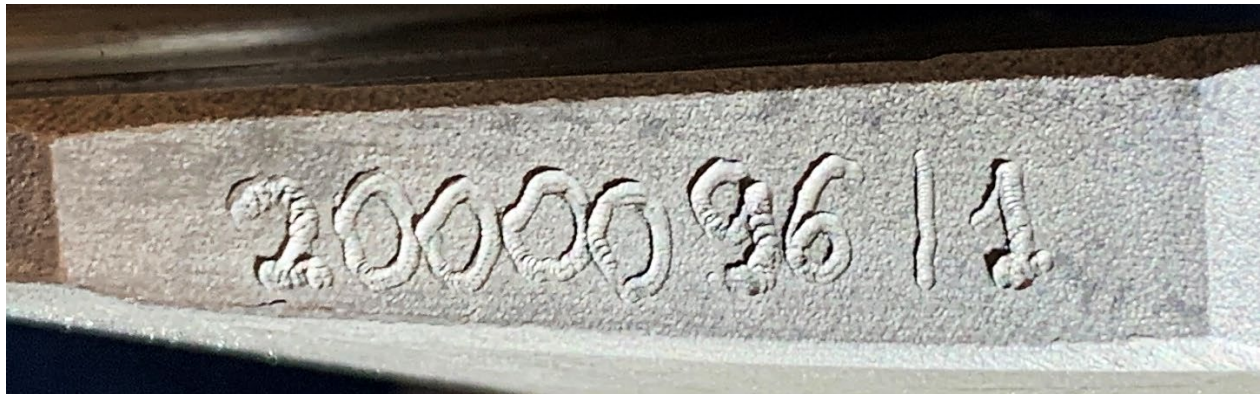
"2000096/1" which according to a representative from UL Power Aero Engines is an internal tracking number used by their Belgium subcontractor. The crankshaft is numbered front to aft, starting with the #1 main journal (#1MJ) and #1 rod journal (#1RJ), and terminating with the #6 rod journal (#6RJ) and the #7 main journal (#7MJ), as show in figure 1. This convention will be used throughout the report. The fracture on the crankshaft intersected the aft radius of the #2 rod journal (#2RJ). The connecting rod arms for all the rod journals when rotated by hand did not show indications of rotational resistance. The #1RJ and #2RJ were disassembled at the NTSB Materials Laboratory from the crankshaft to expose the rod journal surfaces. The remaining rod journals were not disassembled. Figures 4 through 8 show portions of the crankshaft at various stages of disassembly. According to NTSB preliminary report, the engine accumulated a total of 55 hours since new.

**Figure 1.** Photograph of the as-received crankshaft, shown on top of page. The crankshaft is numbered front to aft, starting with the #1 main journal (#1MJ) and #1 rod journal (#1RJ), and ending with the #7 main journal (#7MJ). The crankshaft contained a fracture that intersected the aft radius of the #2 rod journal (#2RJ). The crank cheek of the crankshaft (between the #1 main journal [#1MJ] and the #1 rod journal [#1RJ]) was engraved with an identification mark, shown on bottom of page. Units on the ruler are in inches.

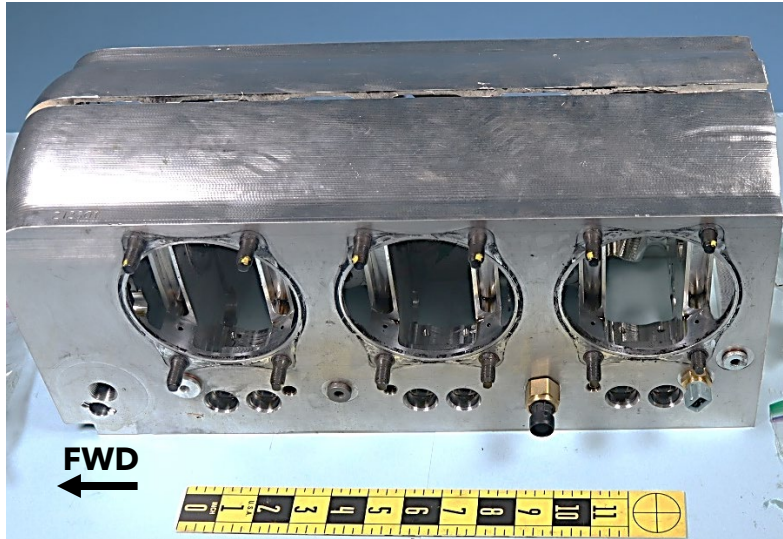
A handheld alloy analyzer indicated the engine case was made from an aluminum alloy. The inside surface of the engine case was covered with fragments containing metals such as copper, aluminum, lead, and tin, typically found in bearing shells. The engine case contained a saddle that accommodated each respective main journal (see figures 13 through 15). The saddle for the #2RJ showed evidence of severe circumferential gouge damage (see figure 14). The saddle (flat-axial portion) for the #1MJ and those on the remaining saddles were smooth and showed no evidence of circumferential gouge damage (see figure 15).

**Figure 2.** As-received engine case halves.

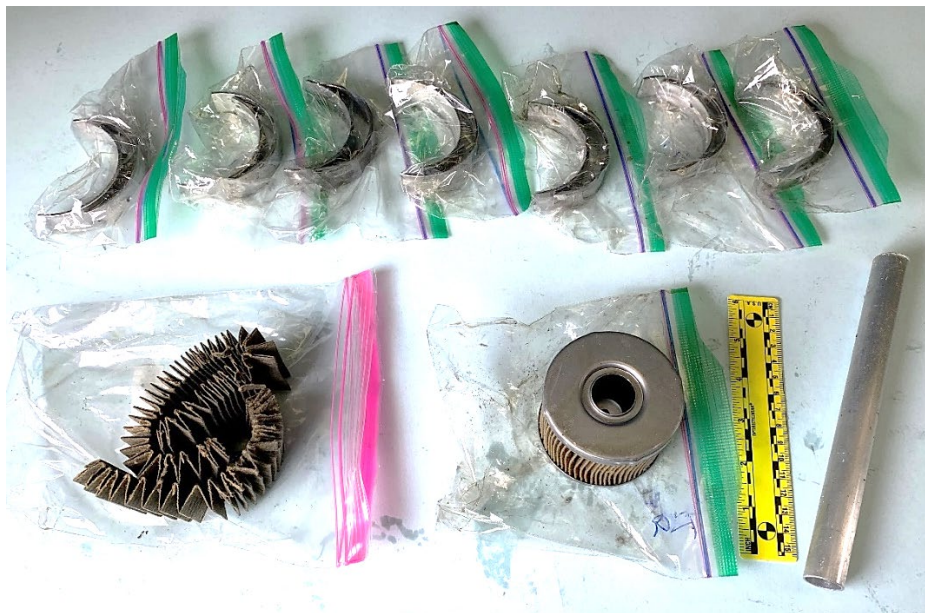
Two oil filters were submitted for examination (see figure 3) The accordion-like fabric portion of a filter was submitted without its canister casing (this oil filter was removed from the engine prior to the accident). The fabric from the other oil filter was attached to its canister casing (an oil filter that was removed from the airplane after the accident). Stereo microscope examination of the exterior surface of the fabric portions of the filters revealed evidence of metallic particles. Metal particles that contained aluminum, lead, copper, iron, zinc, nickel, molybdenum, and chromium in various proportions were detected by a handheld alloy analyzer.

**Figure 3.** As-received parts consisting of seven pairs of main bearing halves; two filters (on left removed prior to accident and on right removed from airplane after the accident); and oil tube that was cut from the engine case to facilitate shipping.

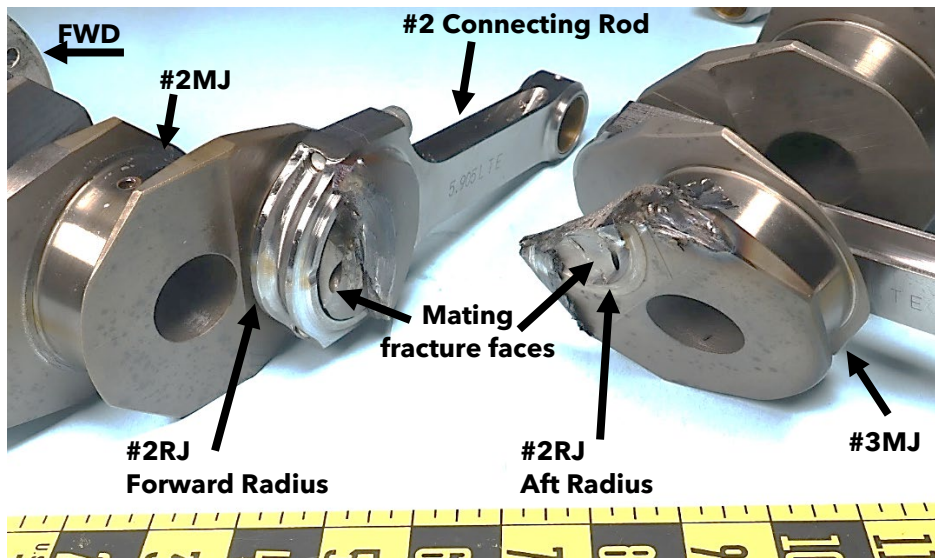
**Figure 4.** Close-up photograph of the crankshaft mating fractures.

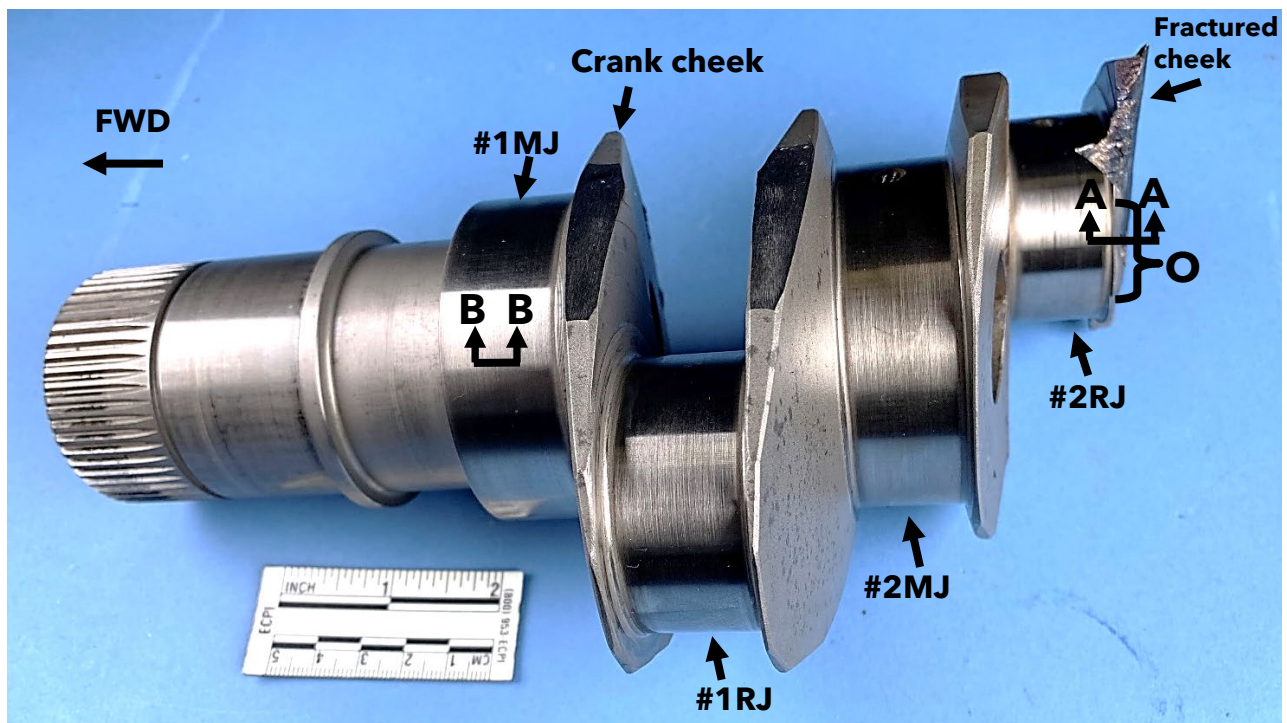
The forward fracture face of the #2RJ contained the mating fatigue crack origin area, see figure 5. This fracture face was excised from the crankshaft for scanning electron microscope (SEM) examination.<sup>3</sup> The fatigue origin area was ultrasonic cleaned with acetone. SEM examination of the fracture face revealed the fine fracture features at the fatigue origin area were obliterated by post fracture mechanical damage. The surface of the radius exhibited evidence of circumferential scoring marks that intersected the fatigue origin area (refer to figure 10).

Metallurgical cross sections were made through the origin of the fatigue crack in the area and orientation indicated by section line “A-A” in figure 5; and through the #1MJ in the area indicated by section line “B-B” in figure 5. Each section was placed in a metallurgical mount. The prepared sections were etched with 2% nital reagent. Each section contained a white layer (also referred to as a compound layer) at the surface, typical of a steel alloy that received a nitriding treatment. The white layer extended along the rod journal surface (axial flat surface) and radius areas. The white layer in each section measured approximately 0.0004 inch (10 µm). The white layer in several areas contained cracks, see figure 11. The portion below the white layer exhibited a microstructure of tempered martensite.

**Figure 5.** Close-up view of the forward end of the crankshaft after disassembly of the connecting rods from the #1 and #2 main journals (#1MJ and #1RJ); and #1 and #2 rod journals (#1RJ and #2 RJ), respectively. Fatigue origin is indicated by bracket "O". Metallurgical sections were prepared from the areas indicated by section lines "A-A" and "B-B".

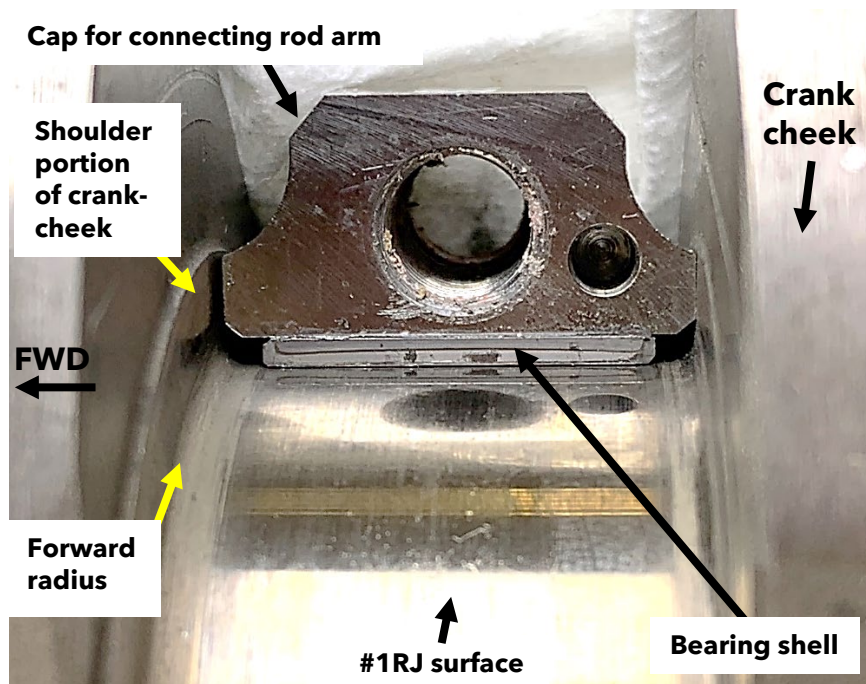
**Figure 6.** Side view of the #1 rod journal (#1RJ) surface with one half of the cap inserted into the rod journal surface; showing the relative position of an intact bearing shell relative to the forward and aft radii.

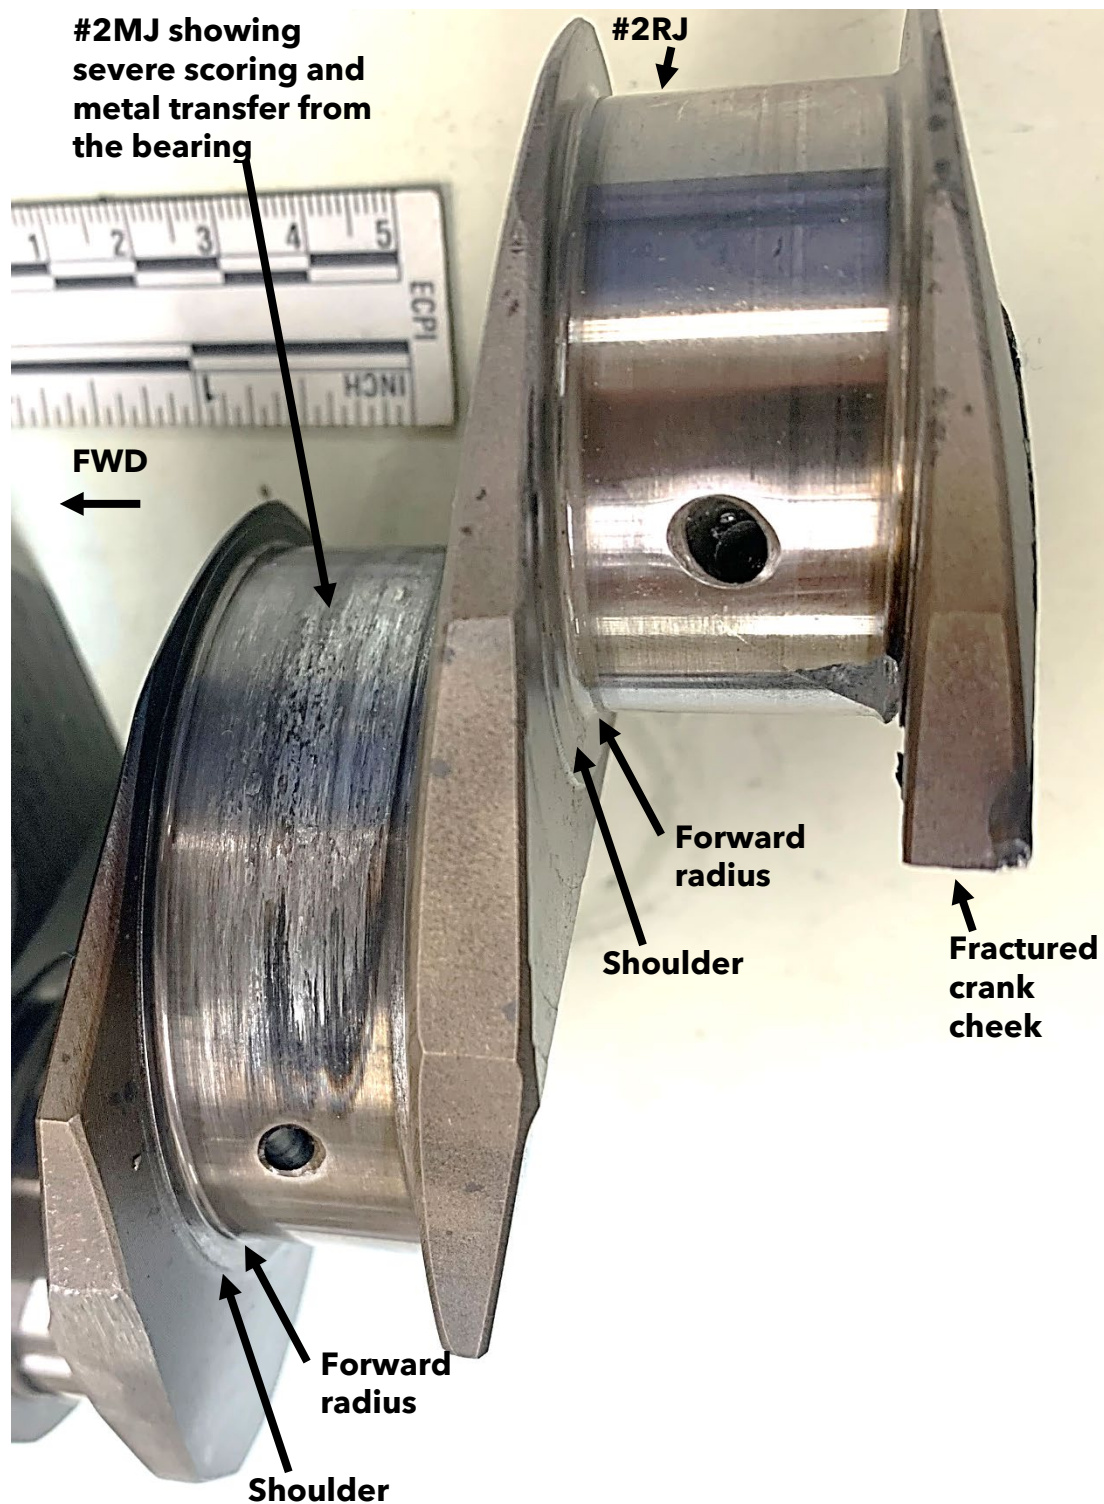
Stereo binocular microscope examination the crankshaft revealed the #2MJ on one half of the circumference showed evidence of metal transfer<sup>7</sup> from the corresponding bearing (see figure 7). The remaining half of the #2MJ circumference, and the entire circumference of #1MJ, #3MJ through #7MJ, #1RJ and #2RJ were smooth. The connecting rod for the remaining rod journal were not disassembled. The main and rod journal contained a forward and aft (fillet) radius, as shown in figure 1 and figures 5 through 8, with the exception of the #1MJ that only had an aft radius and the #7MJ that only had a forward radius. The radii of all the main journals and those of the #1RJ and #2RJ in many areas showed evidence of minor scoring. Each crank cheek contained a reinforcement shoulder that extended beyond each relief radius area. With the exception of the #1MJ, the shoulders and areas slightly outside of the shoulders of the remaining main journals, and those from #1RJ and #2RJ, in

**Figure 7.** View of the #2 main journal (#2MJ) and #2 rod journal (#2RJ) surface. The #2MJ showed evidence of metal transfer from the corresponding bearing shell and localized heat tinting (black/blue/brown) on one half of the journal circumference.

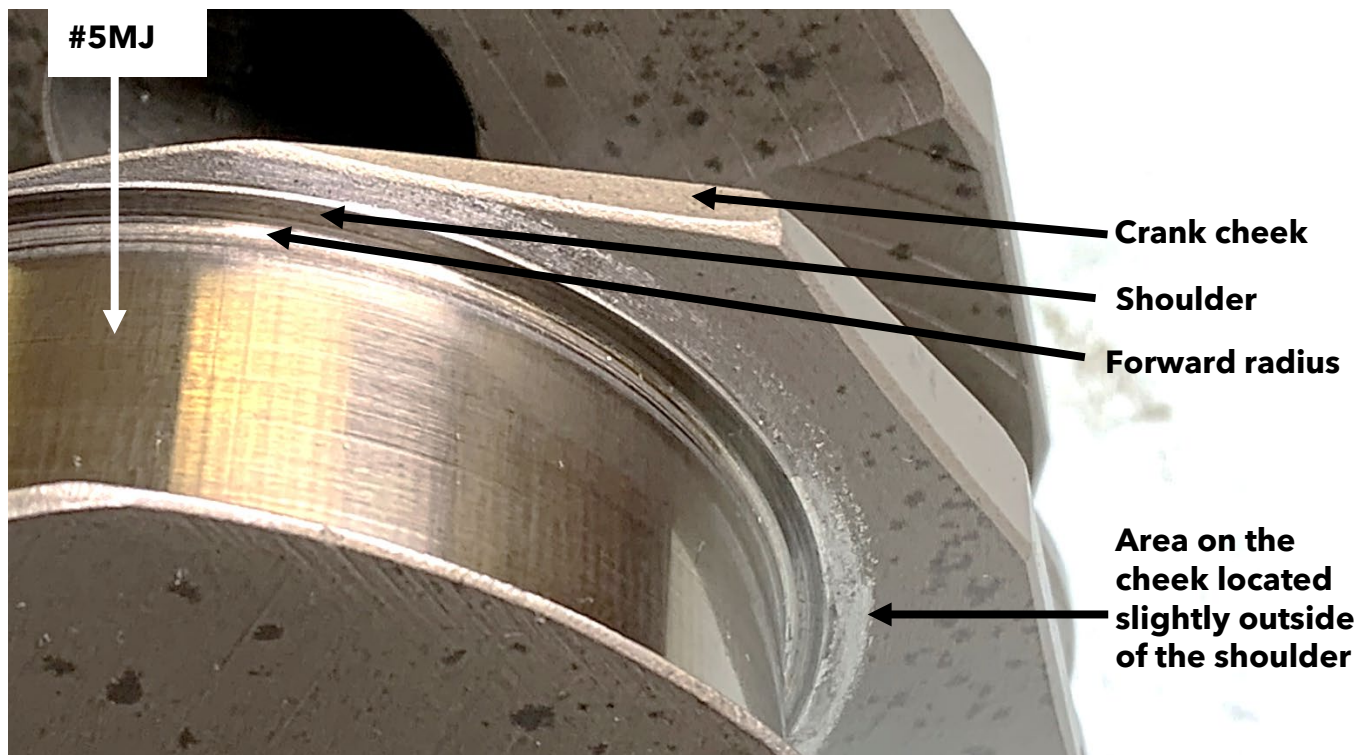
**Figure 8.** View looking forward at the #5 main journal (#5MJ).

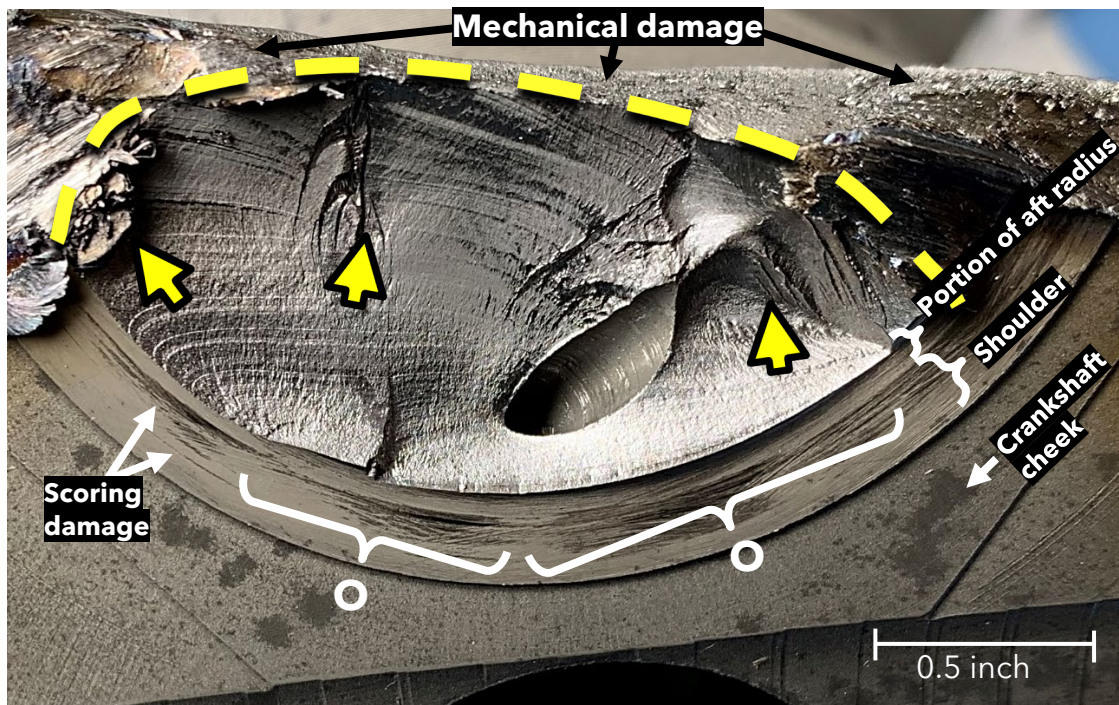
The aft fracture face of the #2RJ contained crack arrest marks, typical of fatigue cracking, that emanated from multiple origins at the surface of the aft (fillet) radius (see figure 9). The surface of the radius exhibited circumferential scoring marks that intersected the fatigue origin area.<sup>2</sup> The length of the multiple-origin fatigue crack measured approximately 1.6 inches. Fatigue propagation was in the general direction indicated by arrows in figure 9 and extended approximately through 30% of the rod journal cross section. The fatigue crack terminated approximately in the areas indicated by a dashed line in figure 9. The remaining portion of the fracture extended axially through the crank cheek in the area between the #2RJ and the #3MJ. The major portion of the crank cheek fracture face exhibited post fracture mechanical damage. The fracture features outside of the fatigue crack zone (outside the dashed line in figure 9) and in areas that were not that were not damaged exhibited a rough irregular texture consistent with overstress separation.

**Figure 9.** Close-up photograph of the aft face of the crankshaft fracture showing a fatigue crack that emanated from multiple origins at the aft radius of the #2 rod journal (#2RJ). Fatigue crack emanated from multiple origins, indicated by brackets "O", and propagated in the general direction indicated by arrows. The fatigue crack terminated approximately in the area indicated by a dashed line.

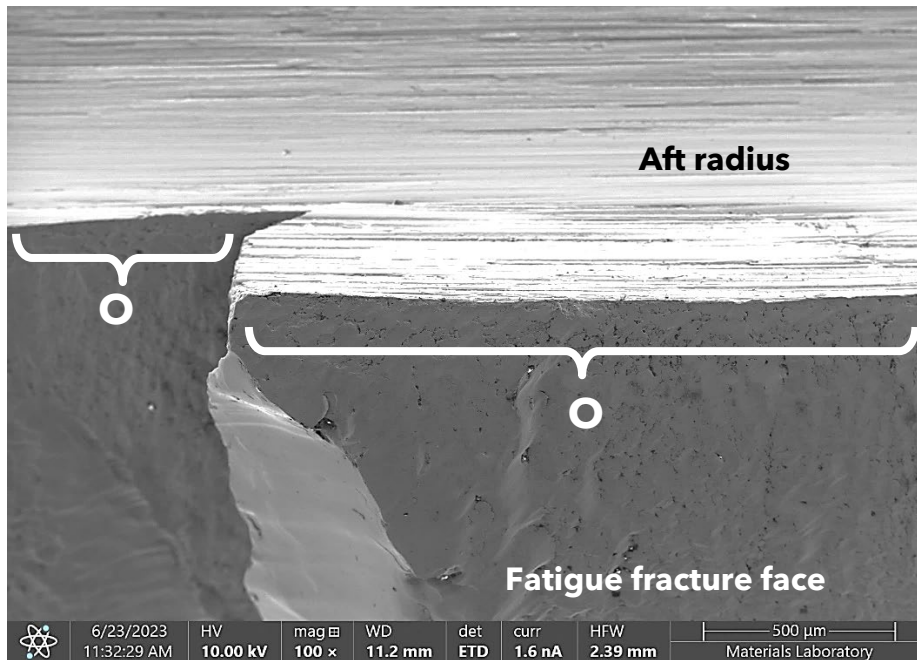
**Figure 10.** SEM image on the forward face of the crankshaft fracture showing a portion of the multiple origin fatigue crack, indicated by brackets "O", that emanated from the aft radius. Circumferential scoring is noted on the aft radius surface.

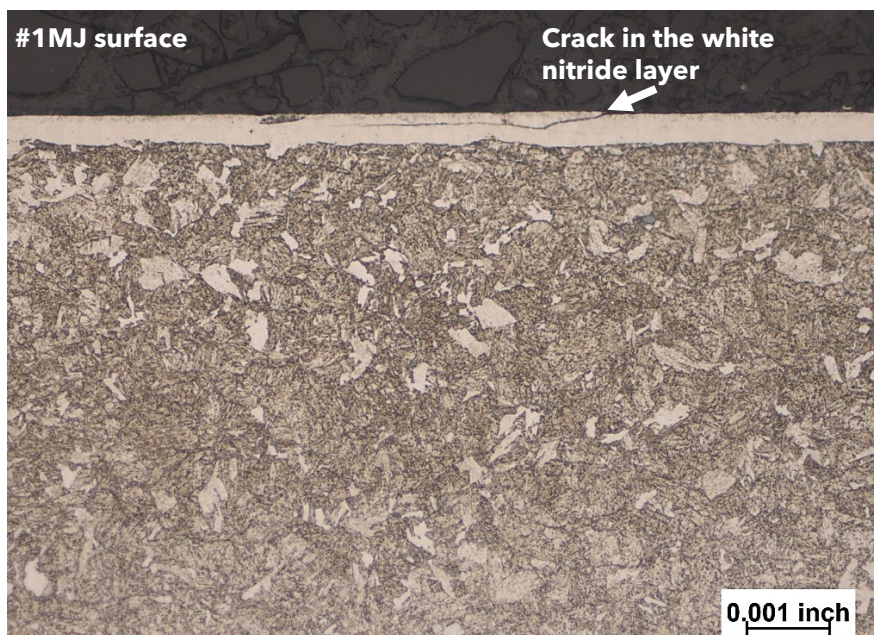
**Figure 11.** Metallurgical cross section "A-A" showing a microstructure of tempered martensite with a white nitride layer at the surface. The white layer contained a crack (2% nital etch).

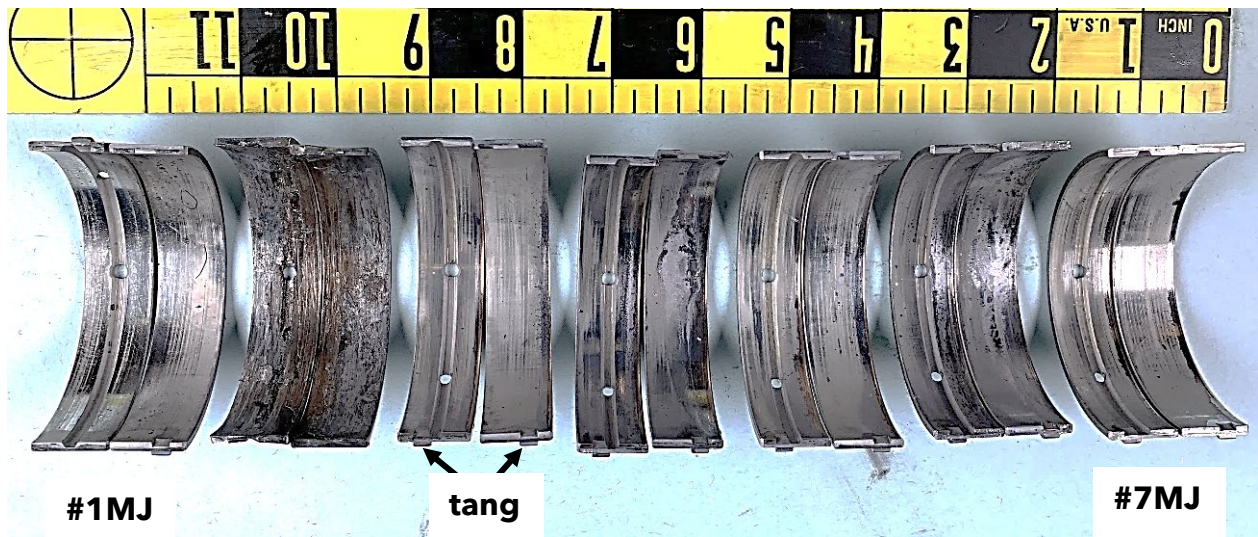
Figure 12 shows a photograph of the inner surface of the main journals bearing. The bearing shell halves for the #2MJ at the inner surface contained evidence of severe circumferential scoring, that exposed the steel core layer, and the inner layers of copper, aluminum, lead, and tin (see figure 9). The inner surface of the remaining main journal bearings showed evidence of moderate circumferential scoring. Each bearing half contained a tang portion at the corner edge that was designed to prevent rotation of the bearing when the crankshaft was rotating. The tang portion for both halves of the bearing for the #2MJ were severely deformed and flattened, whereas the tang portions for the remaining main journal bearings showed no evidence of deformation. The inner surface of the #1RJ and #2RJ are not shown but exhibited severe scoring.

**Figure 12.** View looking at the inner surface of the bearing shell halves for the #1 main journal (#1MJ) through the #7 main journal (#7MJ), left to right. The tang portions from the #2MJ were deformed whereas the tangs from the remaining main journals were intact and showed no evidence of deformation.

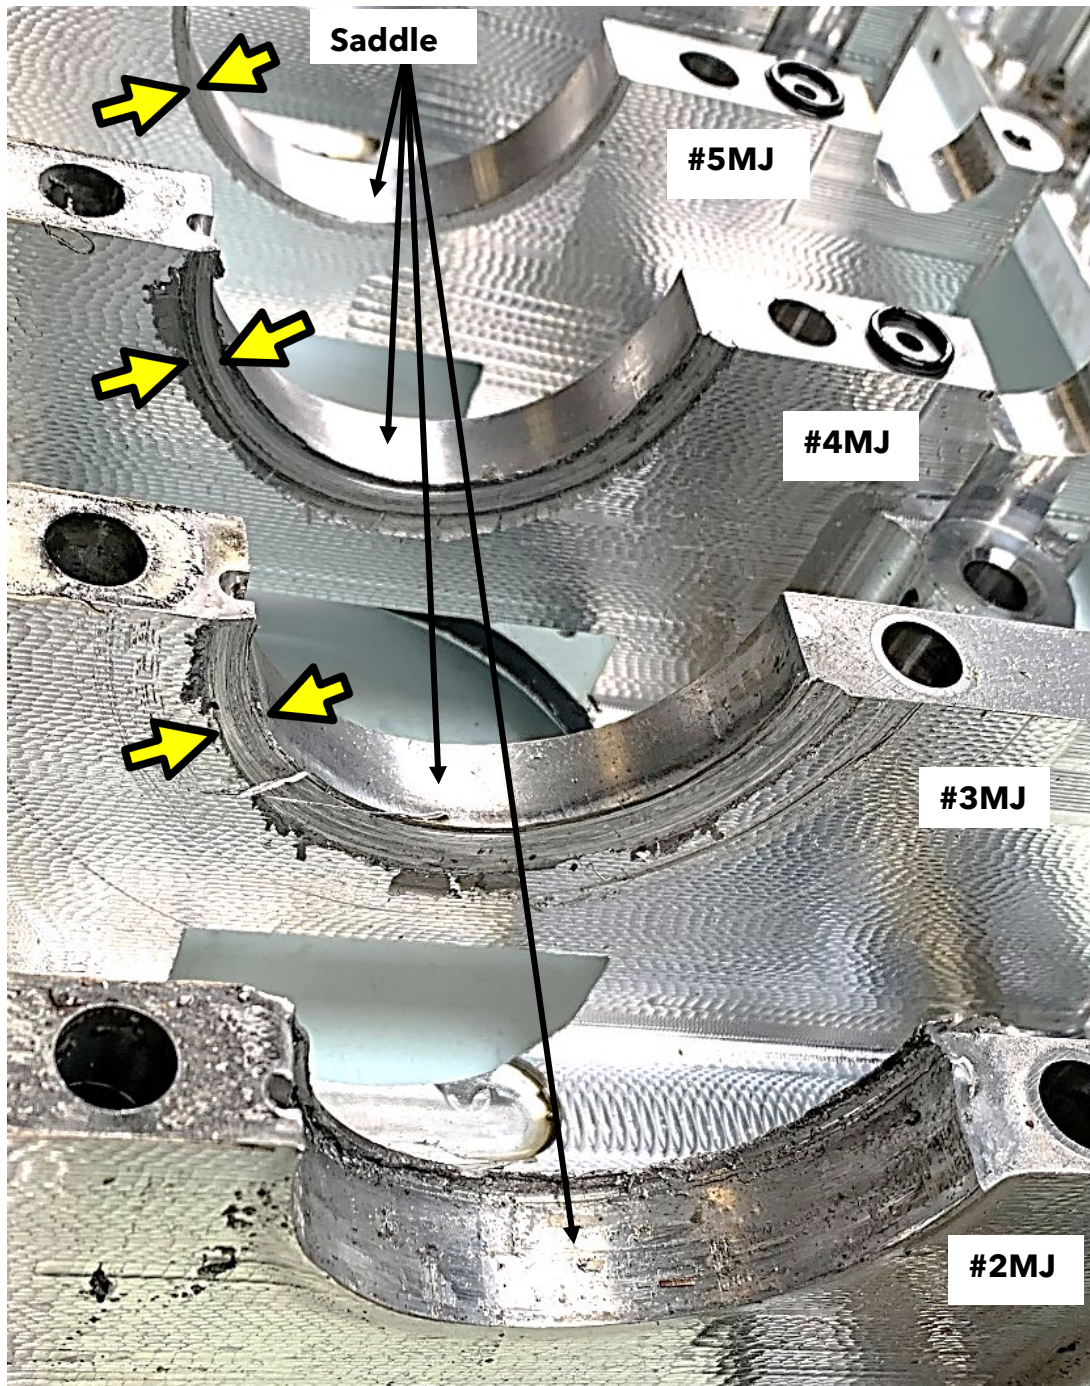
**Figure 13.** View of the inner surface of the engine case looking aft at the saddles for the #2MJ through the #5MJ (foreground to background). The saddles for the #3MJ through #7MJ showed evidence of scoring damage at the forward corners in the areas indicated between arrows. The exception is that the saddle for the #2MJ at the forward corner showed no evidence of scoring damage but showed evidence of compression deformation damage. The saddles for the #6MJ and #7MJ are not shown.

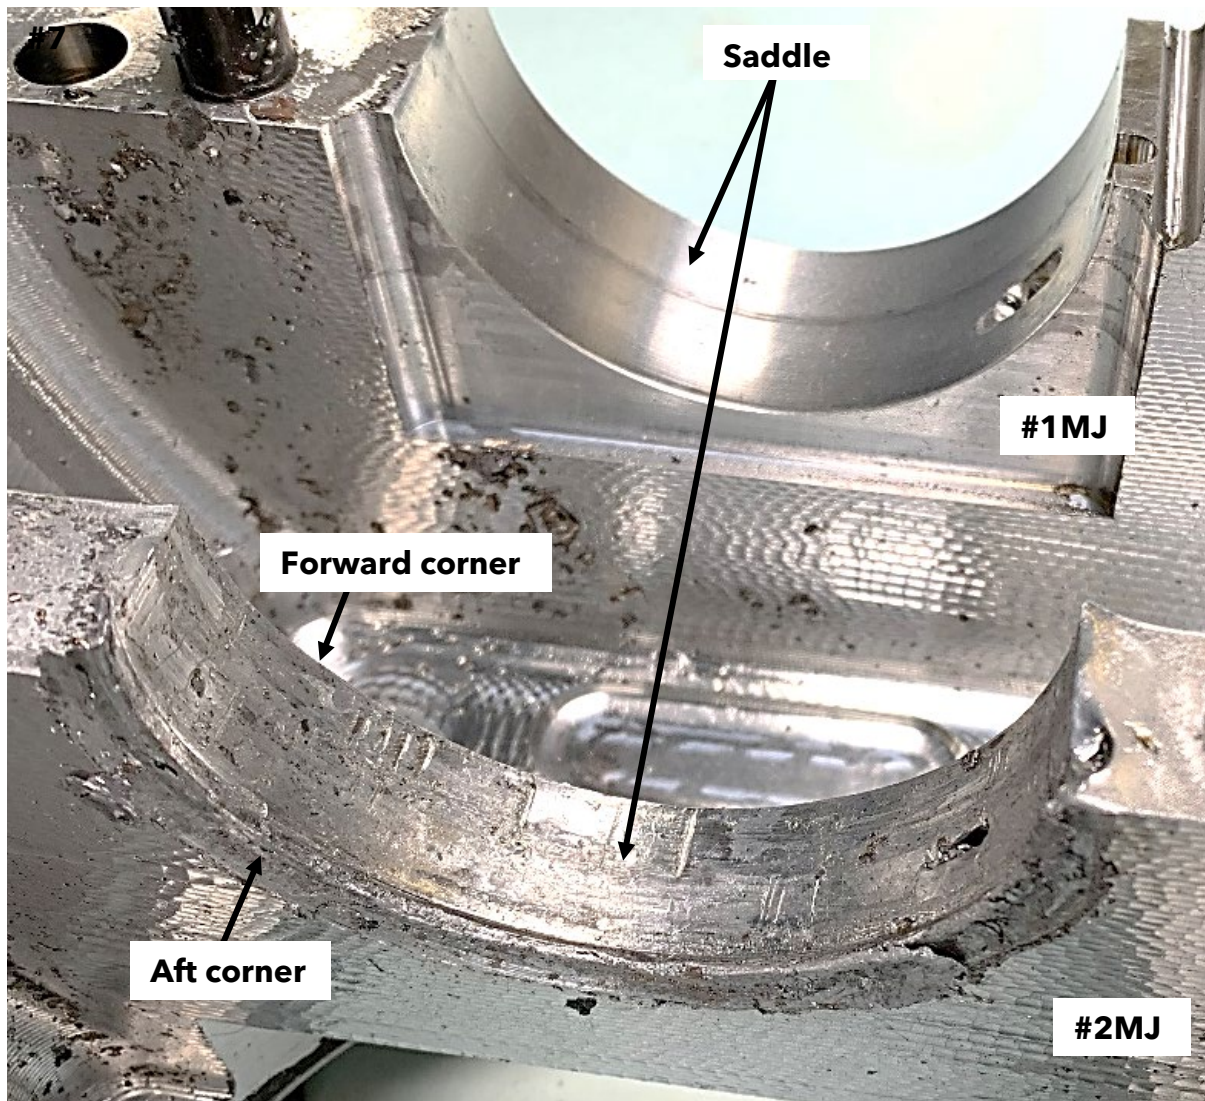
The forward and aft edges of a saddle contain a corner (a corner is intersected by the axially flat surface of the saddle and lateral wall of the saddle). Figure 14 shows an example of a forward and aft corners for a saddle. The saddle for #1MJ at the forward and aft corners showed no evidence of damage. The saddle for the #2MJ at the forward corner (see figure 13) showed evidence of compression deformation damage without circumferential gouge damage, but the aft corner (see figure 14) showed evidence of circumferential gouge damage. The saddles for the remaining main journals (#3MJ through #7MJ) at the forward corners (see figure 13) showed circumferential gouge damage that was similar those at the forward corner of the #2MJ, with the severity of damage decreasing toward the aft end of the crankshaft. The saddles for #3MJ through #7MJ at the aft corners (see figure 15) showed no evidence of damage.

**Figure 14.** Close-up view of the inner surface of the engine case looking forward at the #2MJ and #1MJ (foreground to background). The saddle surface for the #2MJ at the aft corner exhibited severe circumferential scoring damage; compared with the saddle surface for the #1MJ at the aft corner which exhibited no evidence of damage.

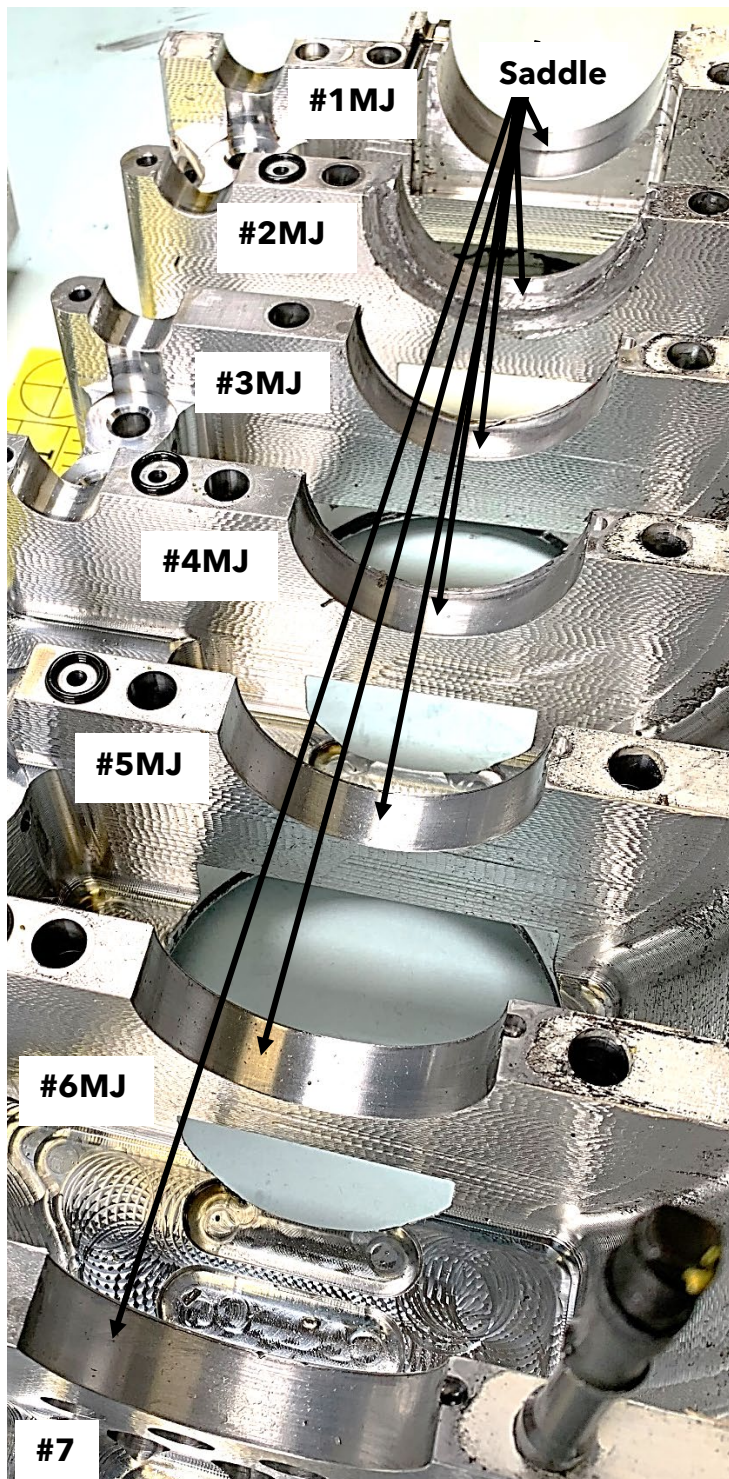
**Figure 15.** View of the inner surface of the engine case looking forward at the saddles for the #1MJ through #7MJ surfaces (background to foreground). The saddle surface for the #1MJ, and #3MJ through #7MJ, at the aft corners showed no evidence of damage.

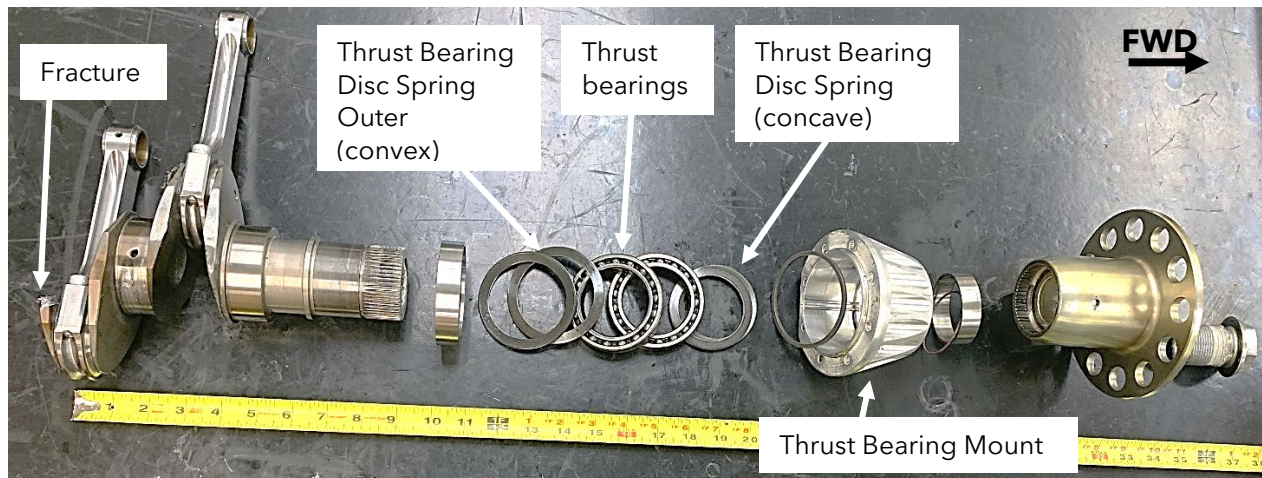
The thrust bearing mount was disassembled to expose the internal pieces, such as the thrust bearing disc springs, and bearings (see figure 16). The mount and internal pieces, including the thrust bearing disc spring and bearings, were intact and showed no evidence of a crack, deformation, or wear damage. The thrust bearing

The specified torque for the propeller flange bolt was 221 foot-pounds (ft-lbs) or 300 Newton-meters(Nm).<sup>9</sup> According to a representative from UL Power Aero Engines, the propeller flange bolt was installed at the factory, and was not removed from the propeller flange since its initial installation. The propeller flange bolt was disassembled at the NTSB Materials Laboratory. The torque was not recorded during disassembly of the bolt. The following observations were observed during disassembly of the bolt. The bolt was tightened by hand with an 18 inch length socket wrench, using moderate hand force, causing the bolt to rotate approximately 20 degrees. Following this step, the bolt was untightened (unscrewed) with the wrench without great difficulty. The threads from the disassembled bolt showed no evidence of mechanical damage.

**Figure 16.** View of the disassembled propeller flange bolt; propeller flange; pieces from the thrust bearing mount; and fractured portion of the crankshaft that was located forward of the fracture (right to left).

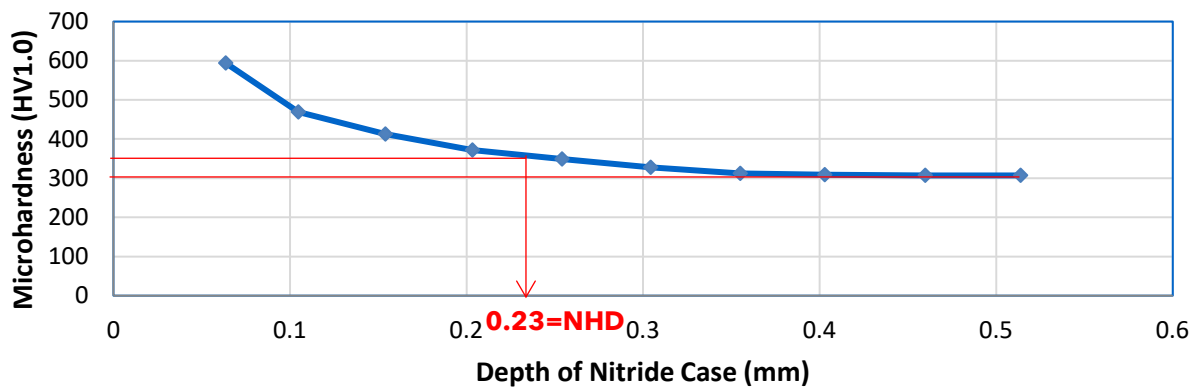
**Plot of Hardness vs. Depth of Nitride Case**

Average core hardness of the crankshaft = 308HV (to the nearest 10 is 310HV)

Limit hardness is equal to an average core hardness + 50HV = 360HV

Nitride Hardness Depth (NHD) at 594HV1.0 = 0.23 mm

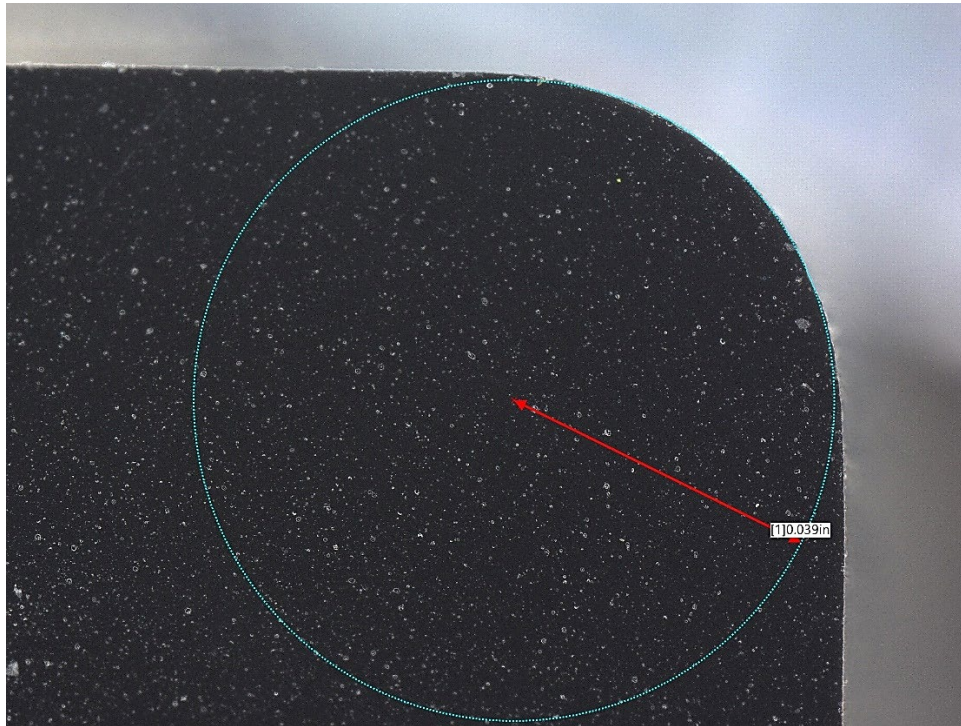
#1MJ Aft Radius (0.039 inch)

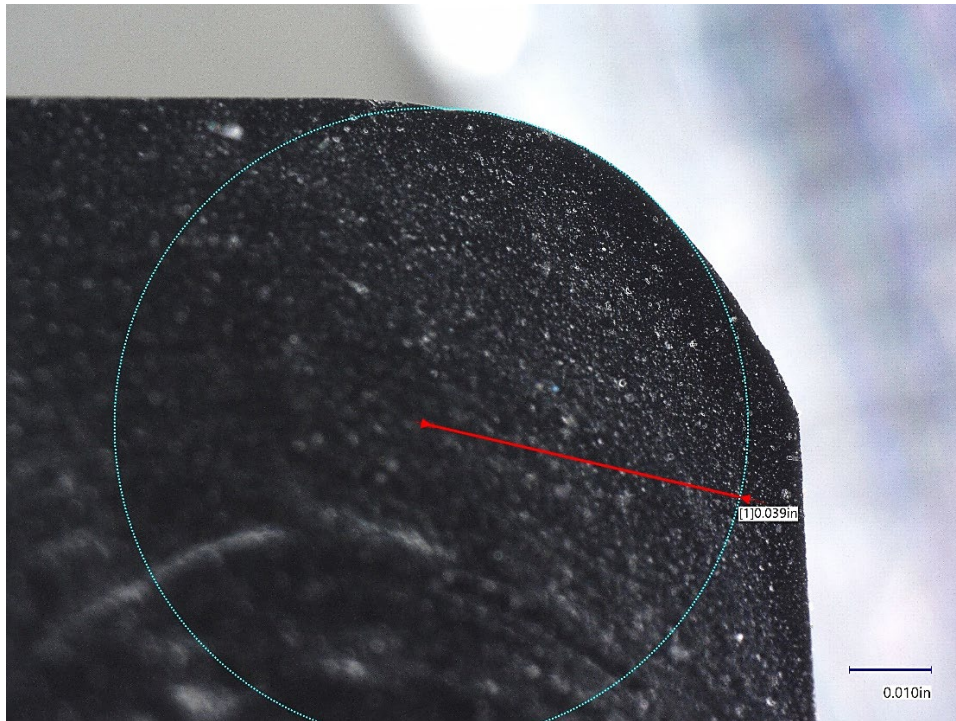
#1RJ Forward Radius (0.039 inch)

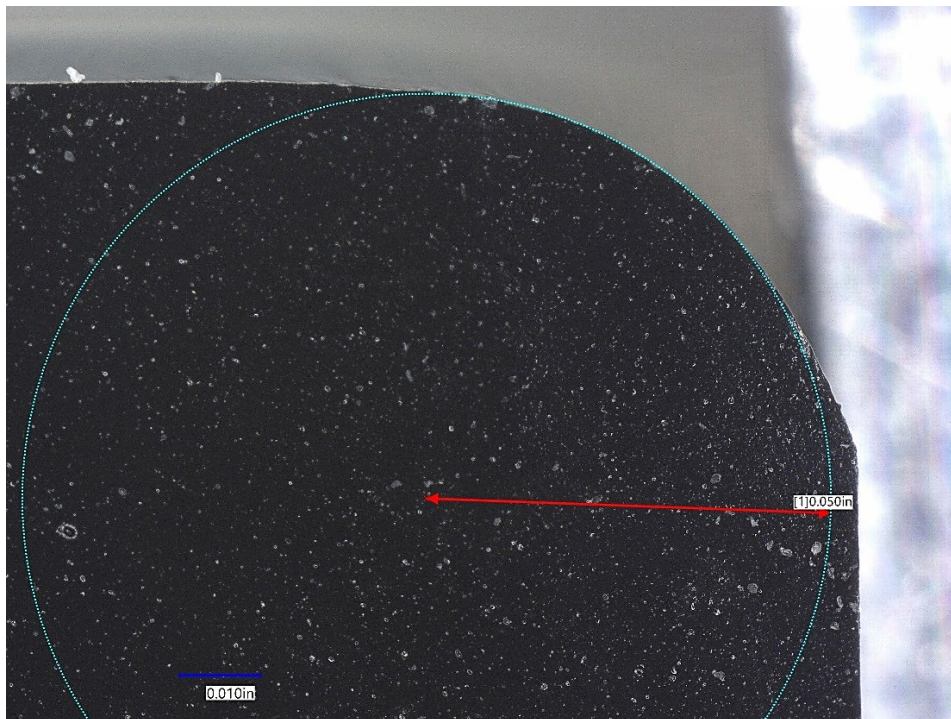
#1RJ Aft Radius (0.050 inch)

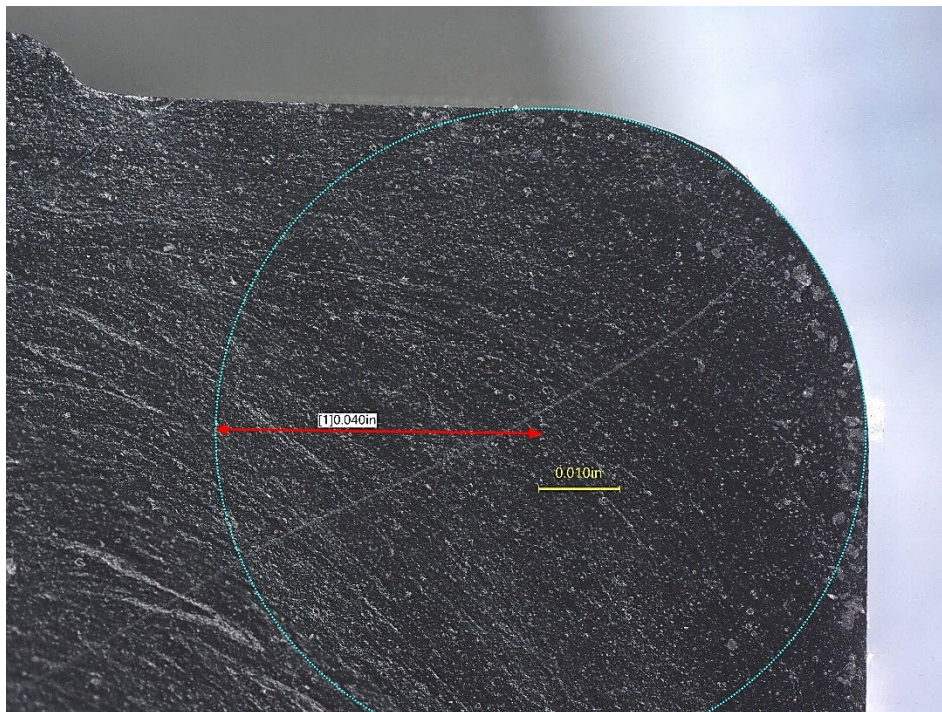
#2MJ Forward Radius (0.040 inch)

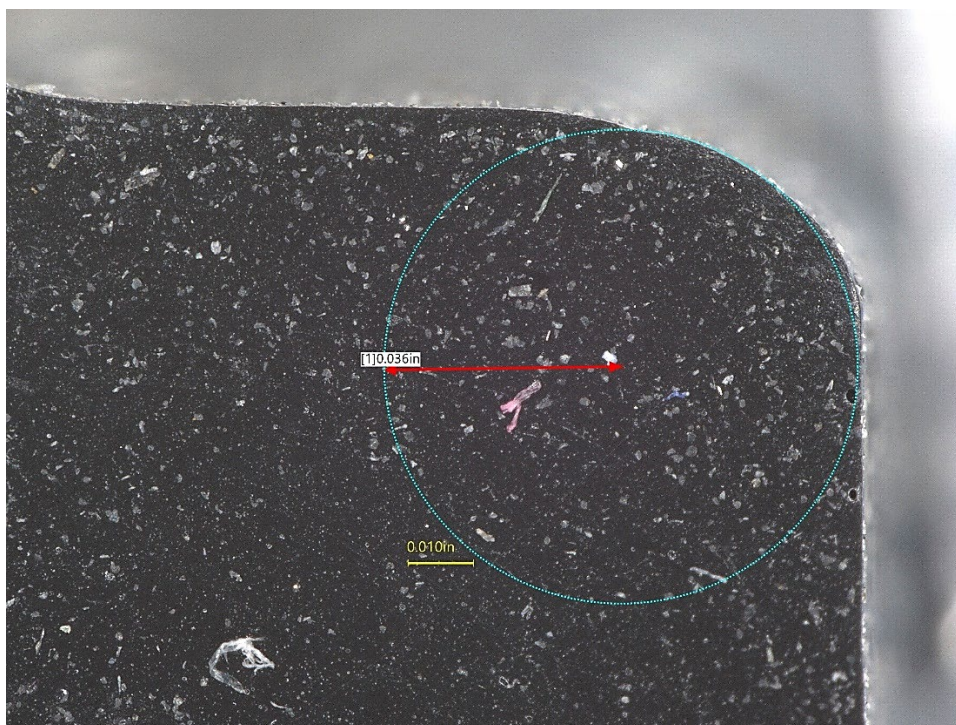
#2MJ Aft Radius (0.036 inch)

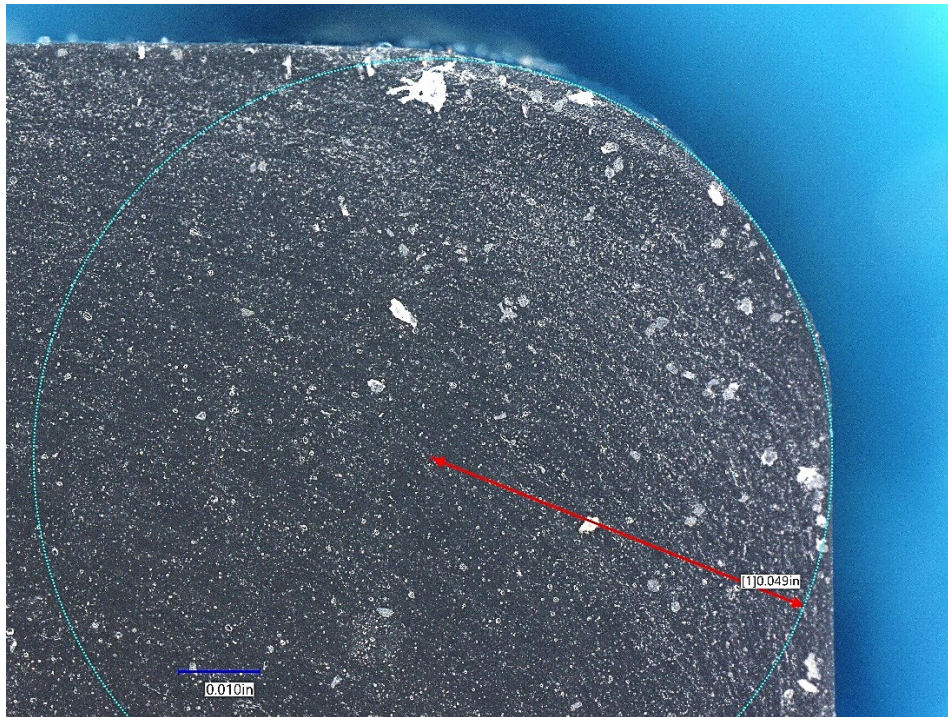
#2RJ Forward Radius (0.049 inch)
