# National Transportation Safety Board

WPR23LA184

## **MATERIALS LABORATORY**

Factual Report 23-068

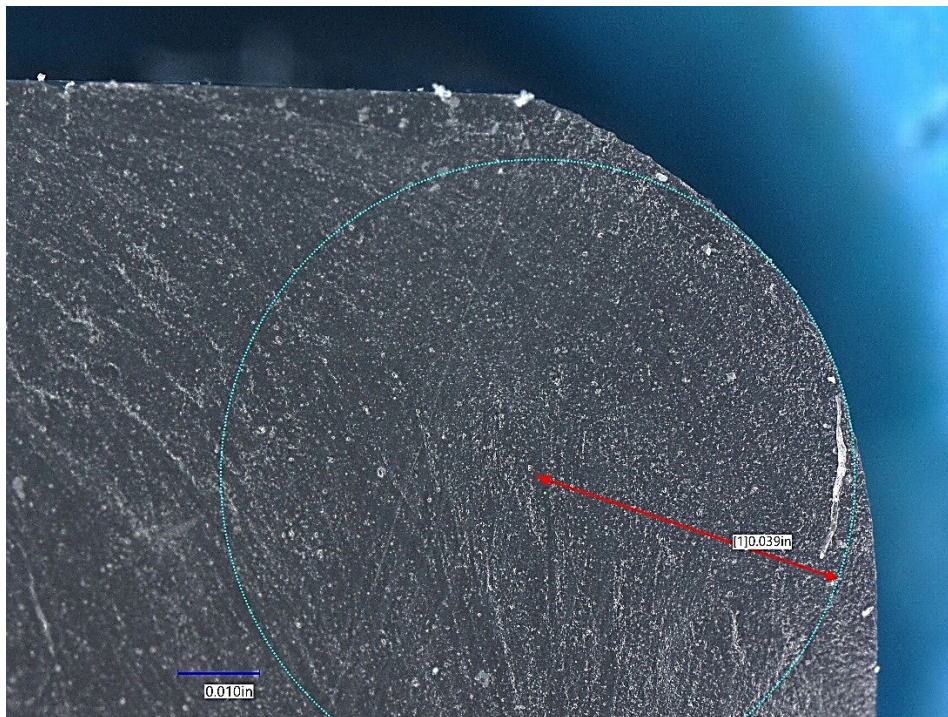
#2RJ Aft Radius (0.039 inch)

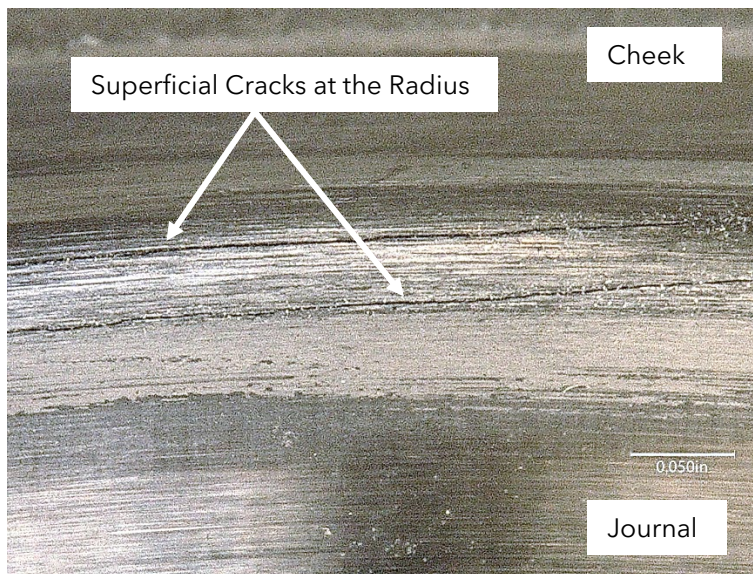
#1 rod journal aft radius

Stereo microscope examination of the radius areas of the crankshaft revealed evidence of superficial cracks at the #1RJ aft radius, #2MJ forward radius, #2MJ aft radius, and #2RJ forward radius (see Appendix 3).

| Table 1.<br>Location and Size of Superficial Cracks Found on the Radii of the Crankshaft | | | | |
|---|---|---|---|---|
| | Aft | 1.4 | 35.6 | Diametrically opposite side of fatigue origin |

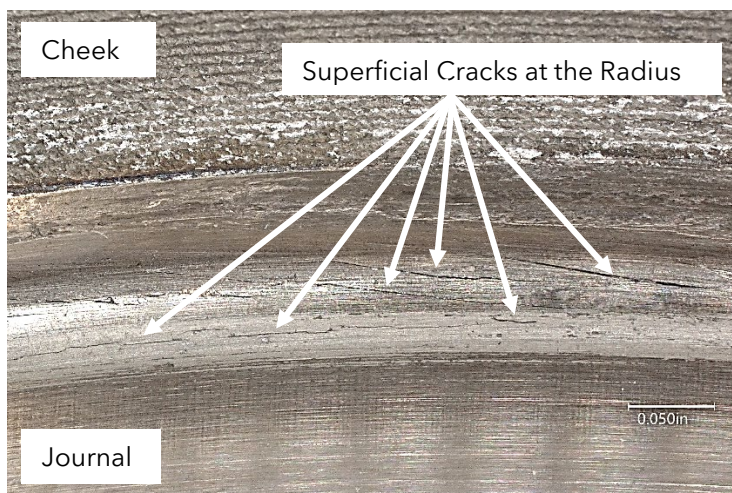
#2 main journal forward radius

| Table 1.<br>Location and Size of Superficial Cracks Found on the Radii of the Crankshaft | | | | |
|---|---|---|---|---|
| #2MJ | Forward | 1.8 | 45.7 | Same side as fatigue origin |

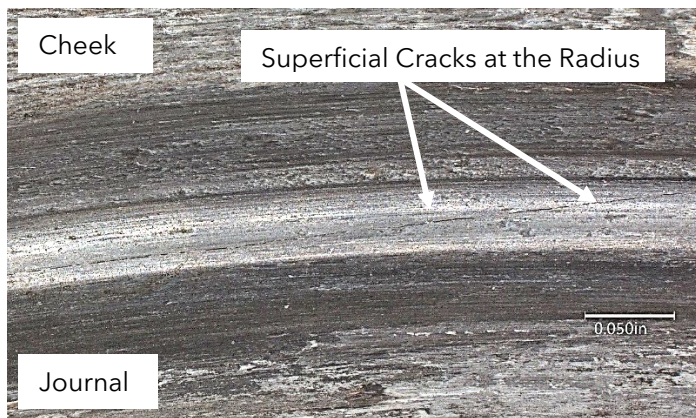
#2 main journal aft radius

| Table 1.<br>Location and Size of Superficial Cracks Found on the Radii of the Crankshaft | | | | |
|---|---|---|---|---|
| | Aft | 0.8 | 20.3 | Diametrically opposite side of fatigue origin |

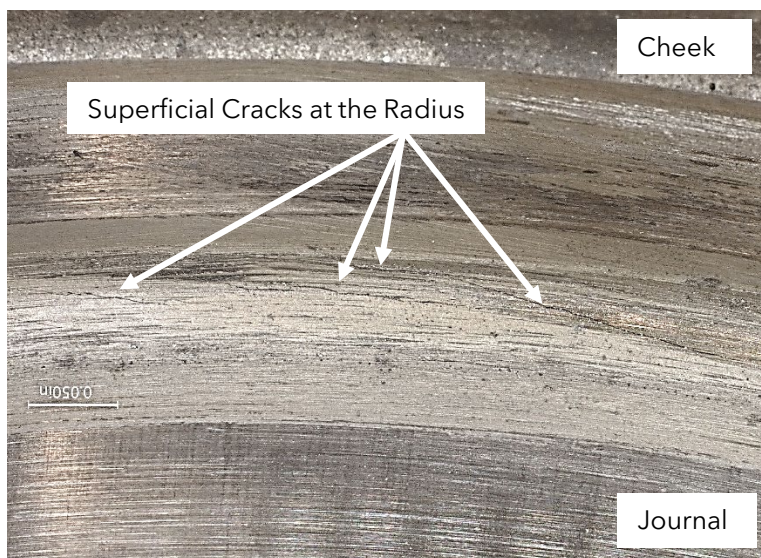
#2 rod journal forward radius

| Table 1.<br>Location and Size of Superficial Cracks Found on the Radii of the Crankshaft | | | | |
|---|---|---|---|---|
| #2RJ | Forward | 1.3 | 33.0 | Same side as fatigue origin |
