National Transportation Safety Board

WPR23LA184

**INVESTIGATIVE SUPPLEMENTAL MATERIAL**

Location: Creswell, Oregon  
Date: 05.09.2023  
Time: 1750 Pacific standard time  
Airplane: Rans S-21

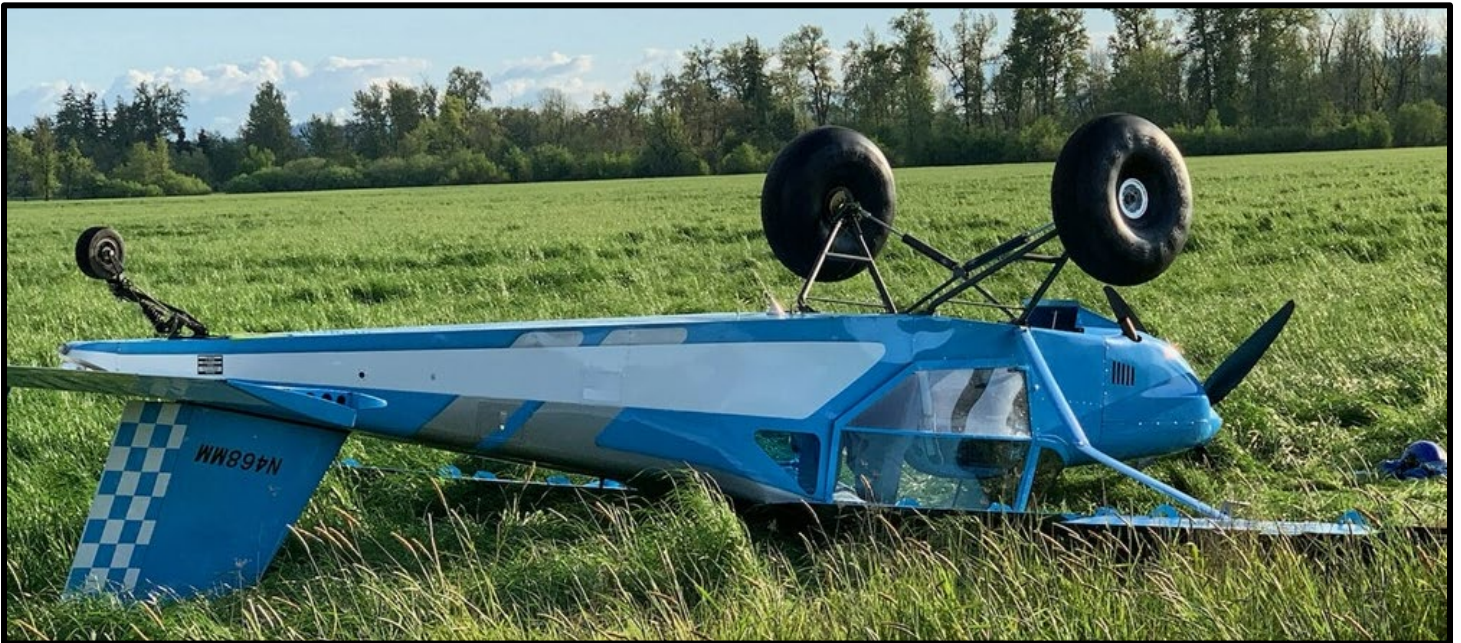
Figure 1: Wreckage at the Accident Site

The pilot and his son had recently finished building the airplane. The accident flight was a series of test flights the pilot was performing after making cowling modifications. After a normal departure, the pilot flew to a test area and was inflight for about 20 minutes. While the pilot was maneuvering at about 700-900 feet above ground level (agl), the engine made “rough” sounds and vibrated. About 20 seconds later, the propeller seized and the pilot made a forced landing in the field below. During landing roll out, the airplane flipped over and came to rest inverted.

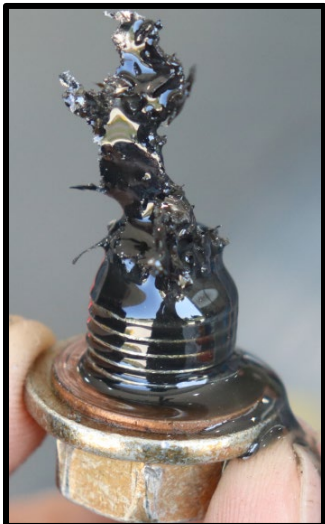
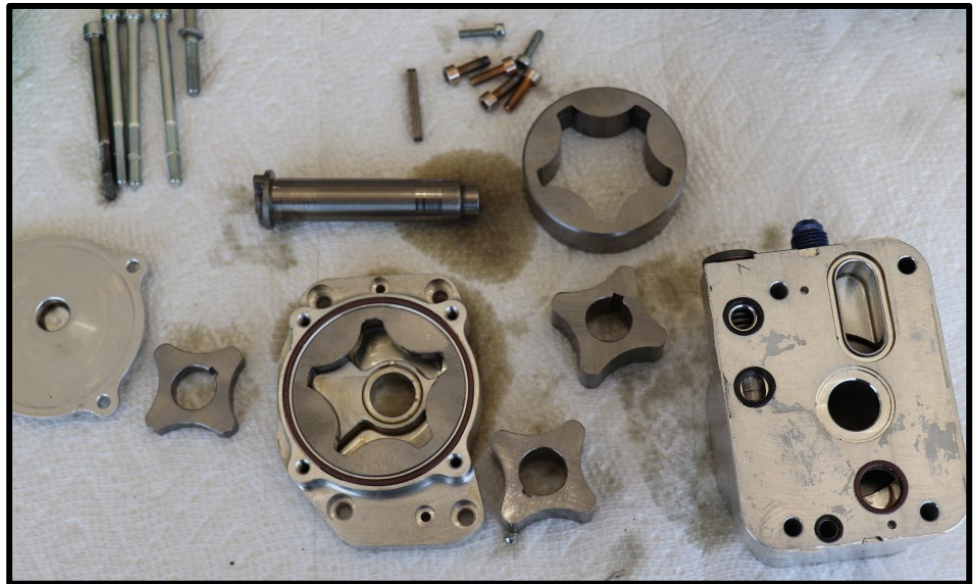
Figure 2: Magnetic Plug and Oil Pump

Removal of the oil sump drain revealed that the magnetic plug was full with ferrous metal. Removal of the oil sump revealed there were pieces of metal in the pan.

plug was full with ferrous metal and metal pieces were found in the oil sump. The oil pump was disassembled and there was limited metal found inside, with the exception of the bypass spring.

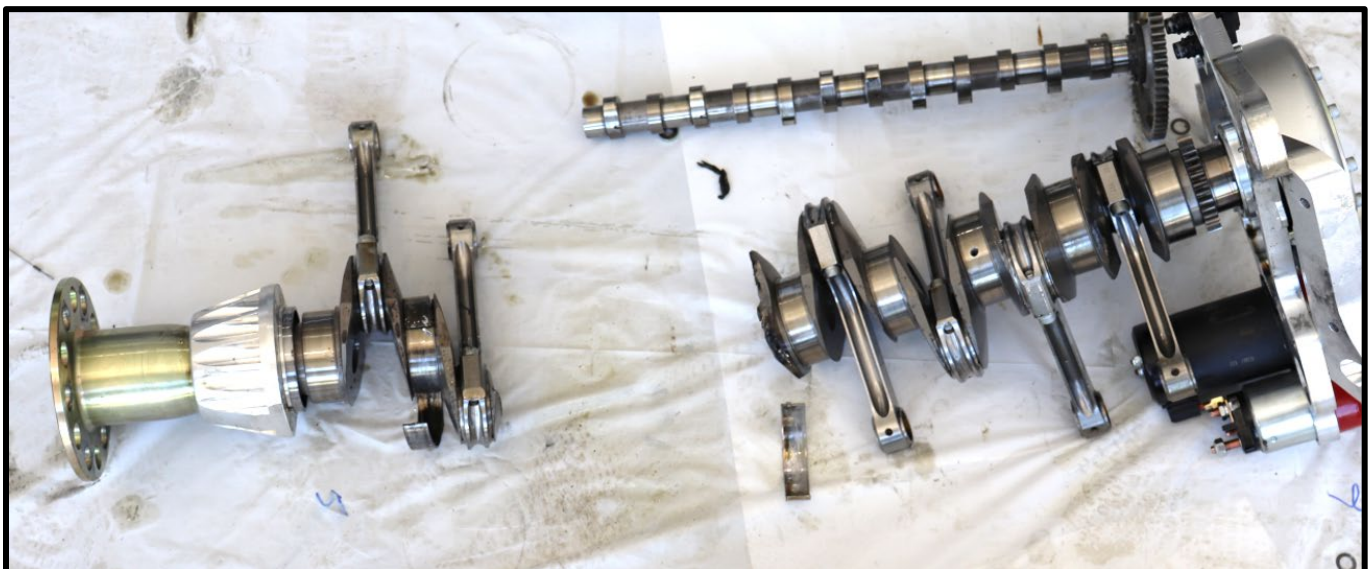
Figure 3: Crankshaft

Upon applying force to the propeller, the engine would not rotate through. Removal of the pistons revealed that the crankshaft was fractured at a web, just aft of the journal of the No. 2 connecting rod. The thrust bearing mount was able to move forward and aft.

Disassembly of the crankcase revealed that the six connecting rod journals still had their respective rods and caps attached; all were able to be easily rotated about their respective journals.

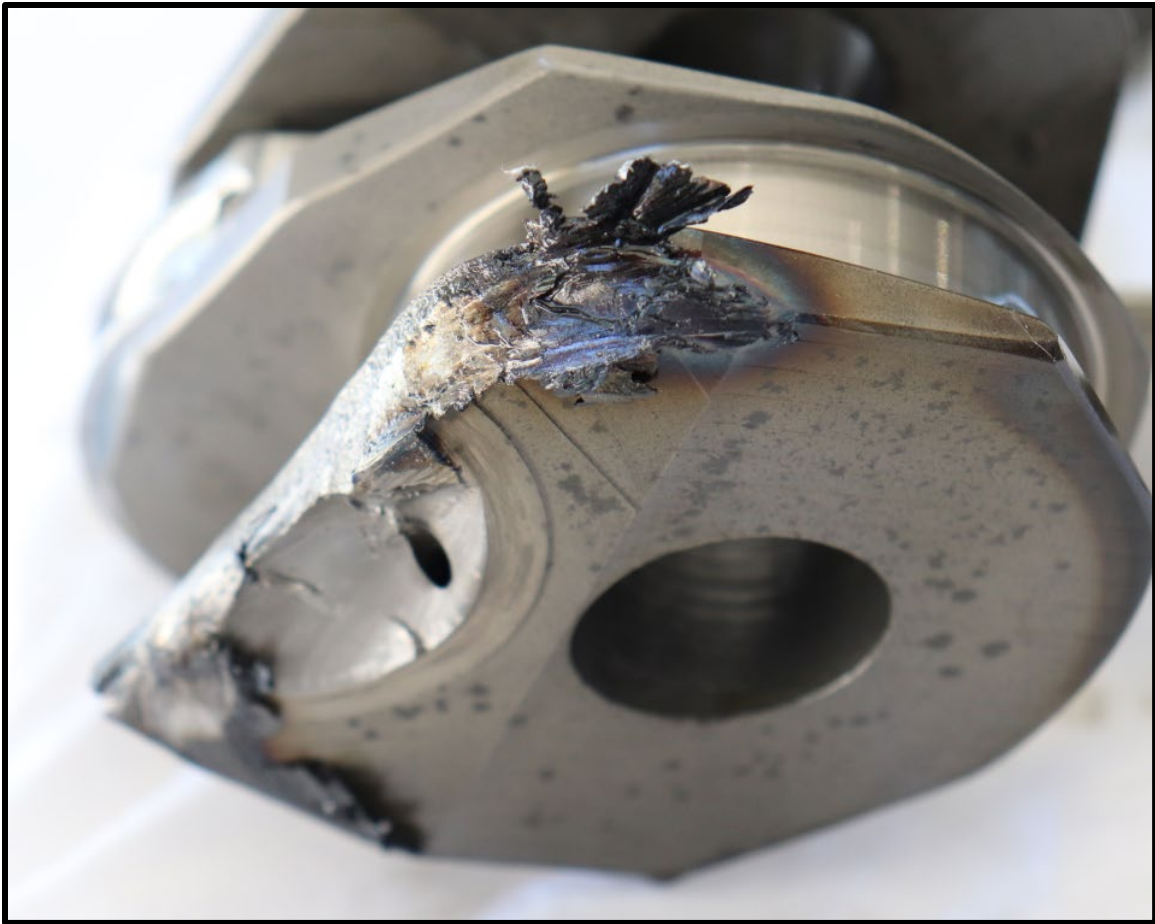
*Figure 6: Crankshaft Fracture Surface*

The fracture exhibited a half-moon shape, having proceeded through approximately half the web. The fracture surface was relatively shiny and reflective, with some areas of heat tinting on the forward face. The preliminary assessment of the fracture surfaces were consistent with a fatigue fracture at the radius on the connecting rod journal

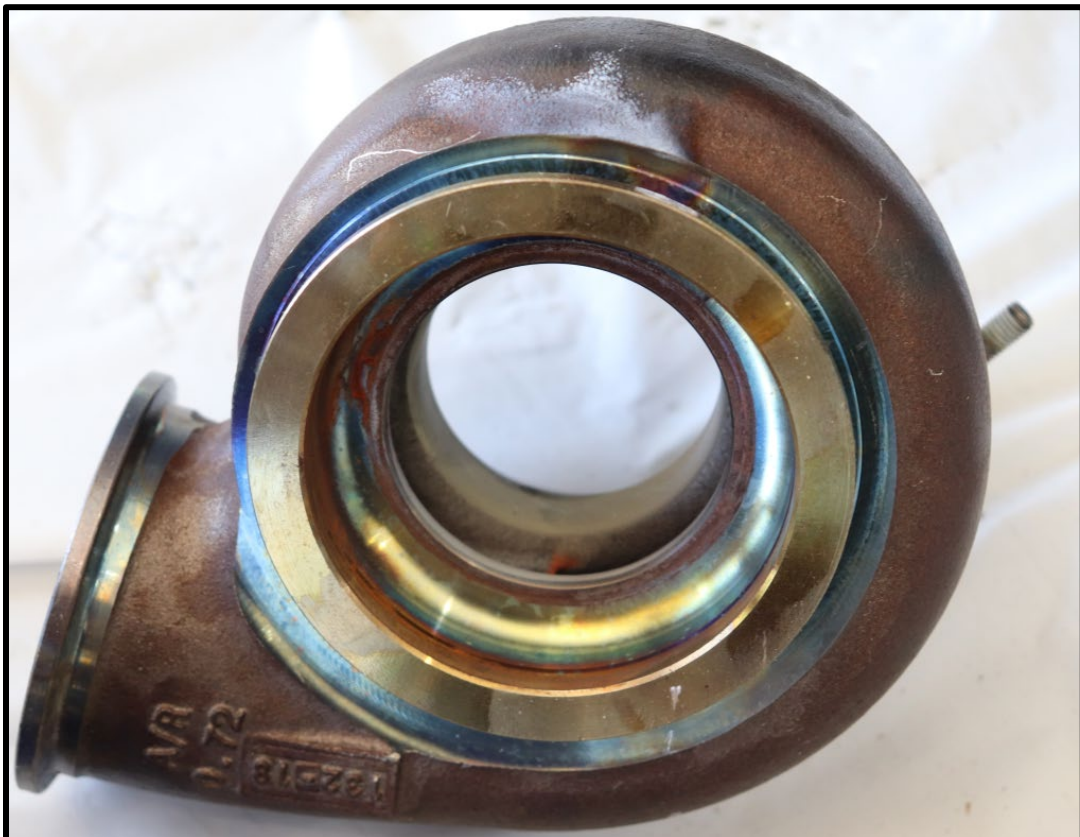
*Figure 9: Turbocharger Housing*

The turbocharger compressor and turbine wheel could both rotate. The wastegate bango fitting was finger tight at the wastegate and tight at the boost valve.
