## Test ECU 210415 at ULpower – 5 July 2023 - N468MM - NTSB ref WPR23LA184

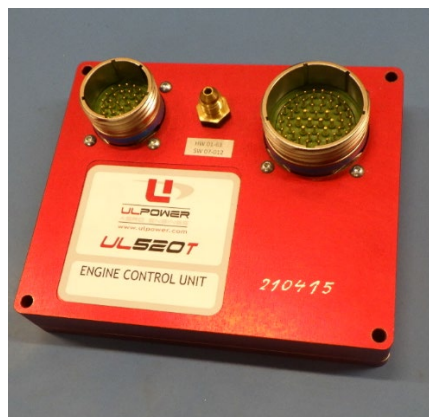
Figure 2, ECU 210415 unpacked

The ECU was identified as serial number 210415 and first visually checked for damage.

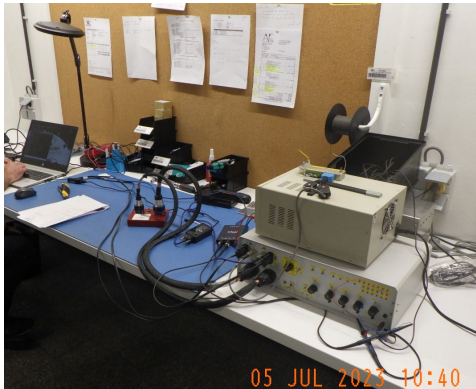
After downloading, the ECU was connected to an electronic test bench and a test program was run. Because during the test the memory is overwritten, this test should be done after downloading. In the test all functions, in- and output signals were checked. An oscilloscope was then connected to check again the output signals of the ECU. During the entire test program, no anomalies were found, and the ECU was working properly.

Figure3, ECU test run set up at ULpower facilities
