# National Transportation Safety Board

WPR23LA186

## **AIRFRAME EXAMINATION NOTES**

Location: Lakewood, Washington  
Date: May 9, 2023  
Time: 1215 Pacific daylight time  
Airplane: Amphibious Aviat A-1C-180 Husky

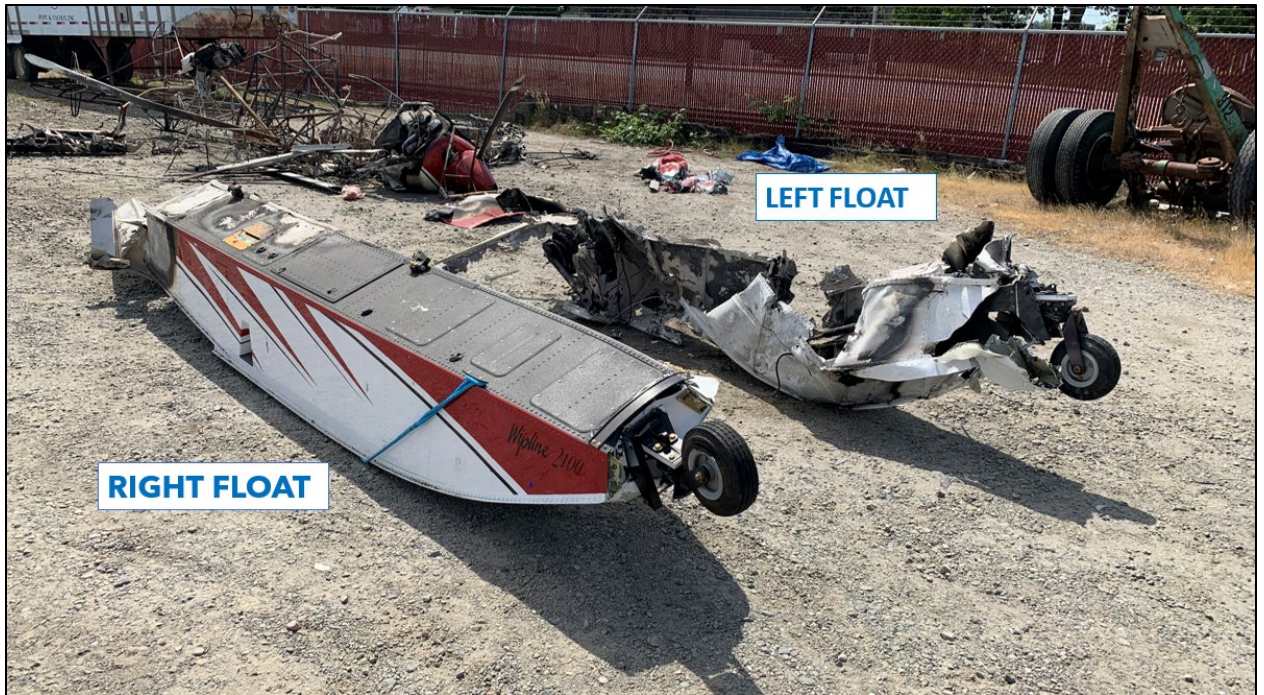
Examination of the airframe revealed that the left float was separated consistent with thermal impact damage and right float was separated consistent with minor impact damage and removal by the aircraft recovery company to facilitate wreckage transport. The hydraulic reservoir and pump were thermally damaged. See figure 1.

Figure 1. Recovered floats

The right float sustained minimal thermal damage. The hydraulic actuator piston and actuator arm assembly was secure and intact in the right float. The cables to the right water rudder were separated consistent with being cut during recovery. The left float sustained extensive thermal damage. The hydraulic actuator piston and actuator arm assembly were thermally damaged and remained attached. The cables to the left water rudder were thermally damaged.

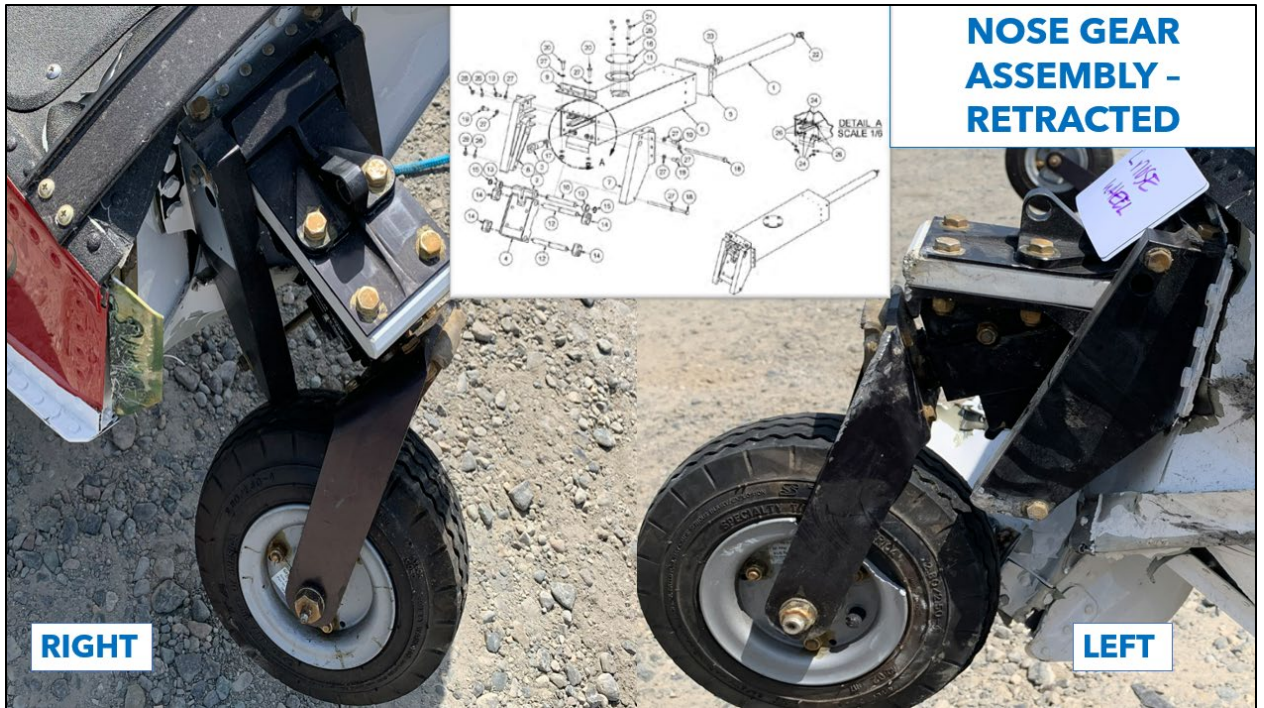
The left and right nose gear assembly remained intact on the left and right tracks. Both nose gears were in the retracted position and the nose wheel tire assemblies could free castor. See figure 2.

Figure 2. Left and Right Nose Wheel in the Retracted Position

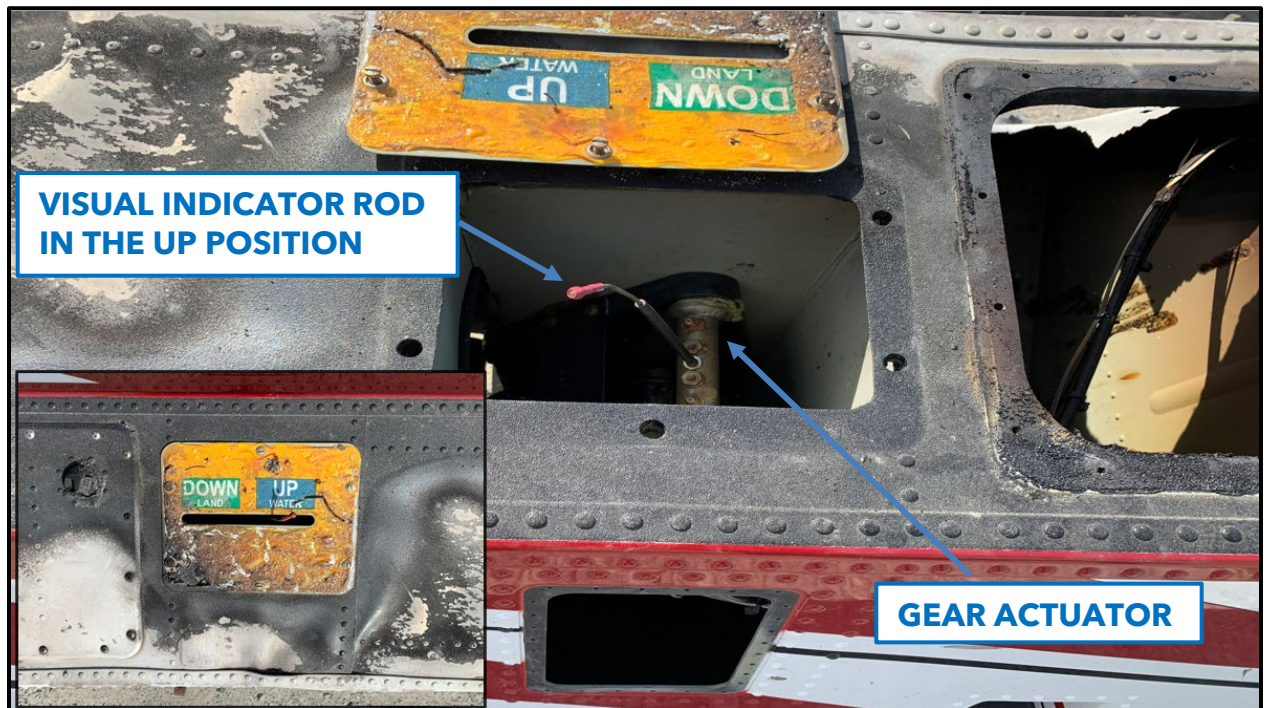
The right main gear visual indicator rod and gear actuator indicated the right main was retracted in the up (water) position. See figure 3. The left main gear visual indicator rod was thermally damaged; however, the left gear actuator indicated that the left main wheel was retracted, in the up (water) position. See figure 4.

Figure 3. Right Main Wheel in Retracted Position

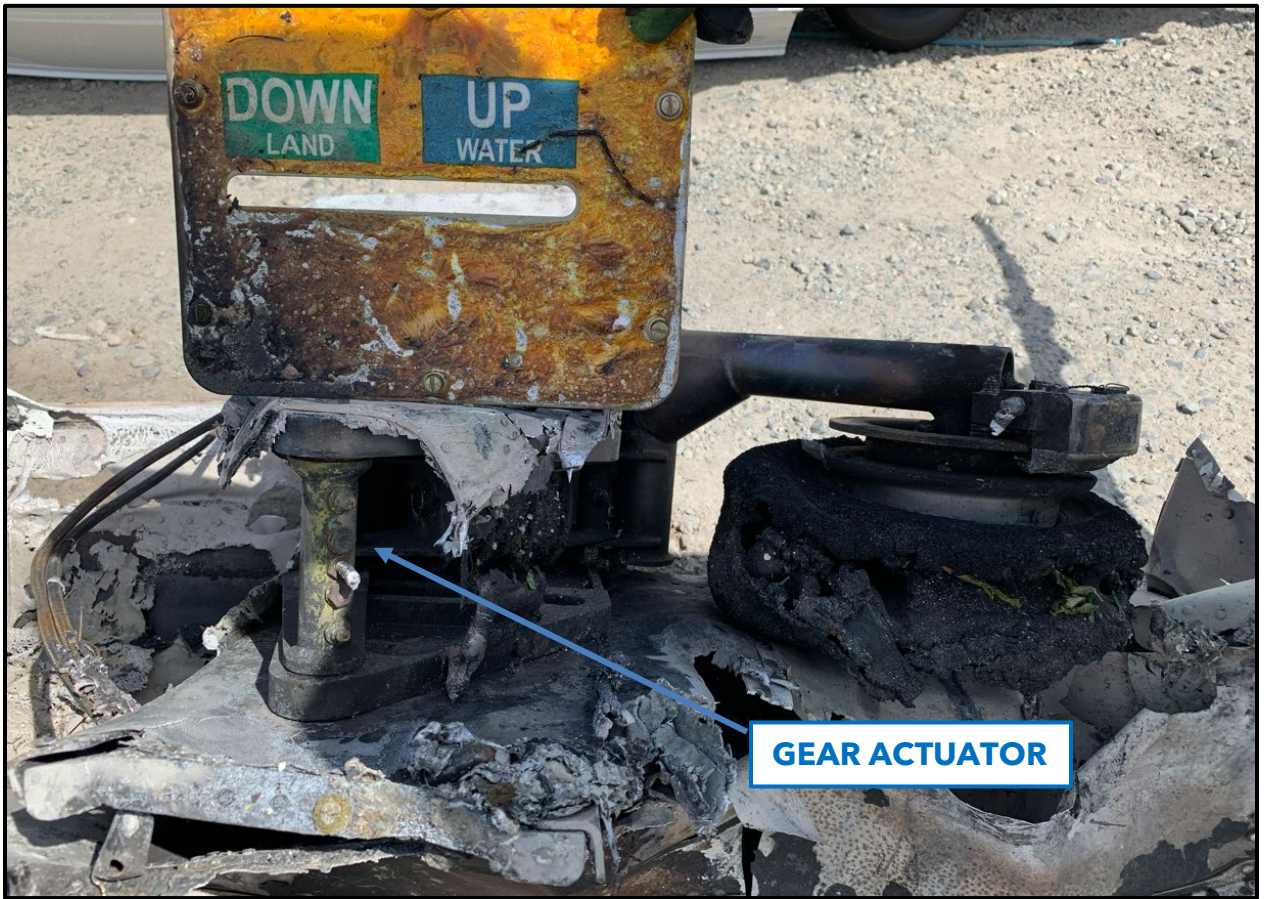
Figure 4. Left Main Wheel in the Retracted Position

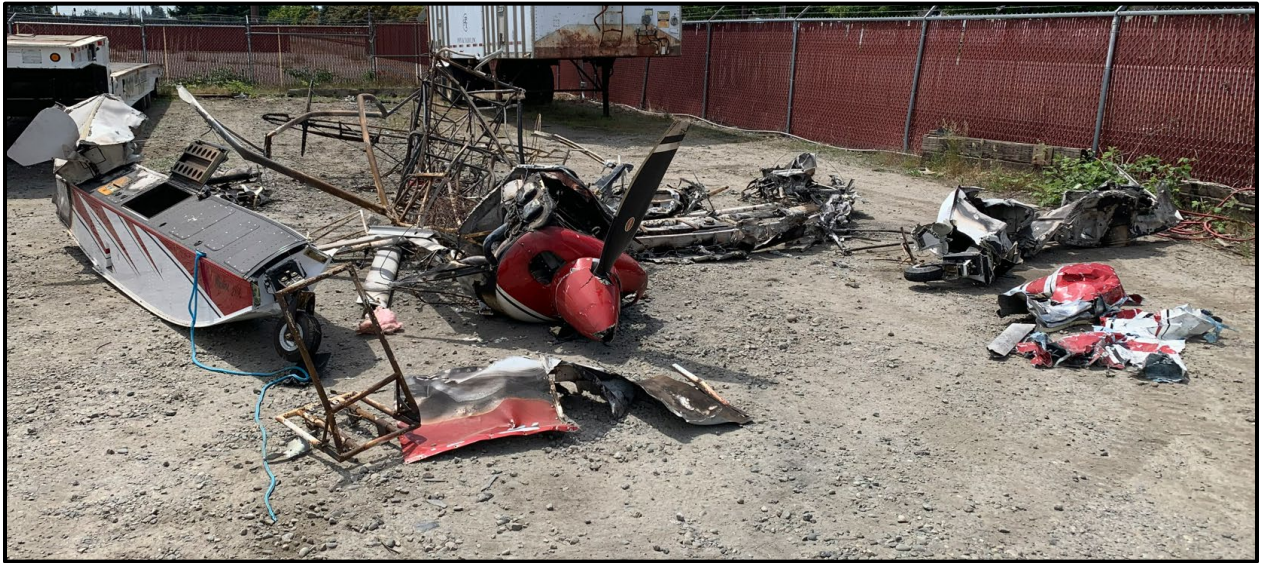
Flight control continuity was established from all flight control surfaces to its respective controls in the cockpit.
