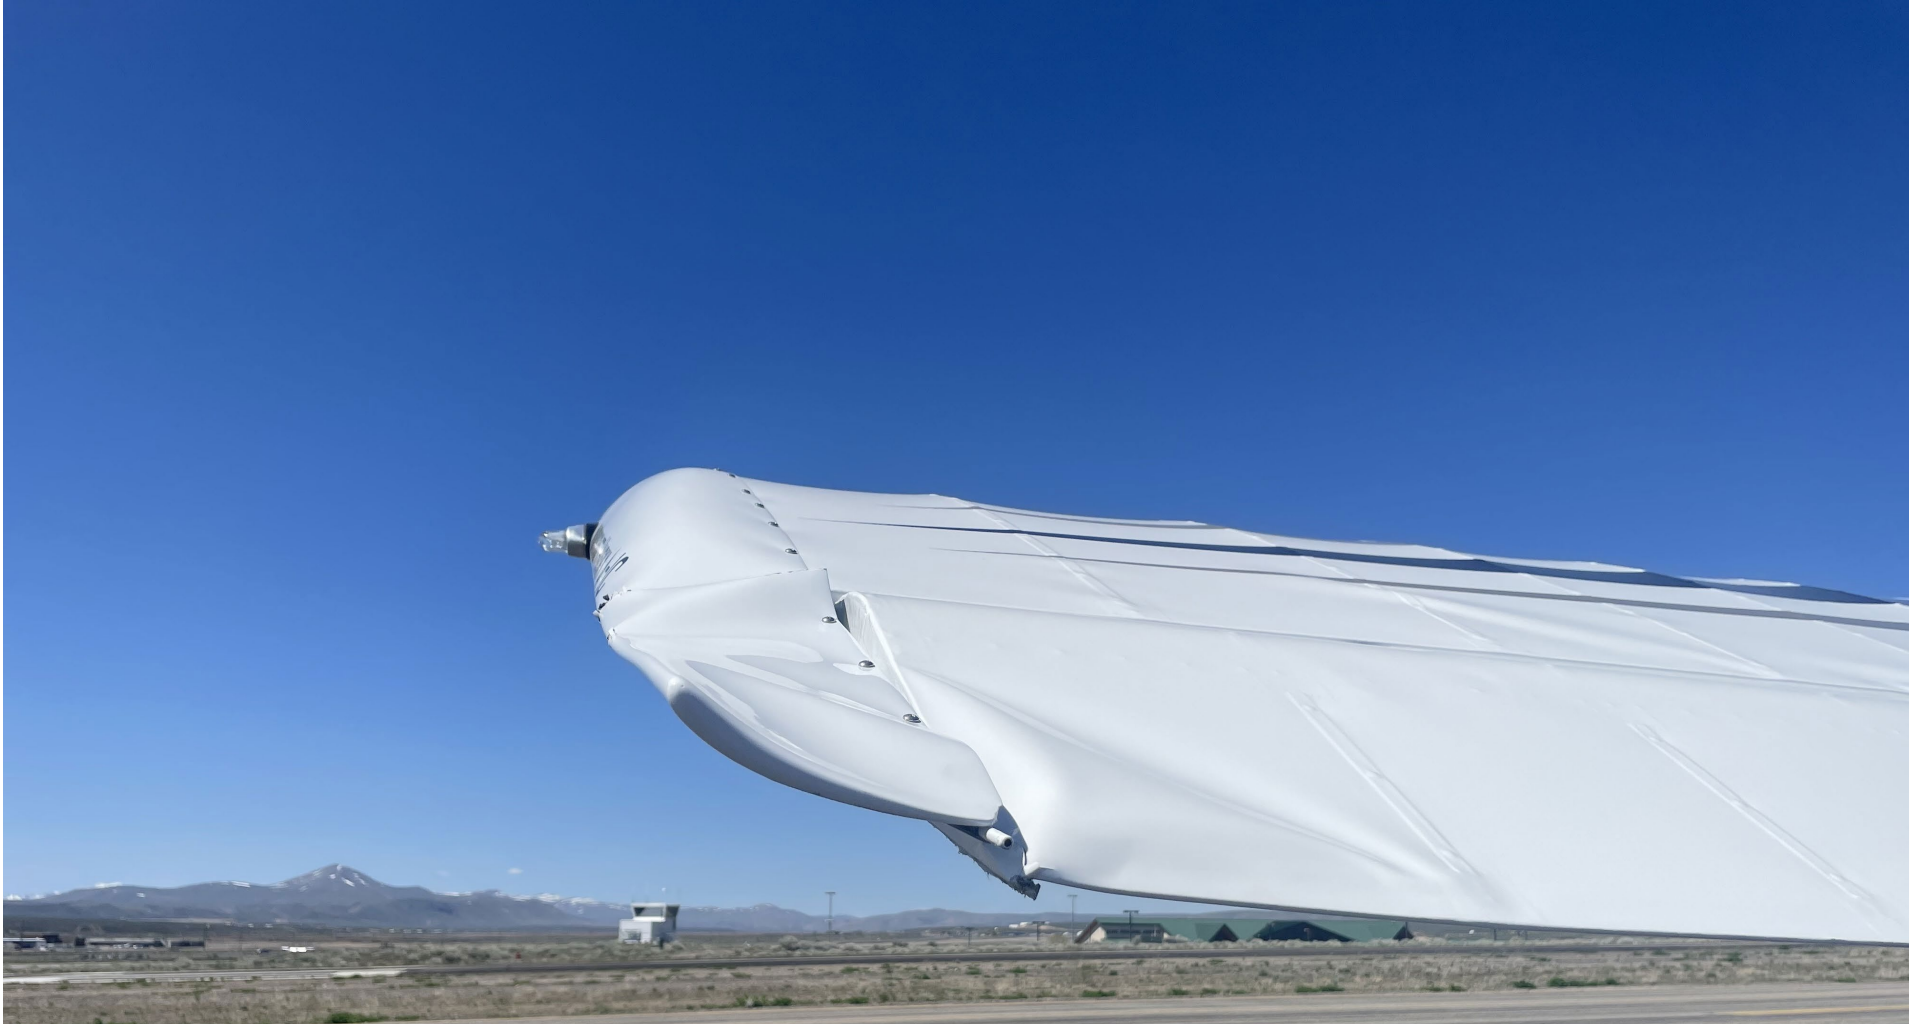
**Photo 1 – View of damage to left aileron (Courtesy of Owner)**

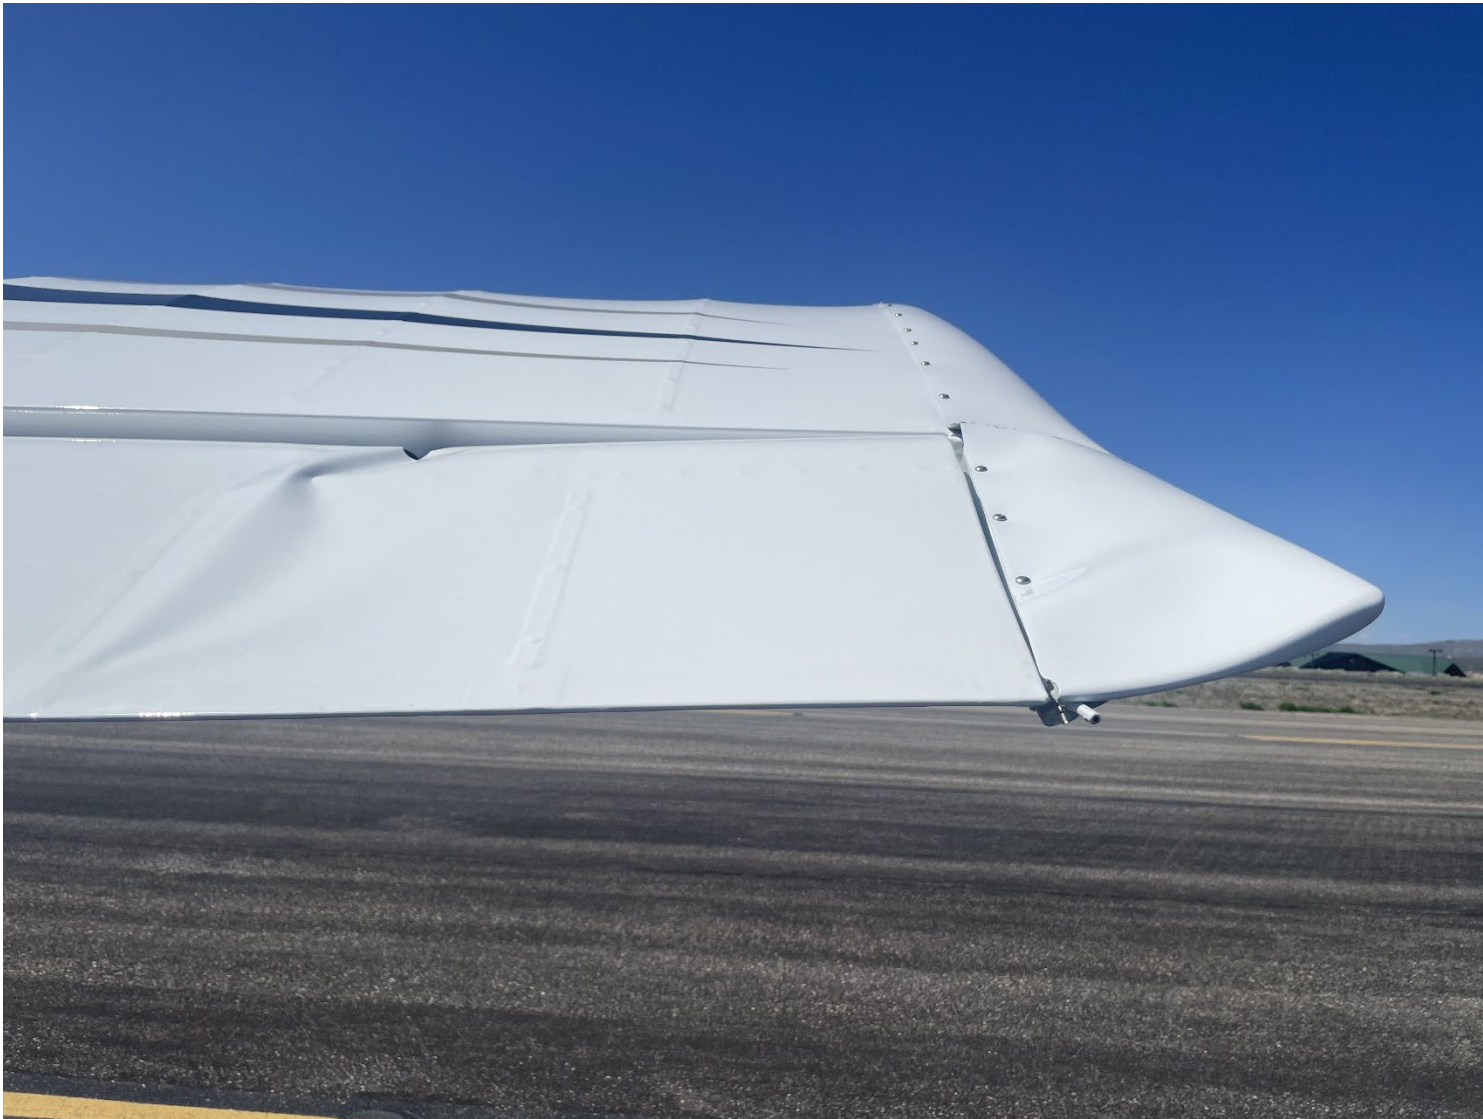
**Photo 2 – View of damage to right aileron (Courtesy of Owner)**
