VIKING AIR DHC-6-400 TWIN OTTER  
FAA REGISTRATION: N153QS  
NTSB ACCIDENT NO: WPR23LA192  
PROJECT FINAL REPORT

**DATE:** March 06, 2023

**Submitted To:**  
Richard Ball  
Lone Star Retrieval (LSR)

**Submitted By:**  
Eclipse Group, Inc.

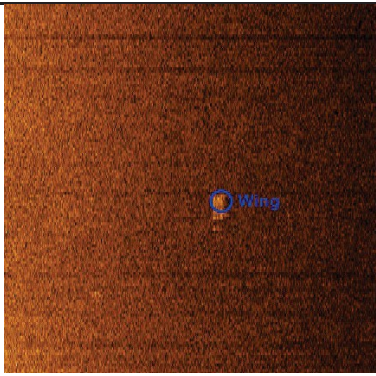
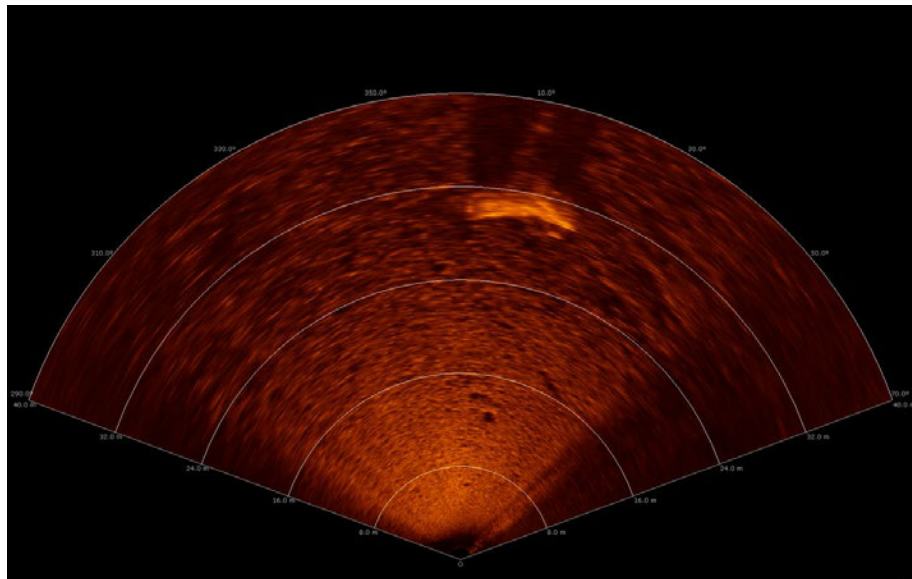
Figure #15. Wing and Engine Sonar

| | <b>Starboard Wing / Engine</b> <ul style="list-style-type: none"> <li>• Sonar Time at Target: 7/27/2023 9:35:12 AM</li> <li>• Click Position<br/>37.5221937842 -123.0973649870 (WGS84)<br/>(X) 491396.45 (Y) 4152808.04 (Projected)</li> <li>• Map Projection: EPSG:26910</li> <li>• Acoustic Source File: HMB_209_0115_0918.jsf</li> <li>• Ping Number: 30413</li> <li>• Range to target: 195.28 Meters</li> <li>• Fish Height: 62.67 Meters</li> <li>• Heading: 149.600 Degrees</li> <li>• Course Made Good: 158.782 Degrees</li> <li>• Event Number: (-1)</li> <li>• Line Name: HMB_209_0115_0918</li> <li>• Water Depth: 631.22 Meters</li> </ul> | <b>Dimensions and Attributes</b> <ul style="list-style-type: none"> <li>• Target Width: 5.70 Meters</li> <li>• Target Height: 0.96 Meters</li> <li>• Target Length: 11.12 Meters</li> <li>• Target Shadow: 3.05 Meters</li> <li>• Mag Anomaly: N/A</li> <li>• Avoidance Area: N/A</li> <li>• Classification1: N/A</li> <li>• Classification2: N/A</li> <li>• Area: N/A</li> <li>• Block: N/A</li> <li>• Description: N/A</li> </ul> |

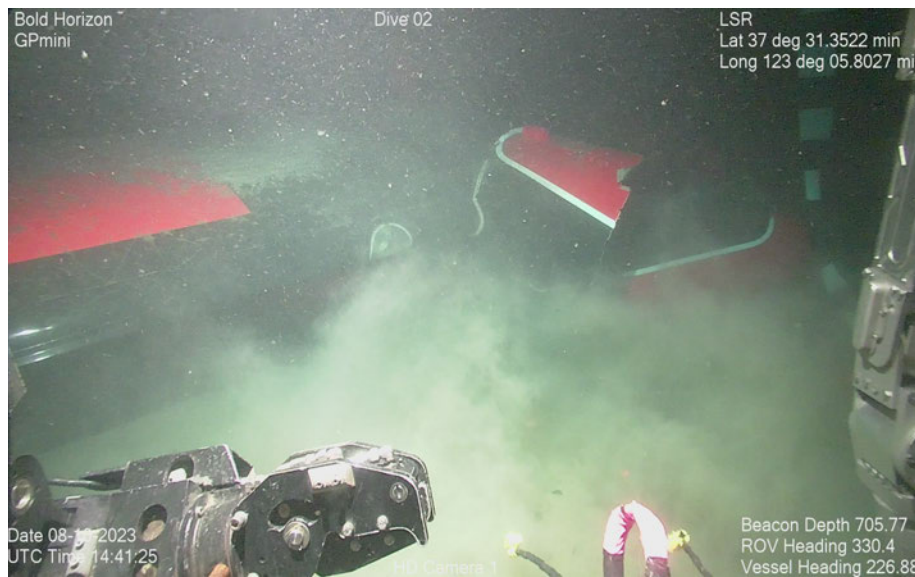
Figure #16. Wing and Engine Inspection (1)

| 10-Aug | THURS | 06:16- ROV in water, Begin Dive #2, area "Bravo 115"<br>07:28- ROV locates what appears to be a wing with engine/prop attached, depth 705m.<br>07:30- Confirmed ROV team has found Twin Otter Starboard wing<br>08:06- Engine confirmed not structurally attached<br>08:56- ROV recovery<br>09:40- ROV on deck, End of Dive #2<br>09:52- BH moving to area "Delta"<br>11:49- ROV off deck, Begin Dive #3<br>12:30- ROV investigates target, target appears to be shipping container. Corner numbers: ICSO 415081, USA 2210; container is upside down<br>13:09- ROV recovery<br>13:42- ROV on deck, End of Dive #3<br>13:50- BH moving to area "Charlie#1"<br>15:55- ROV off deck, Begin Dive #4<br>16:30- ROV inspects target, appears to be rock pile<br>16:40- ROV recovery<br>17:10- ROV on deck, End of Dive #4<br>17:20- BH moving to area "Charlie#2"<br>17:57- ROV off deck, Begin Dive #5<br>18:28- ROV inspects target, appears to be rock pile, begin ROV recovery<br>19:05- ROV on deck, End of Dive #5<br>19:30- BH moving to area "Bravo", Begin Search Operations<br>23:59- BH running survey lines / operating tracking patterns with pinger |

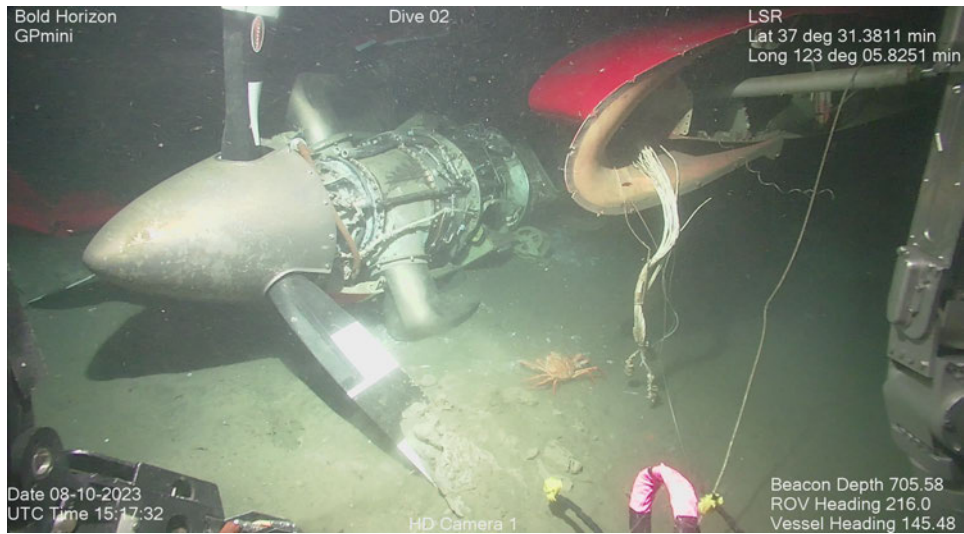
**Figure #17. Wing and Engine Inspection (2)**

| Dive #1 | Date | Time (UTC) | Log Entry |
|---|---|---|---|
| | | | <b>Notes:</b><br>Found starboard wing & engine attached to wing<br>Wing and engine are right-side up<br>Traction winch level-wind working correctly—magnetic sensor replaced 08/08/2023<br>Replaced Yaw hose fitting for ISE arm<br>Rigging in place on porch (of ROV) |

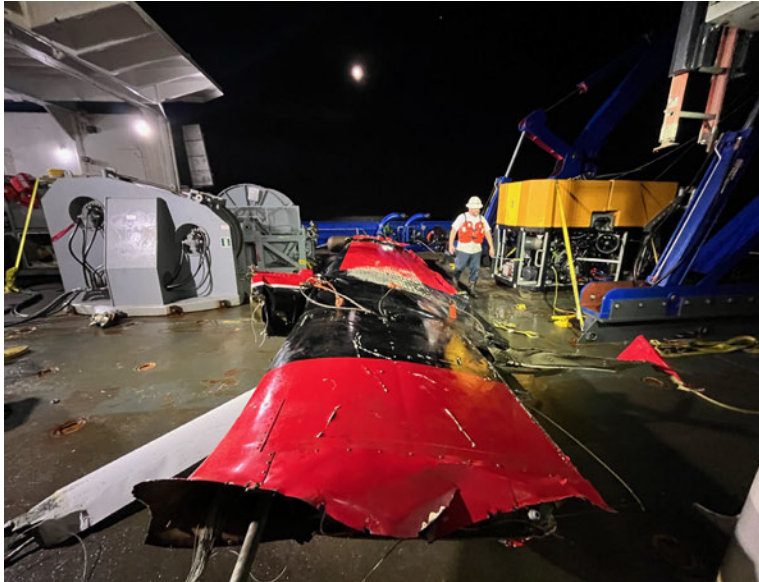
Figure #25. Twin Otter Wing Recovery

Since EGI's Swift Responder had just completed an aircraft recovery off the coast of San Clemente Island, CA, the vessel was already properly mobilized for an aircraft recovery, it was decided to utilize the vessel to complete the twin otter wing and engine recovery. After 2 days of transit, the recovery operation was completed within five (5) hours on October 29, 2023. The wing and engine were pre-rigged up from the Bold Horizon's previous evolution, so upon arrival at the wreck site, operations began to ensure the wing and engine were still rigged properly to ensure for a successful recovery. After making minor adjustments, the wing and engine were successfully recovered and secured onboard the vessel by 20:05.
