# National Transportation Safety Board

WPR23LA192

## **WRECKAGE EXAMINATION SUMMARY REPORT**

Airplane: Viking Air DHC-6-400 (Twin Otter)

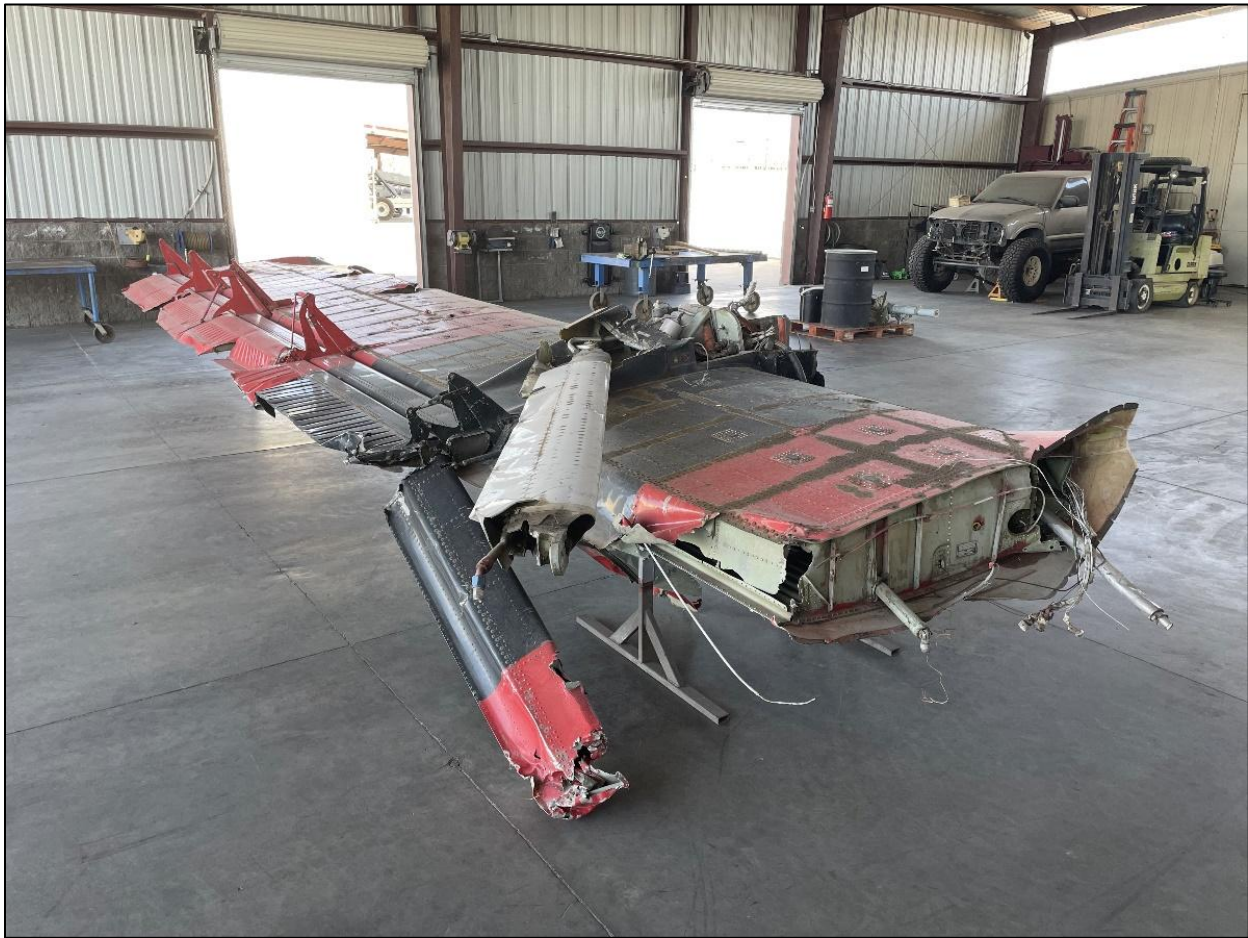
The right wing remained intact and had impact damage throughout. The engine separated from the engine mount and nacelle. The oil cooler assembly remained attached to the firewall. The lower cowling remained attached to the engine. The wing tip fairing remained partially attached to the wing and the wing tip fuel distribution components remained attached to the tip rib. The tip tank was

compressed on both the top and bottom surfaces and the tank cap was not secured to the tank port. The cap was removed and was unremarkable. The cap was resecured to the tank port. Leading edge crush damage was observed from wing station (WS) 335 to WS 260. The wing fence was deformed inboard and remained attached to the wing. A 5-inch hole was observed on the lower side of the leading edge between WS 210 and 197. The nacelle assembly was distorted to the inboard side with crush damage on the top and inboard side.

**Figure 1-Right wing inverted.**

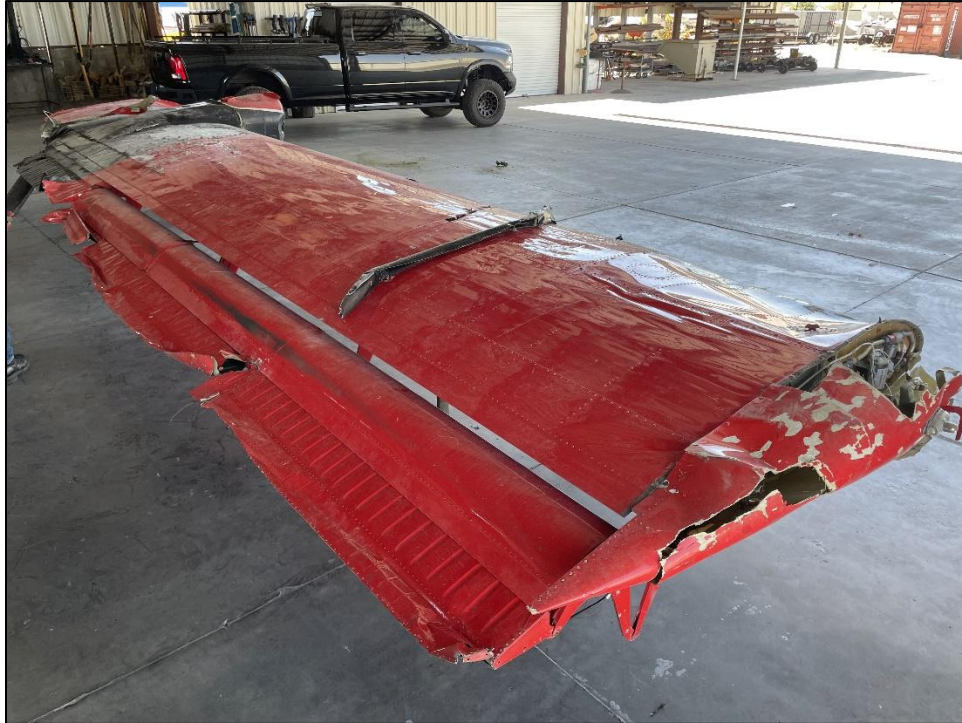
The wing support strut remained attached to the wing attach point and separated from the fuselage attach point. The wing support strut fuselage attach

point aft lug fracture separated and the forward lug was intact. The lower attachment bolt was not found. The internal fuel line was present in the support strut and separated at the fuel tank transfer pipe. The fuel line was attached to the fuel filter assembly in the nacelle area.

**Figure 2-Right wing.**

The aft wing spar was distorted and damaged from WS 60 to 35. And the rear wing attach fitting was torn from the spar and bent outboard with the inboard attachment lug missing. The wing root rib forward section to the front wing attach adapter was missing and the forward wing attach fitting was missing. The forward attach adapter bolt section remained attached to the wing adapter. The bolt appeared to have necking signatures consistent with tension overload.

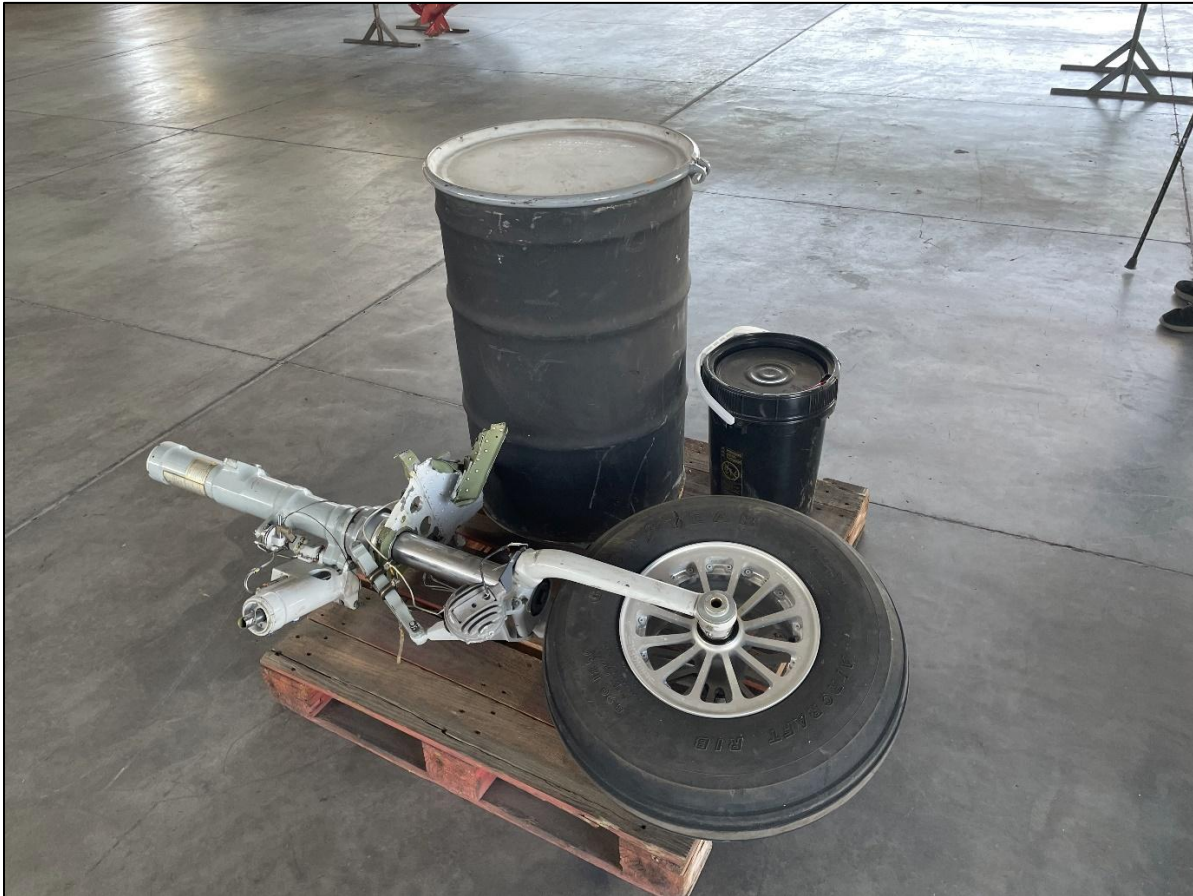
The nose landing gear upper attach lug was fracture separated. Portions of the fuselage attachment remained attached to the nose landing gear. The centering pin was engaged in the collar and the nose wheel was centered.

**Figure 3-Nose landing gear and bladder shipping barrel.**

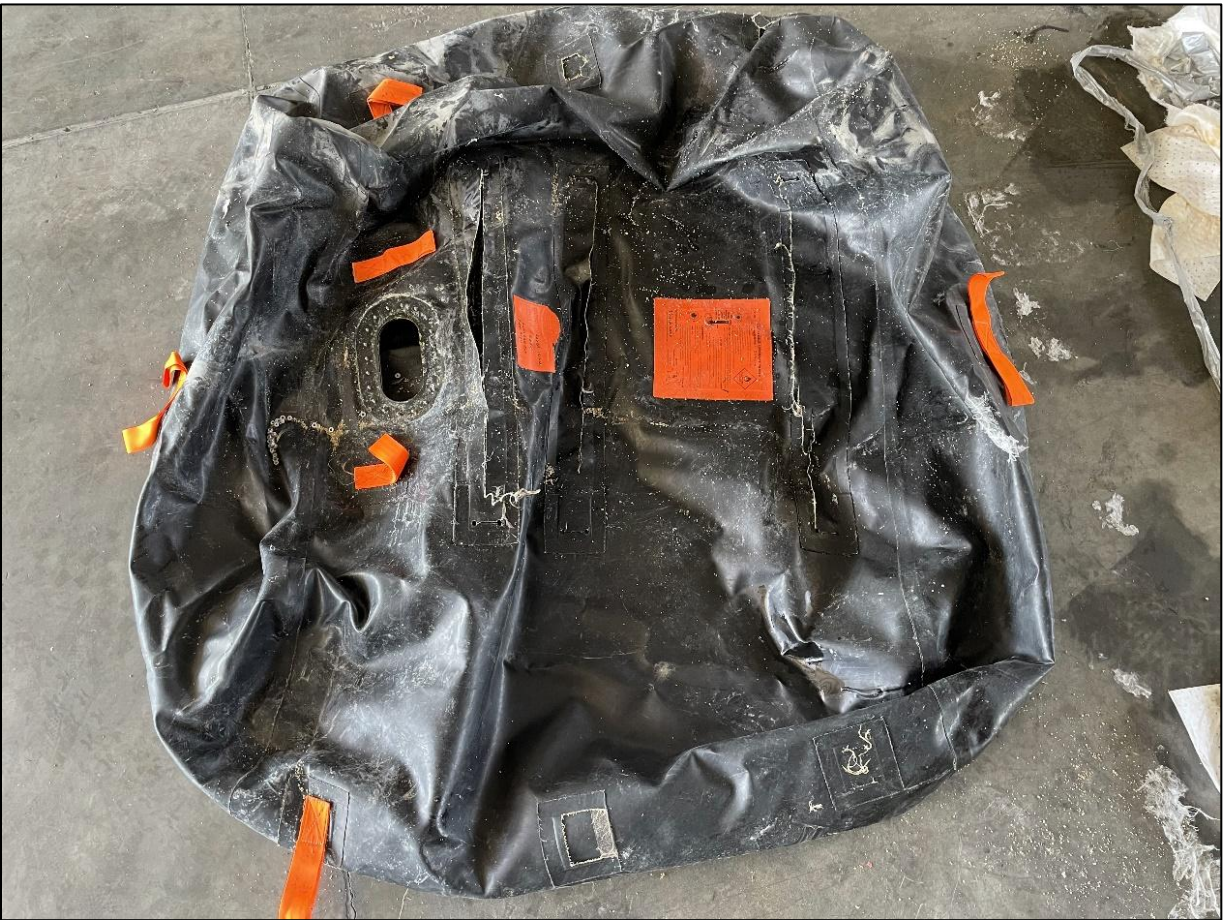
The 400-gallon fuel bladder was removed from the shipping barrel and plastic bag. Jet fuel was present during the examination. The flat tube and cap were attached to the bladder and were undamaged. The top plate was damaged on one side between fasteners. No leaks of the bladder was noted. The outlet fitting attached to the top plate was undamaged and uncapped. The three longitudinal strap loops were damaged, and the straps were missing. The five tie-down lift points remained attached to the bladder on one side. Both forward and aft center tie-down lift points separated. Two tie-down lift points on the other side separated with the one remaining attached. The fuel cap was removed from the filler neck and sand was present in the flat tube. The top plate was removed from the bladder and the inside

of the bladder had a presents of fuel and was clear of debris. The outlet fitting was unobstructed.

**Figure 4-Fuel bladder.**
