**FACTUAL NOTES, ENGINE TEARDOWN INVESTIGATION IN SUPPORT OF ACCIDENT INVESTIGATION OF VIKING AIR LIMITED DHC6-400 (N153QS) PERFORMED FOR NATIONAL TRANSPORTATION SAFETY BOARD.**

**Customer:** Bayshore Global LLC  
**Aircraft Model:** VIKING AIR LIMITED, DHC6-400, **Registration:** N153QS  
**Location:** [REDACTED] (examination site)  
**Accident Date:** 20 May 2023  
**Engine Model:** PT6A-34, **Serial No.** RB0988

**Civil Aviation Authorities Identification:** WPR23LA192  
**TSB Identification:** A23F0156  
**P&WC File No.:** 23-075  
**RFA No.:** 23SIE00139

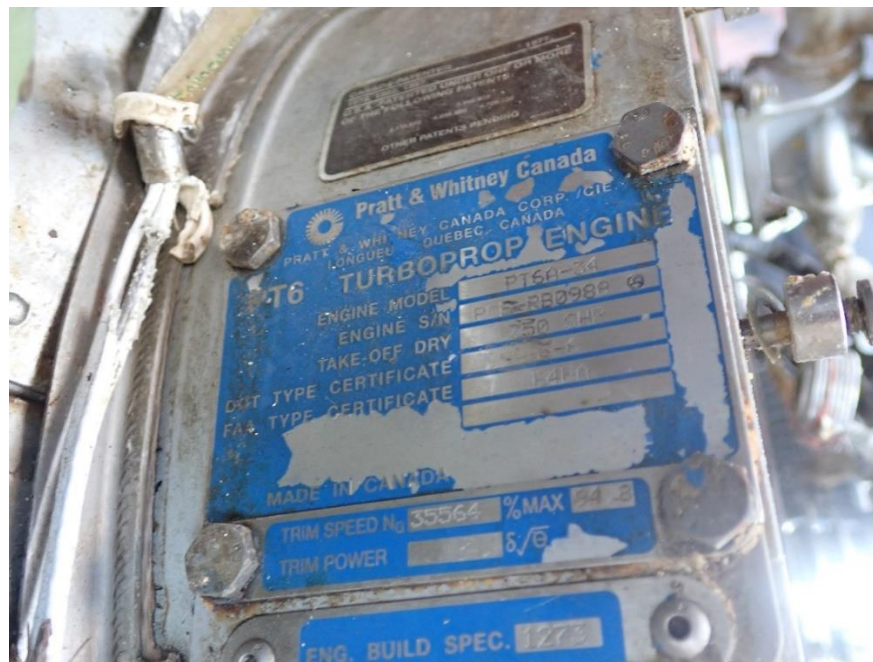
Photo No. 1

The engine data plate confirmed the engine serial number RB0988 (Ref. Photo No.1). The engine had been removed from the airframe with the top airframe cowling remaining attached (Ref. Photo No. 2). The external surfaces of the gas generator case and exhaust duct were corroded with environmental deposits present. The air inlet housing was attached to the gas generator case with no cracks or distress observed on the inlet case struts. The accessory gearbox (AGB), reduction gearbox (RGB) assemblies and internal components were not present with the engine (Ref. Photo No. 3 and No. 4). Laying loose with the engine were three (3) AGB gears, the internal AGB scavenge oil pump, main oil pressure

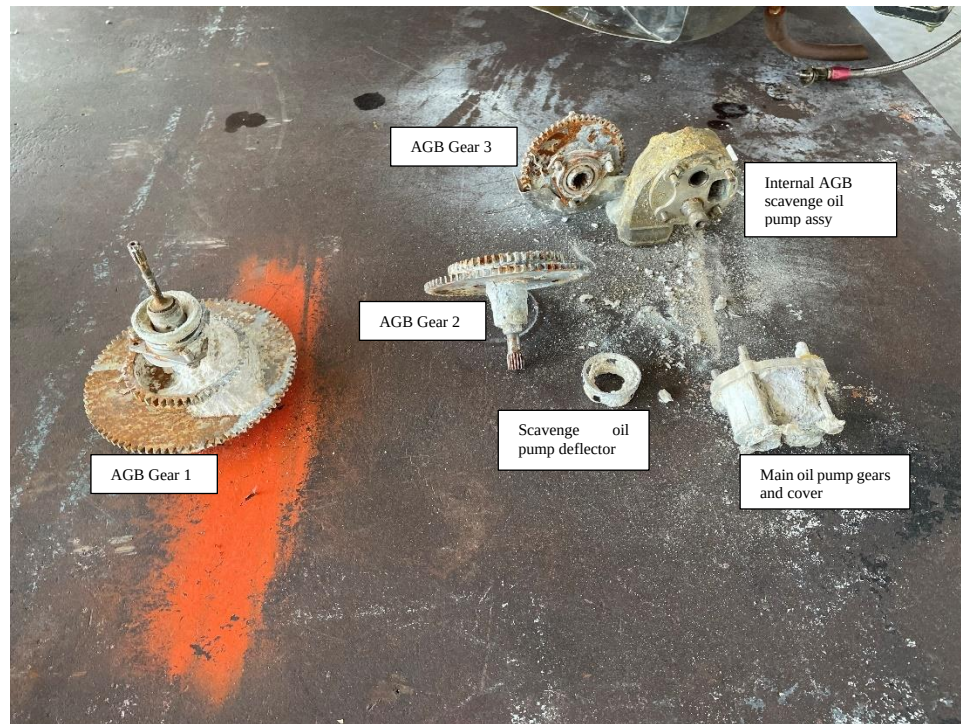
Photo No. 5

pump gears and cover and scavenge oil pump deflector, all were heavily corroded (Ref. Photo No. 5). The airframe exhaust ducts were attached to the engine exhaust duct (Ref. Photos No. 6). The accessory gearbox mounted engine controls were present and attached to their respective hardware (Ref. Photo No. 7). The P3, PY, wire rope/casing, fuel, and oil lines were present.

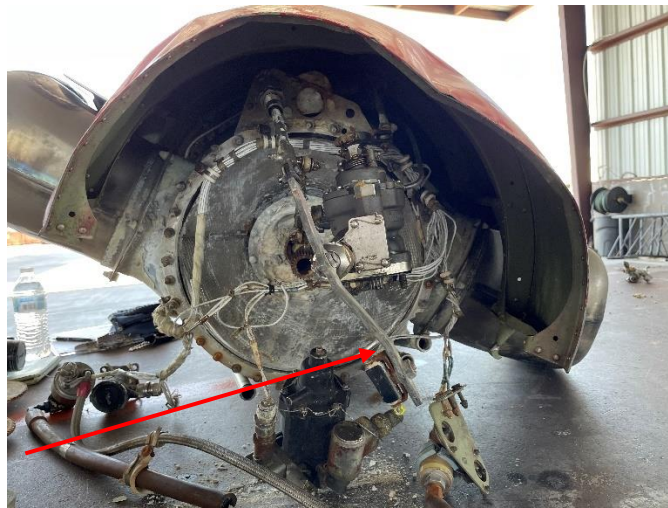
Photo No. 8

The reversing lever and the front linkages were in place and secured with safety wire and cotter keys. The airframe carbon block was attached to the reversing lever (Ref. Photo No. 8, red arrow). The airframe propeller speed control rod end was bent (Ref. Photo No. 9, red oval). The wire rope casing was in place and secure but was not capable of manual movement. The rear linkage was connected to the 2<sup>nd</sup> from top hole of the CAM box (Ref. Photo No. 10, red oval) and secured. The airframe FCU rod end connector was fractured (Ref. Photo No. 10, red arrow).

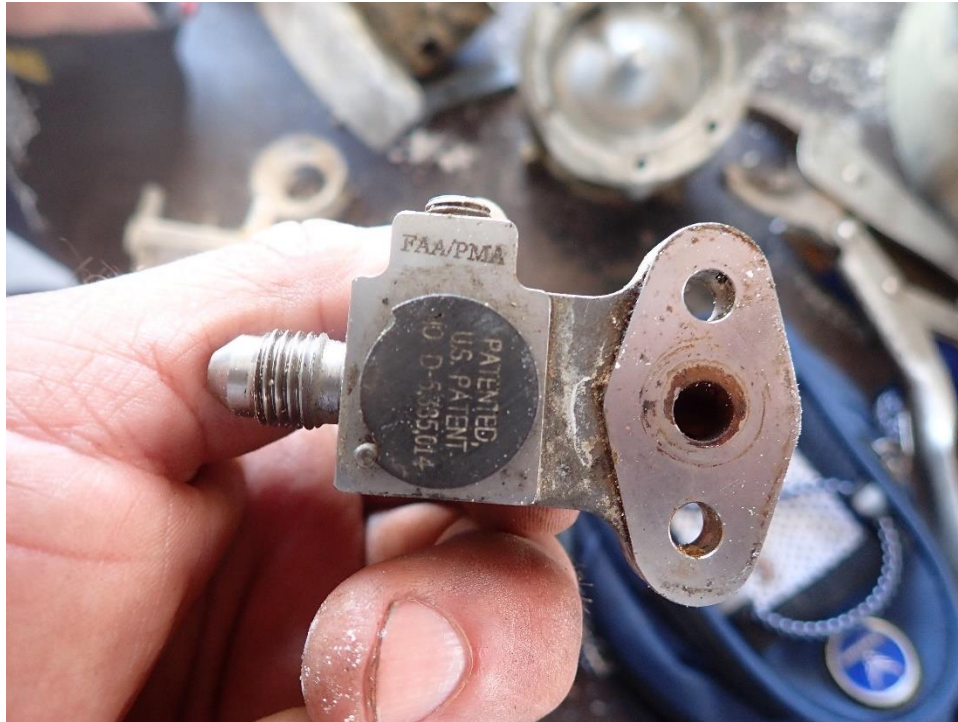
Photo No. 11

**Compressor Discharge Air (P3) and P3 Filter:** The front end of the line was secured to a PMA boss attached to the gas generator case port (Ref. Photo No. 11). The B nut to the fuel control fitting was lockwired and torqued. The P3 filter and housing contained sediment and environmental debris (Ref. Photo No. 12).

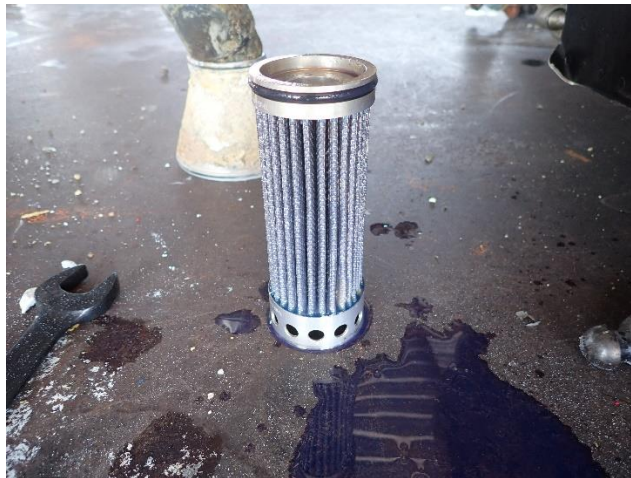
Photo No. 13

**Oil Filter:** Residual oil present and water in the filter housing. Environmental debris present, no metallic debris present (Ref. Photo No. 13).

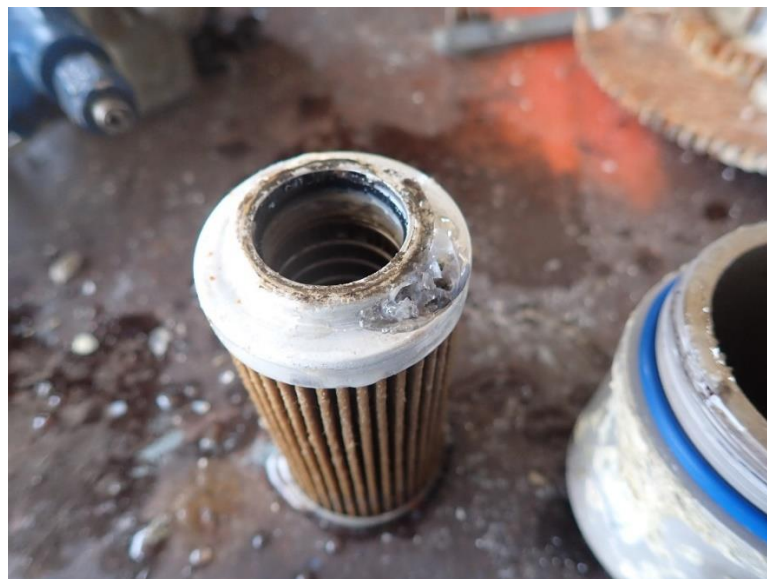
Photo No. 14

**Fuel Filter:** Water and environmental sediment/debris present in the filter bowl with an odor of fuel. No metallic debris was found in the filter pleats (Ref. Photo No. 14).

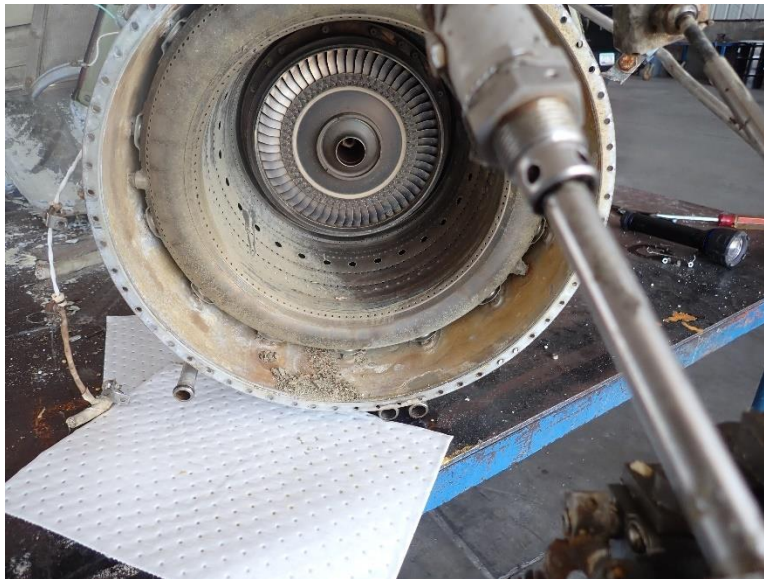
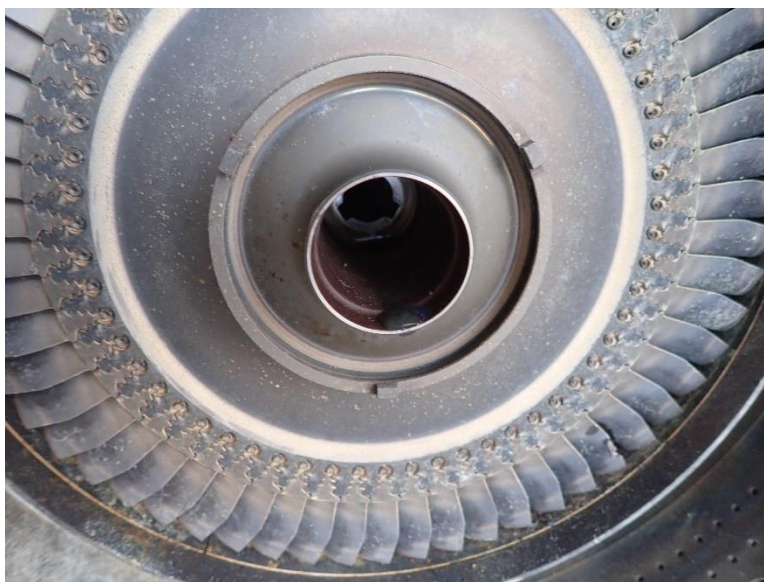
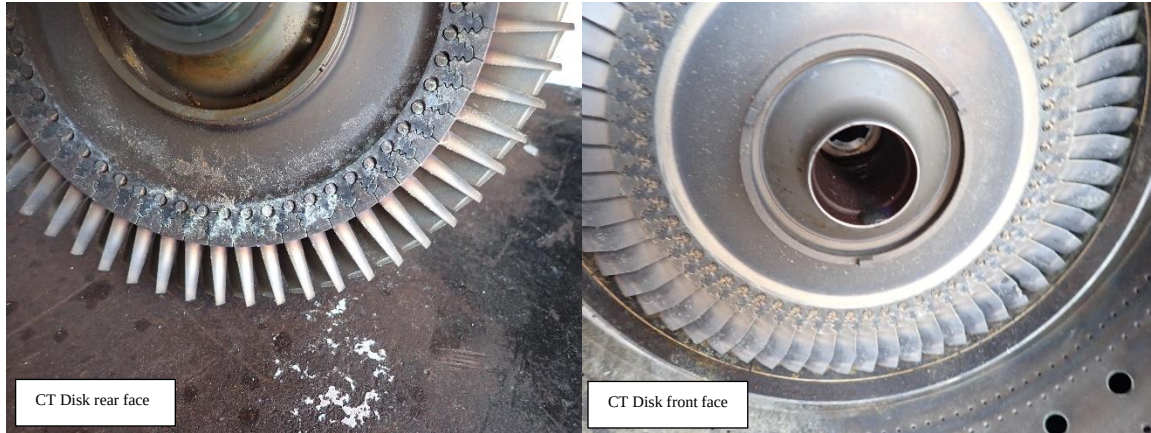
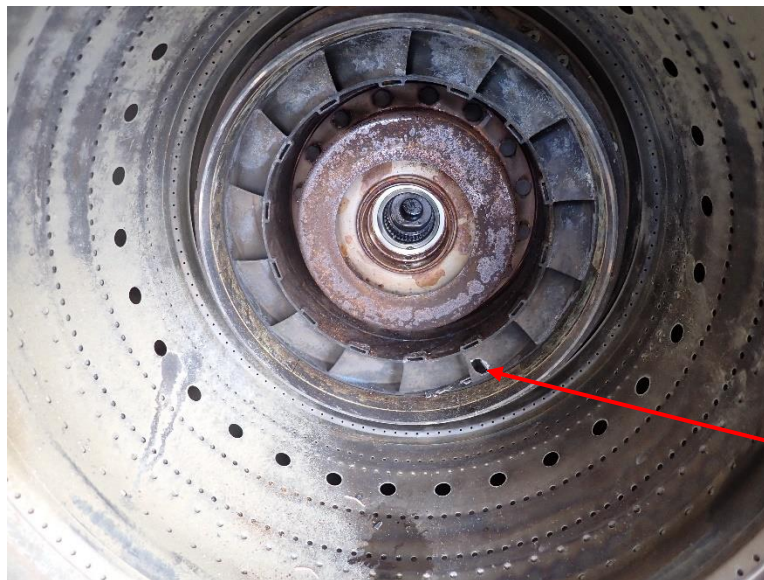
The gas generator case, bladed CT disk assembly and CT Vane ring were covered with sediment and environmental debris (Ref. Photo No. 15 through No. 18). The bladed CT disk was mechanically wedged between two CT blades and the CT vane ring to allow removal of the CT disk assembly which damaged two blades and one CT vane airfoil. The CT shroud segments were environmentally stained and corroded.

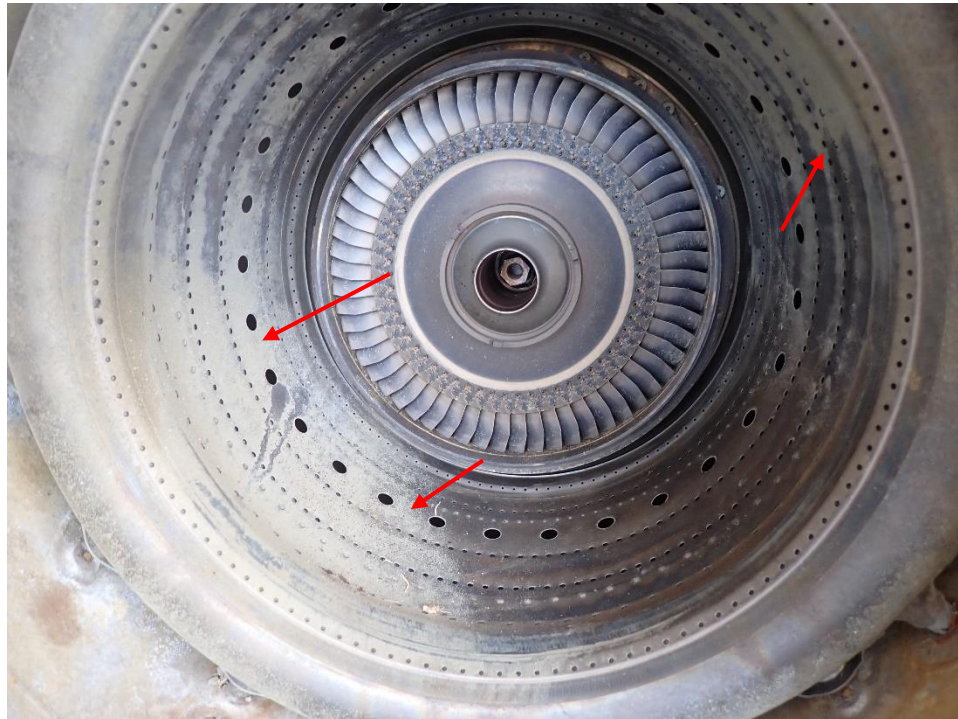
Photo No. 19

The external surface of the CC liner assembly was covered with environmental staining and debris, no damage was observed (Ref. Photo No. 19, red arrows). The CC Liner was not removed during the investigation.

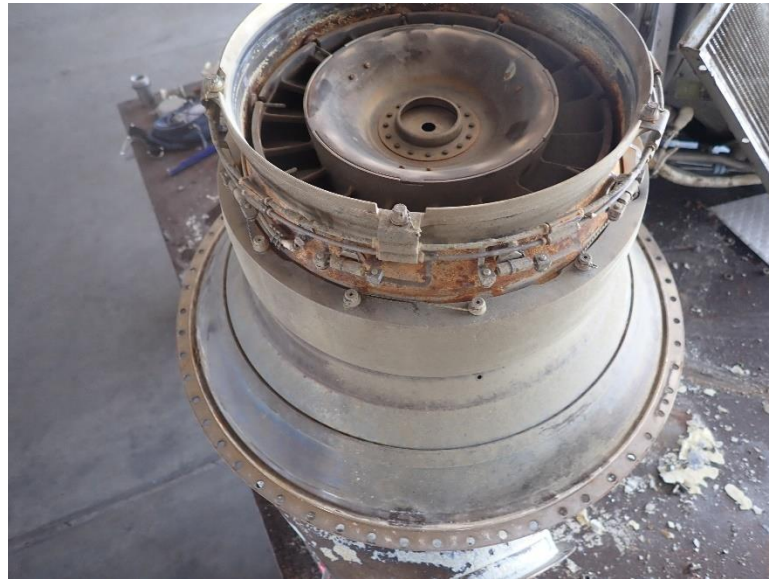
Photo No. 20

The ITT probes, busbar and harness were intact with no burning or damage noted and were covered with environmental staining and corrosion (Ref. Photo No. 20). The bladed PT disk and PT Vane ring were covered with environmental staining and corrosion (Ref. Photo No. 21 and No. 22).

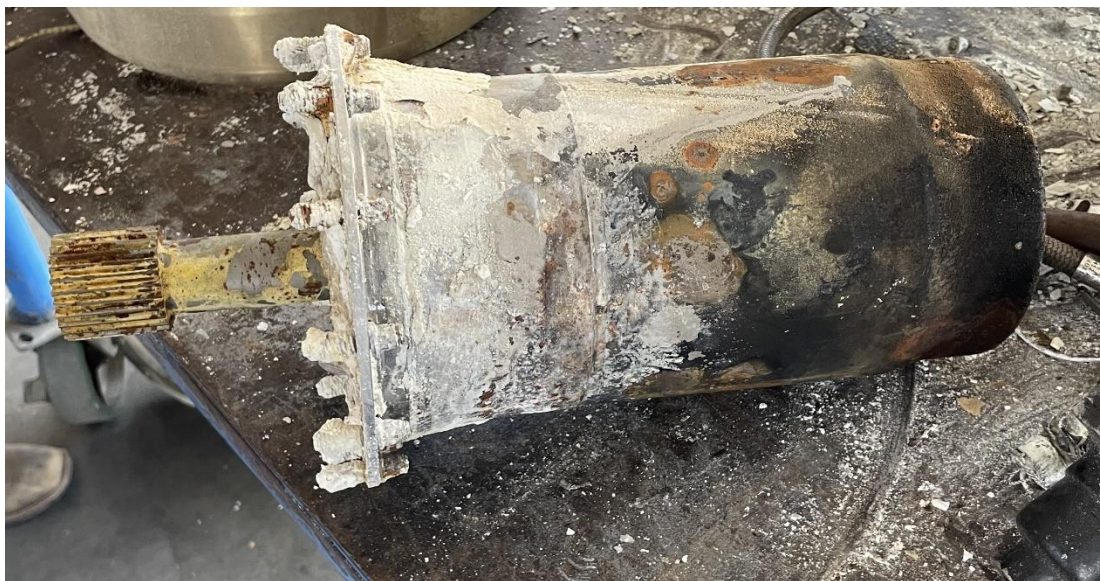
Photo No. 23

The PT Shaft housing was heavily corroded at the RGB rear housing mating diameter (Ref. Photo No. 23). Manual rotation of the PT shaft was difficult but possible with use of a breaker bar. No further disassembly of the PT shaft housing was carried out during the investigation.

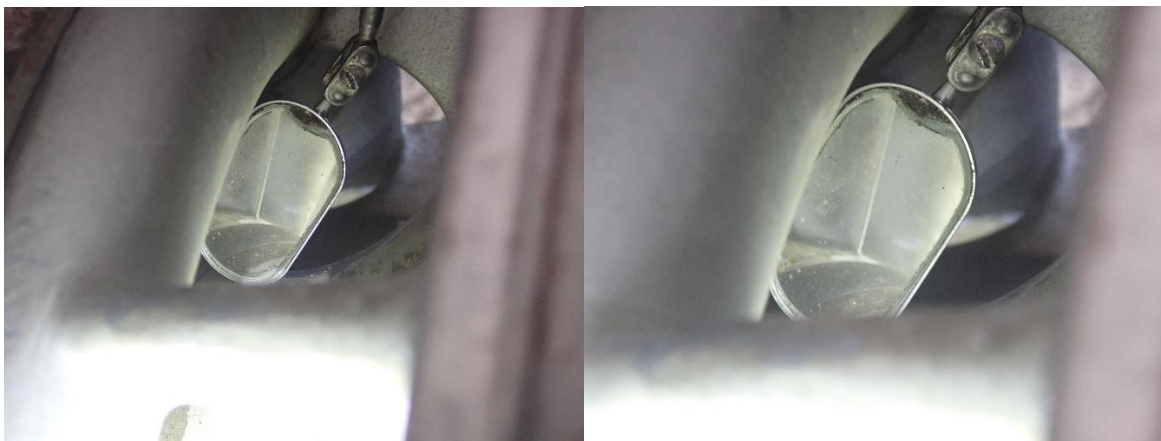
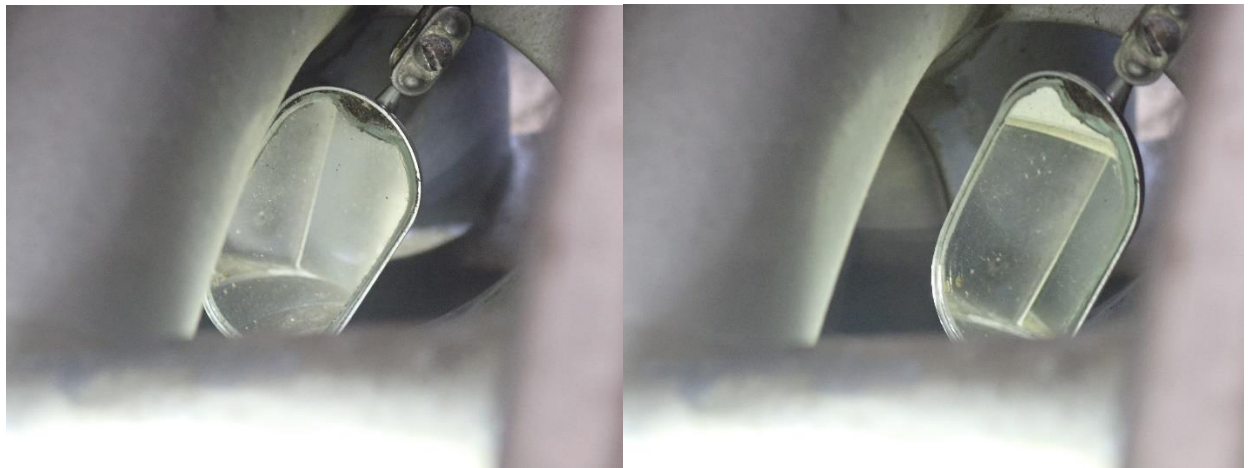
The 1<sup>st</sup> stage compressor rotor blades were inspected through the air inlet struts and found to be in satisfactory condition with no evidence of distortion or foreign object damage (FOD) (Ref. Photos No. 22 and No. 23). The shroud around the blade tips was unremarkable. The No. 1 bearing flexible housing was visible at the air inlet housing and was heavily corroded (Ref. Photo No. 24). No further access or disassembly of the compressor rotor assembly was carried out during the investigation.

The engine did not display deformation to the 1<sup>st</sup> stage compressor rotor airfoils characteristic of the engine developing power at the time of impact.

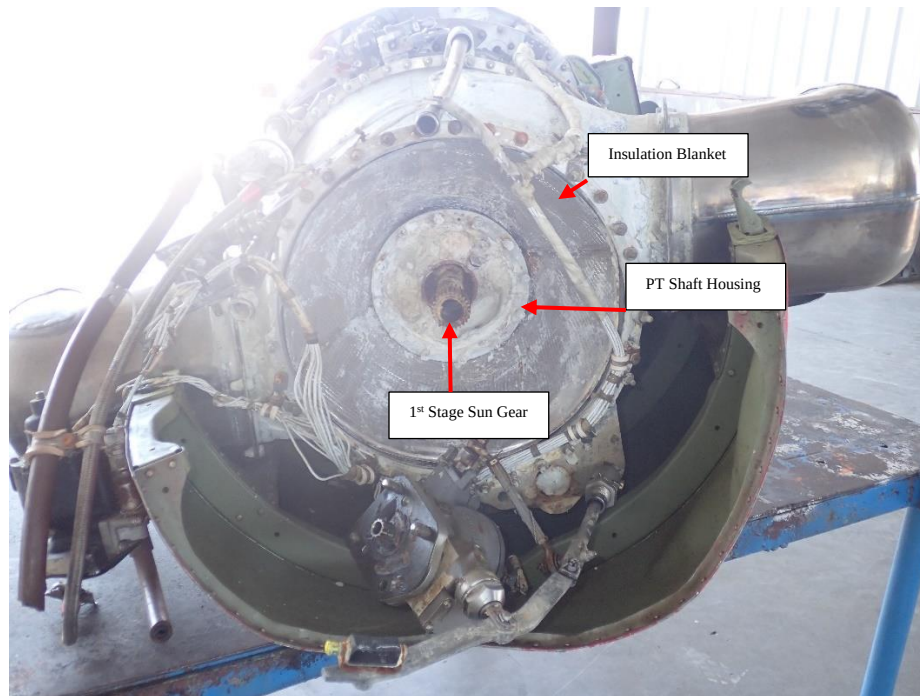
Photo No. 25

The front and rear RGB housings were missing along with all internal 1<sup>st</sup> and 2<sup>nd</sup> stage reduction gear components. The 1<sup>st</sup> stage sun gear was attached to the PT shaft housing assembly and heavily corroded (Ref. Photo No. 25).

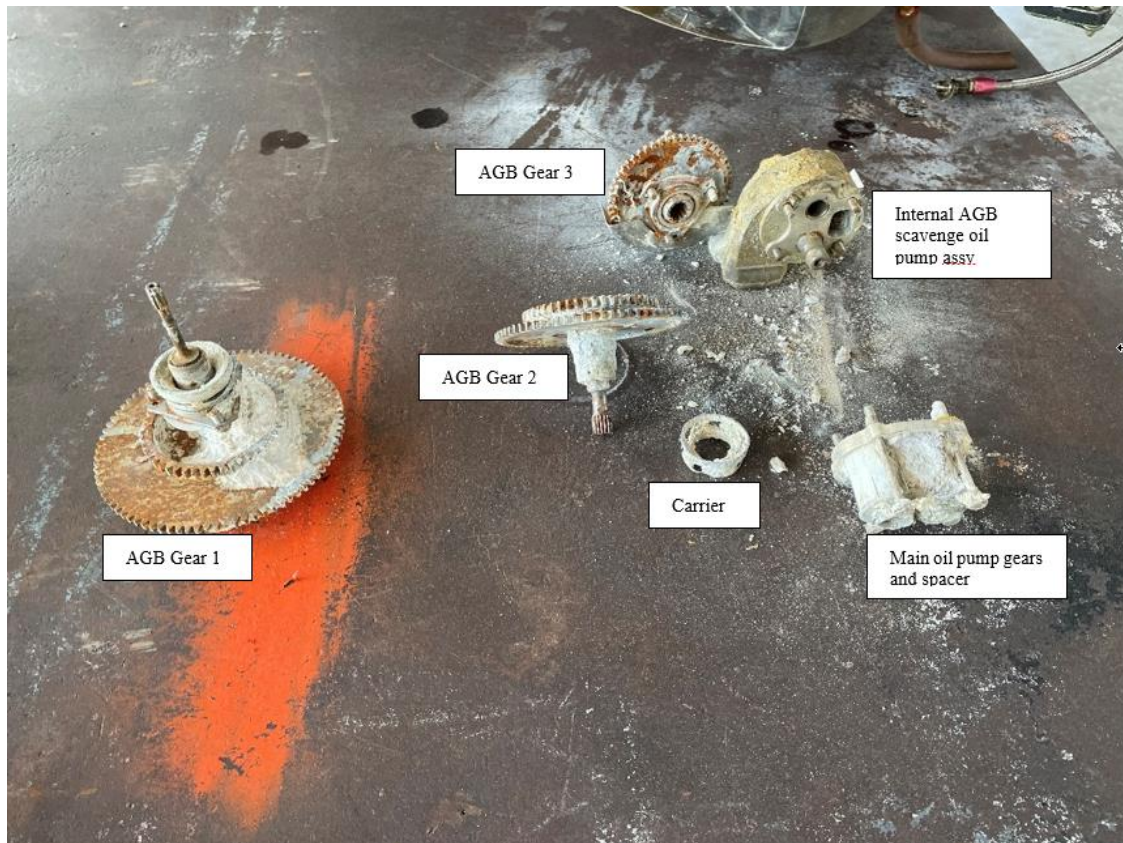
Photo No. 26

The AGB cover, diaphragm and external scavenge oil pumps were not present during the examination. Three (3) AGB gears, the internal AGB scavenge oil pump, main pressure pump gears and spacer, all were laying loose with the engine and heavily corroded (Ref. Photo No. 26).

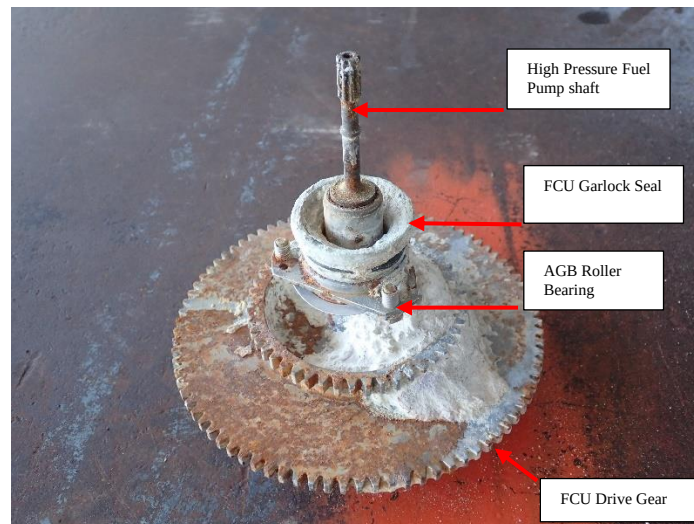
Photo No. 27

The high-pressure fuel pump and fuel control unit were attached to their respective fuel lines. The fuel pump drive shaft was attached to the AGB drive gear which was separate from the engine (Ref. Photo No. 27).

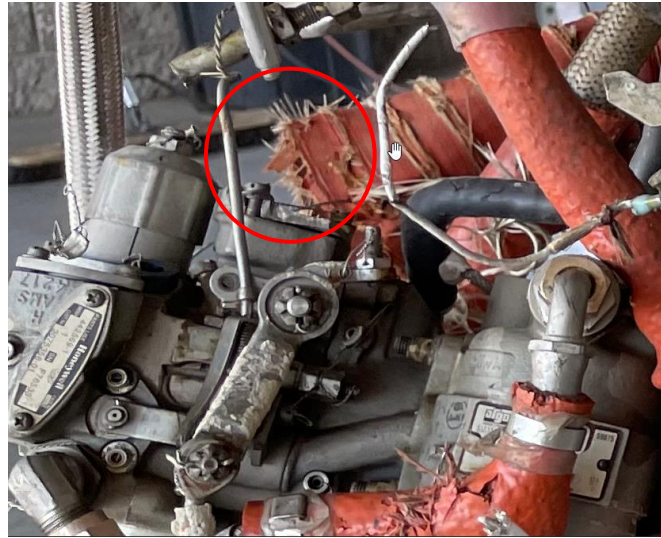
Photo No. 28

The FCU condition lever was fractured from the FCU and was not present during the investigation (Ref. Photo No. 28, red oval).

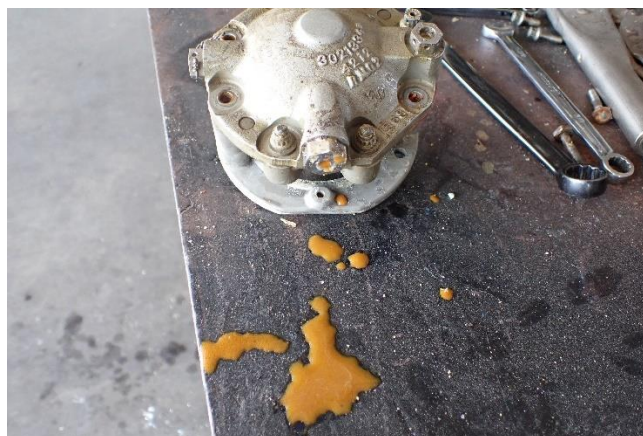
Photo No. 29

The BOV was removed and found to be contaminated with water (Ref. Photo No. 29). The BOV piston was able to be moved freely by hand.
