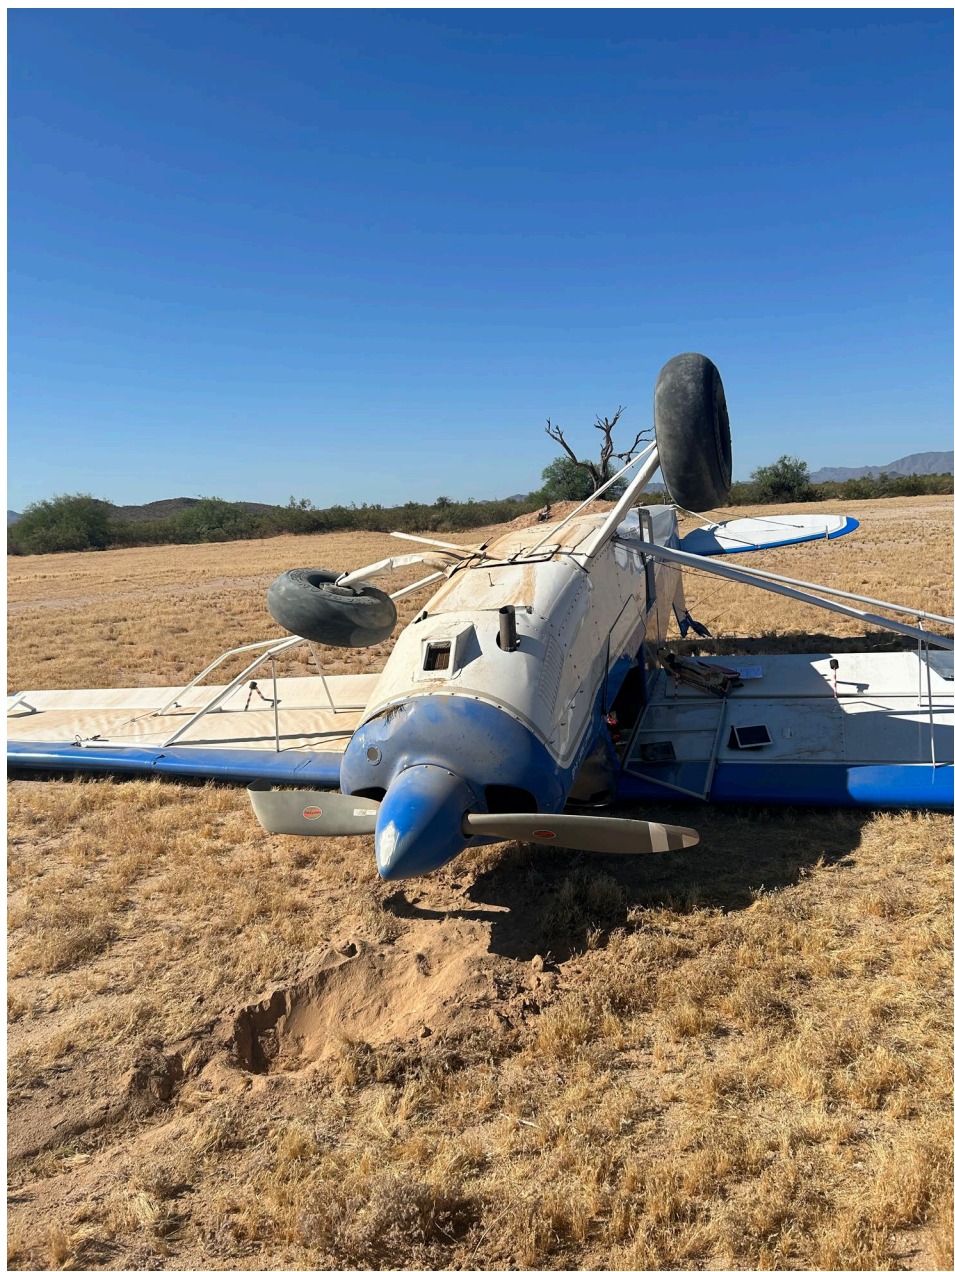
**Photo 1 – View of damage to left wing struts (courtesy of pilot)**

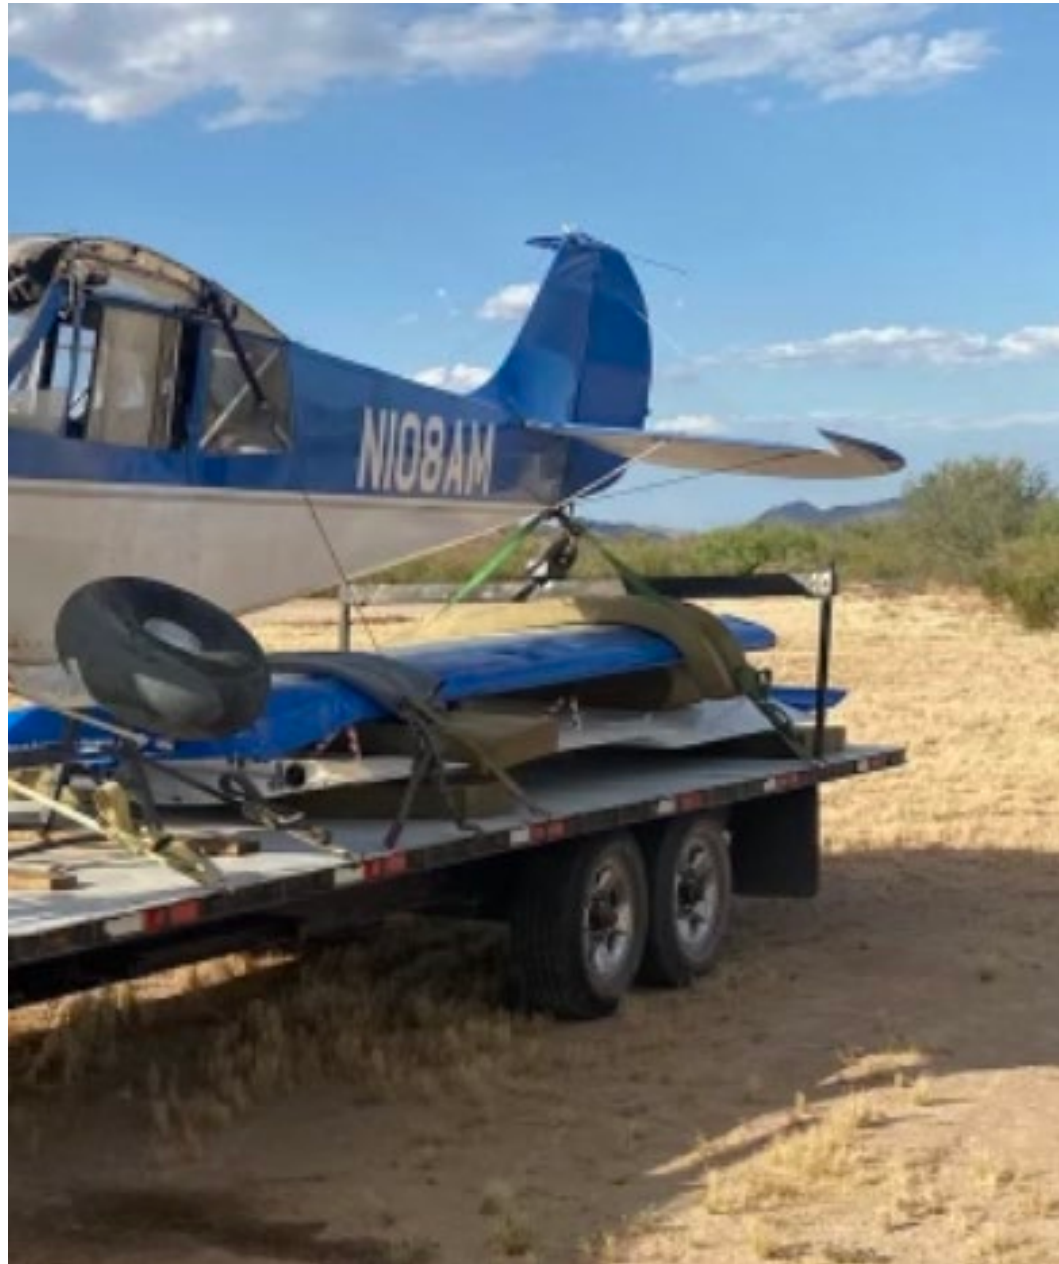
**Photo 2 – View of damage to vertical stabilizer and rudder (courtesy of pilot)**
