# National Transportation Safety Board

WPR23LA196

## **ENGINE AND AIRFRAME EXAM NOTES**

Location: Seattle, Washington  
Date: May 18, 2023  
Time: 1817 Pacific standard time  
Airplane: 1967 Cessna 172H N2550L

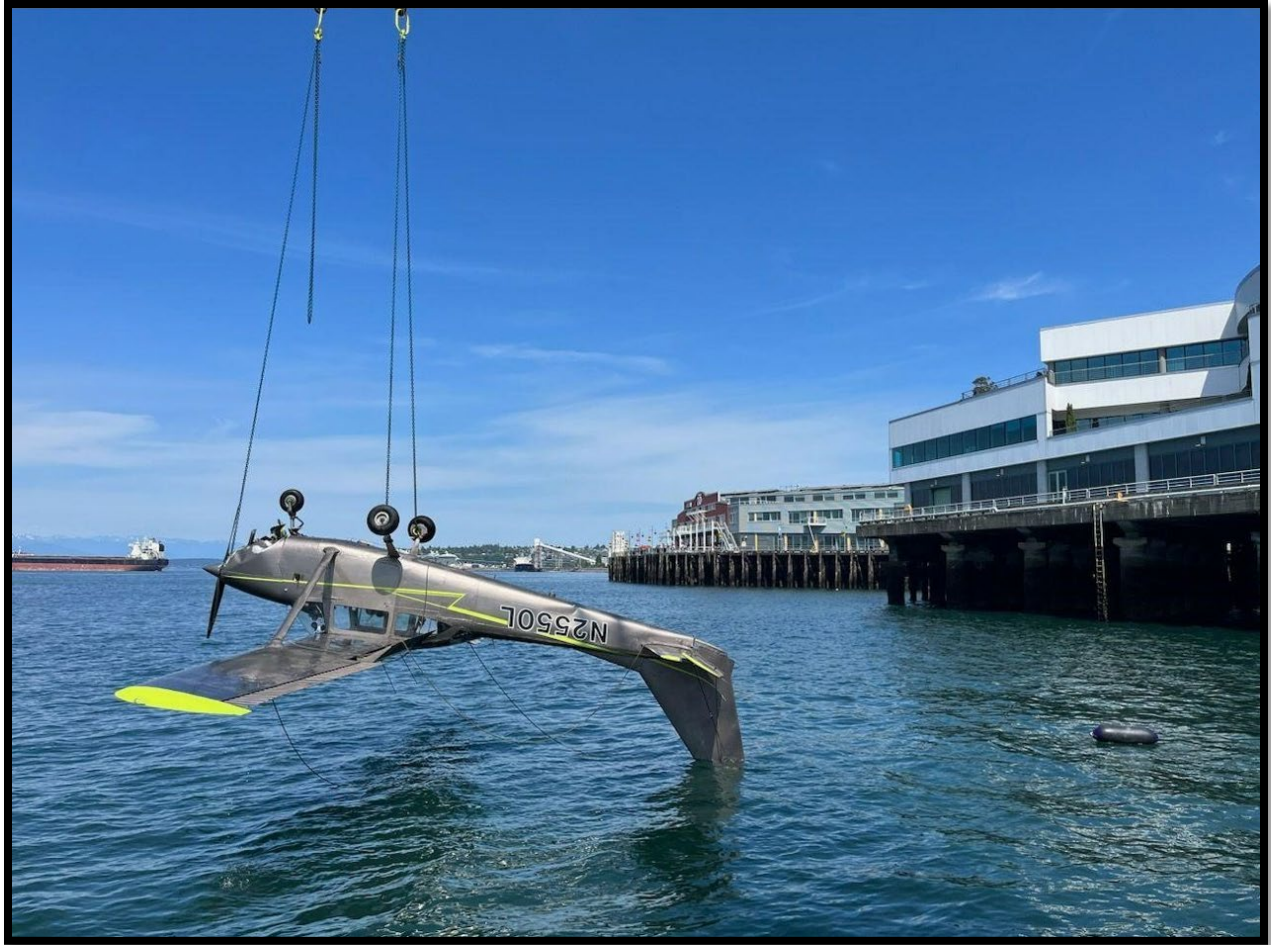
The pilot reported 1000 ft from the shoreline of Elliott Bay, he experienced a partial engine power loss. The engine RPM dropped to 1400 RPM and was no longer able to maintain altitude to reach the destination. He elected to conduct a water ditching. The pilot was rescued by local authorities and the airplane was recovered. (See figure 1& 2).

Figure 1. Airplane Recovery. Photo courtesy of AvTech Services

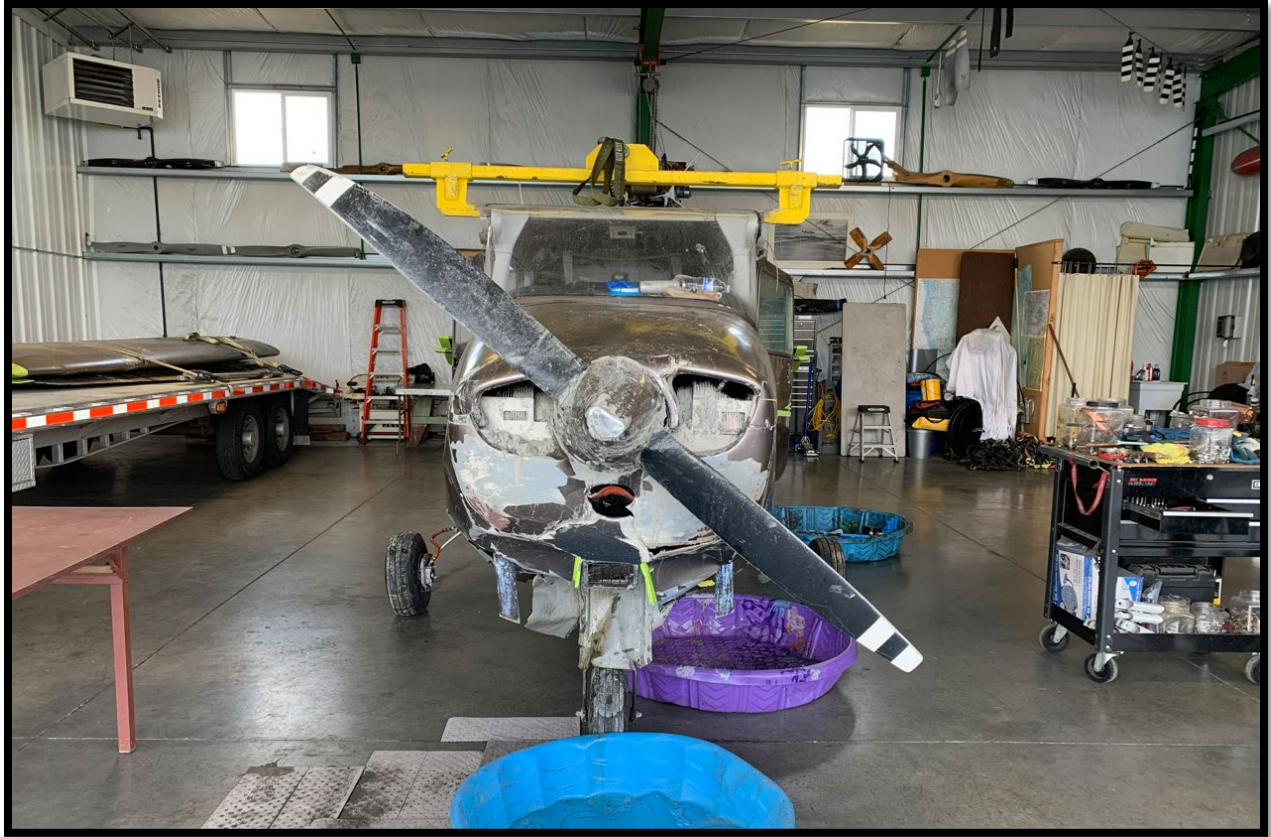
Figure 2: Recovered airframe.

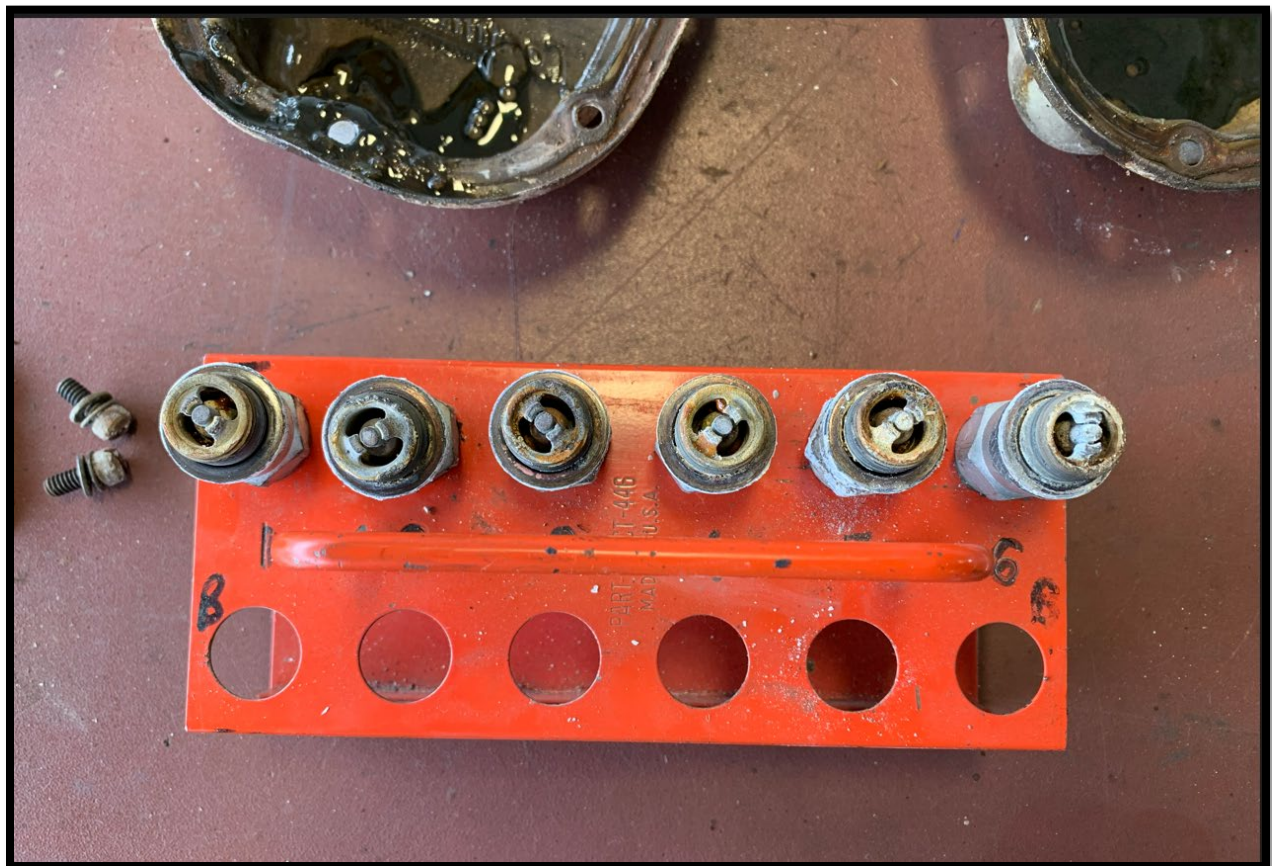
The upper spark plugs were removed from all 6 cylinders. They exhibited normal operational signatures and varying degrees of corrosion and debris (See figure 3). The left magneto was removed and was unable to be disassembled due to corrosion.

Figure 3. Upper spark plugs

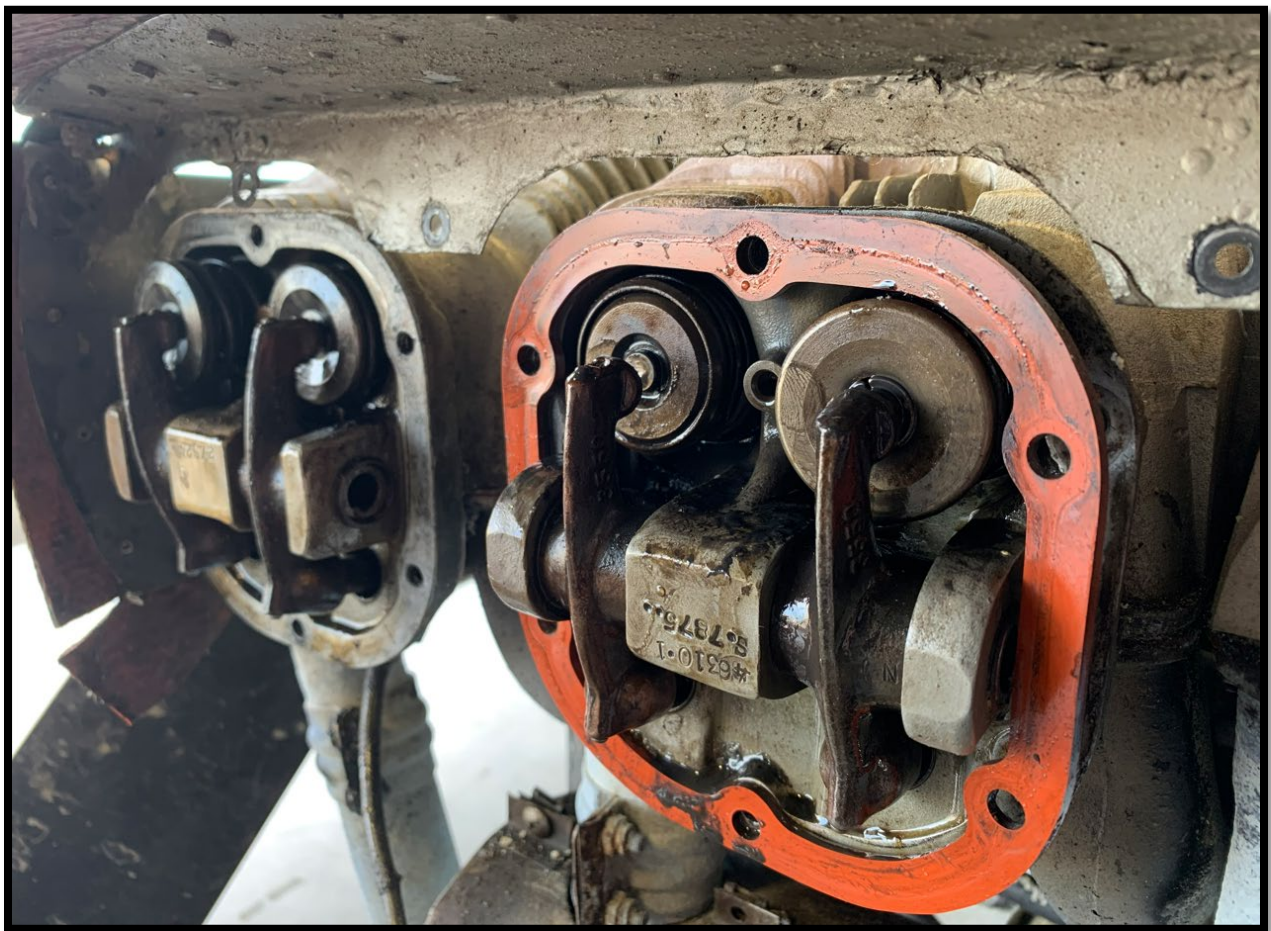
Cylinder no. 4 was removed for further examination (See figure 4). The intake valve was removed with little effort; however, the exhaust valve was found stuck in the partially open position (See figure 5). The exhaust valve was removed utilizing a punch and hammer along with significant force. The no. 4 exhaust valve guide exhibited evidence of oil coking along with an area of polishing on one side of the guide. A slight amount of discoloration consistent with corrosion was observed adjacent to the polished area (See figure 6). The exhaust valve stem was intact with some coking near the valve fillet. All intake and exhaust valve springs were found intact and undamaged (See figure 7). Cylinder No. 2 and 4 cooling fins showed thermal damage (See figure 8).

Figure 4. Cylinder no. 4 exhaust valve

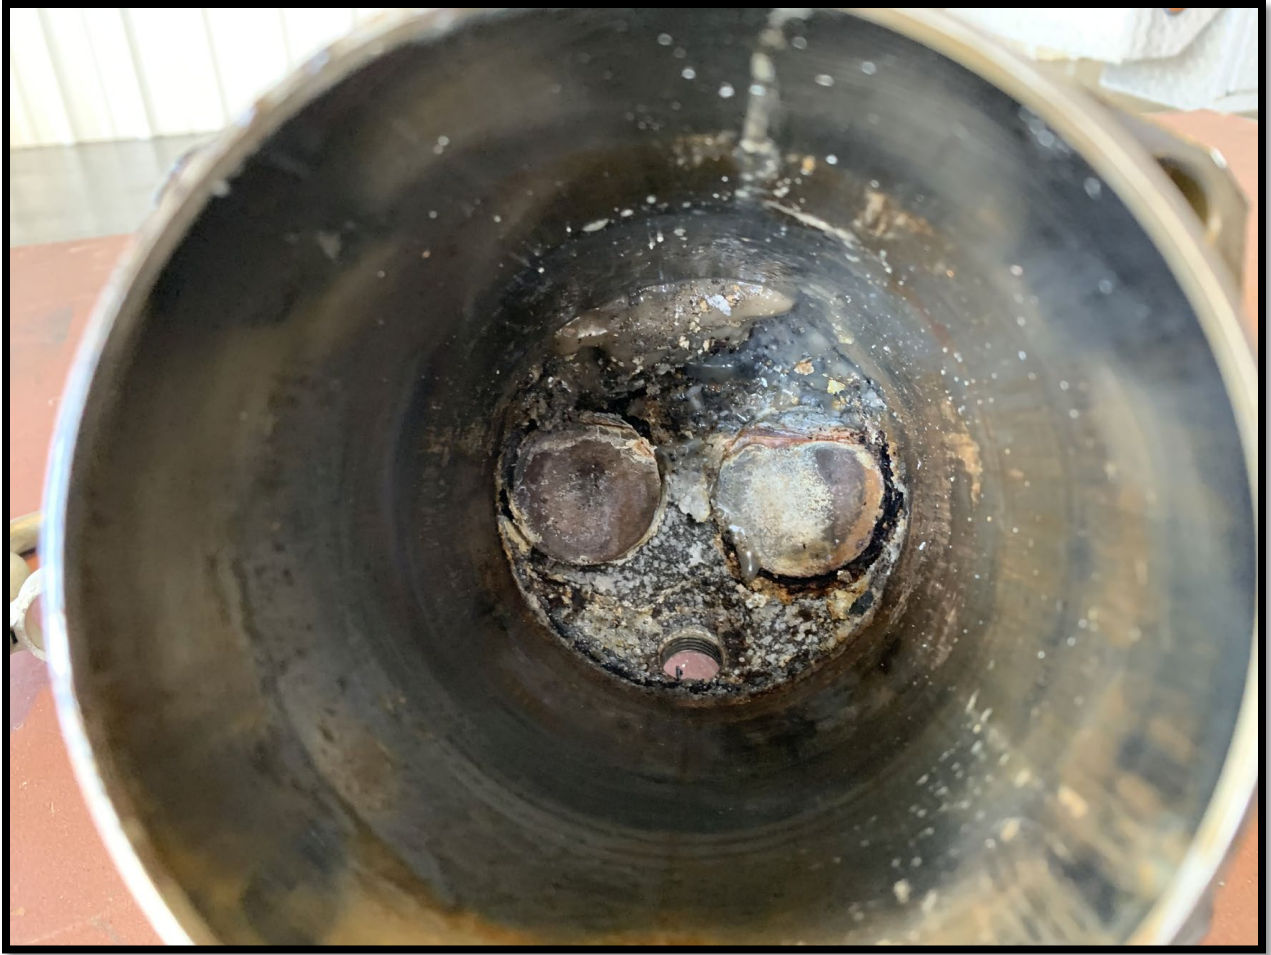
Figure 5. No. 4 stuck exhaust valve

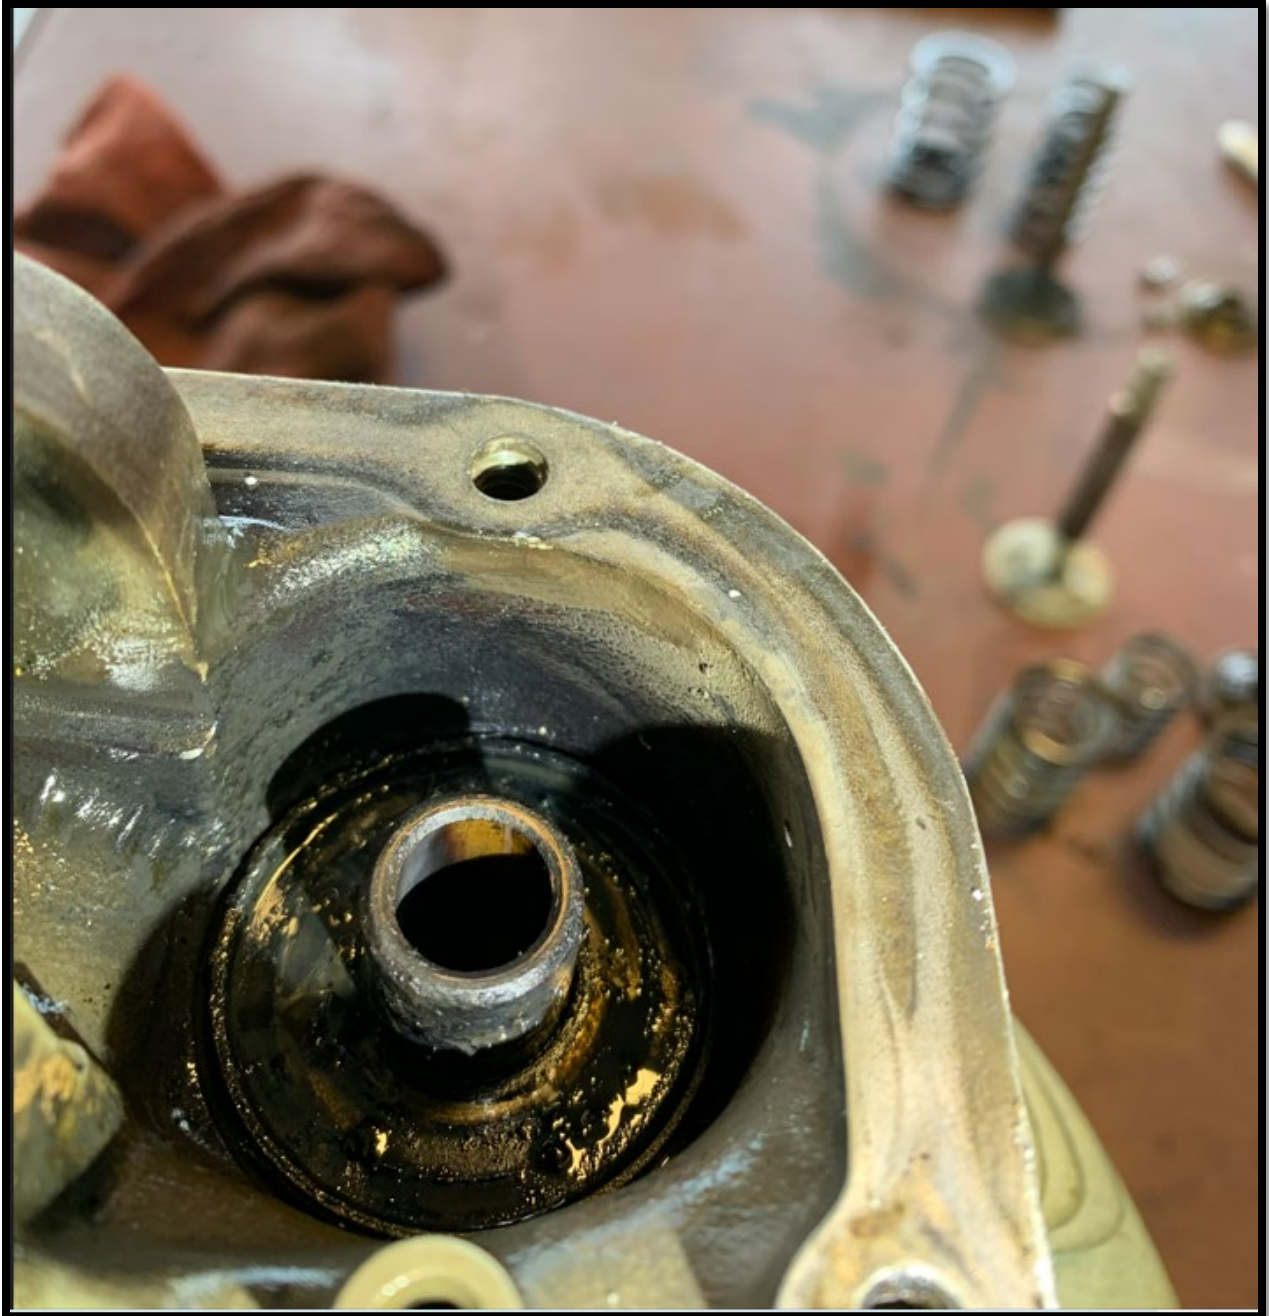
Figure 6. Cylinder No. 4 valve guide wear and corrosion.

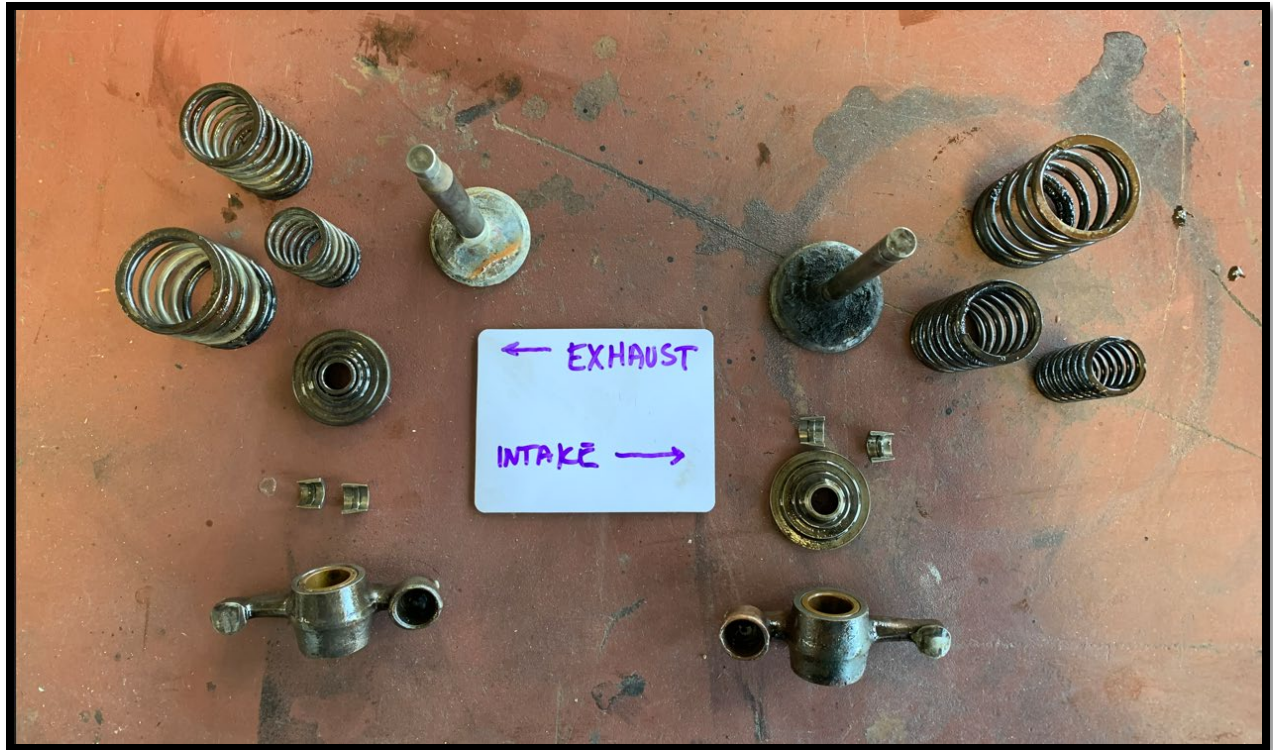
Figure 7. Exhaust and intake components

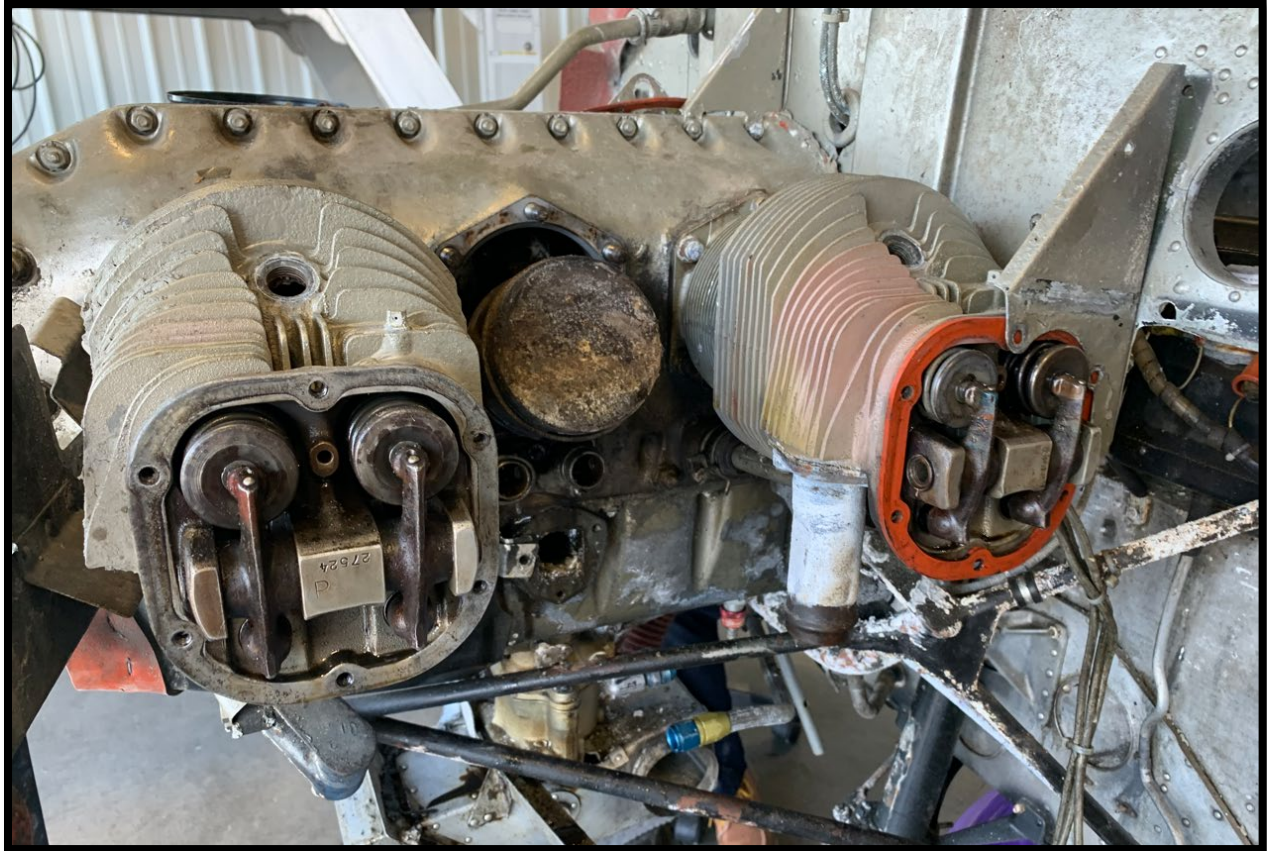
Figure 8. Thermal damage to cylinder cooling fins
