# National Transportation Safety Board

WPR23LA197

## **FUEL INJECTION SYSTEM EXAMINATION**

Location: Redding, California  
Date: May 20, 2023  
Airplane: Cessna 210, N9433T

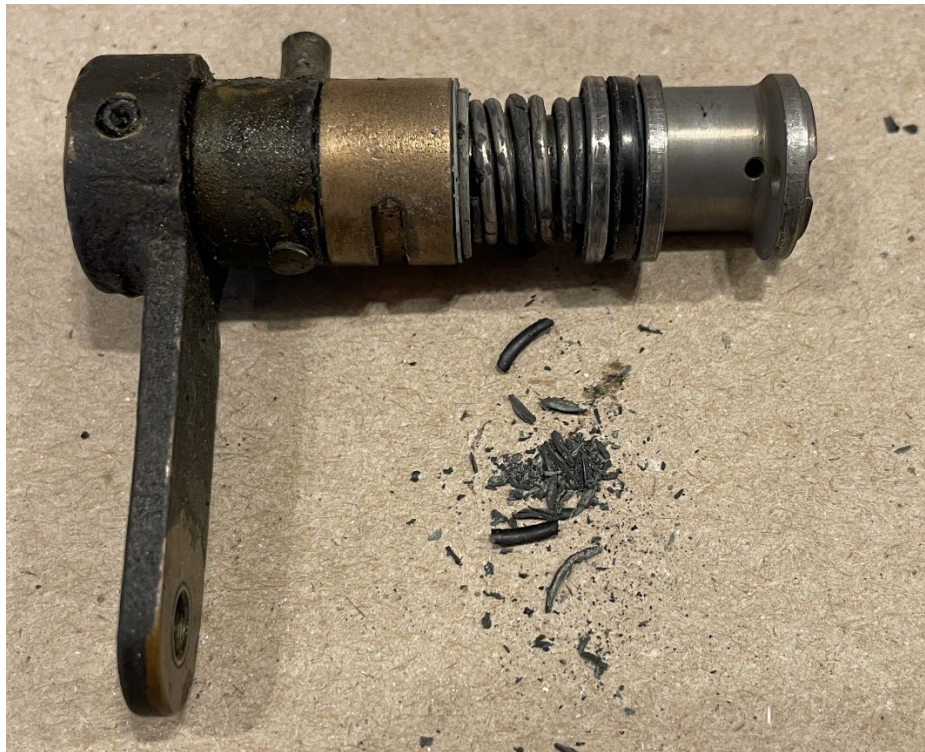
The retaining screws for the mixture and metering shafts were safety wired in place, with a "TCM" seal. The screws were removed, and both shaft assemblies were pulled out. Both appeared to be partially bound within the cavity and dark grey carbon-like deposits fell out of the compression spring sections (see figures 1, 2). According to representatives from Continental motors, the deposits were likely degraded molybdenum grease, which is used during assembly.

The O-rings for both shafts were hard and square rather than round and pliable (see figure 1,2). The internal passages within both the controller casing and the fuel metering plug were clear.

Figure 1 - Mixture control shaft with carbon deposits

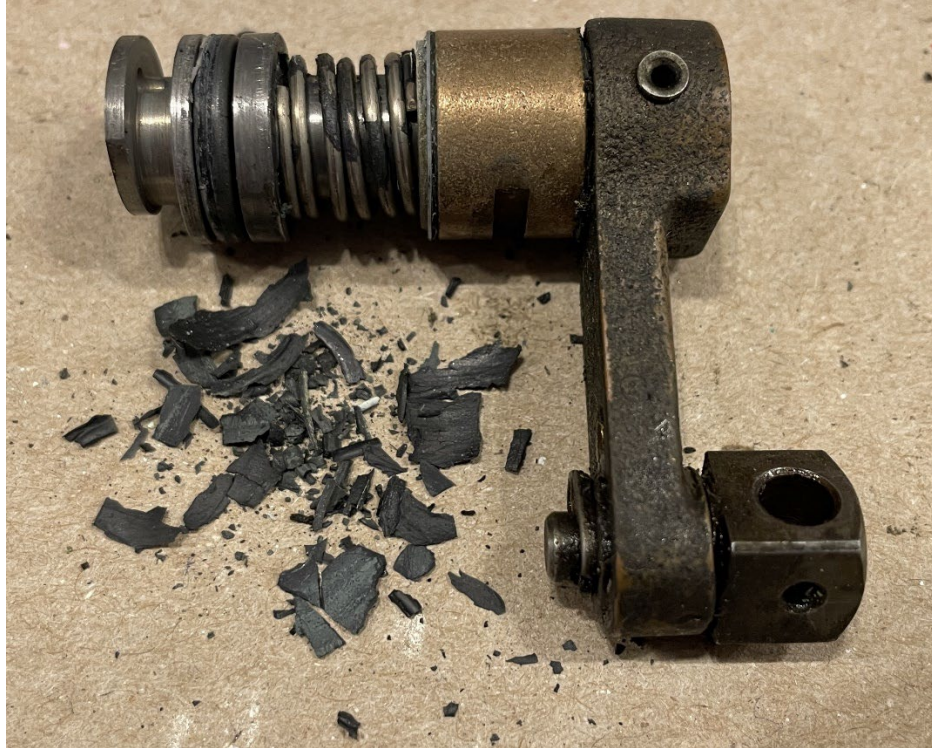
Figure 2 - Metering shaft with carbon deposits

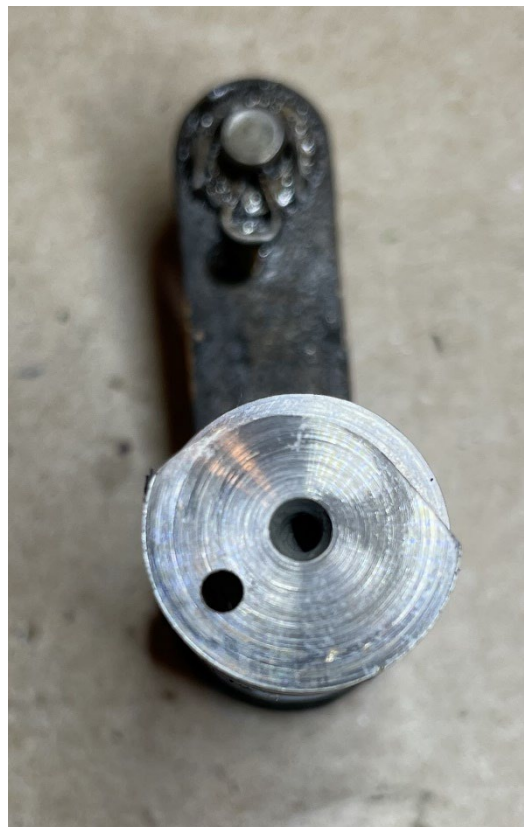
The rotational mating surfaces between the metering plug and both the metering and mixture shaft ends displayed evidence of gouging and rotational wear (see figures 3, 4, 5, 6).

Figure 3 - Metering shaft mating surface with metering plug

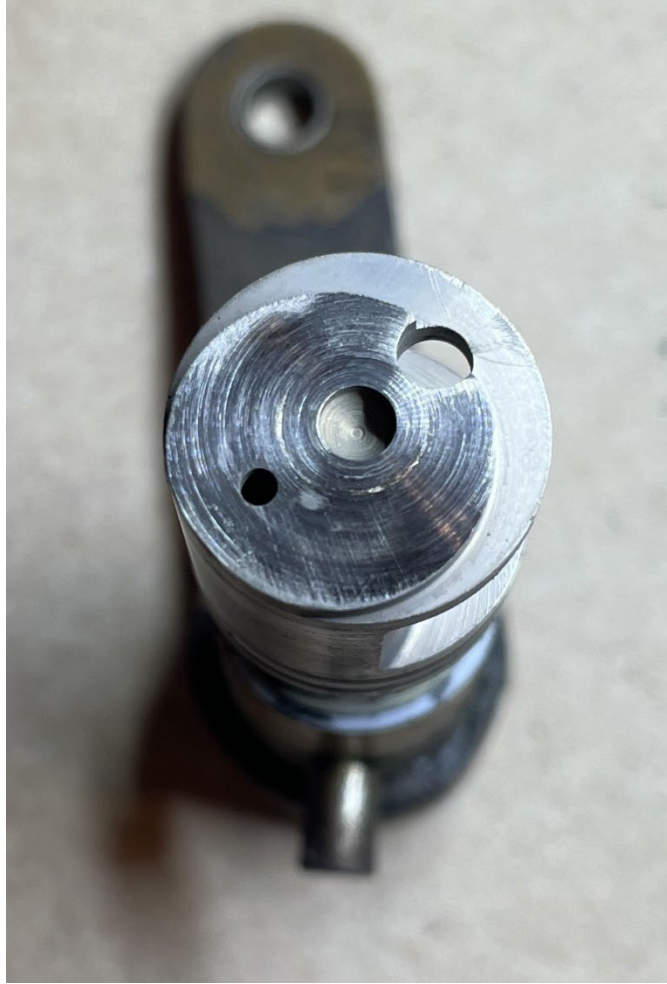
Figure 4 - Mixture shaft mating surface with metering plug

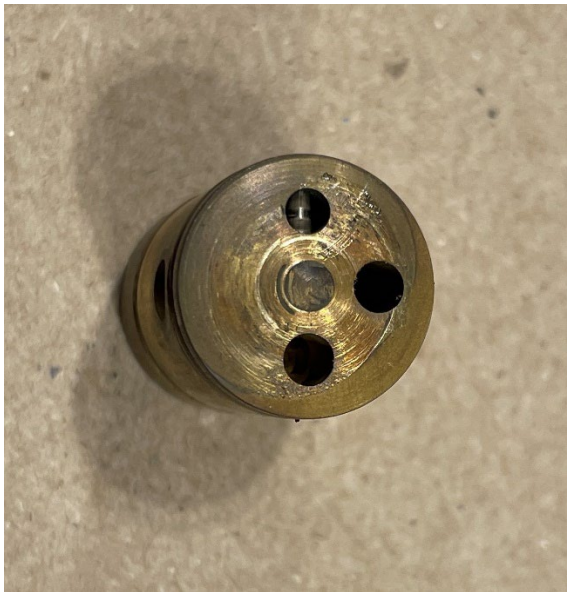
Figure 5 - Metering plug mating surface

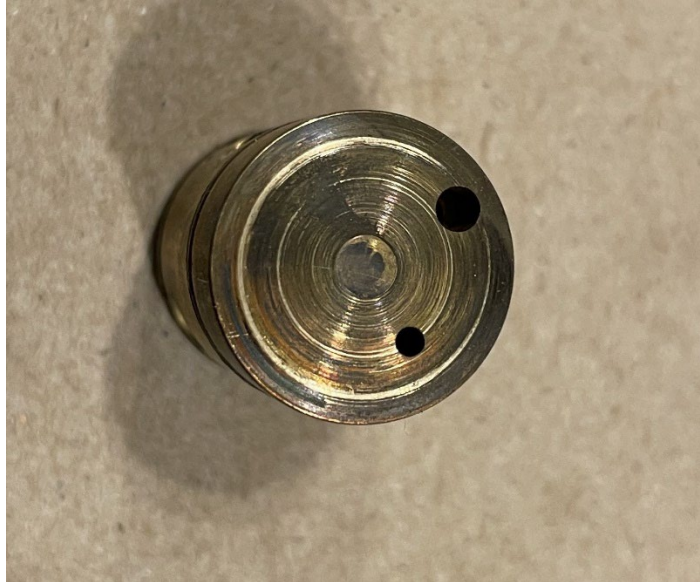
Figure 6 - Metering plug mating surface

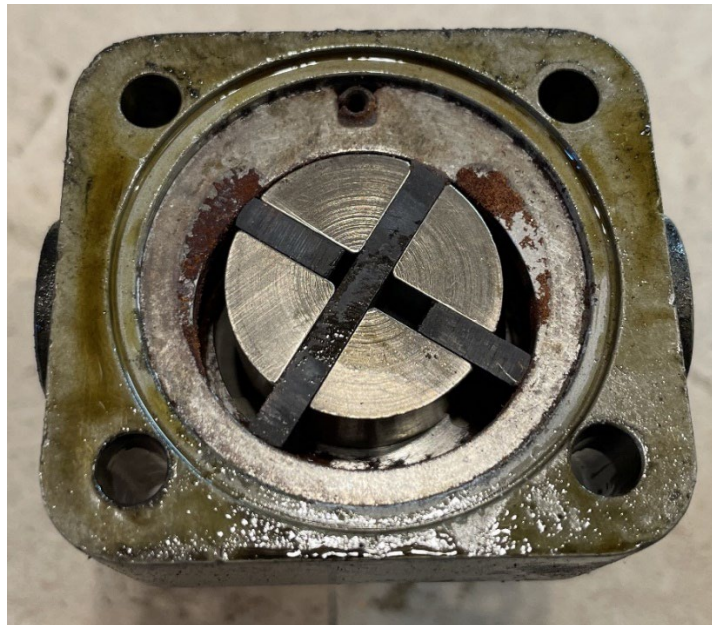
The fuel pump was intact and undamaged. The input drive shaft could be rotated by hand and was smooth, and the drive coupling was intact. The pump was completely disassembled revealing multiple areas of internal corrosion, primarily within the area of the pump cavity (figure 7), and bypass valve. However, the pump still appeared to be functional. The relief valve diaphragm was intact and pliable. All passages were free of blockage.

Figure 7 - Fuel pump cavity and blades
