# National Transportation Safety Board

WPR23LA197

## **ENGINE AND AIRFRAME EXAMINATION**

Location: Redding, California  
Date: May 20, 2023  
Airplane: Cessna 210, N9433T

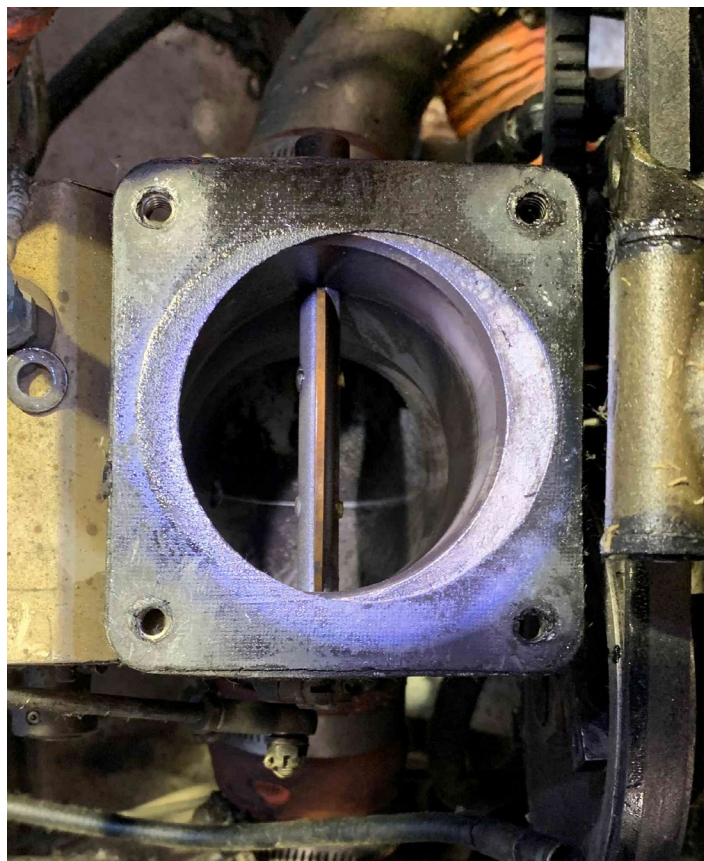
Removal of the air box assembly revealed the interface gasket was installed back to front, resulting in an area reduction of about 10 % (figure 1).

**Figure 1 - Throttle body inlet gasket**

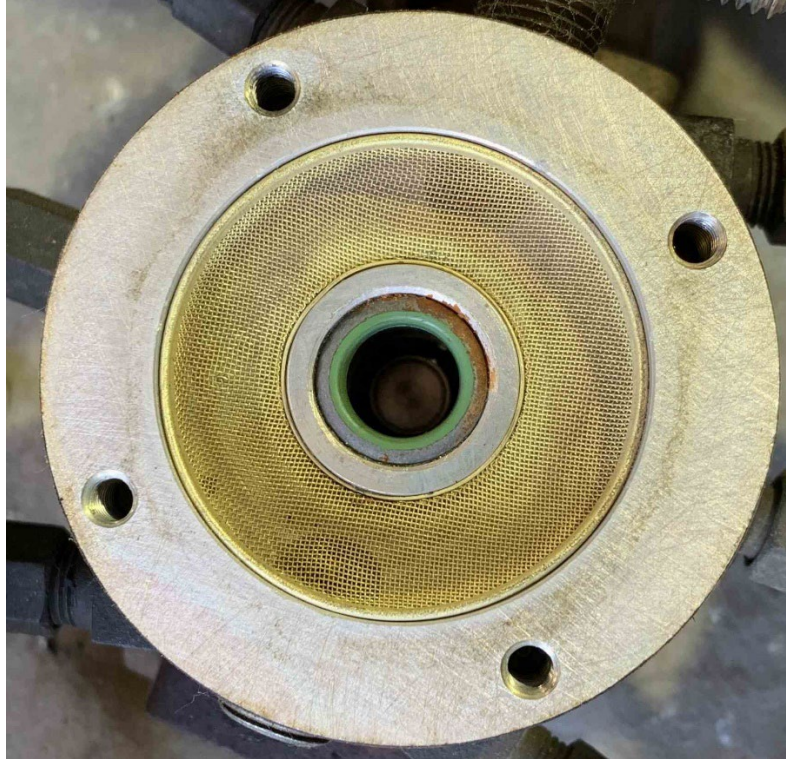
Removal of the fuel manifold valve cap revealed that the rubber diaphragm was intact and flexible, and the screen was clear. There was no fuel within the cavity, and brown rust-like oxidization was present in the area between the screen and the rubber seal, and in the forward plug within the valve cavity (figure 2,3,4).

**Figure 2 - Fuel manifold screen with corrosion**

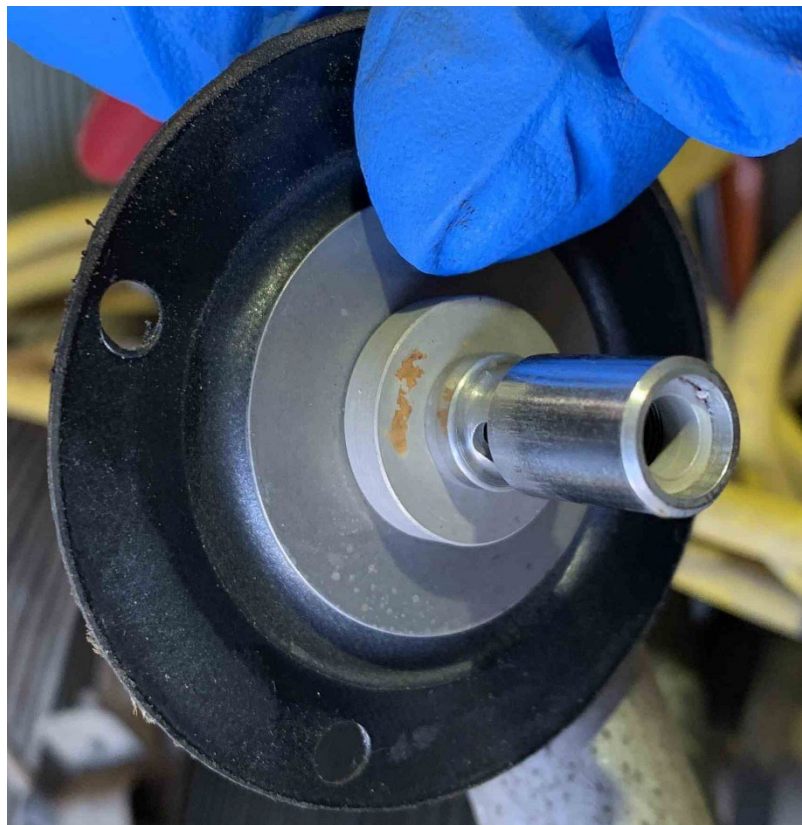
**Figure 3 - Fuel manifold diaphragm with corrosion**

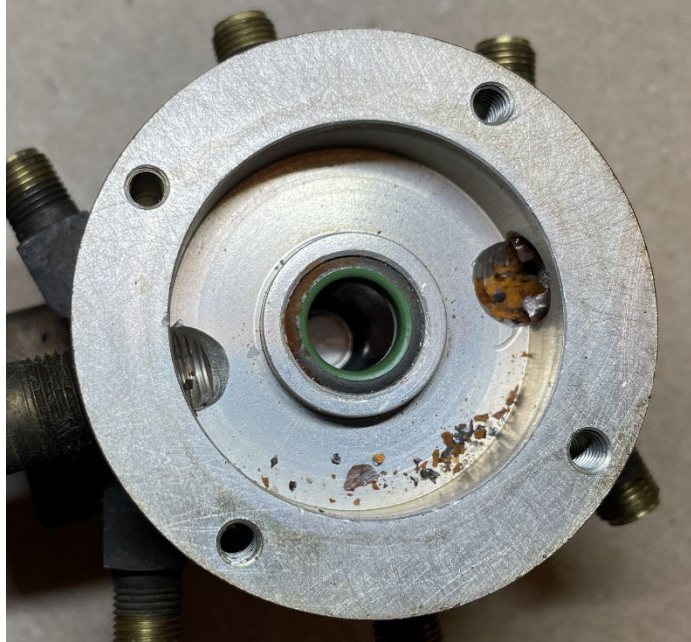
**Figure 4 - Fuel manifold cavity with corrosion**

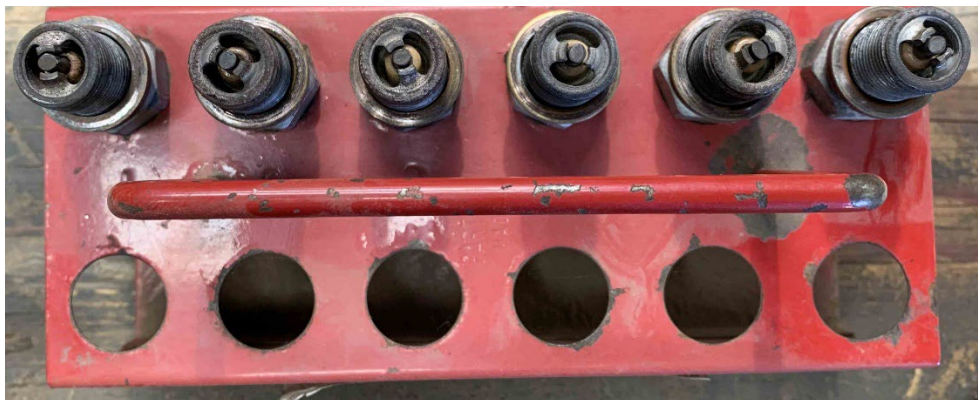
The top spark plugs were removed, and all exhibited dark grey and tan deposits, along with normal to worn out-normal signatures when compared with the Champion spark plugs AV-27 chart (figure 5).

**Figure 5 - Top spark plugs**

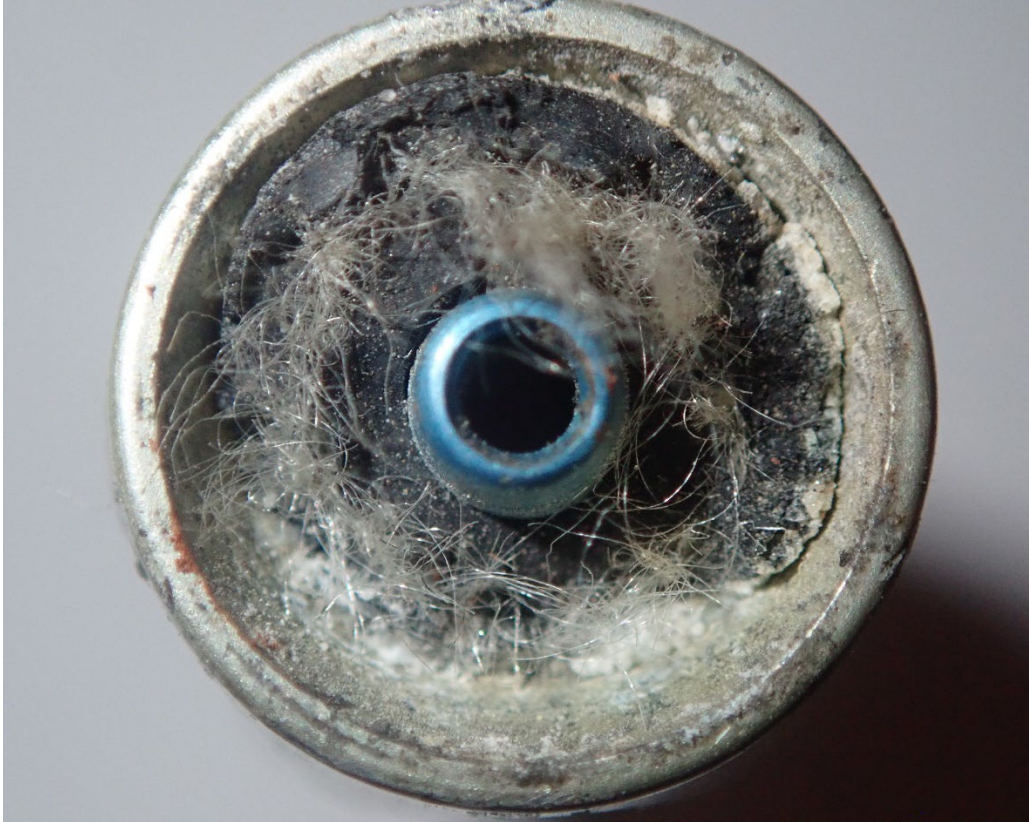
The fuel supply lines were all intact on the firewall side, and their fittings were tight. The metered side fuel pressure indicator line had broken away from the fuel controller. The line was made of rubber and was brittle and had limited flexibility. There were white oxidization-like deposits at the break in the fitting, and the rubber remnants of the line could be easily broken off (see figure 6).

**Figure 6 - Fuel pressure line with corrosion and brittle rubber**
