# National Transportation Safety Board

WPR23LA199

## **NTSB ENGINE EXAMINATION REPORT**

Location: Casa Grande, Arizona  
Date: May 24, 2023  
Time: 0900 mountain standard time  
Airplane: Cessna 172S

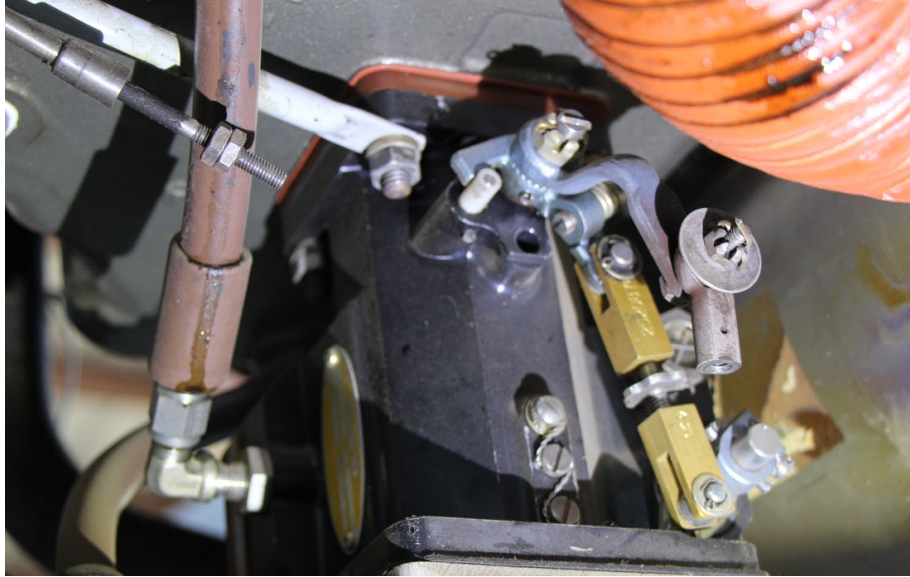
Postaccident photographs of the fuel servo showed that the threaded end of the throttle linkage had separated from the throttle arm at the fuel servo.

The throttle cable had separated from the rod end at the throttle lever. Both sets of threads were intact and unremarkable. The jam nuts were located about 3/4 inches from the end of the throttle cable. The linkage was threaded into the throttle arm and proper thread engagement was achieved as the throttle arm moved from idle to full power (stop to stop) without resistance.

**Figure 1: Throttle linkage and throttle arm**

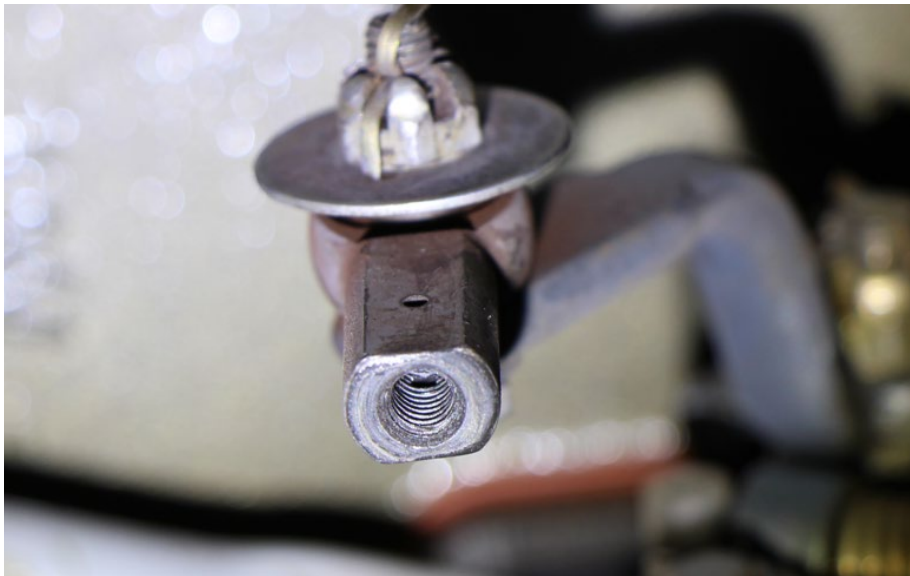
**Figure 2: Threads at throttle arm**
