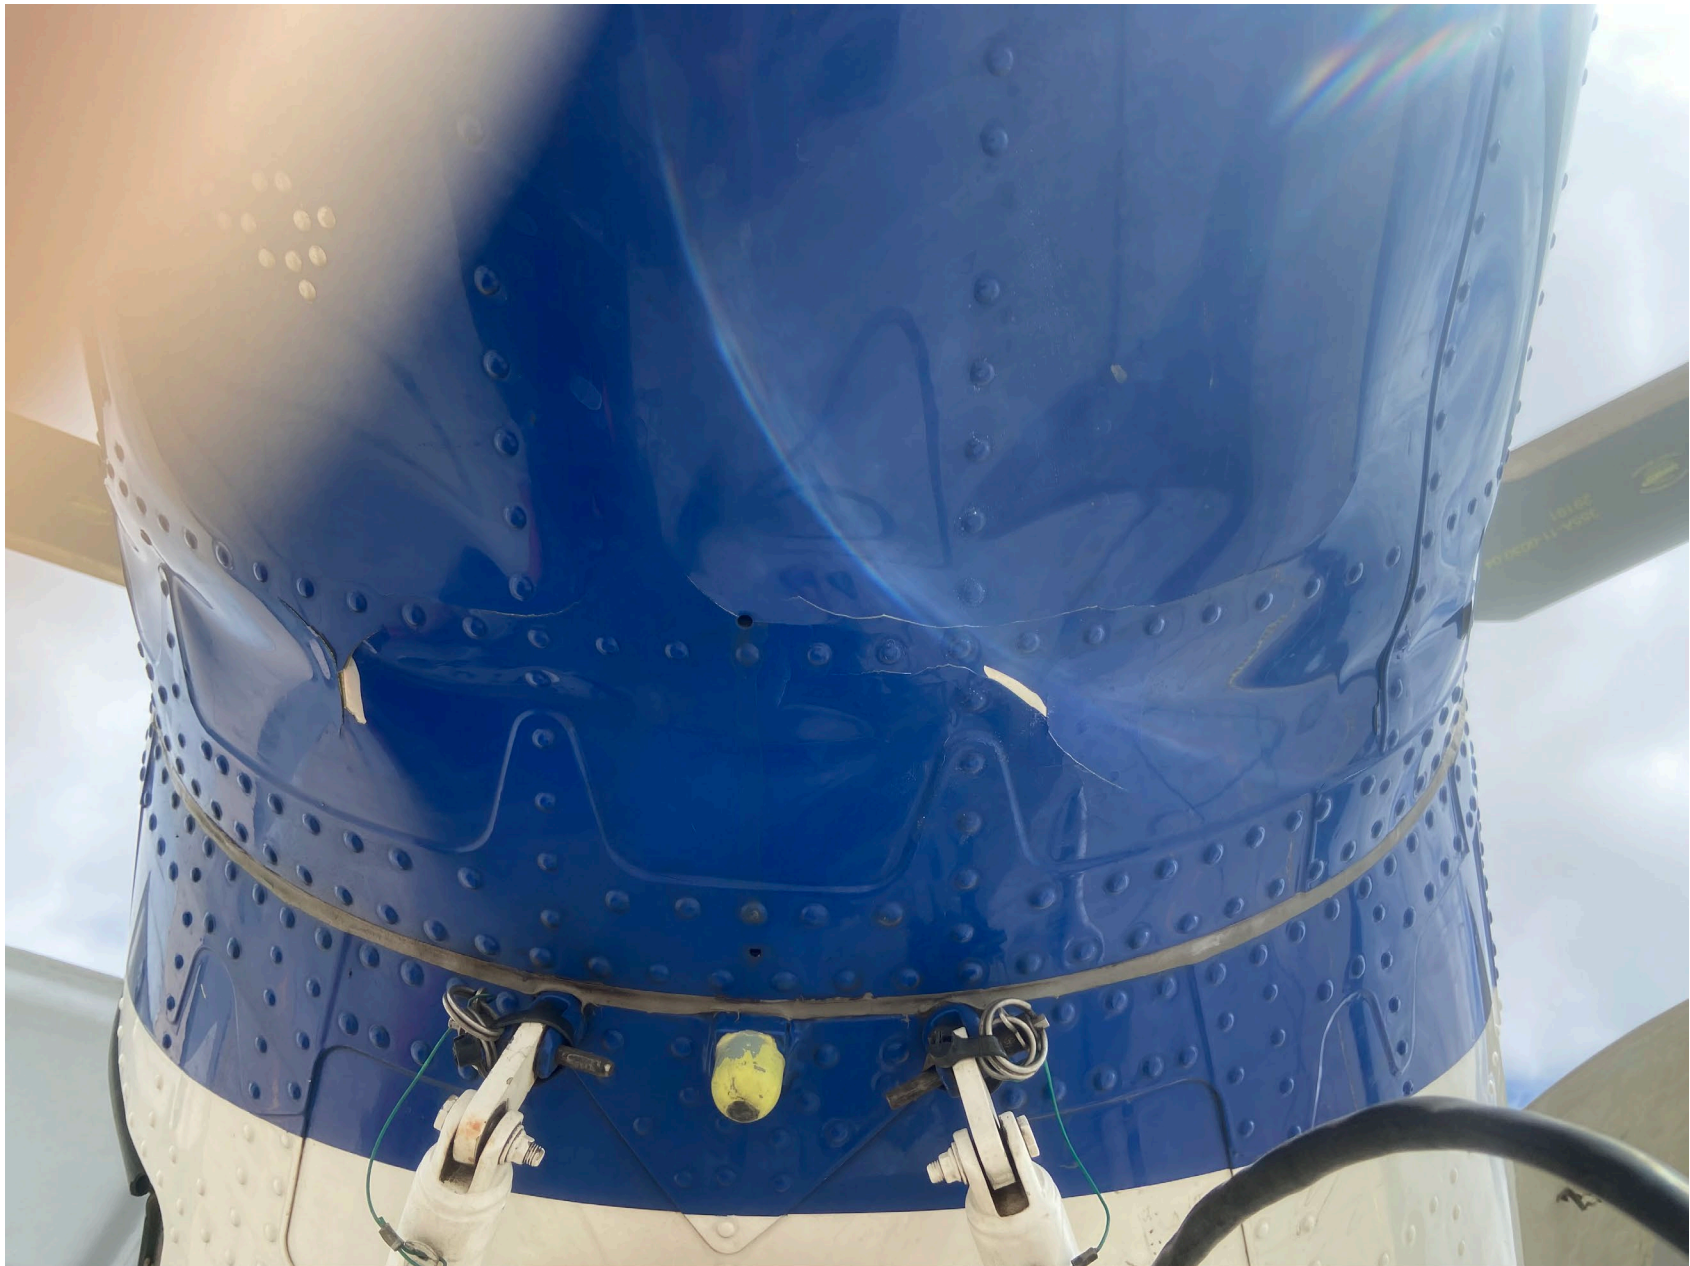
**Photo 2 – Bottom damage tail boom (Photo courtesy of Customs and Border Protection)**
