# National Transportation Safety Board

WPR23LA201

## **EXAMINATION SUMMARY**

Location: Tucson, AZ  
Date: May 24, 2023  
Time: 0940mst  
Airplane: Cessna 177B

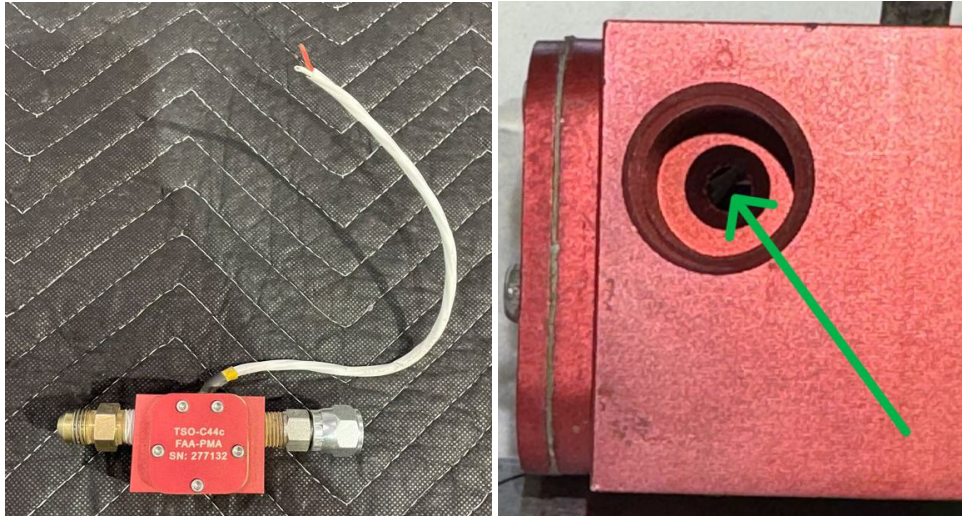
that there were no obstructions in the fuel system from each tank to the engine drive fuel pump inlet line. A small amount of dirt was found in the fuel strainer bowl. The fuel flow transducer exhibited a fuel flow restriction that limited the quantity of fuel delivered to the carburetor. The transducer was removed and retained for further examination. The carburetor was removed, disassembled and unremarkable. Fuel intake lines remained attached to each respective cylinder. No anomalies were observed with the carburetor, induction, or exhaust systems.

**Figure 1:** Fuel Flow Transducer after removal from airplane, before disassembly

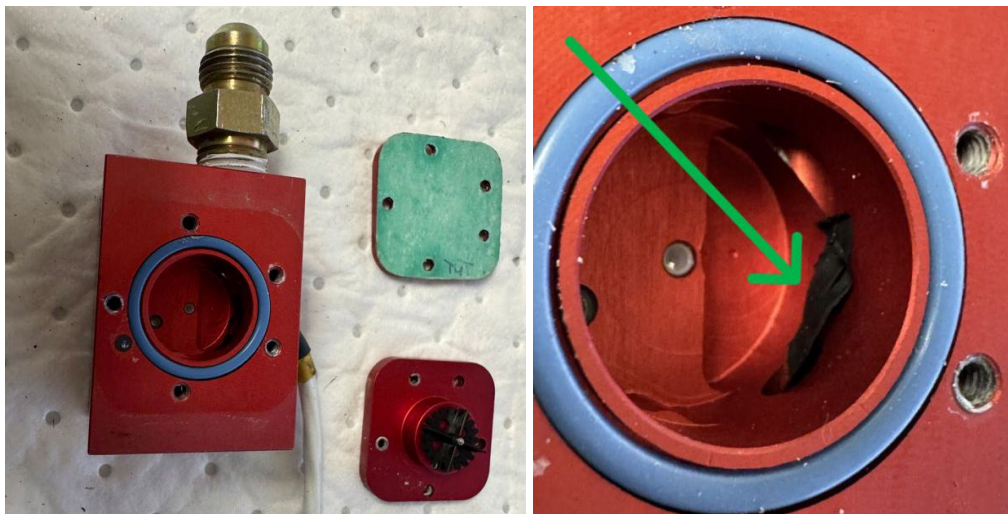
**Figure 2:** Disassembled transducer showing restricted orifice

Fuel system continuity was observed from the wing tanks through to the fuel flow transducer. With the application of air pressure into the transducer, the volumetric outflow was inhibited. The lines to and from the transducer were unrestricted and free of debris.

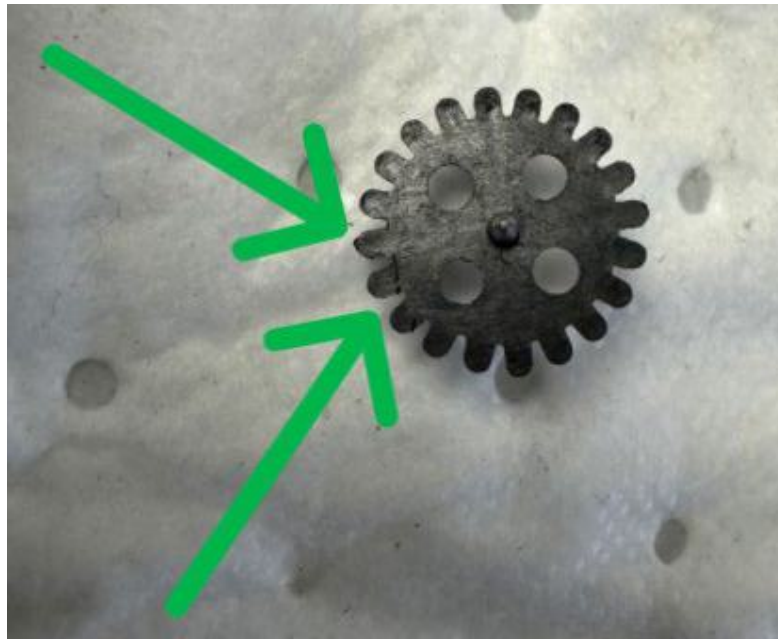
**Figure 3:** Transducer rotor deformation and witness markings

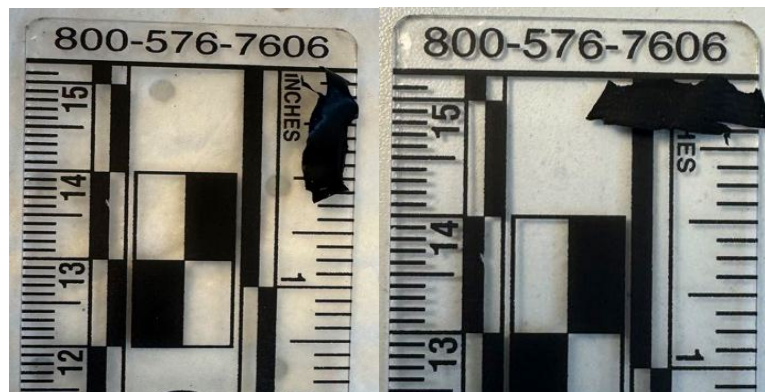
Further examination of the fuel flow transducer was conducted to identify the fuel flow restriction. The Electronics International Inc. FT-60 transducer was disassembled and revealed that the rotor was unremarkable, however, inside the transducer there was a 5/8" length x 1/4" width polymer material strip inside of the fuel entry port bore.

**Figure 4:** Polymer material restriction size
