# National Transportation Safety Board

WPR23LA213

## **MATERIALS LABORATORY**

Factual Report 23-060

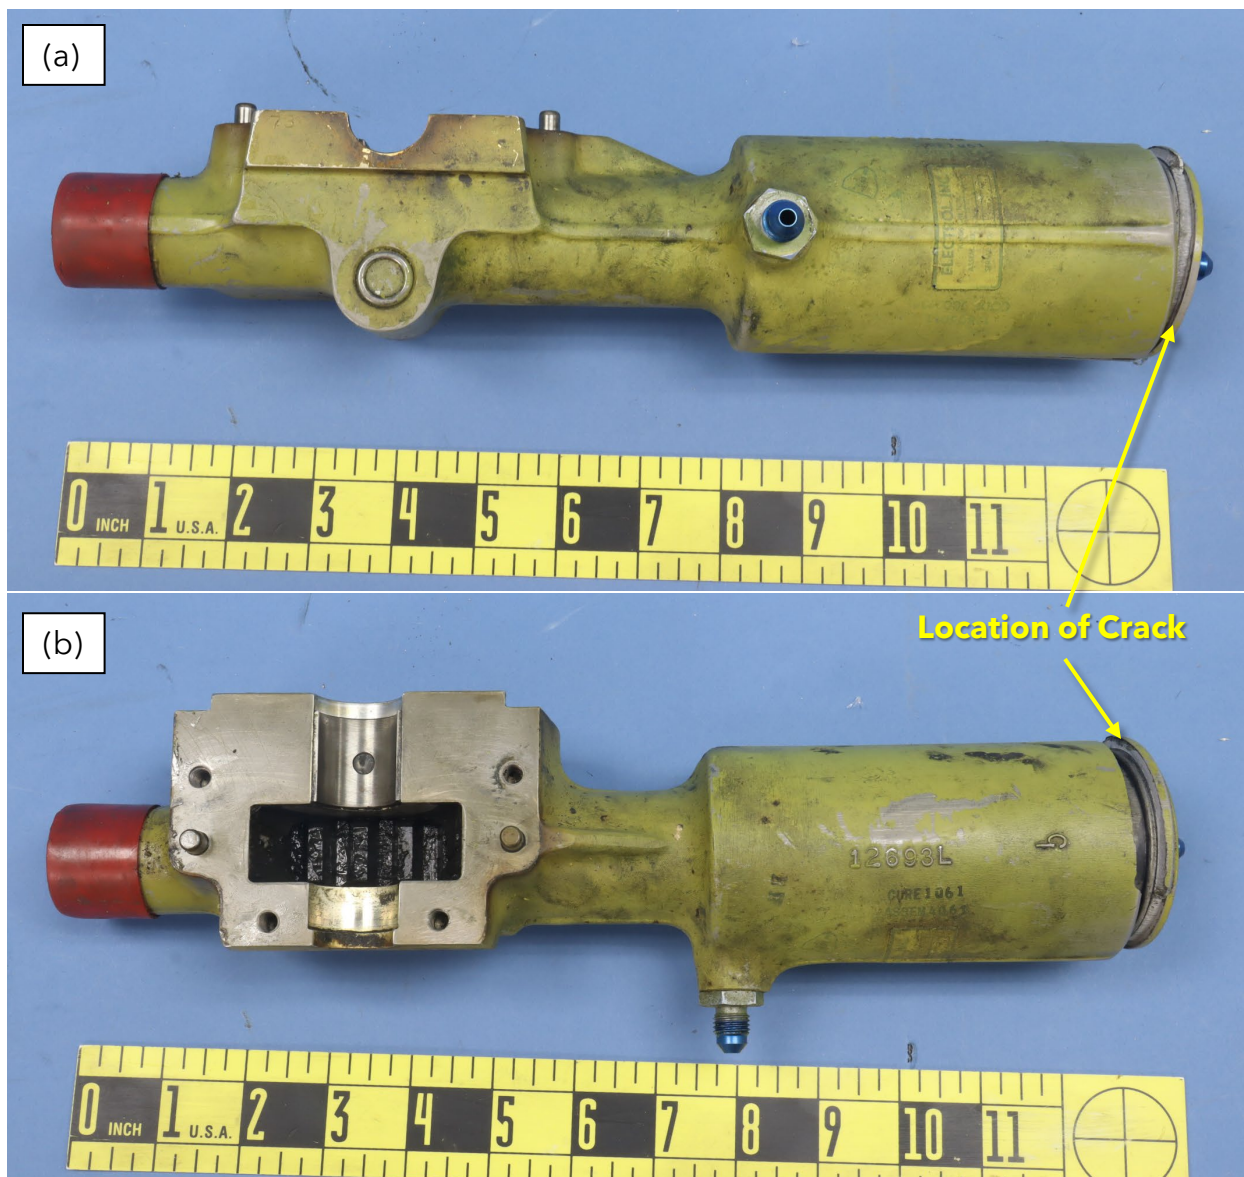
The cracked hydraulic actuator is illustrated in Figure 1 and Figure 2, as received from different sides. The part had cracked around the barrel, with circumferential components. Figure 3 shows the identification markings for the actuator. The embossed markings on the barrel stated:

**Figure 1.** The hydraulic actuator, as received.

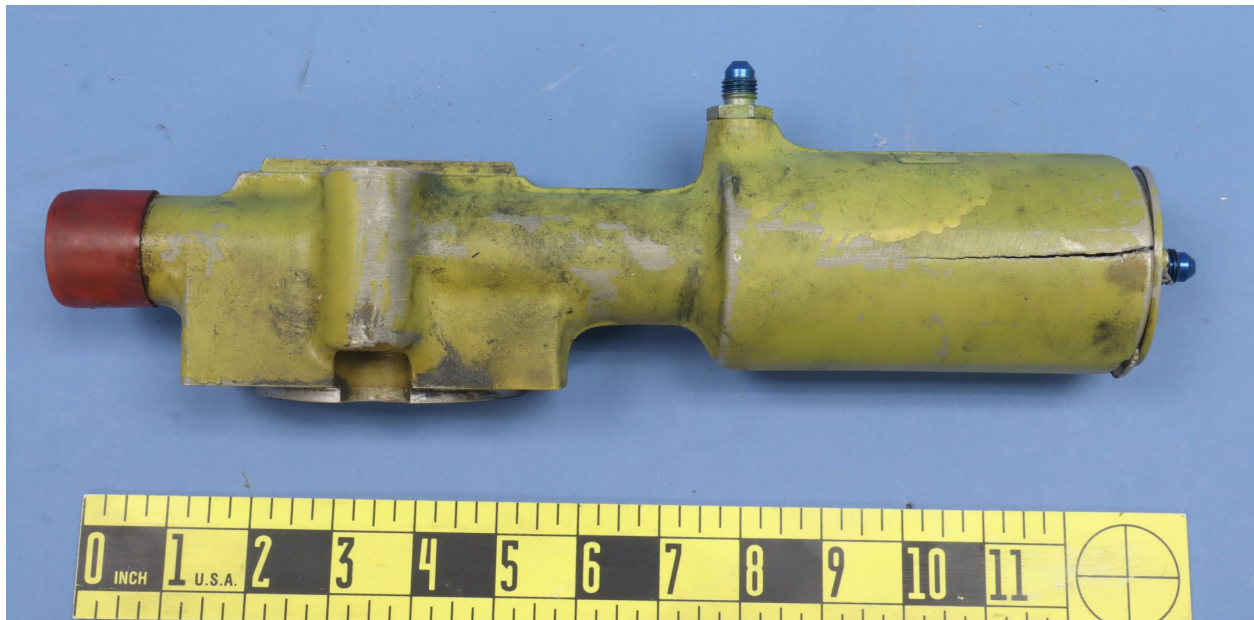
**Figure 2.** View of the hydraulic actuator, viewed opposite that in Figure 1b. This shows the longitudinal crack on the housing barrel.

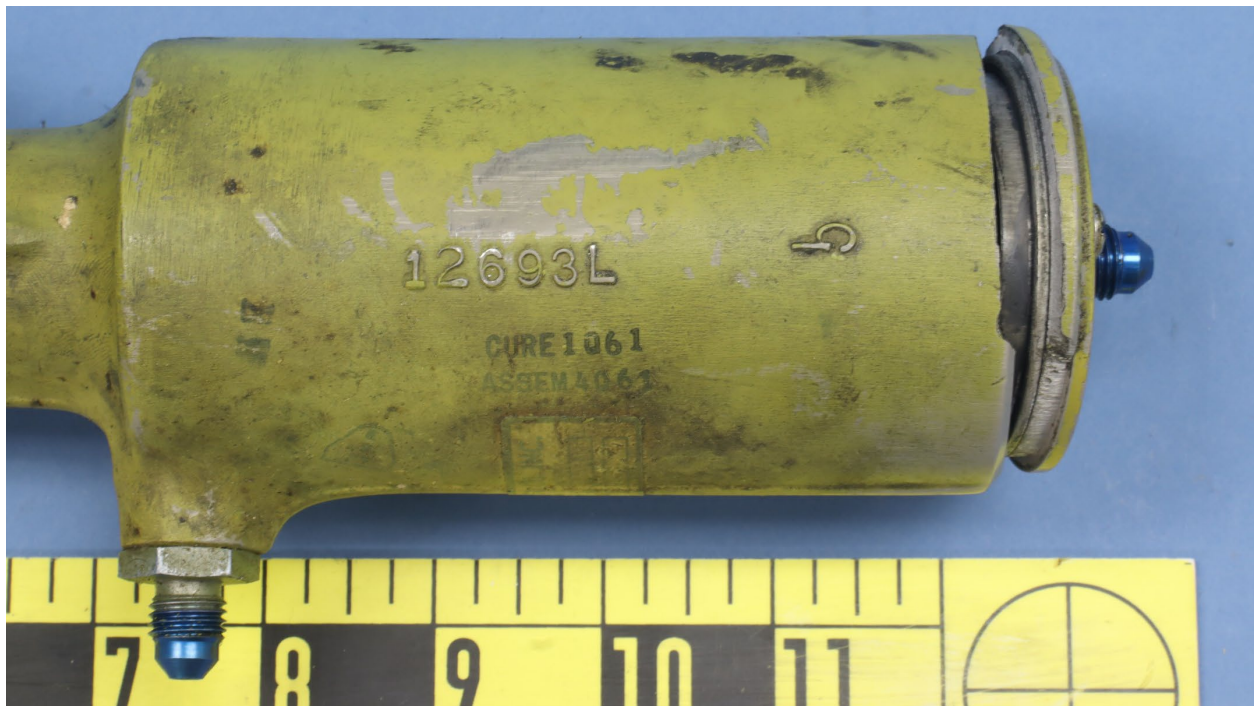
**Figure 3.** View of the markings on the housing barrel of the actuator, with the circumferential crack on the right.

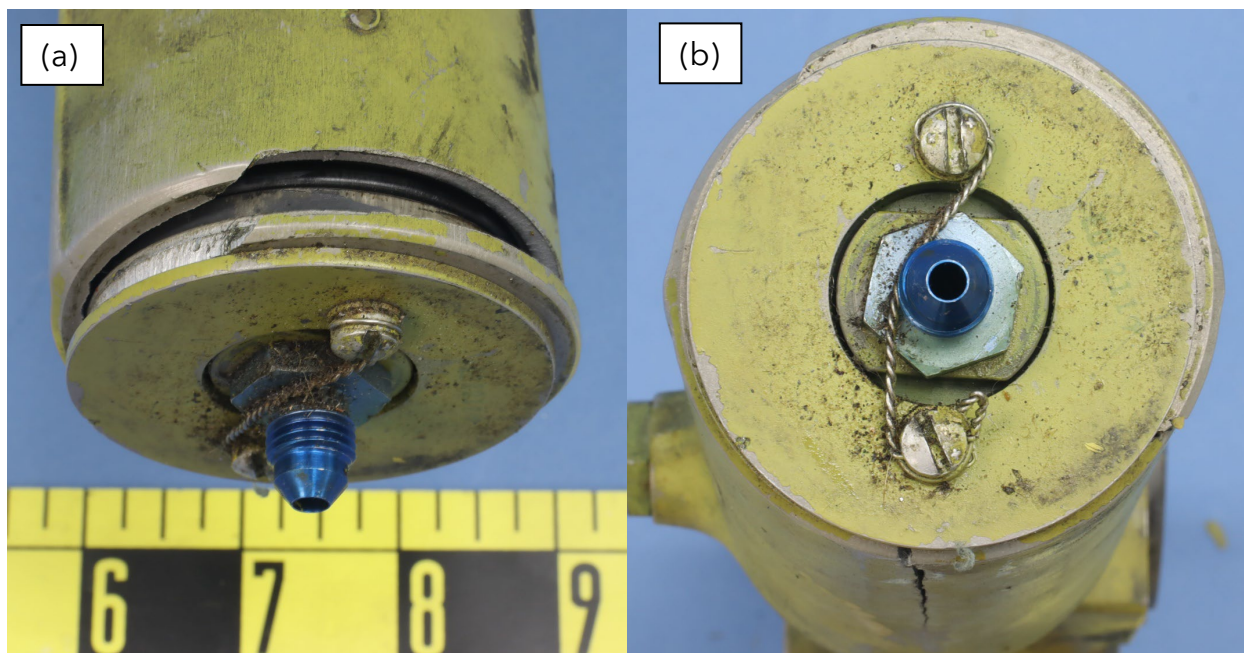
The part was cracked about the barrel section adjacent to the endcap, as illustrated in Figure 4. The circumferential portion of the crack was 5.75 in long (in circumference). Figure 5 shows the transition from circumferential to a longitudinal crack along the housing barrel (Figure 6)—the longitudinal section of the crack extended for 3.33 inches.

**Figure 4.** The end of the hydraulic actuator, showing the circumferential portion of the crack.

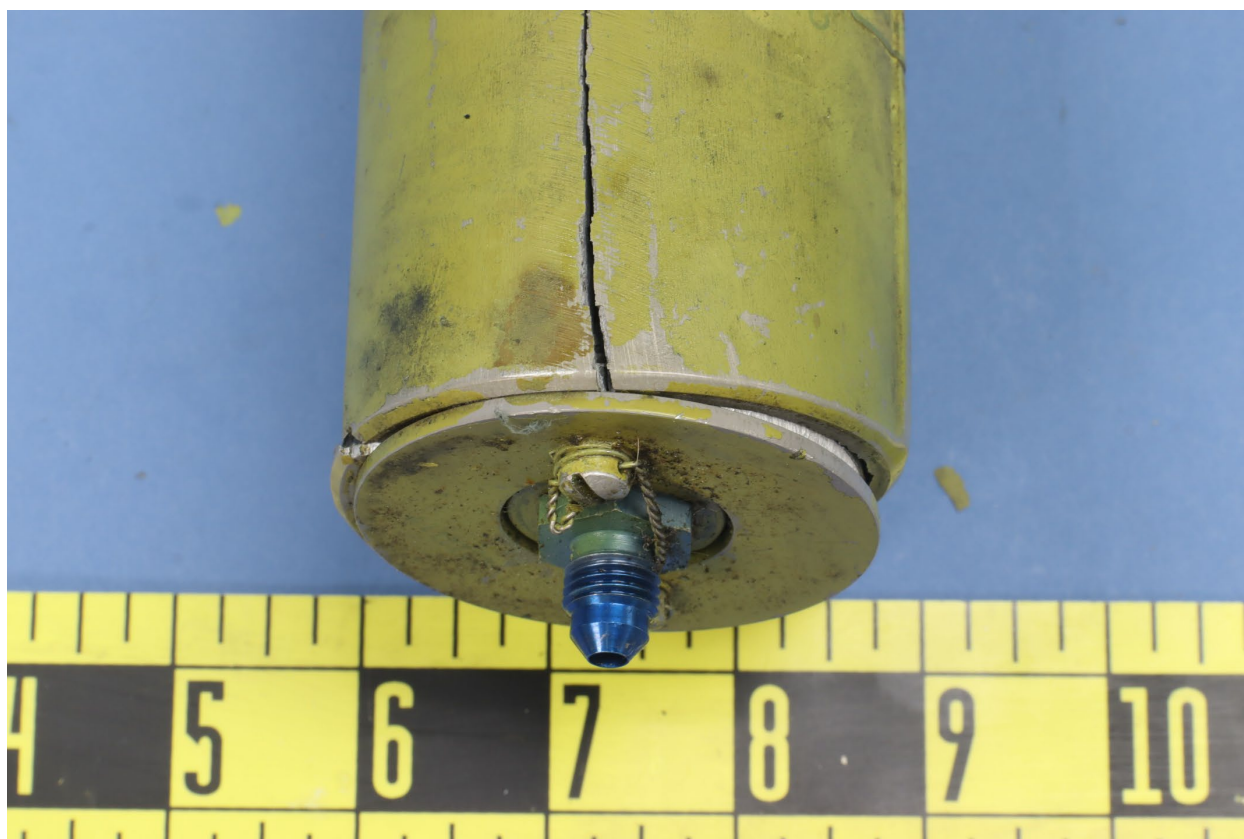
**Figure 5.** The longitudinal crack on the actuator housing, emanating from the circumferential crack (opposite the view in Figure 4a).

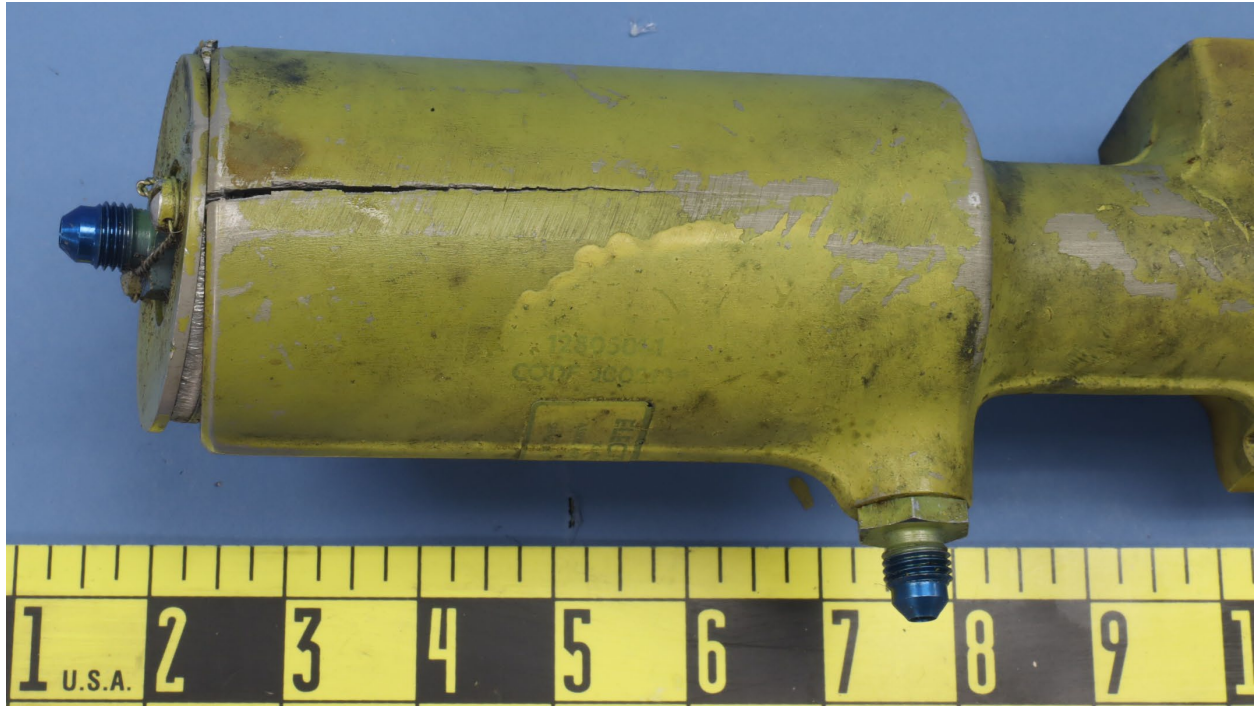
**Figure 6.** The longitudinal crack along the actuator housing barrel.

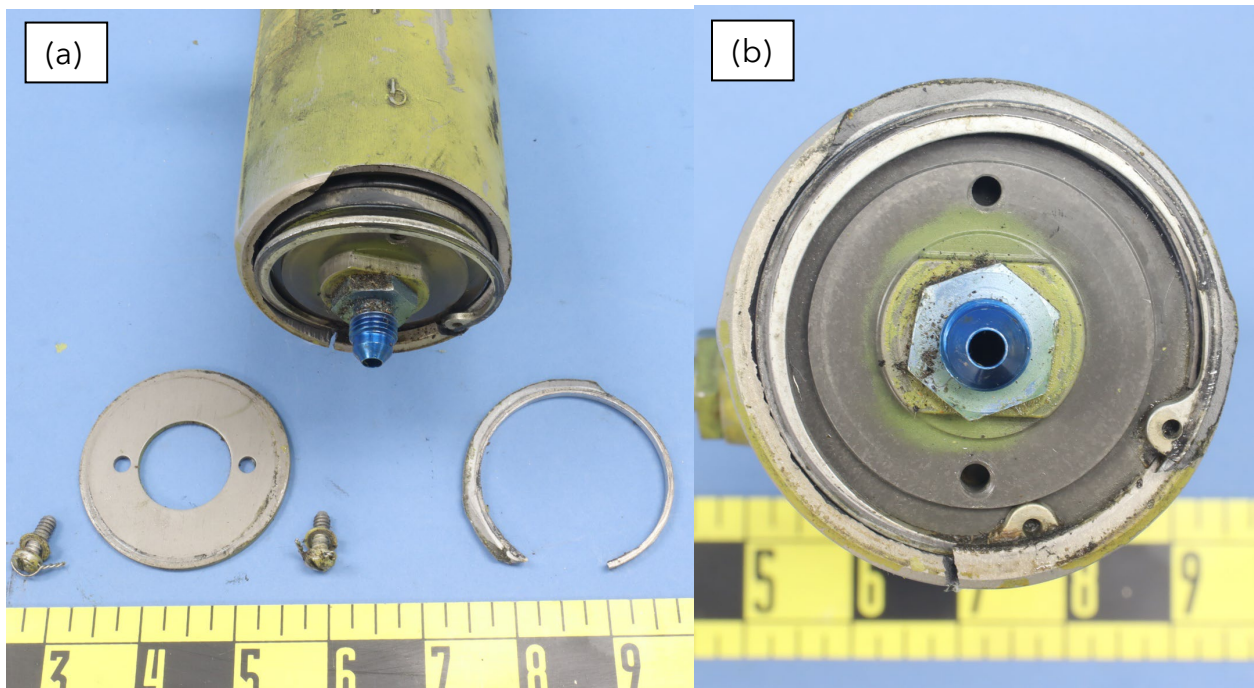
The end cap of the actuator was separated by sectioning the safety wire and removing the retaining screws. Once the endcap was removed, the extent of the circumferential cracking was revealed (Figure 7). The end flange had completely separated from the rest of the barrel, and the clip was still positioned inside a remnant of the groove seat.

**Figure 7.** The cracked end of the actuator pictured in Figure 4, after removal of the screws and the end cap.

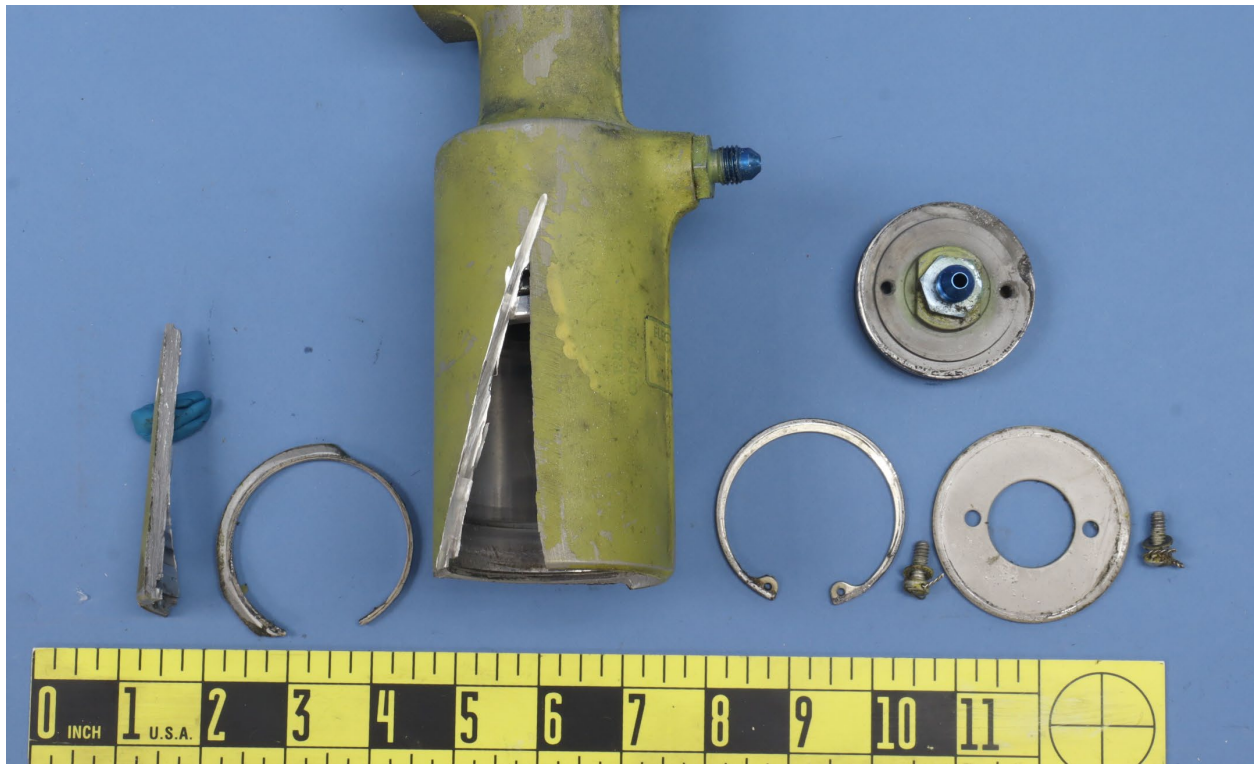
The barrel of the housing was sectioned at a 45° angle to separate the longitudinal crack face. Figure 8 illustrates the sectioned cracked area positioned next to the actuator body, with the retaining ring and endcap and other fractured pieces.

**Figure 8.** The cracked end of the actuator pictured in Figure 7a, after sectioning and removal of the cracked regions of the housing barrel.

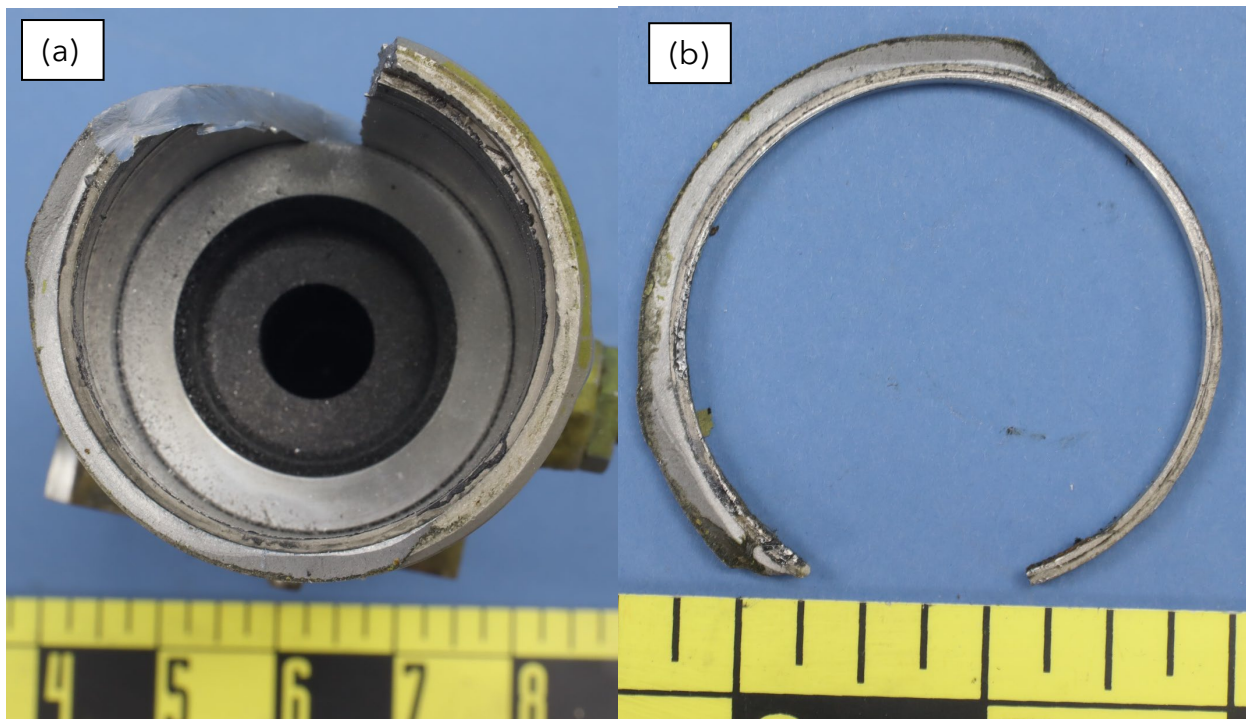
The mating fracture surfaces of the opened circumferential crack are shown in Figure 9. This fracture surface exhibited one thumbnail-shaped crack, shown in Figure 11. In contrast, the longitudinal crack exhibited a rough surface texture and a dull luster. The surface revealed V-shaped chevron marks pointing toward the circumferential crack at the endcap, consistent with fracture from that location. The mating sides of the longitudinal crack portion are depicted in Figure 10.

**Figure 9.** The mating faces of the fractured end of the actuator, after sectioning and disassembly.

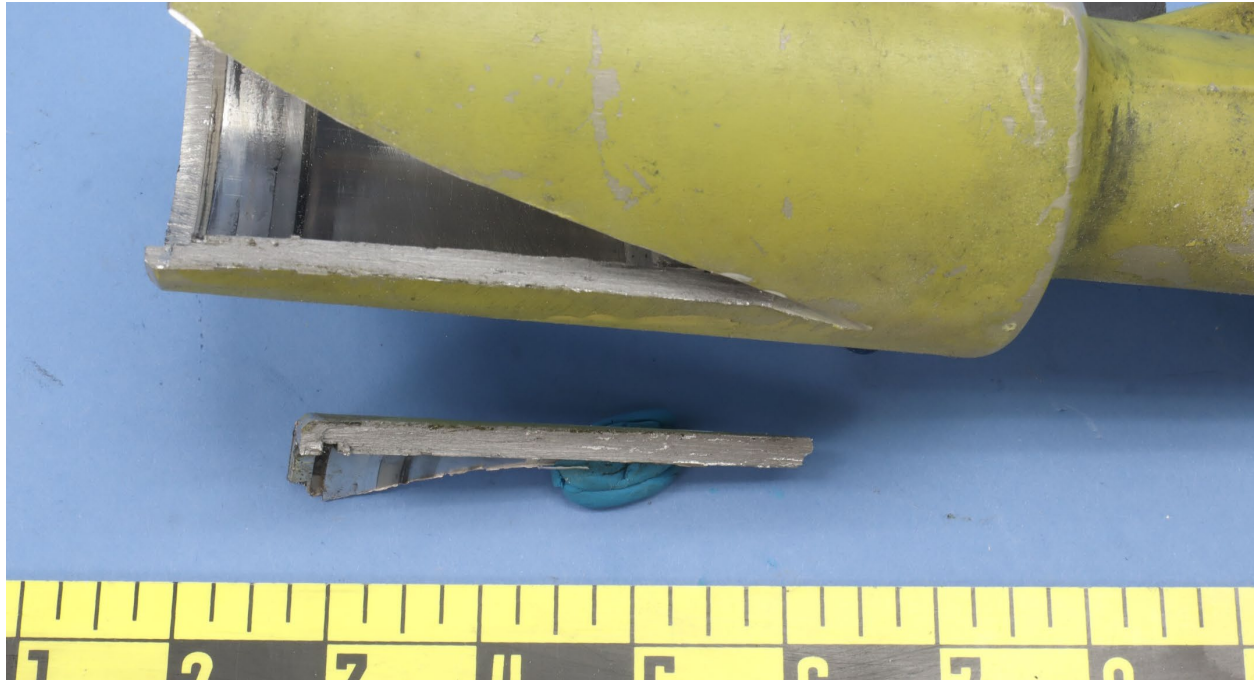
**Figure 10.** Mating faces of the longitudinal crack, after sectioning to open the crack faces.

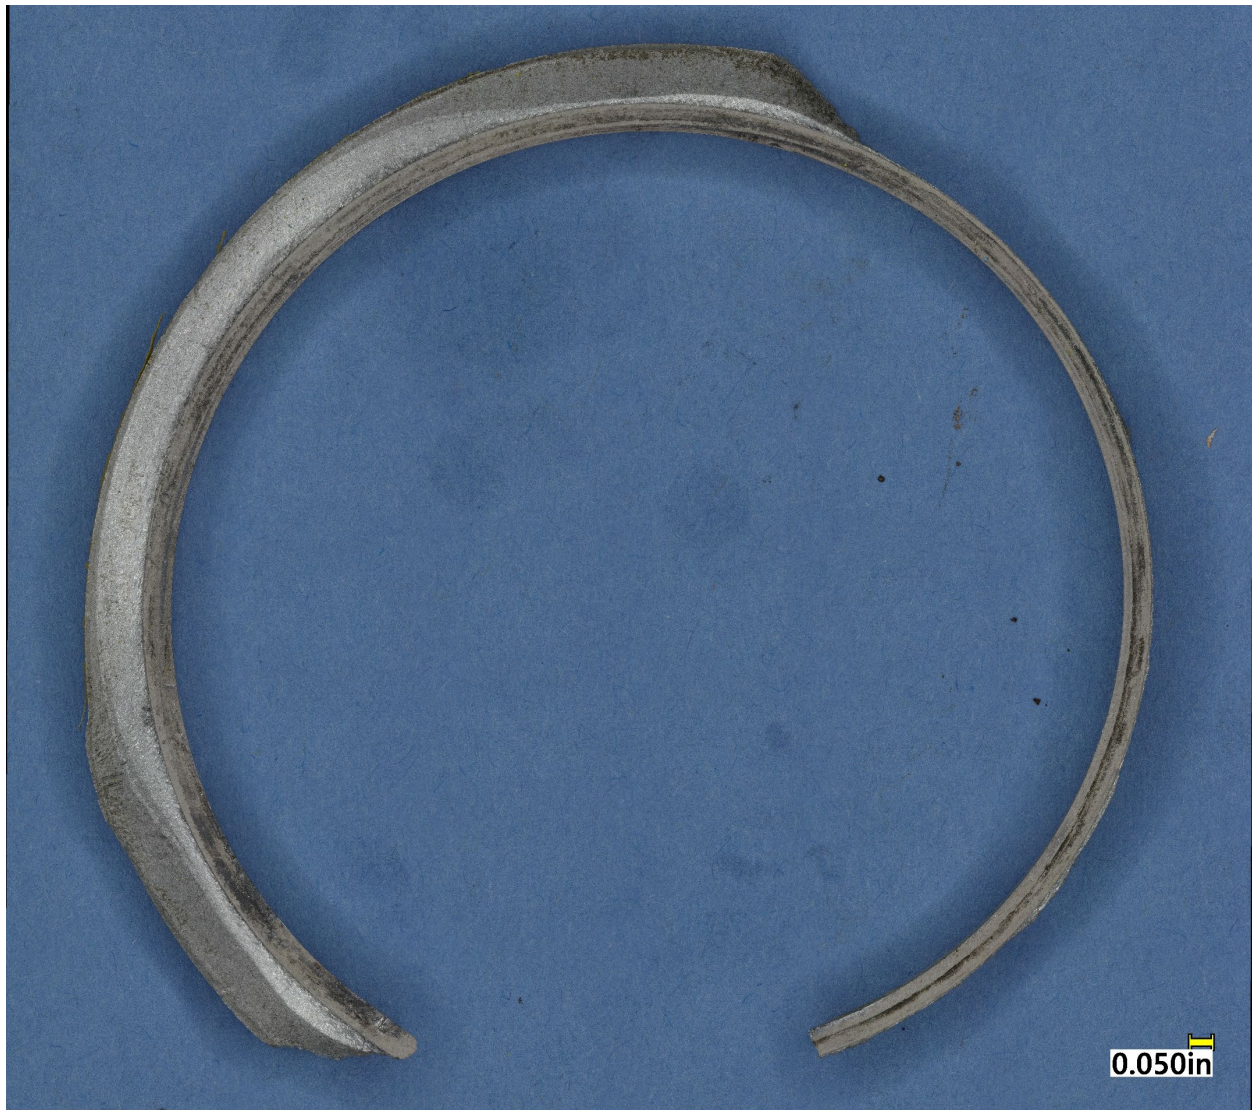
The length of the fatigue portion of the crack was 3.63 inches or 184° of the part circumference. The depth was 1.8 inches from the retaining ring at its maximum, with the remaining 1.0 inch exhibiting subsequent fracture features. The thumbnail crack initiated at a corner in the retainer clip groove.

**Figure 11.** Montage of magnified images of the crack face of the circumferential crack, showing indications of progressive cracking.

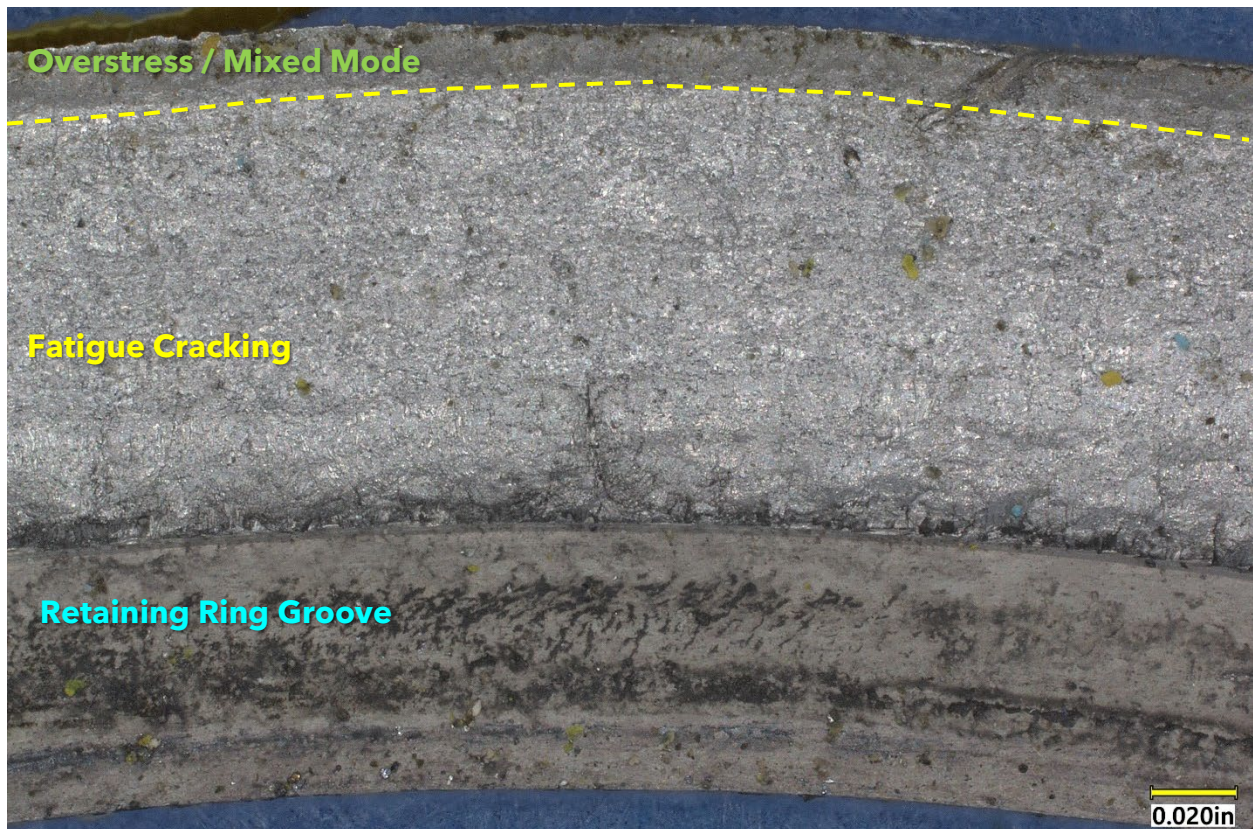
Figure 12 shows a closer view of the deepest area of the thumbnail crack on the outer circumferential fracture face. The middle part of this fracture surface exhibited crack arrest marks, consistent with progressive cracking, later determined to be fatigue. The fatigue cracks originated from the retaining ring groove, progressing through more than half of the actuator barrel thickness at the largest portion (see Figure 12). Figure 13 shows a closer view of the groove, with multiple initiation sites identified by yellow arrows. The crack propagation direction is annotated with dashed white arrows.

**Figure 12.** The progressive crack in Figure 11, showing the area of crack initiation.

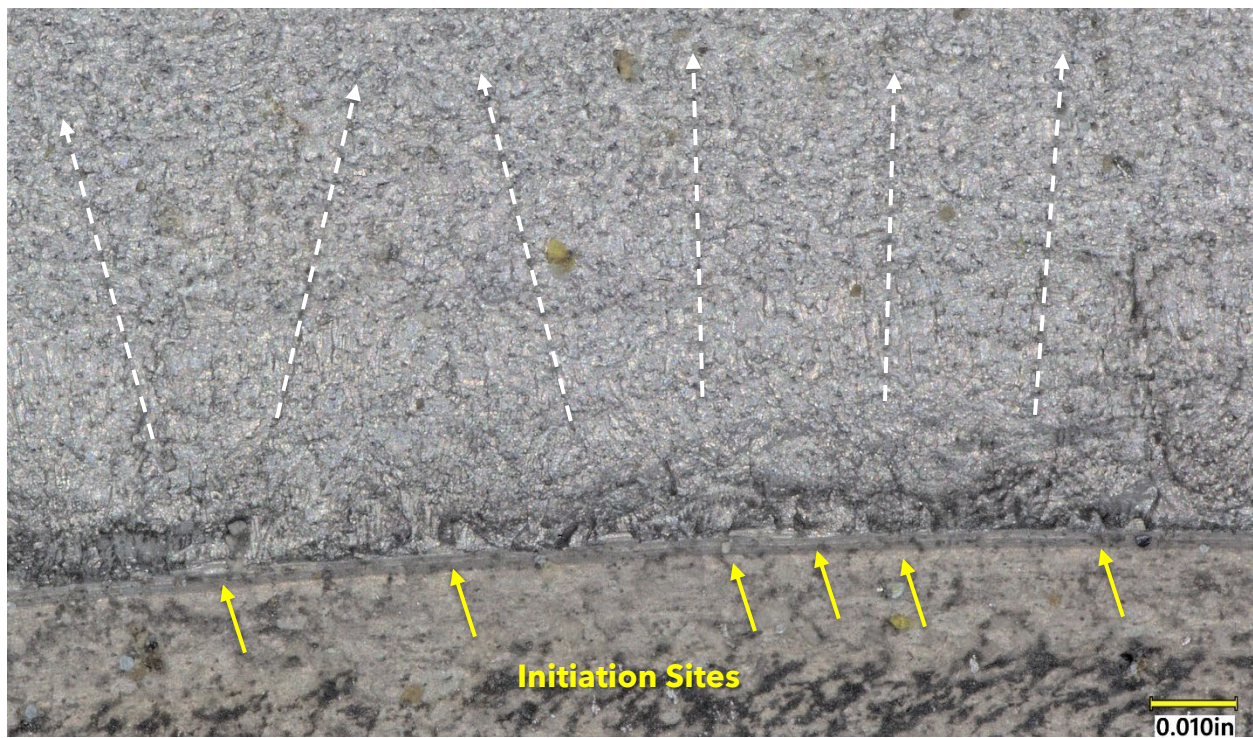
**Figure 13.** Closer view of the crack initiation area, with some initiation sites identified (yellow arrows) and the local crack growth directions annotated (white arrows).

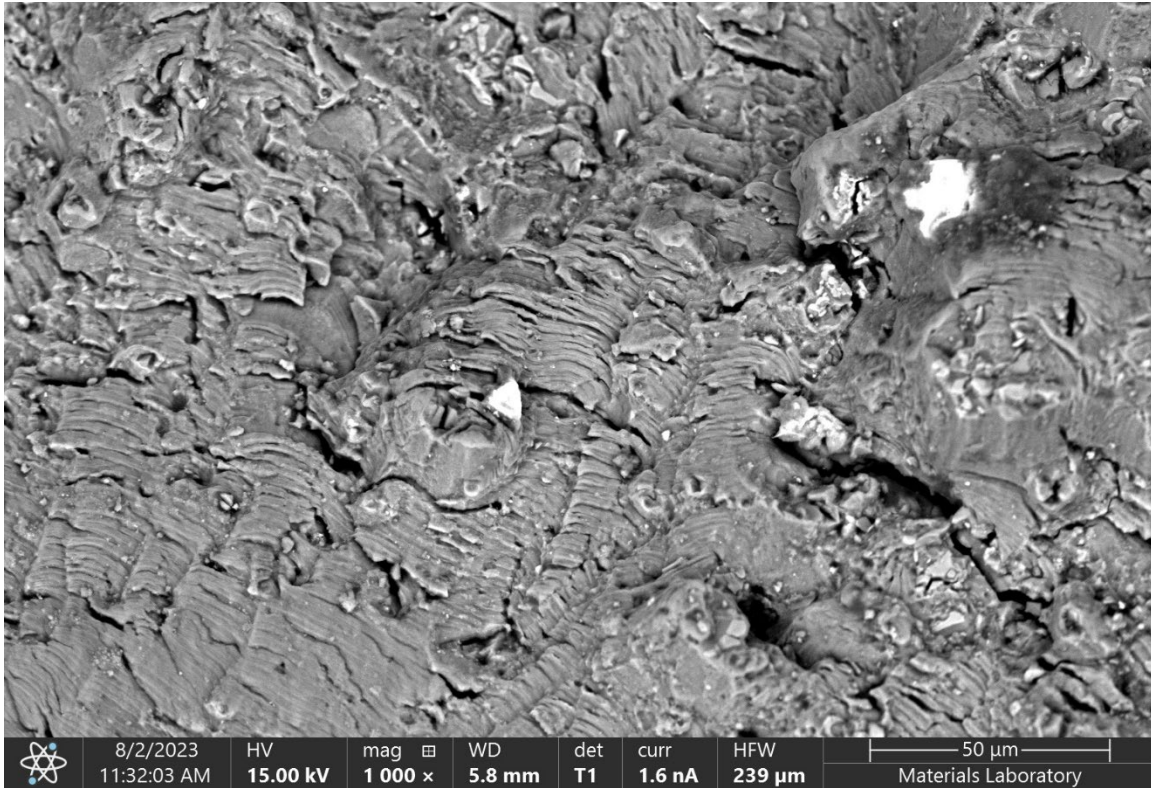
This fracture surface was examined using a scanning electron microscope (SEM). Figure 14 shows a typical area of the thumbnail crack near the initiation region in Figure 13. As shown in this figure and Figure 15, the thumbnail crack exhibited striations consistent with fatigue crack propagation. Portions of the fracture surface outside the fatigue crack revealed mostly dimple rupture, consistent with subsequent

**Figure 14.** Backscattered electron (BE) micrograph of a typical area of the fatigue crack in Figure 13, showing multiple areas of fatigue striations.

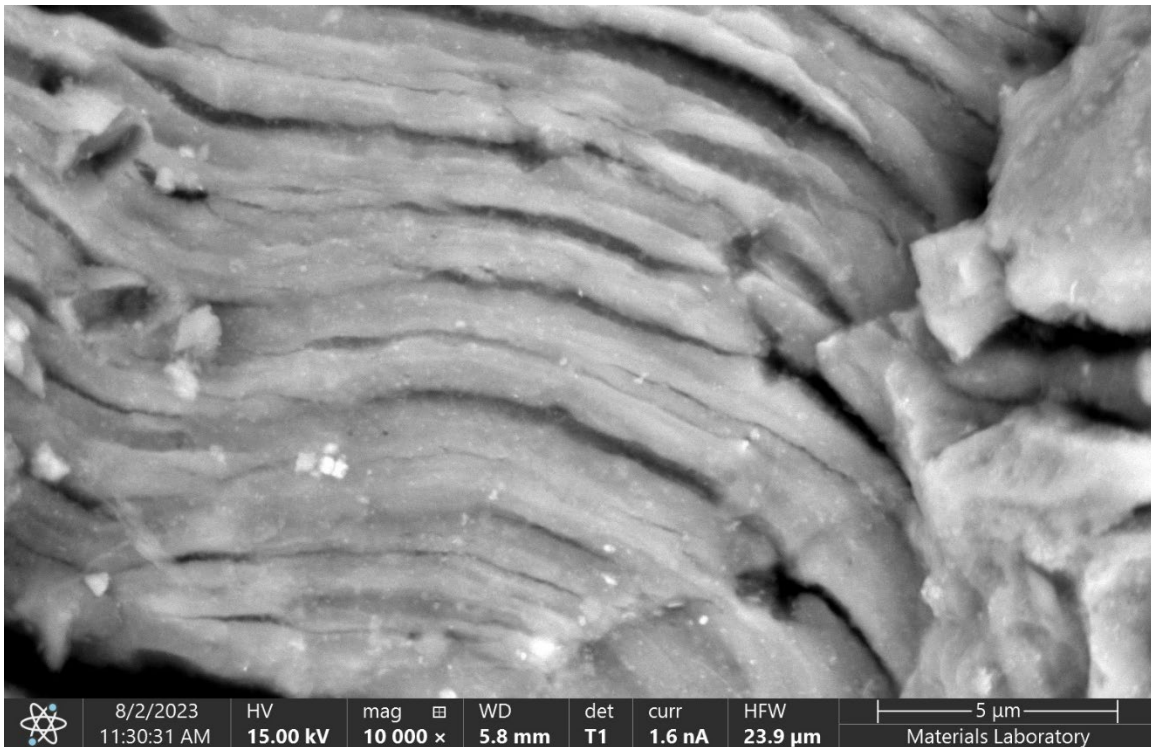
**Figure 15.** BE micrograph of a closer view of the fatigue striations in Figure 14.

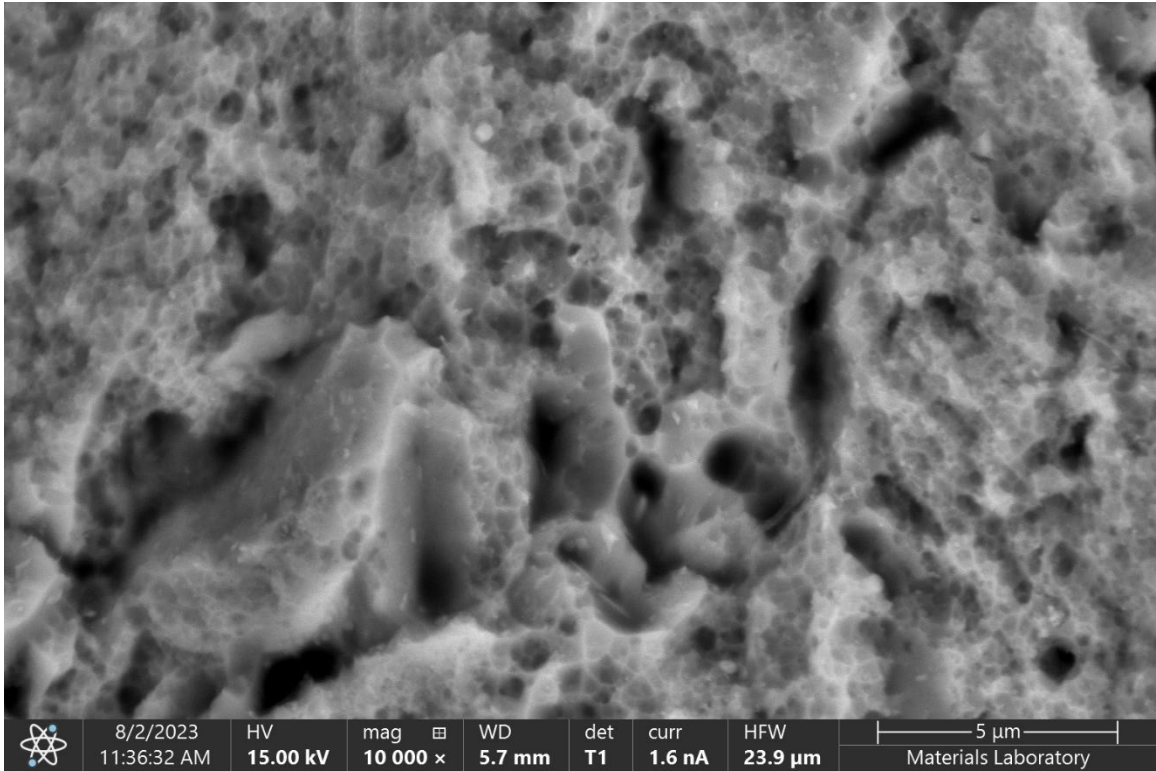
overstress fracture (Figure 16). However, there were also isolated fatigue striations, indicating an area of mixed-mode fracture. One such region was typified in the location shown in the backscattered micrograph of Figure 17.

**Figure 16.** BE micrograph of dimpled rupture in the area outside the primary fatigue crack.

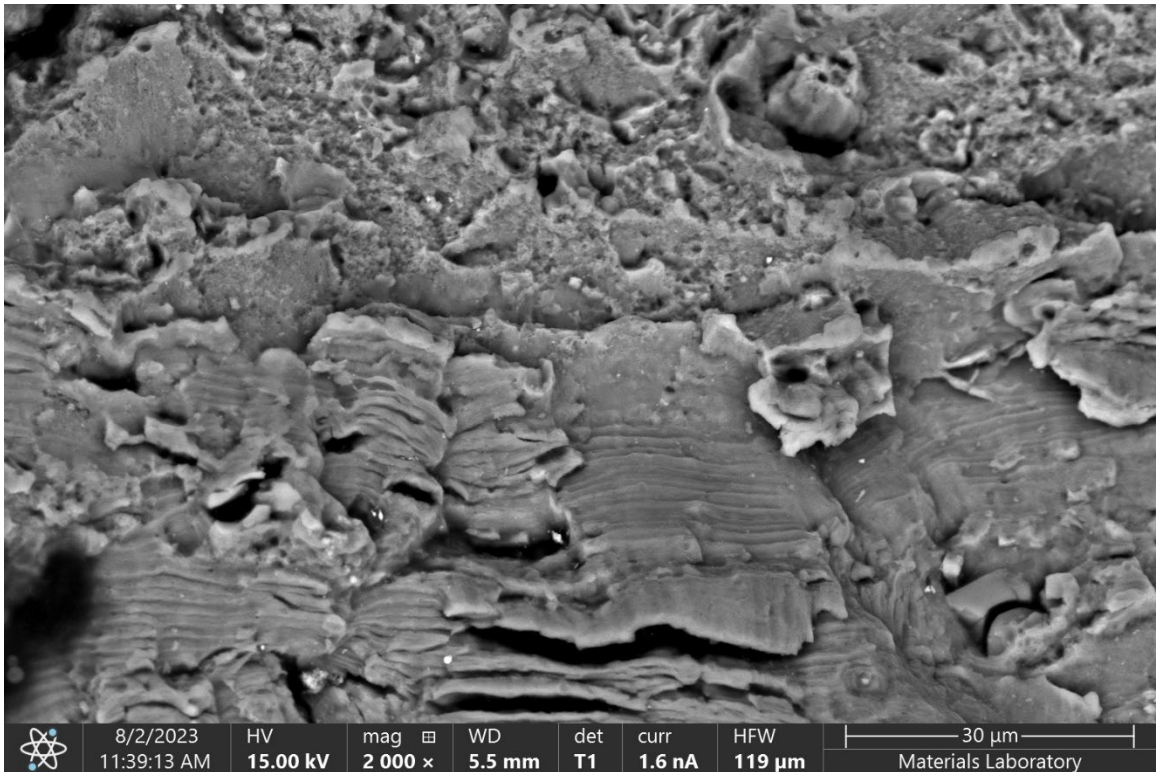
**Figure 17.** BE micrograph of the mixed mode area outside of the primary fatigue crack, showing dimpled rupture and striations.

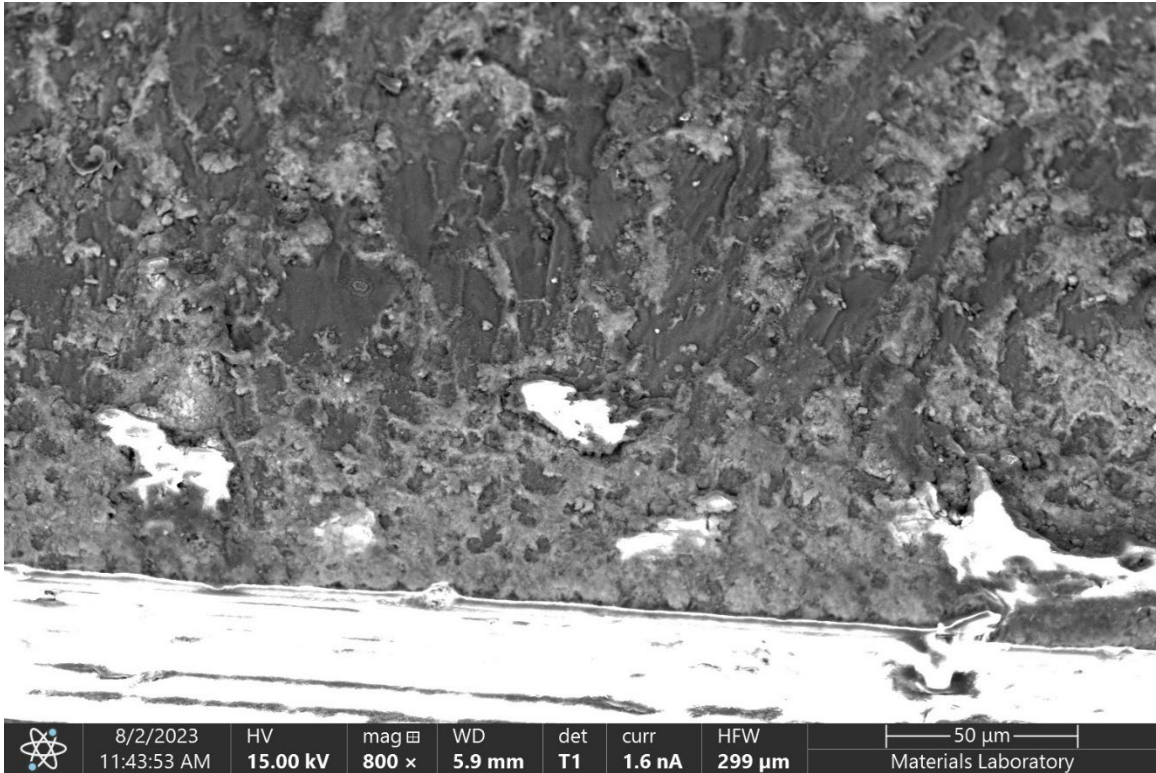
The thumbnail-shaped fatigue cracks exhibited ratchet marks, consistent with multiple fatigue crack initiation. One such crack initiation site is illustrated in Figure 18. Along this initiation site, a small corrosion pit was observed (Figure 19). Similar examination along the retaining ring groove edge found pits at other crack initiation sites, as shown in Figure 20. Figure 20 also demonstrates the layer of nonconductive material present along the groove, manifesting as brighter contrast charging areas. A backscattered examination of the corrosion pit at this site revealed a darker contrast surface layer with a small pit-like valley (Figure 21).<sup>1</sup>

**Figure 18.** BE micrograph of one of the fatigue crack initiation sites on the cylinder groove.

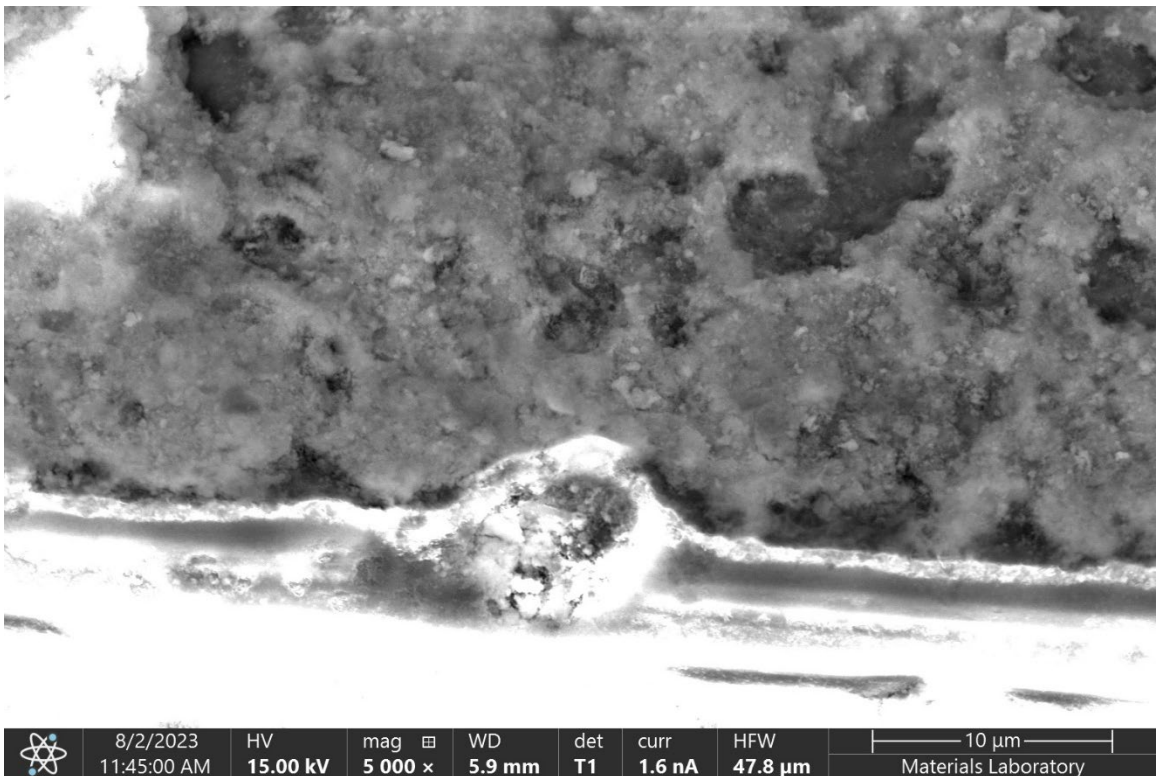
**Figure 19.** BE micrograph of the corrosion pit at the initiation site in **Figure 17**.

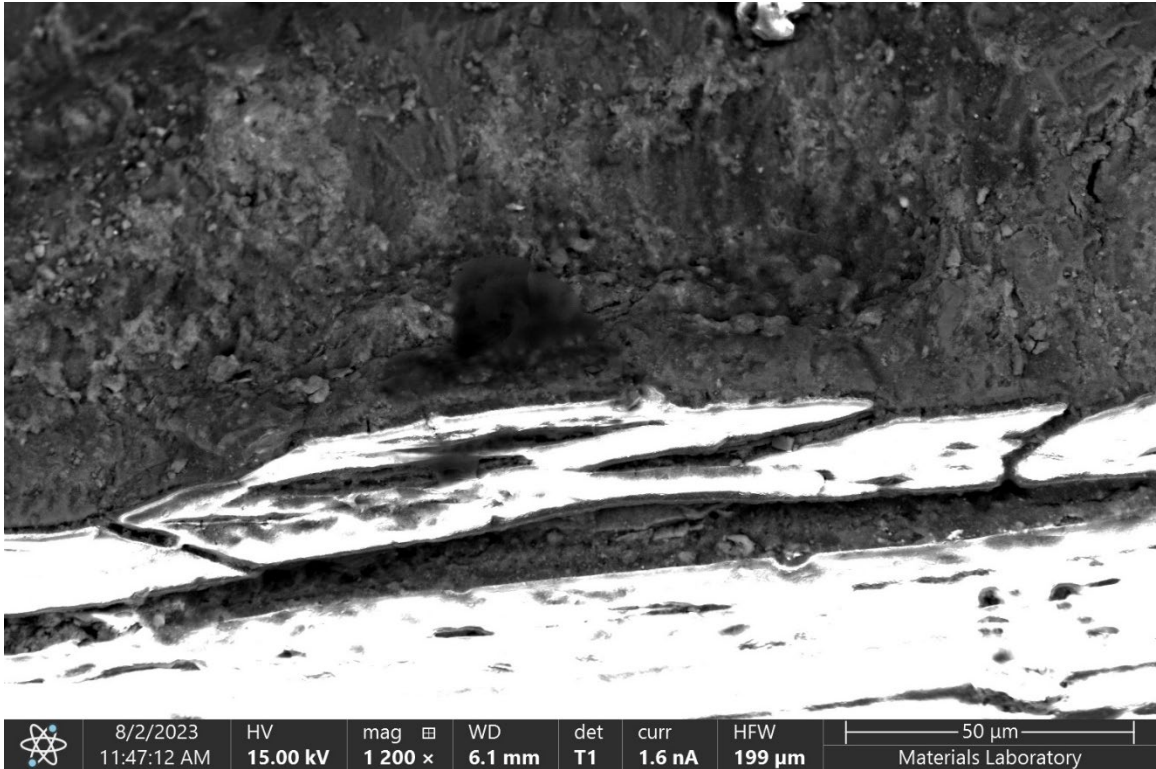
**Figure 20.** BE micrograph of a second crack initiation site, showing charging (nonconductive) compounds along the groove.

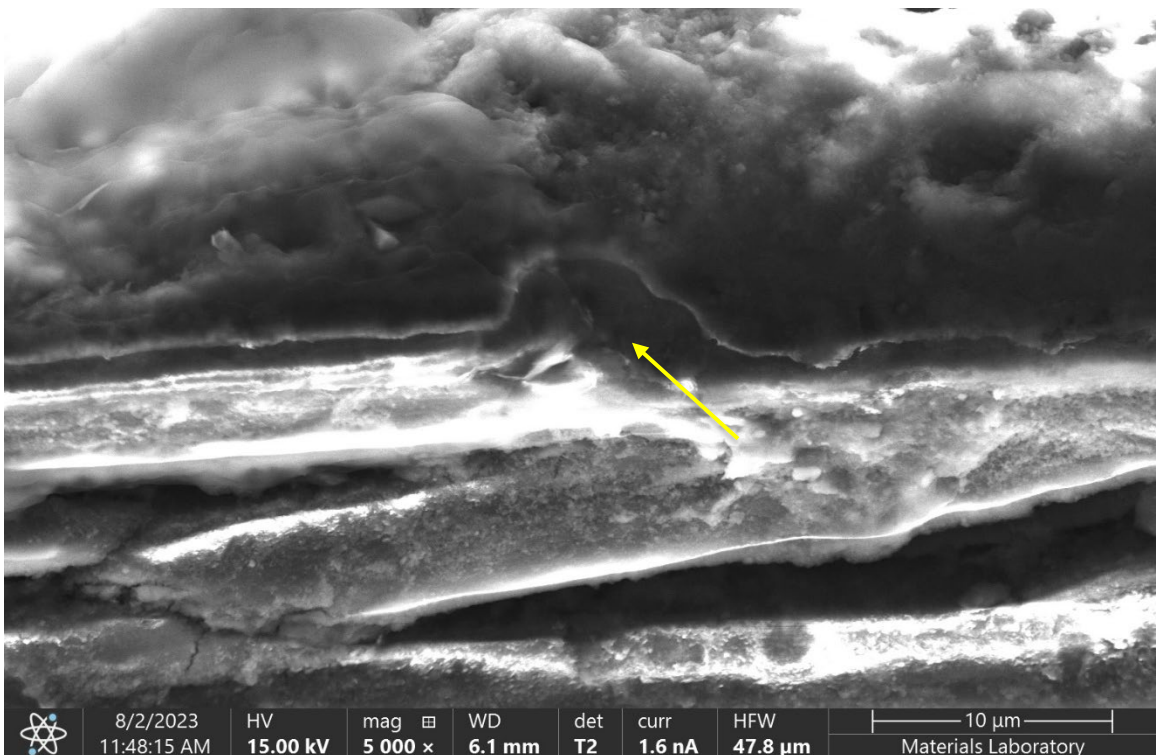
Examination of the material using energy dispersive x-ray spectroscopy (EDS) found it to be consistent with aluminum oxide. This surface layer of oxide and inward depressions were typical of the other fatigue crack initiation sites along the retaining ring groove. These sites also contained cadmium, consistent with cadmium plating remnants from the clip that sat in the groove.

**Figure 21.** Secondary electron (SE) micrograph of the initiation site edge, showing a small groove (arrow).

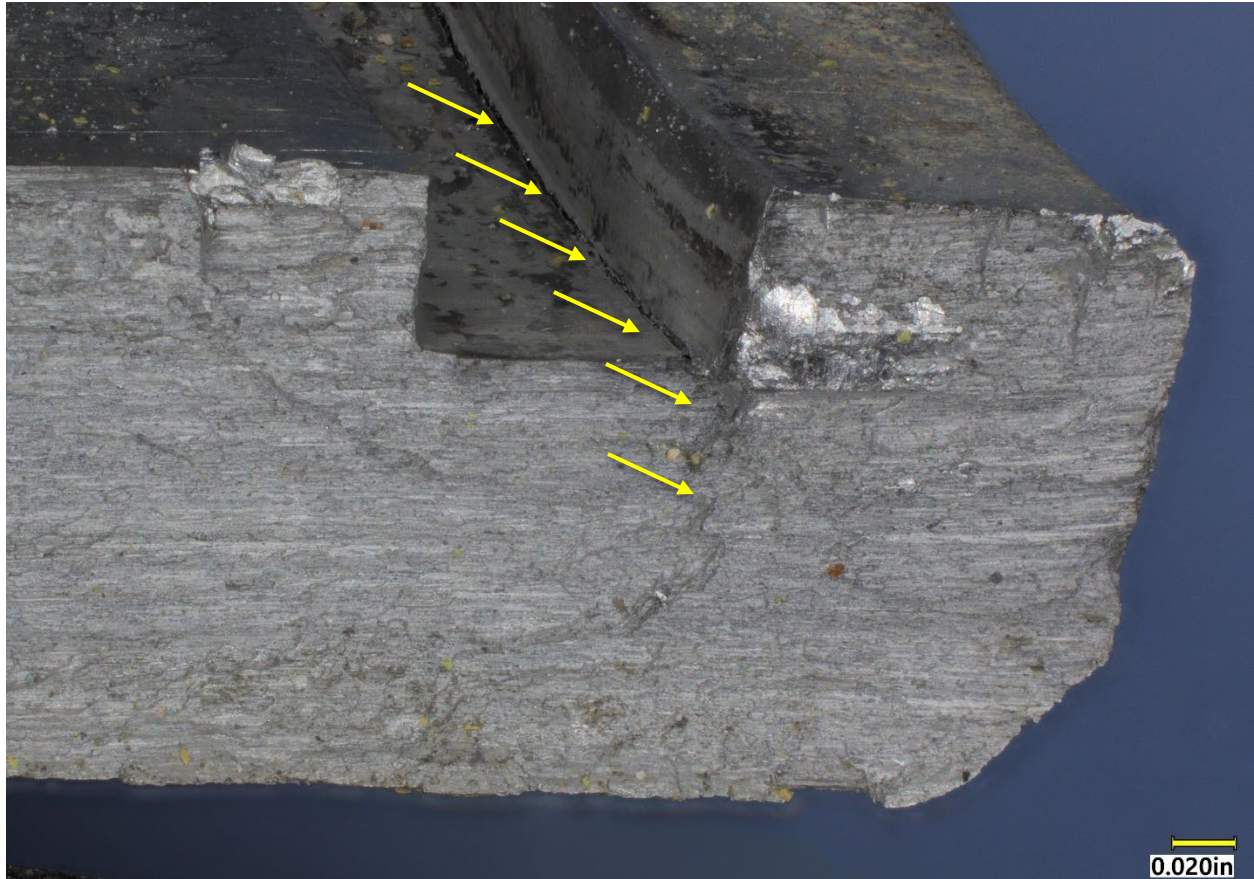
The opened longitudinal crack face was also examined, and Figure 22 shows the fracture surface along the clip groove. This figure demonstrates the rough, fibrous texture and dull luster of the longitudinal fracture. The figure also shows a crack along the outboard corner of the groove, which had propagated into the area of the longitudinal crack (yellow arrows in Figure 22). When examined using SEM, the longitudinal fracture exhibited dimple rupture, consistent with tensile overstress fracture.

**Figure 22.** View of the longitudinal fracture at the clip groove, showing cracking along the outside corner that had progressed into the material exposed on the fracture surface (arrows).
