# National Transportation Safety Board

WPR23LA213

## **MATERIALS LABORATORY**

Factual Report 23-060

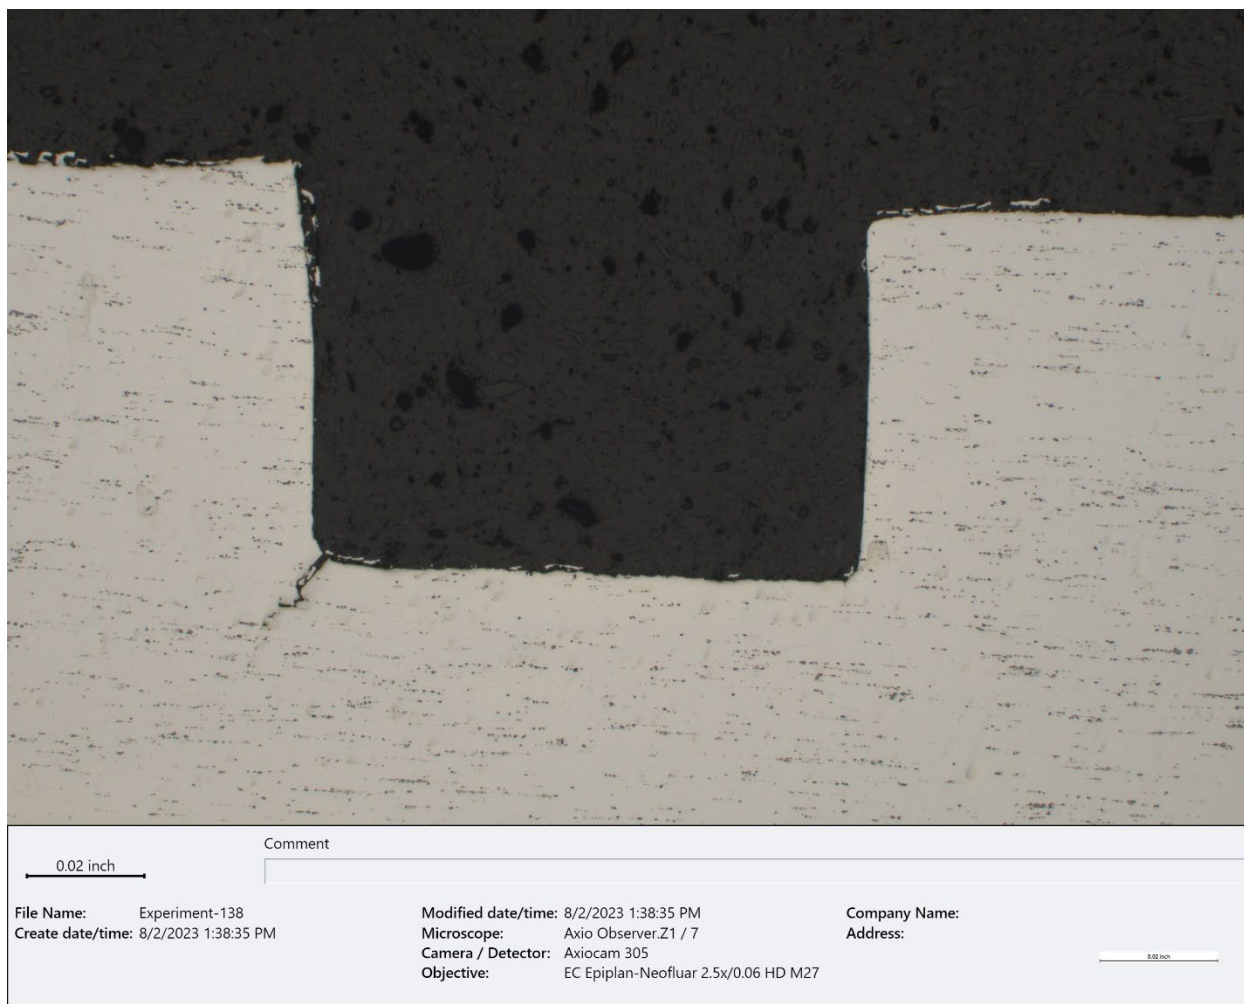
A portion of the actuator housing was cross-sectioned through the clip groove. Figure 23 shows this cross-section after mounting and polishing (this figure is oriented opposite that in Figure 22). Overall, the microstructure exhibited grain flow consistent with wrought material processing. As shown in Figure 23, an angled crack approximately 0.025 inches long had propagated out this corner of the groove (lower left in the figure). Figure 24 shows closer views of this crack at the groove corner. Examination of the opposite corner revealed an additional smaller crack (Figure 25). There were also corrosion pits present along the flat of the clip groove (see Figure 26). This pit exhibited nonmetallic compounds, which contrasted darker against the cross sectioned housing metal alloy.

**Figure 23.** Bright-field (BF) optical metallograph cross-section of the actuator retaining ring showing an angled crack propagating from the left groove radius (~25X, as polished).

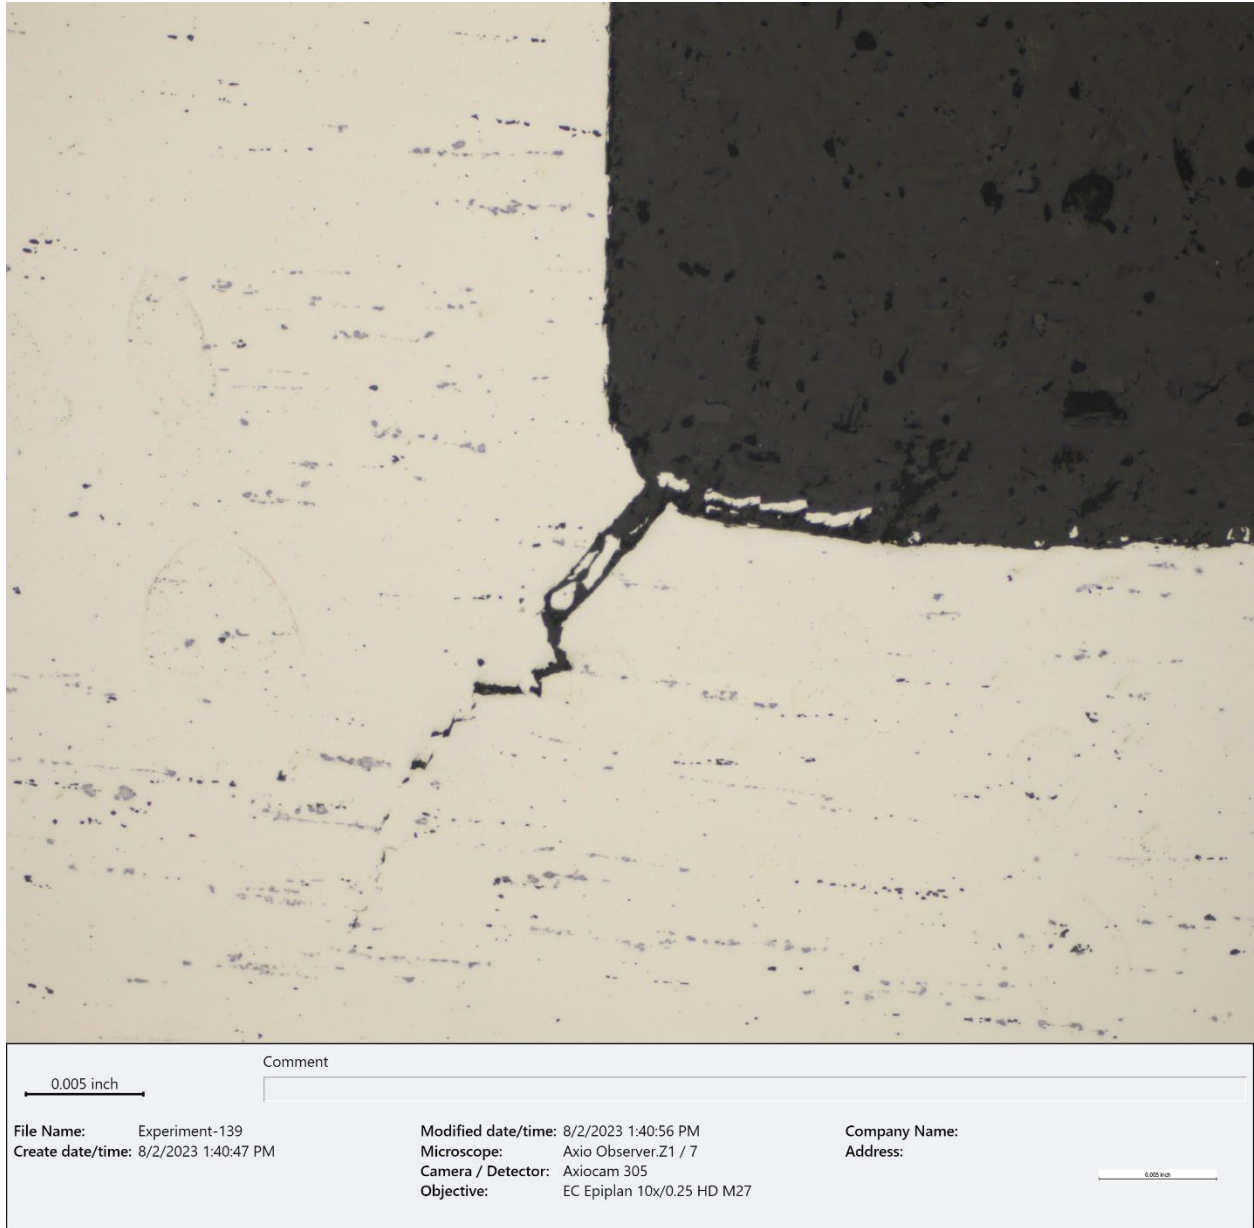
**Figure 24.** BF optical metallograph showing a closer view of the left corner crack from **Figure 22** (~100X, as polished).

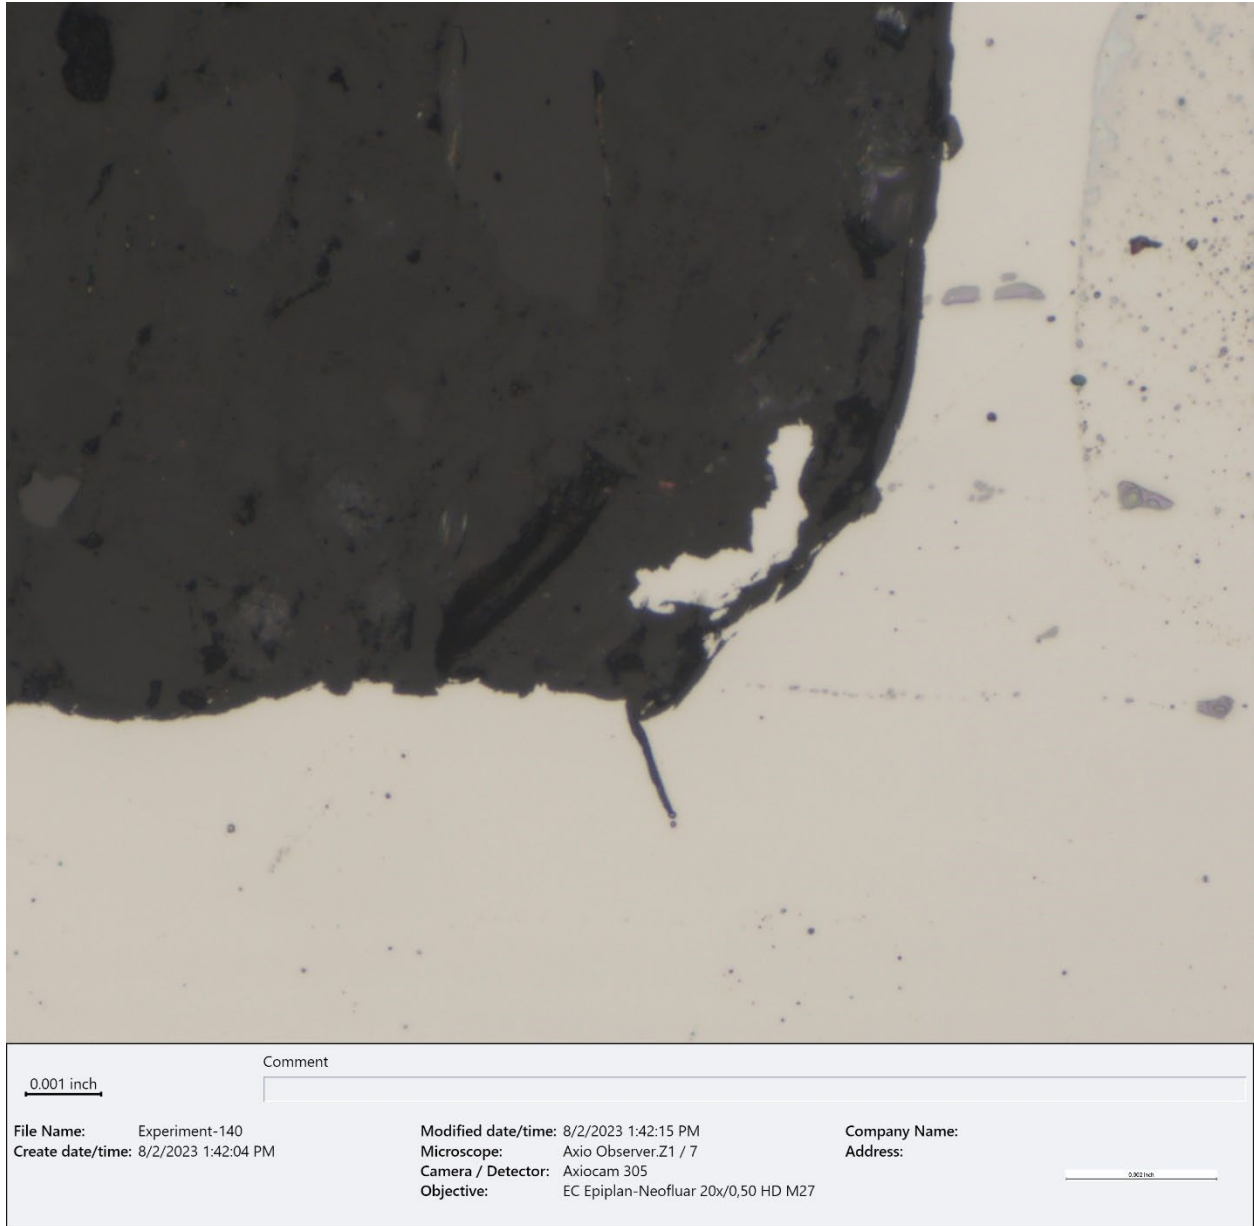
**Figure 25.** BF optical metallograph showing a closer view of the opposite right (inboard) corner crack from **Figure 22** (~320X, as polished).

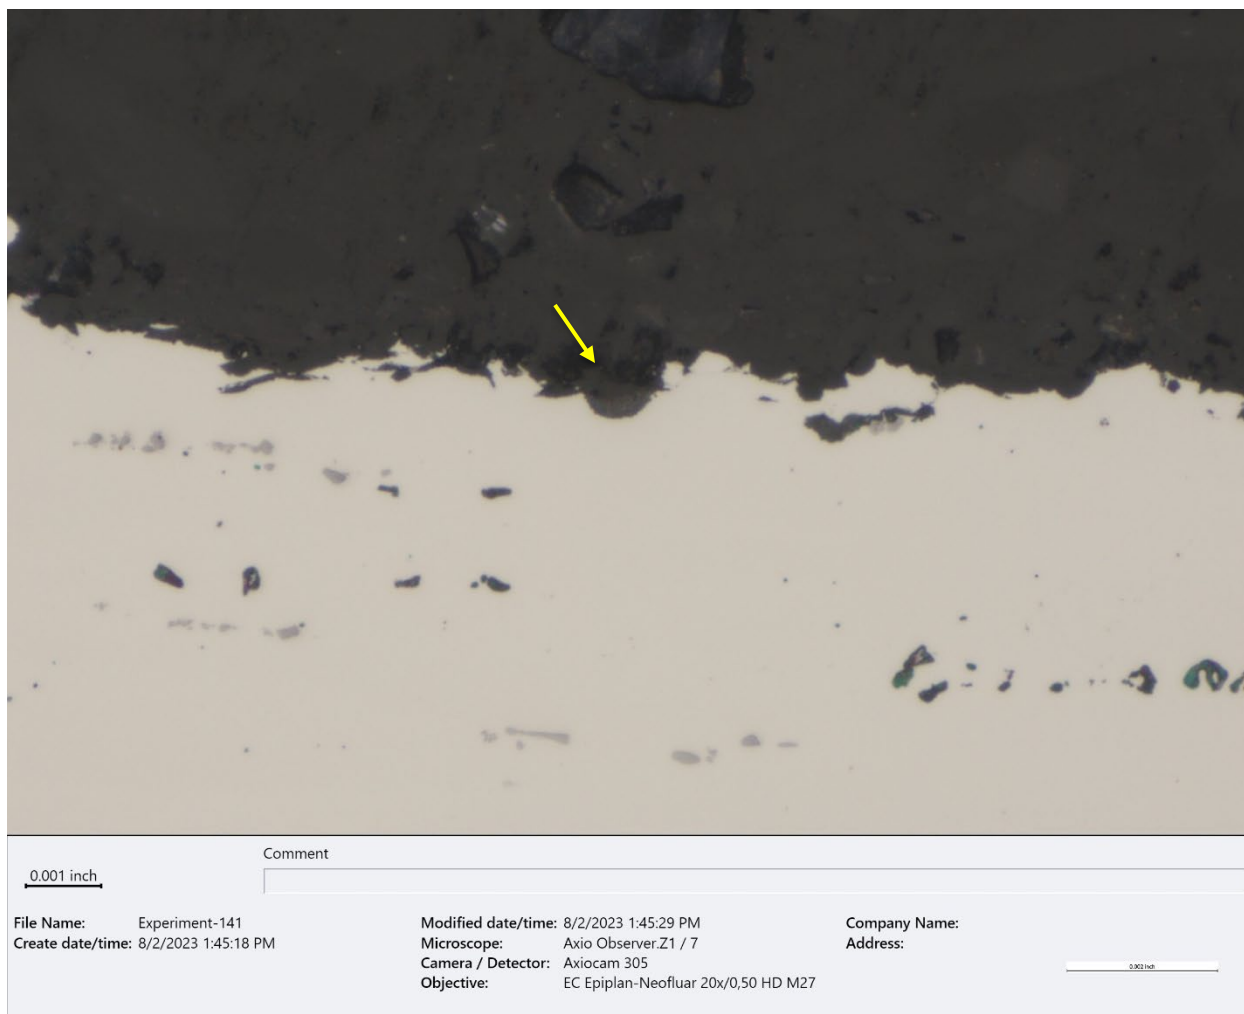
**Figure 26.** View of a corrosion pit (arrow) along the bottom surface of the groove shown in **Figure 22** (~320X, as-polished).
