# National Transportation Safety Board

## **MATERIALS LABORATORY**

Factual Report 24-019

Location: Belfair, Washington  
Date: June 4, 2023  
Vehicle: Piper J3C-65  
Investigator: Daniel Baker

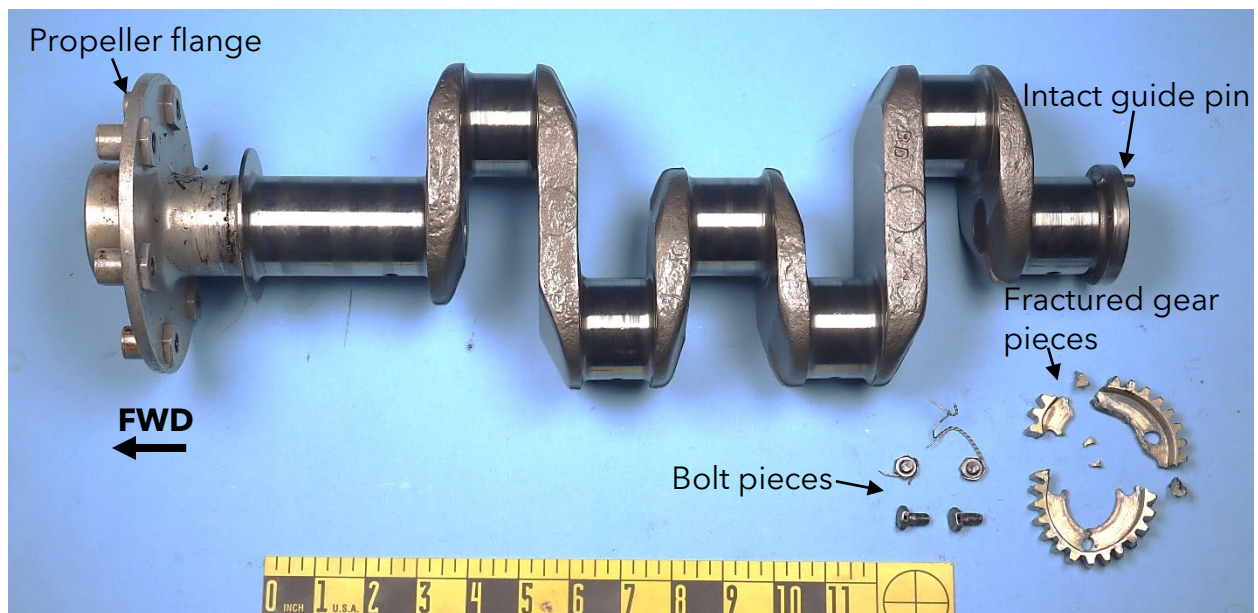
Figures 1 through 3 show photographs of the as-received crankshaft parts. The crankshaft was intact and the main and rod journals exhibited a smooth surface with no evidence of tinting (heat damage). The gear located on the aft side of the crankshaft fractured into multiple pieces (7 pieces were submitted). The gear is attached to the crankshaft by four bolts. The four bolts were submitted for examination. Two bolts were intact. The head portion separated from the other two bolts and their thread fragments were lodged in their respective bolt holes.

**Figure 1.** As- received crankshaft (top), fractured crankshaft gear pieces and attachment bolts for the crankshaft gear (bottom right corner).

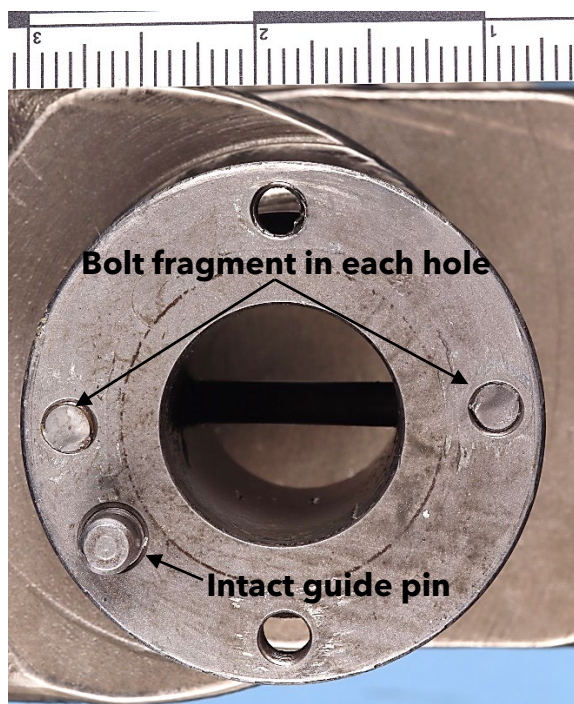
**Figure 2.** Aft end of the crankshaft showing the intact guide pin and threaded fragment of two bolts that remained lodged in their respective holes.

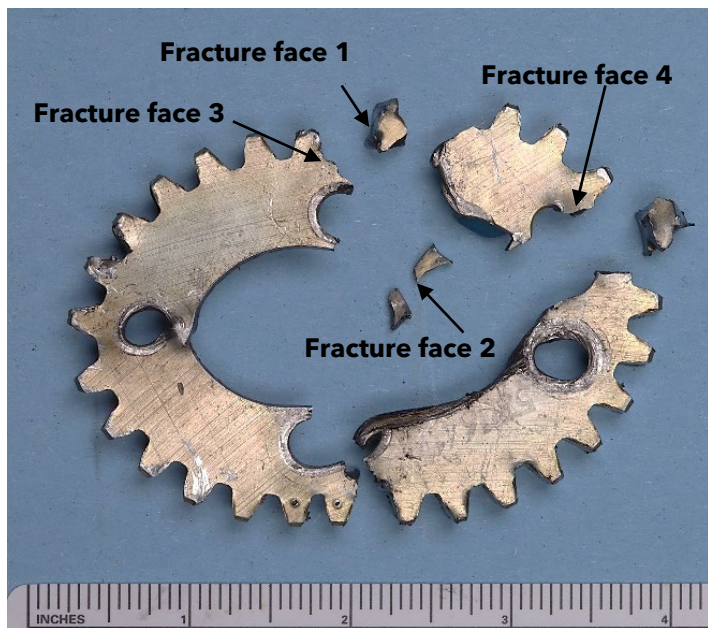
Binocular microscope examination of the submitted parts revealed the fracture faces of the bolts exhibited fine fracture features and ductile deformation typical of overstress separation in shear mode. Detailed examination of the gear revealed the fractures intersected the root areas of the teeth. The fracture faces of the gear contained mechanical damage. SEM examination was performed on four fracture faces, arbitrarily labelled "1" through "4" in figure 3. Two of the fracture faces, arrowed "1" and "3" in figure 3, contained fatigue striations typical of fatigue cracking that emanated from the root of the gear. The fatigue crack in these two gear fragments extended through the entire width of the gear. Figure 4 shows an SEM image of typical fatigue striations. On fracture face "1" the fatigue crack propagated at least 0.14 inch below the root of the tooth and on fracture face "3" the fatigue crack propagated at least 0.18 inch below the root of the tooth. The terminus of each fatigue crack was not defined because of the severe mechanical damage on the fracture faces. Fracture faces "2" and "4" contained microvoid coalescence features typical of overstress separation. The remaining fracture faces contained severe mechanical damage.

**Figure 3.** Fractured gear pieces. Fracture faces that were examined by SEM were arbitrarily labelled "1" through "4".

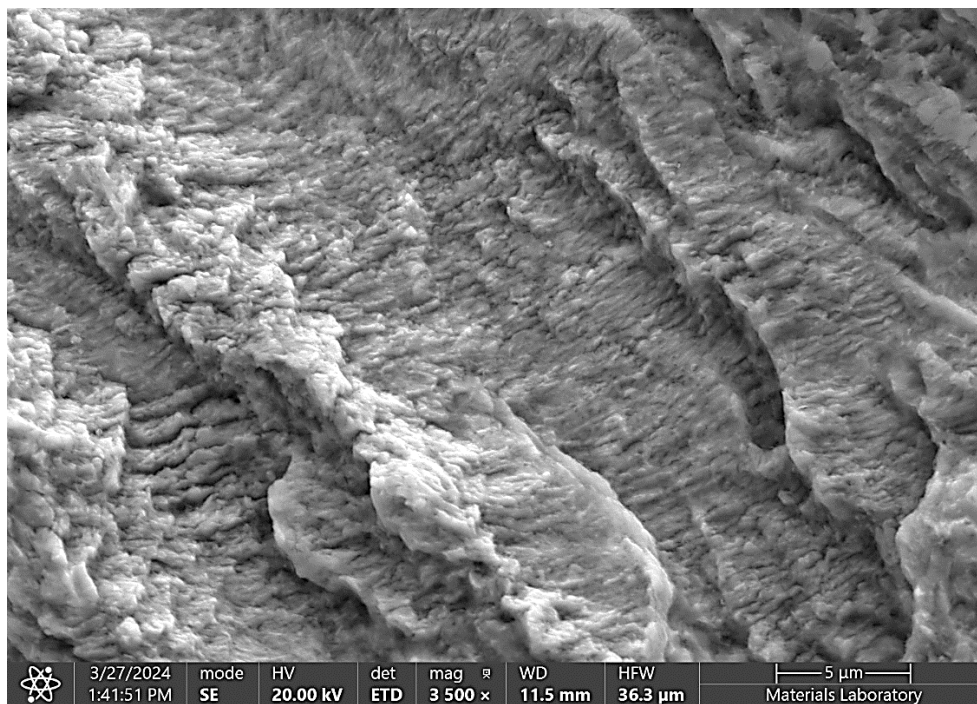
**Figure 4.** SEM image of typical fatigue striations found on the fractured gear.
