WPR23LA215

## INVESTIGATION PHOTOGRAPHS

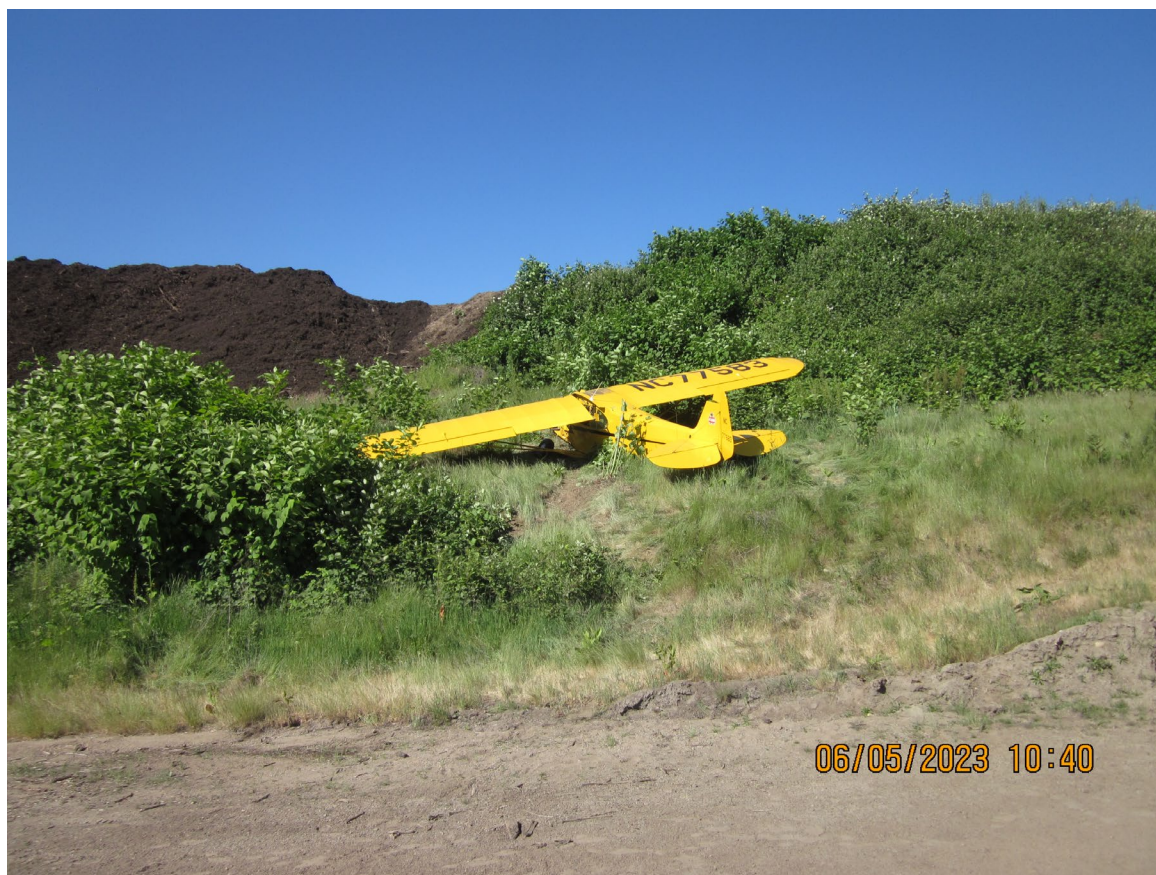
**Photograph 1 - Rear View of Wreckage (Courtesy of FAA)**

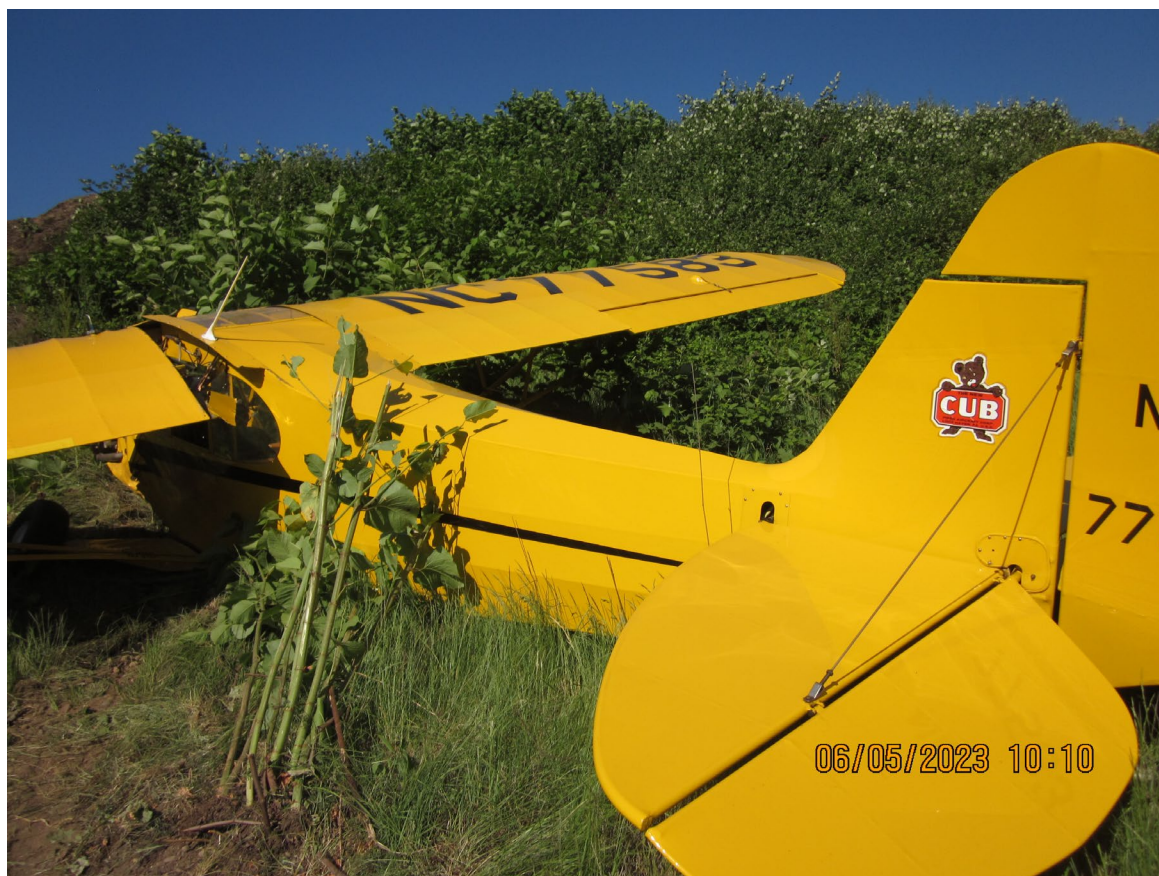
**Photograph 2 - Wreckage, Left Side Damage (Courtesy of FAA)**

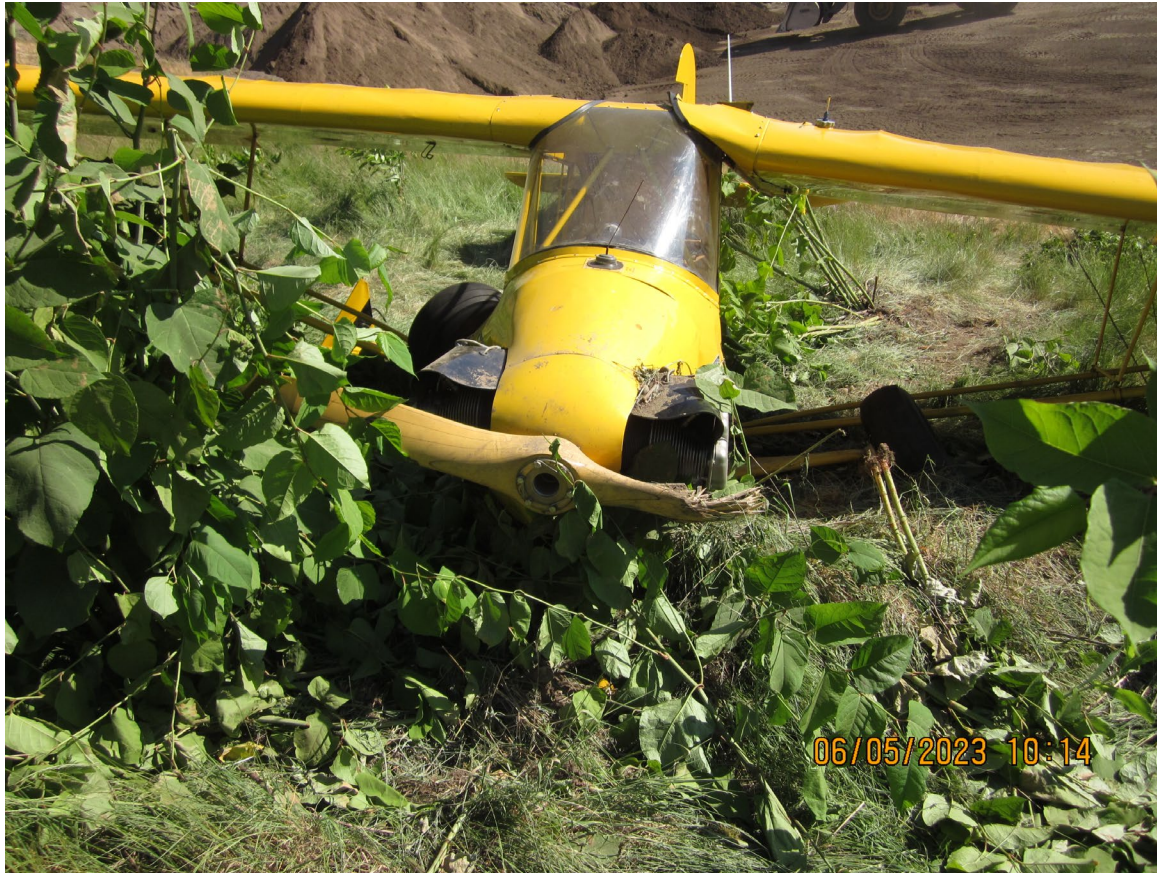
**Photograph 3 - Wreckage, Front (Courtesy of FAA)**

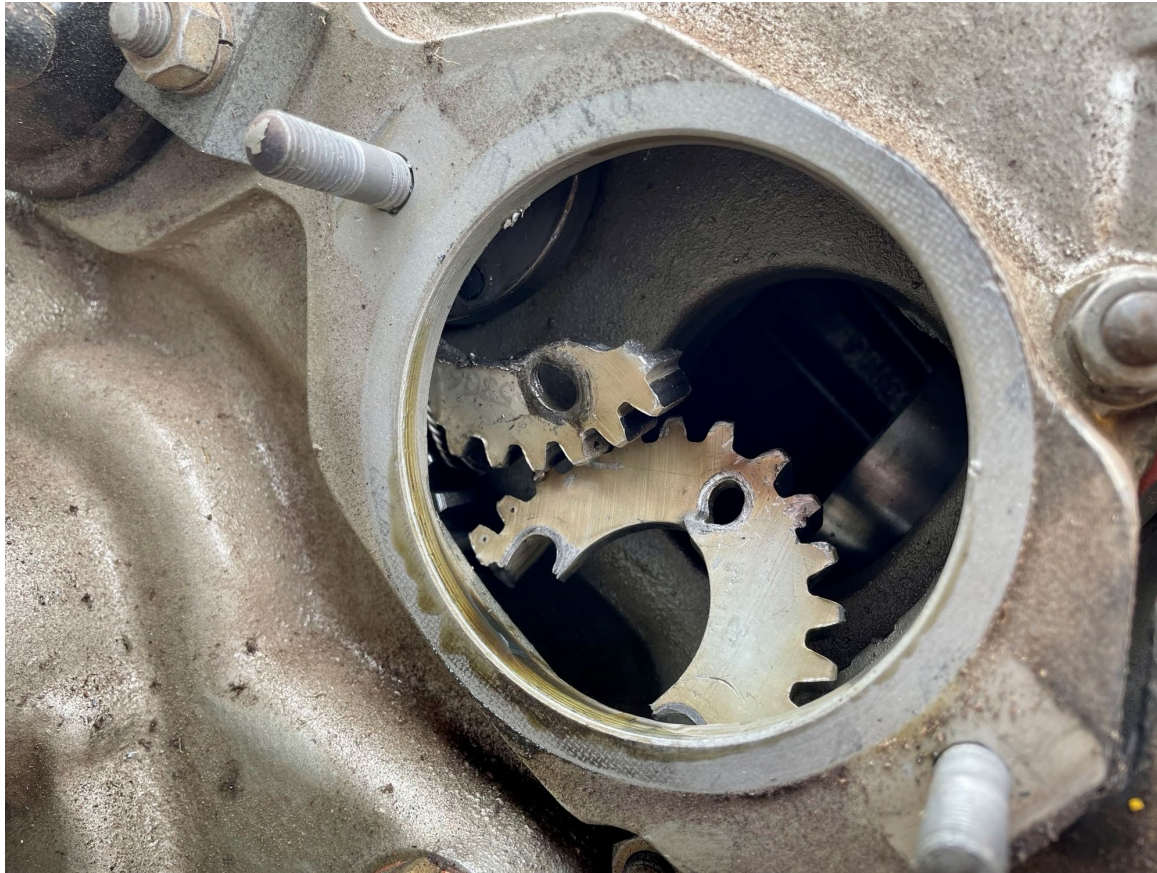
**Photograph 4 - Broken Crankshaft Gear in Accessory Case (Courtesy of NTSB)**

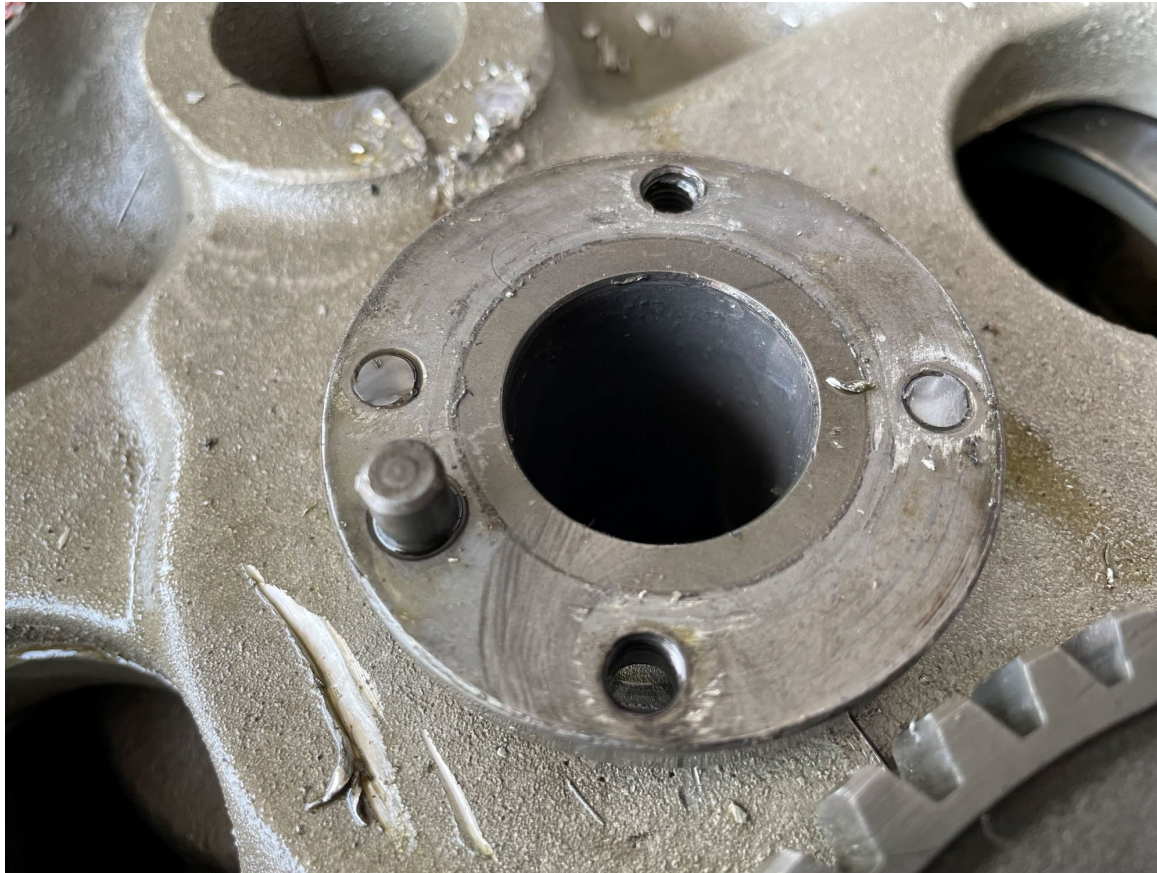
**Photograph 5 - Crankshaft Gear Bolt Damage (Courtesy of NTSB)**

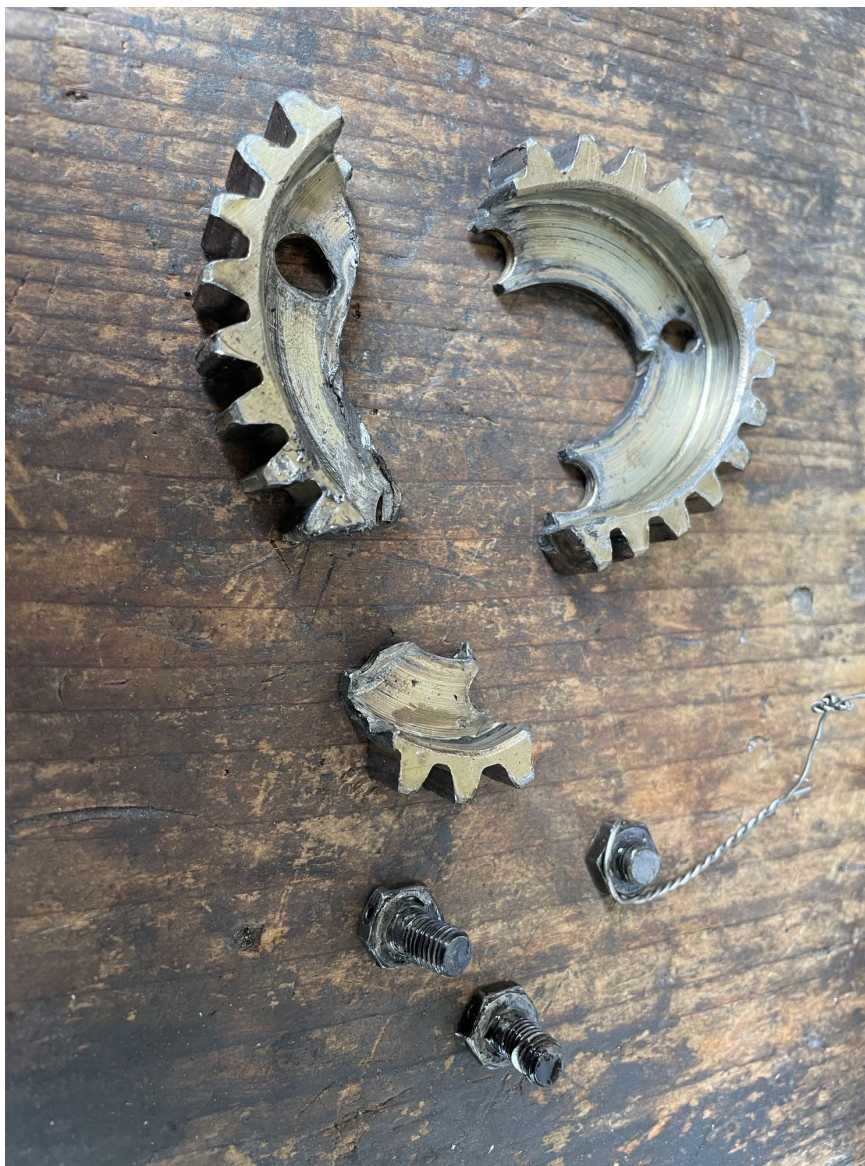
**Photograph 6 - Camshaft Gear Fragments (Courtesy of NTSB)**
