# National Transportation Safety Board

WPR23LA216

## **MATERIALS LABORATORY**

Factual Report 23-091

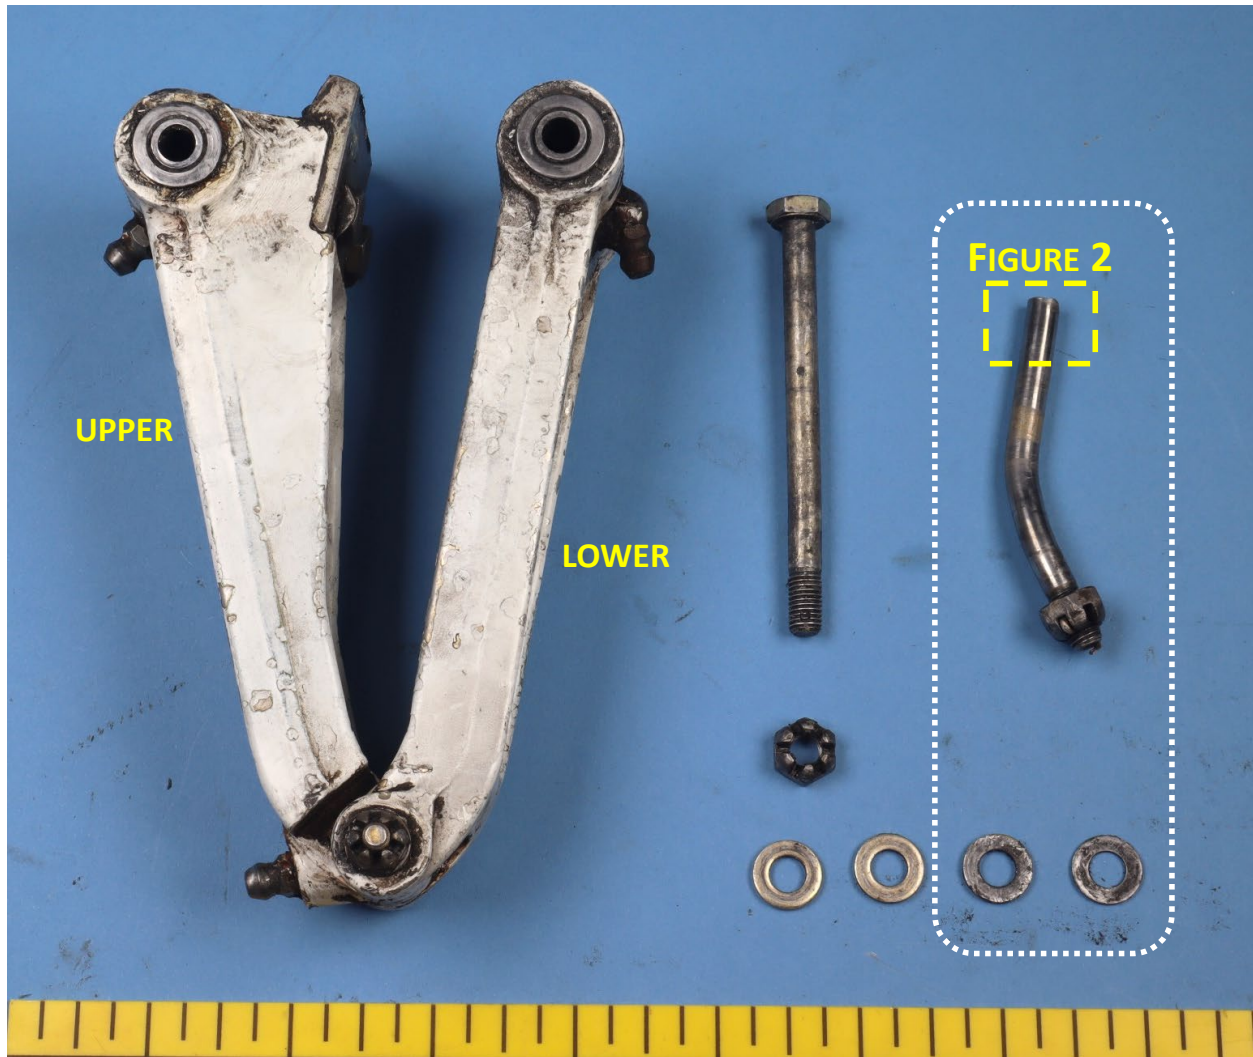
During landing after flight, the nose landing gear on the subject aircraft experienced a shimmy immediately on contact with the runway. The shimmy intensified as the aircraft slowed; during slowdown, a metallic sound was reported by the pilot, who subsequently could not control the travel direction of the aircraft, resulting in the right wing striking the ground and the aircraft nosing over to land inverted. While performing a sweep of the runway after the accident, personnel discovered a bolt from the nose wheel torque link. Examination of the nose wheel torque link assembly determined the separated bolt was from the upper torque link. The torque link assembly was removed from the aircraft and, along with the separated bolt, was submitted to the NTSB Materials Laboratory in Washington, D.C. for examination. The submitted components are shown in Figure 1.

**Figure 1.** Macro photo showing the torque link assembly components. The white dotted line encircles the washers and separated bolt that mated with the upper torque link.

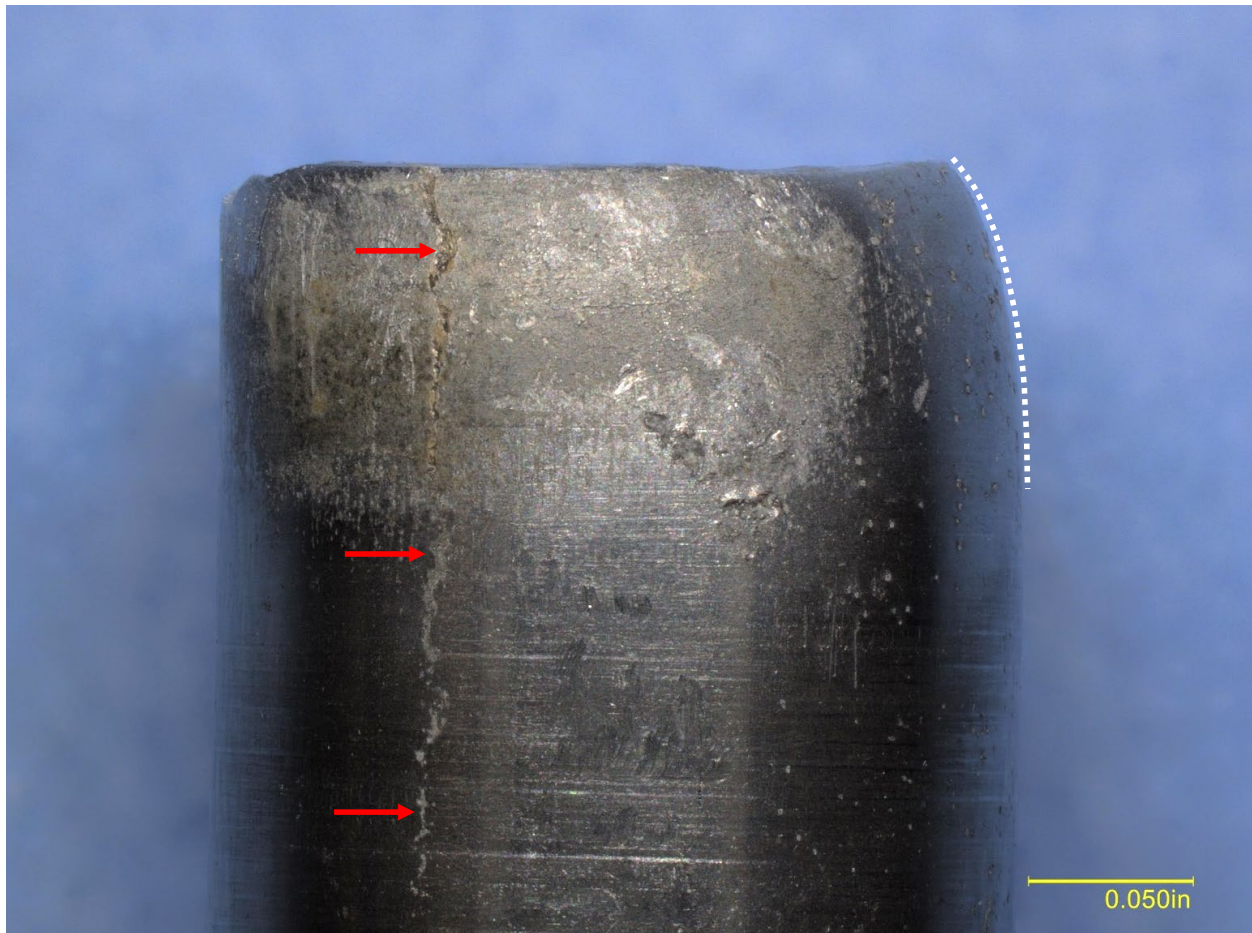
The separated upper torque link bolt was compared to the intact lower torque link bolt. The lengths of both bolts were measured; the upper torque link bolt separated through the shank approximately ¼ inch below the head. A bend was observed in the approximate middle of the remaining upper torque link bolt. A ridge of smeared material (red arrows, Figure 2) was noted on one side of the shank adjacent to the fracture surface. The ridge of material was located on the side opposite the direction of the bend in the bolt. Adjacent the fracture surface on the same side as the bend in the bolt the shank was deformed inwards and pushed slightly upwards, as highlighted by the white dotted line in Figure 2.

**Figure 2.** Digital microscope image showing the profile of the separated upper torque link bolt. The red arrows point to a ridge of smeared material on one side of the shank adjacent to the fracture surface. The white dotted line highlights an area of shank that was deformed inwards and pushed slightly upwards.

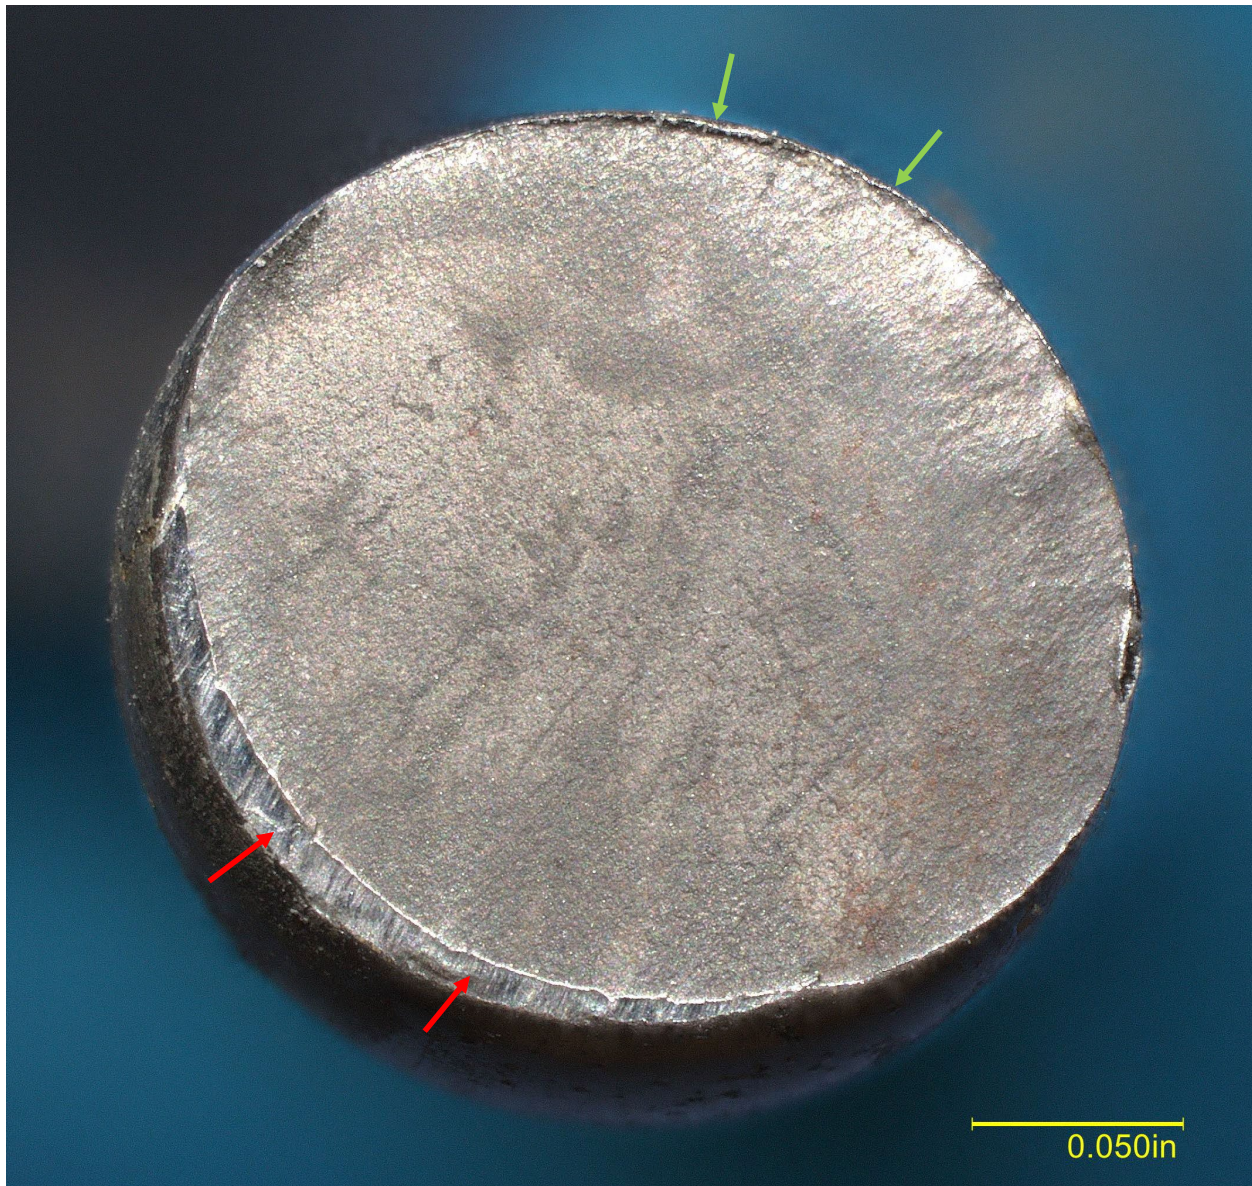
Figure 3 shows the fracture surface on the separated upper torque link bolt was flat with transgranular macro features. A lip of smeared material (red arrows) was noted on the fracture surface emanating from the ridge of material. On the opposite

side of the bolt, a ridge of material corresponding to the deformation of the shank was observed around the edge of the fracture surface (green arrows).

**Figure 3.** Digital microscope image showing the fracture surface on the separated upper torque link bolt. The red arrows point to a lip of smeared material on one side of the fracture surface. The green arrows point to a ridge of material corresponding to the deformation of the shank observed around the edge of the fracture surface.

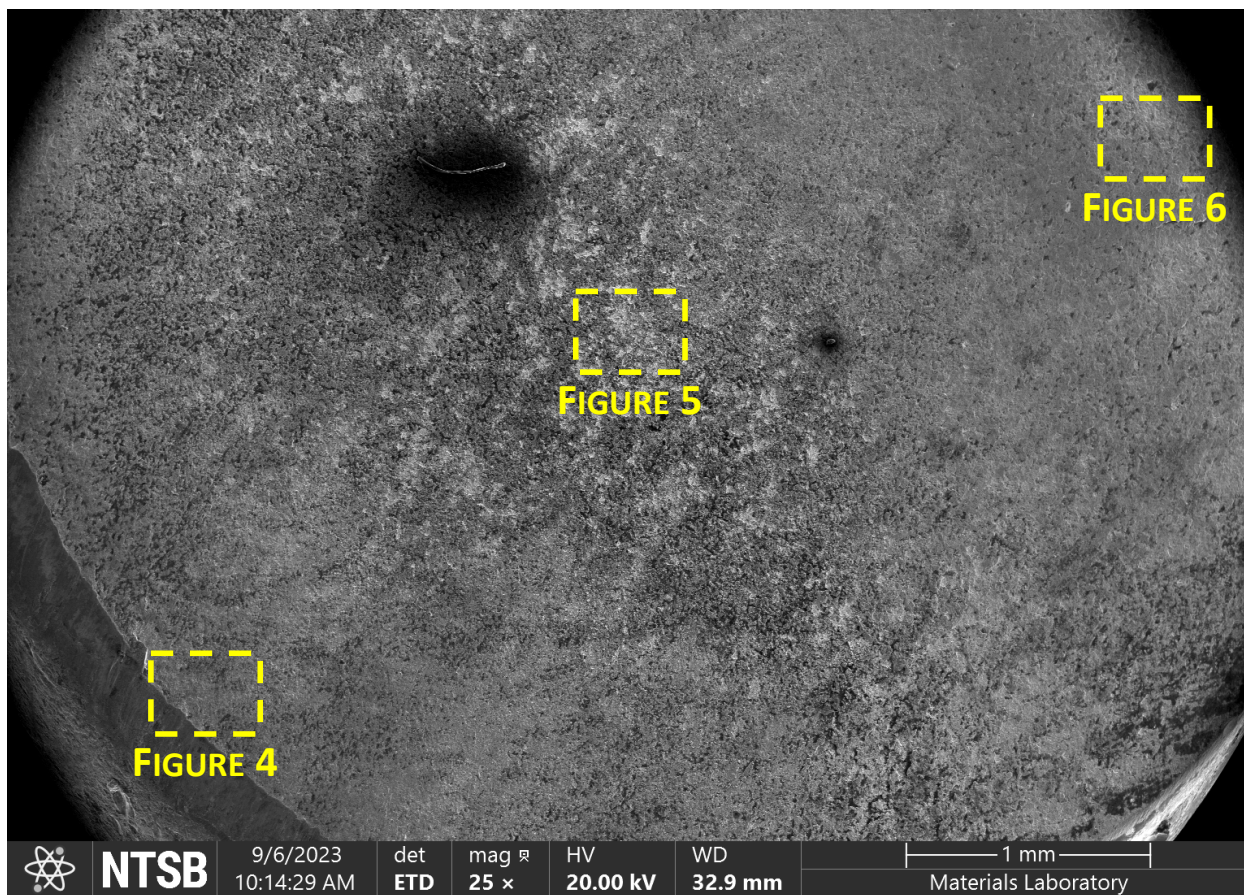
The fracture surface was sectioned from the upper torque link bolt piece, cleaned, and examined using a field-emission scanning electron microscope (SEM). Smearing damage obscured some areas on the fracture surface, but the undamaged areas had directional ductile dimples consistent with shear overstress. The dimples were observed across the entire fracture surface, as shown in Figures 4-7.

**Figure 4.** Secondary electron (SE) SEM image showing the fracture surface on the separated upper torque link bolt. Higher magnification images of the fracture surface in the areas highlighted are shown in subsequent images.

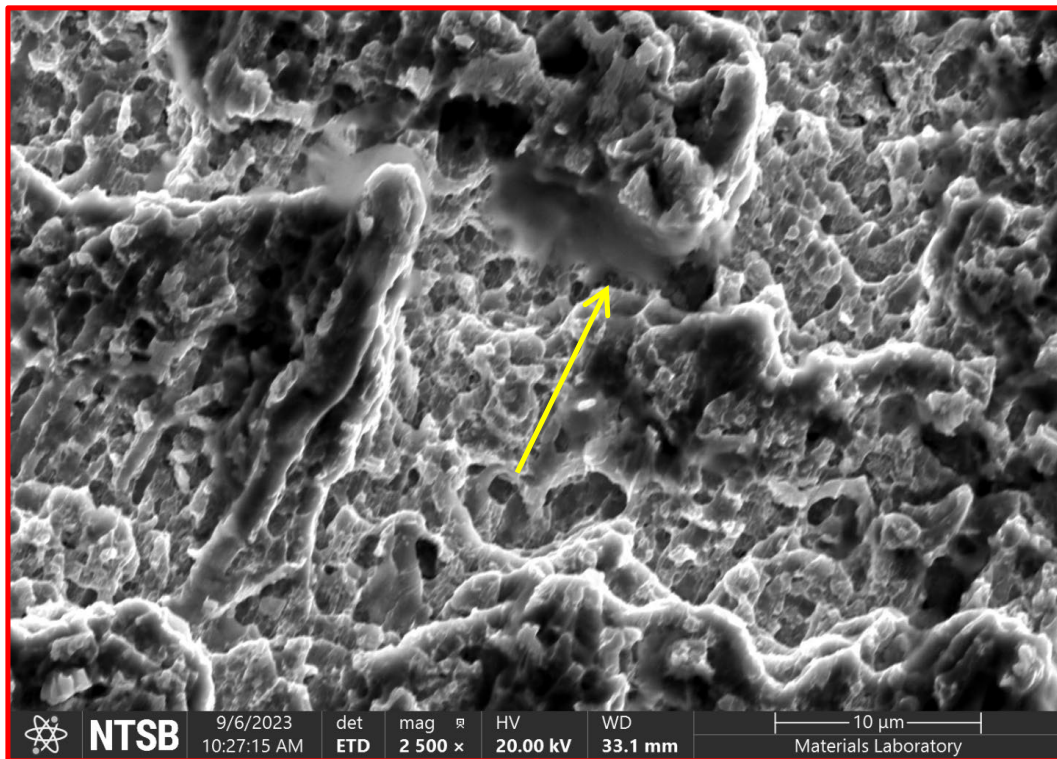
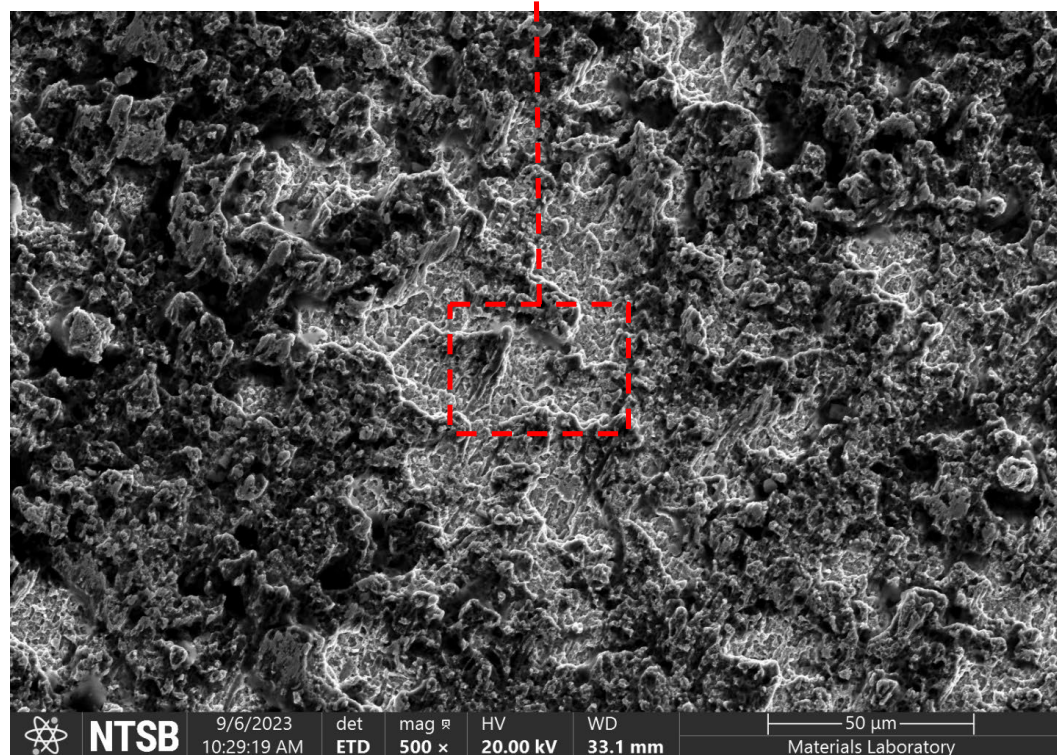
**Figure 5.** SE SEM image showing the fracture surface on the separated upper torque link bolt in the area indicated in Figure 4. The yellow arrow indicates the direction of shear stress that resulted in the observed directional ductile dimples.

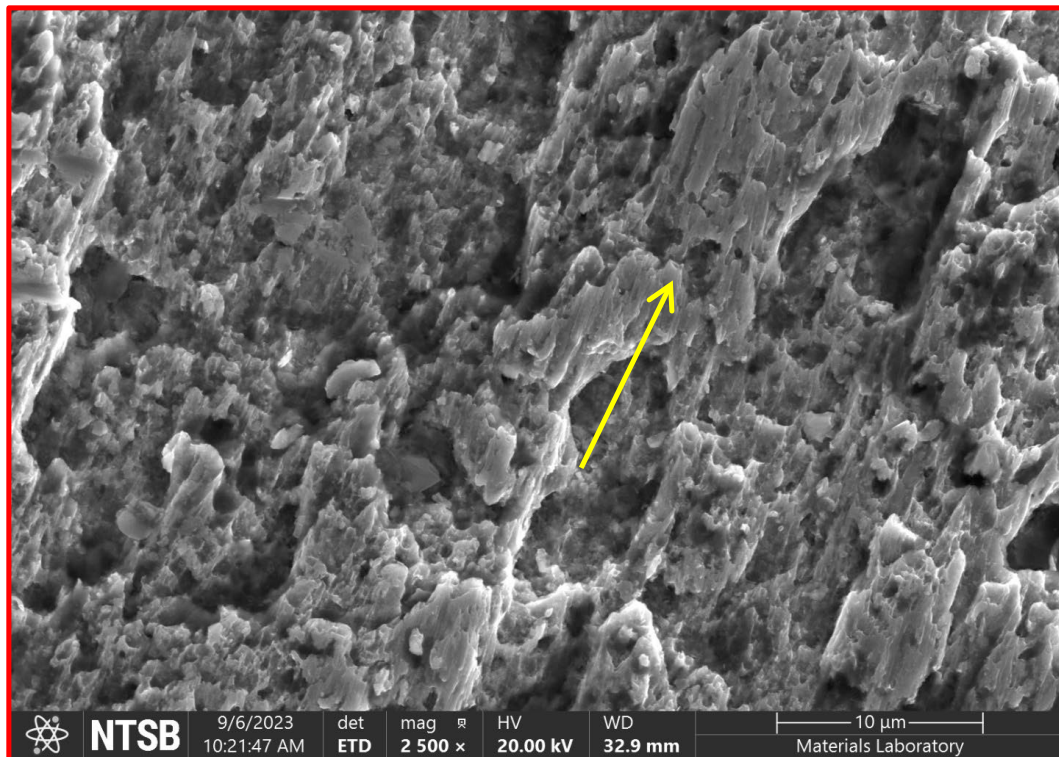
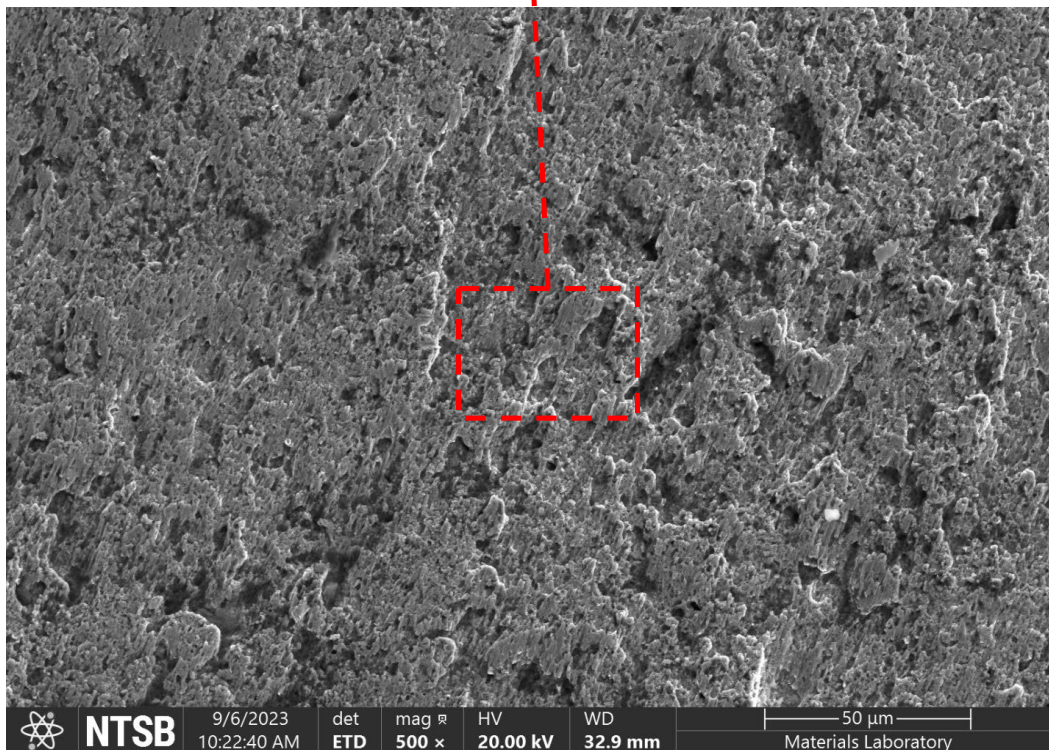
**Figure 6.** SE SEM image showing the fracture surface on the separated upper torque link bolt in the area indicated in Figure 4. The yellow arrow indicates the direction of shear stress that resulted in the observed directional ductile dimples.

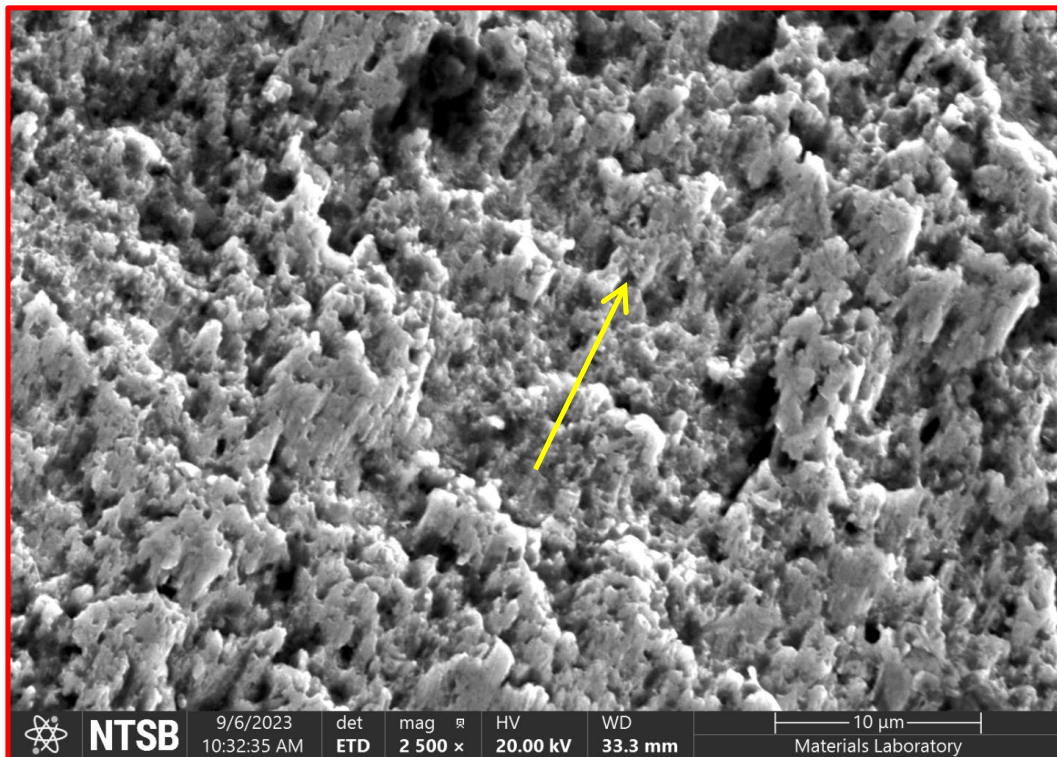
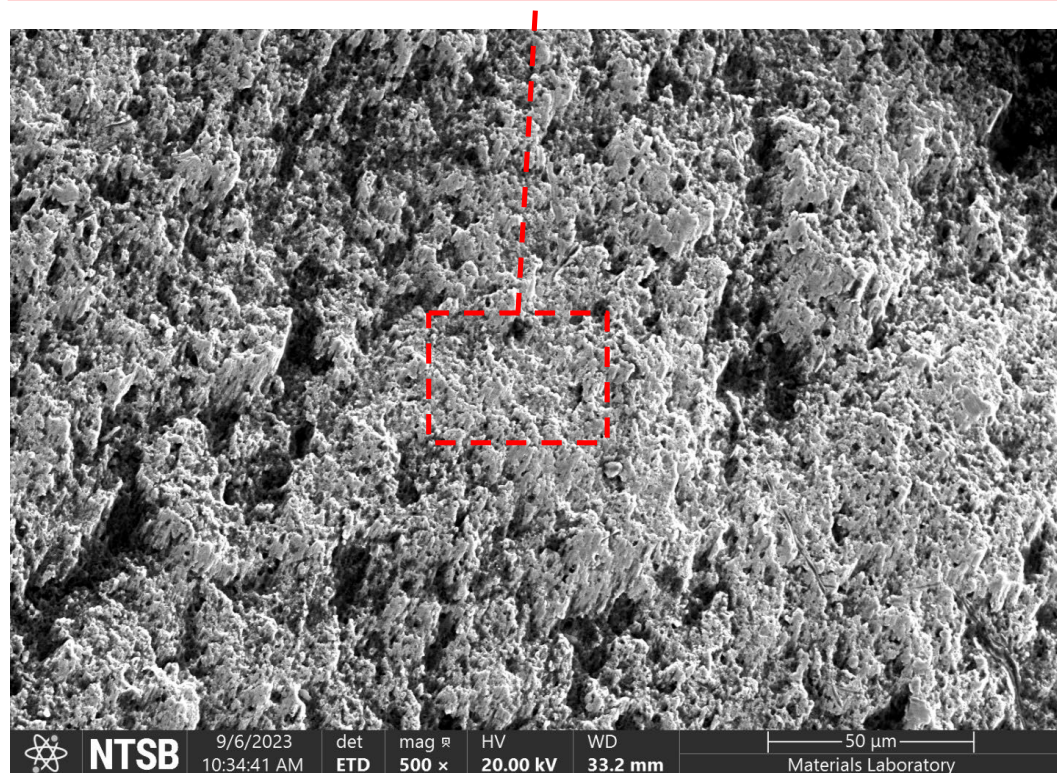
**Figure 7.** SE SEM image showing the fracture surface on the separated upper torque link bolt in the area indicated in Figure 4. The yellow arrow indicates the direction of shear stress that resulted in the observed directional ductile dimples.

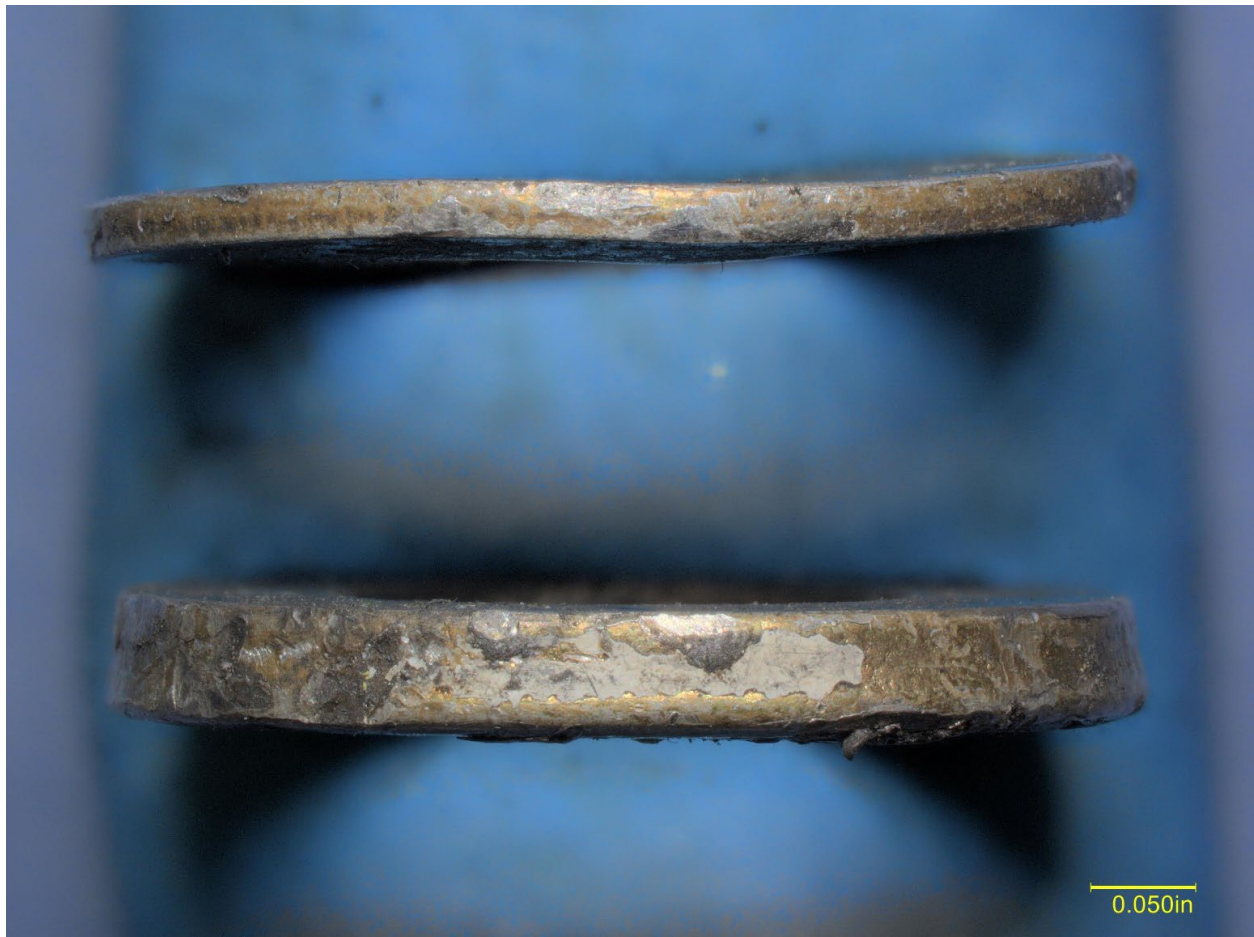
The washers that were assembled to the intact lower torque link bolt appeared to be in good condition, with a shallow wear pattern on both faces. The washers that were assembled to the upper torque link bolt were rough with scrape marks, plating that had worn away, and had deformation. The lower torque link washers both measured 0.063 inches thick. One of the upper torque link washers was noticeably thinner than the other, as shown in Figure 8; one washer measured 0.62 inches thick and the other washer measured 0.31 inches thick.

**Figure 8.** Digital microscope image showing the profile of the washers that had been assembled to the upper torque link bolt.
