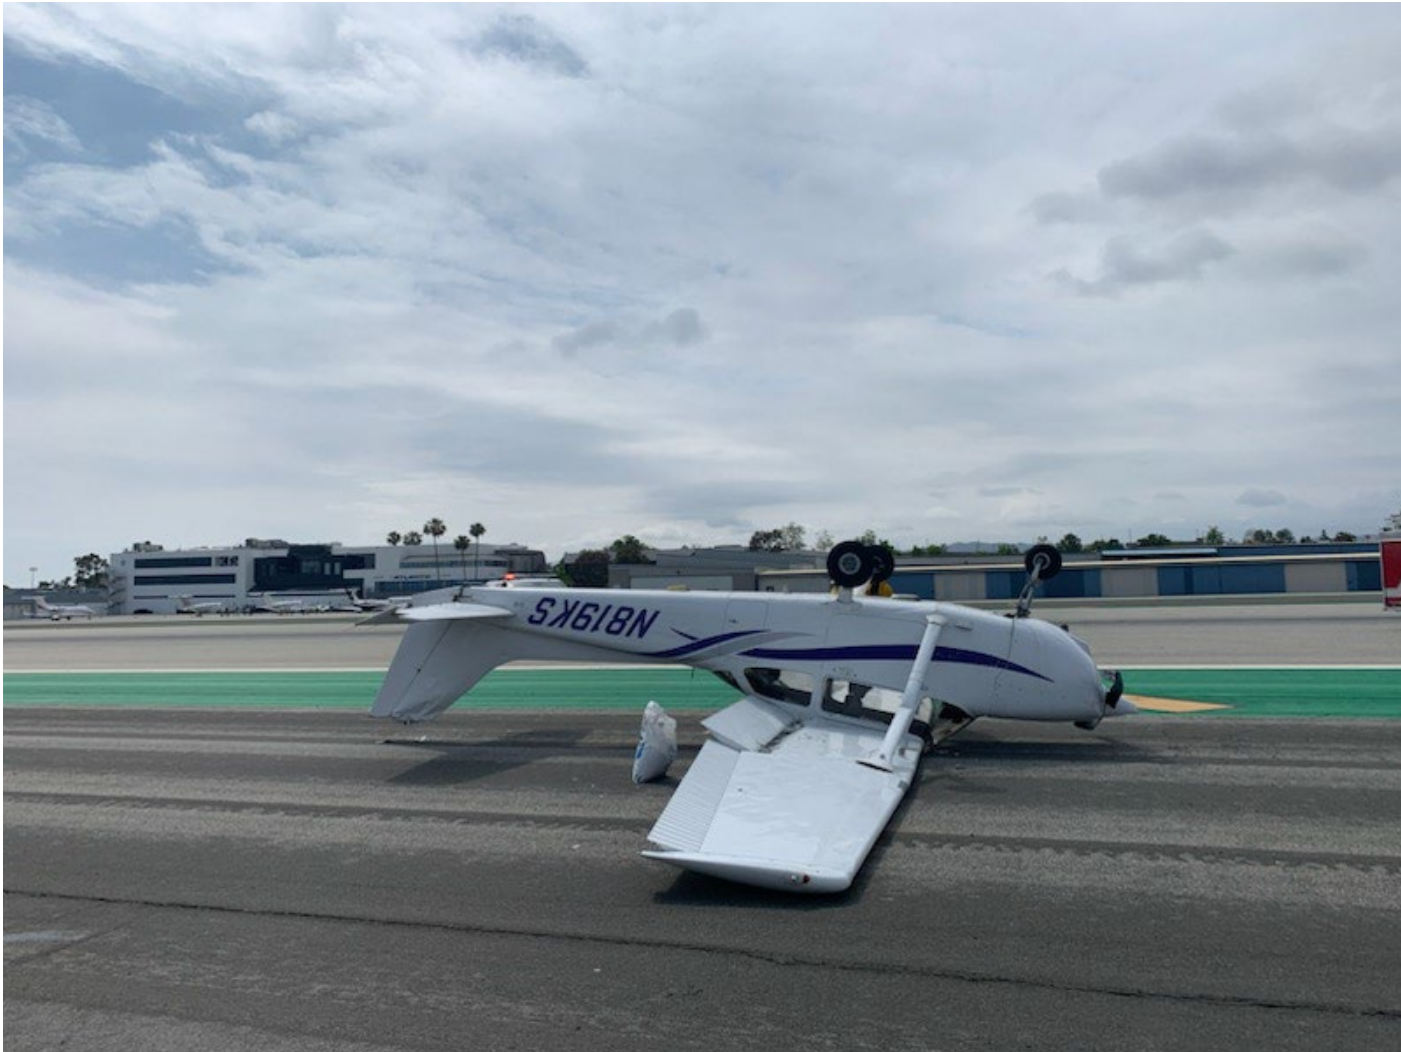
**Photo 1 – Airplane at accident site (courtesy of FAA)**

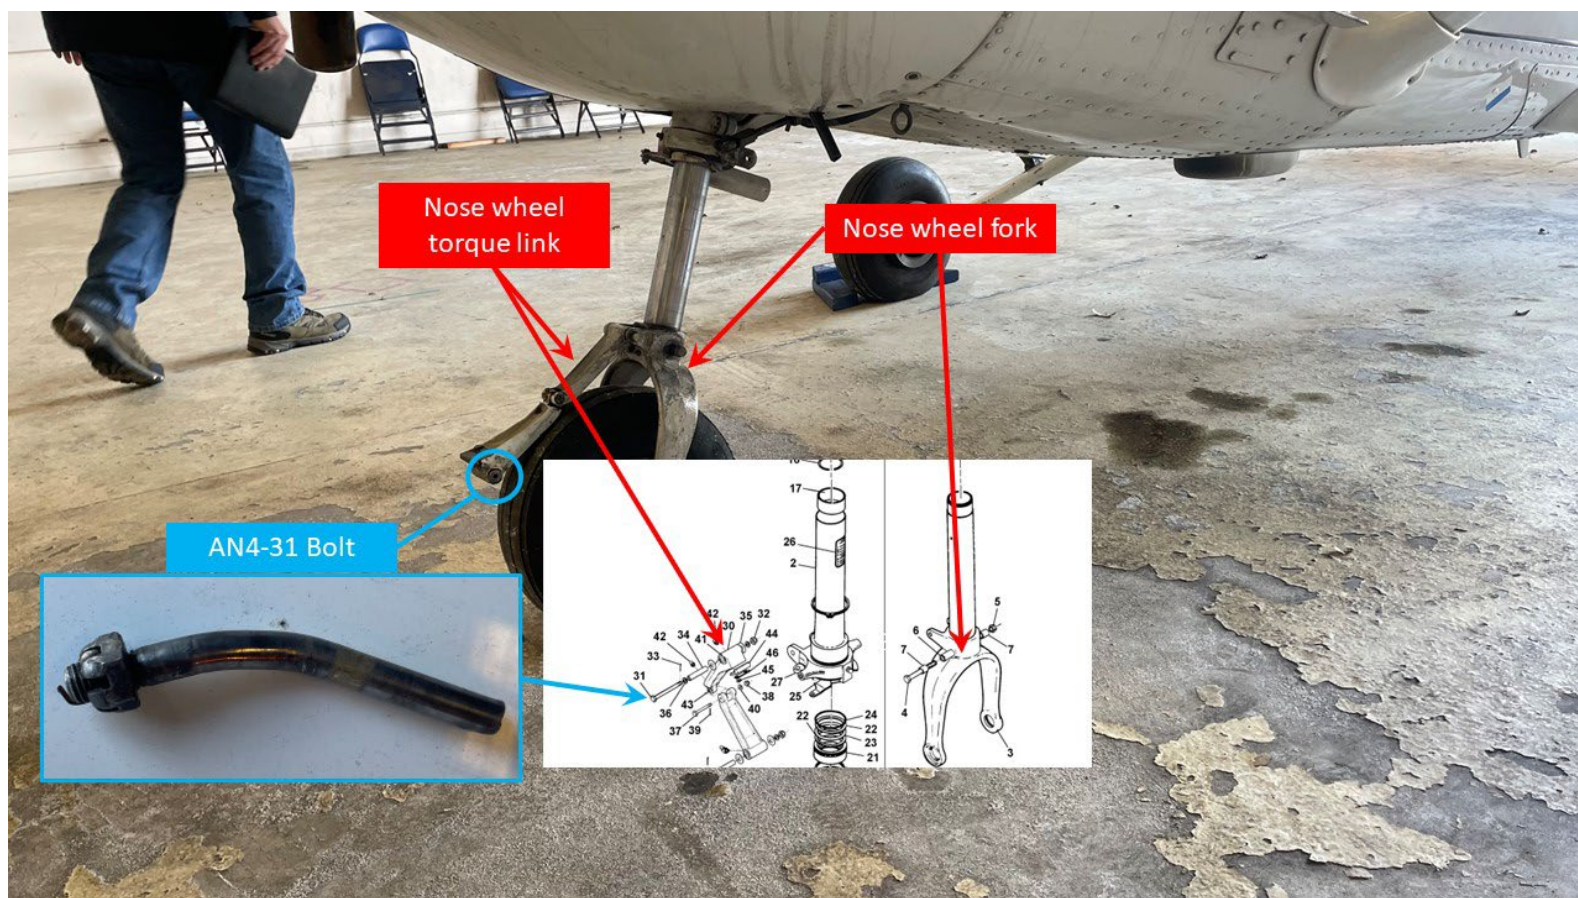
**Photo 2 – Figure of fractured bolt and nose landing gear torque link (photo courtesy of FAA)**

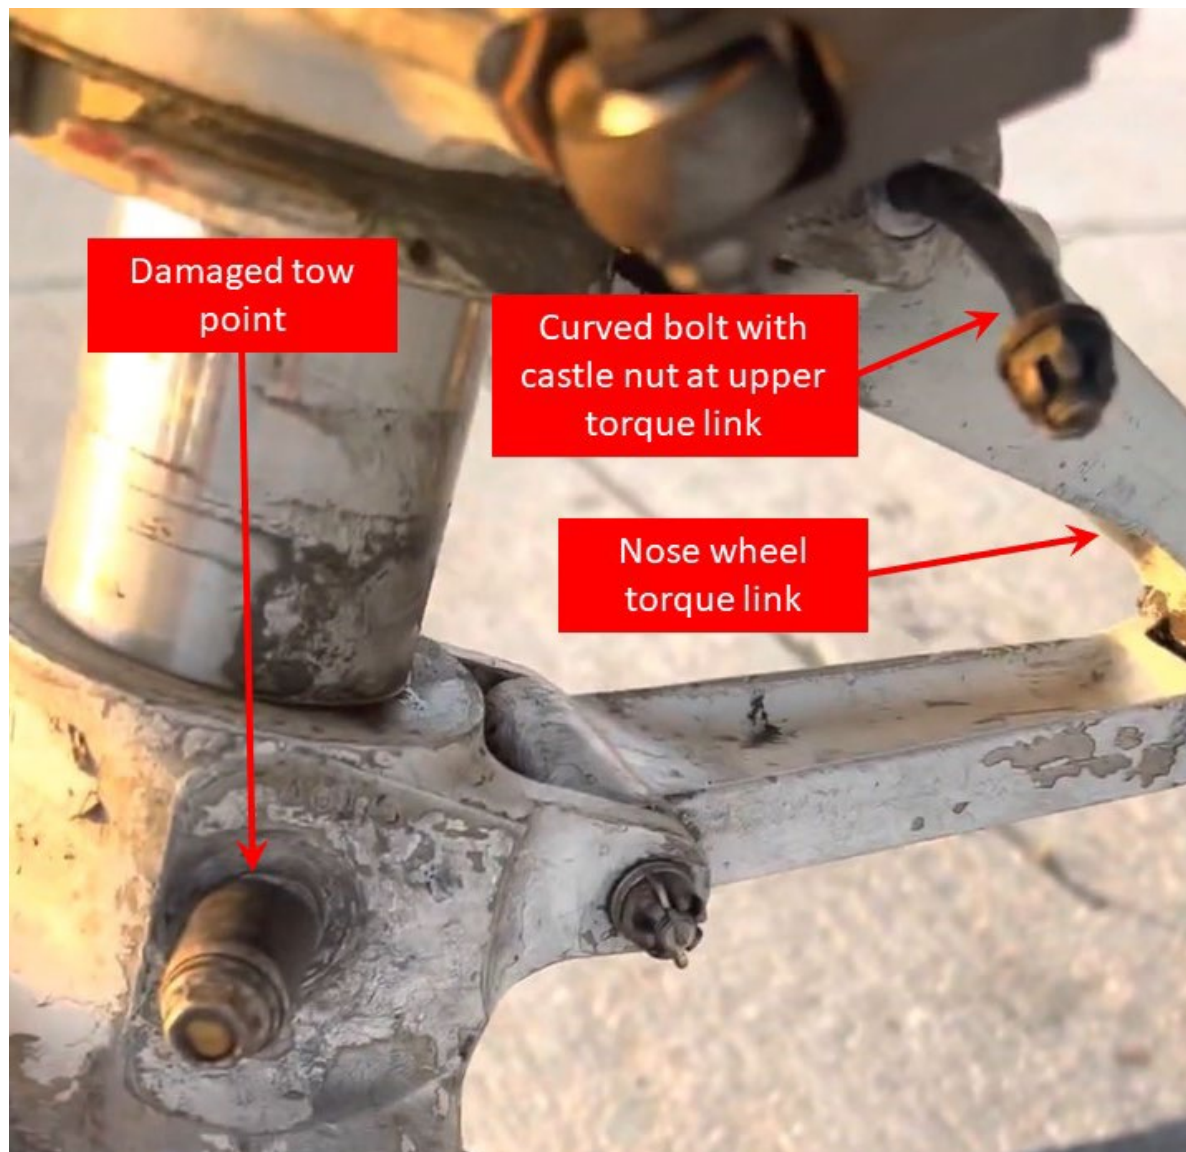
**Photo 3 – Nose landing gear strut and torque link after pickup truck collision (still from video courtesy of airplane owner)**

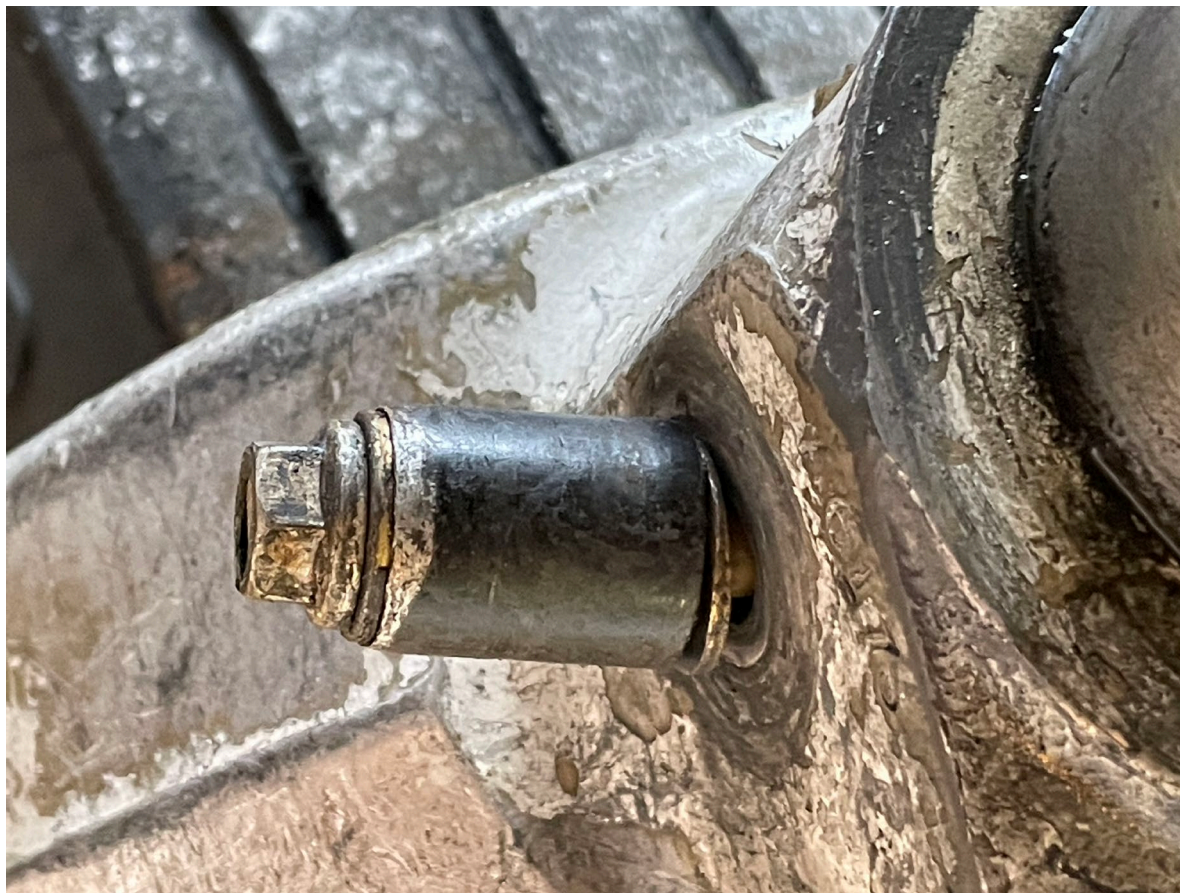
**Photo 4 – Bent tow point after accident (courtesy of FAA)**
