# National Transportation Safety Board

WPR23LA218

## **AIRFRAME & ENGINE EXAM**

Location: Chillicothe, Missouri  
Date: June 6, 2023  
Time: 1454 central daylight time  
Airplane: Cessna A188B, N731UF

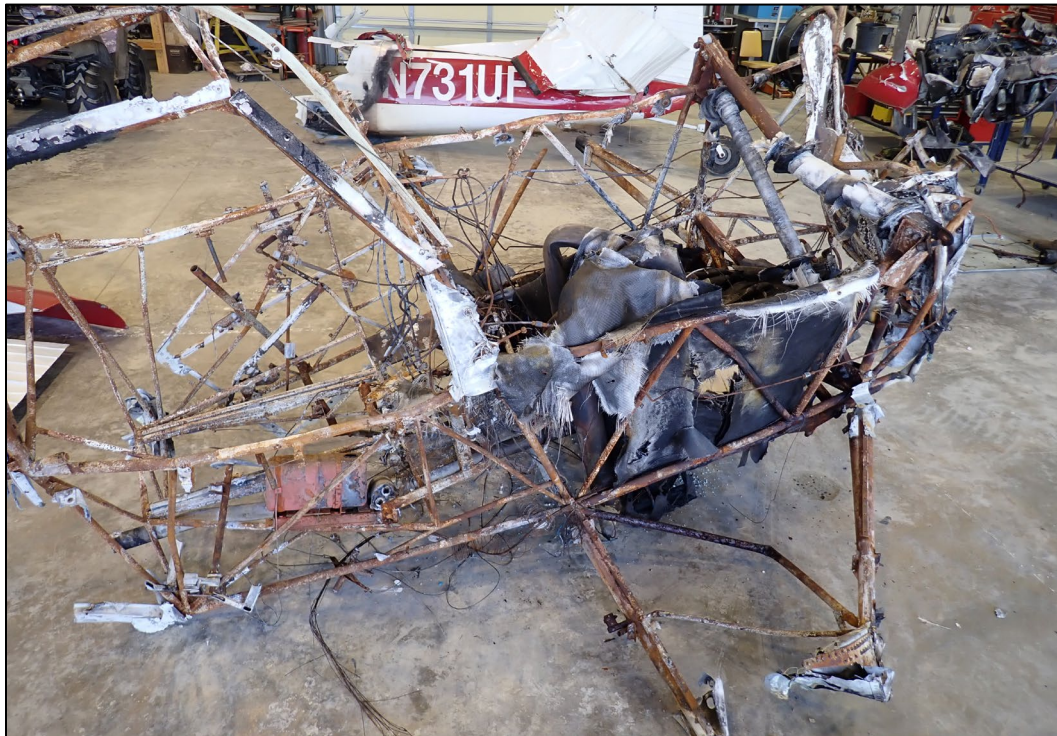
Examination of the recovered wreckage revealed that the cockpit, fuselage structure was mostly destroyed by thermal and impact damage. The engine, engine mount, firewall, main landing gear, instrument panel, flight controls, and seats were separated, exhibited thermal and impact damaged throughout.

**Figure 1: View of fire damage to cockpit (photo courtesy of Textron Aviation)**

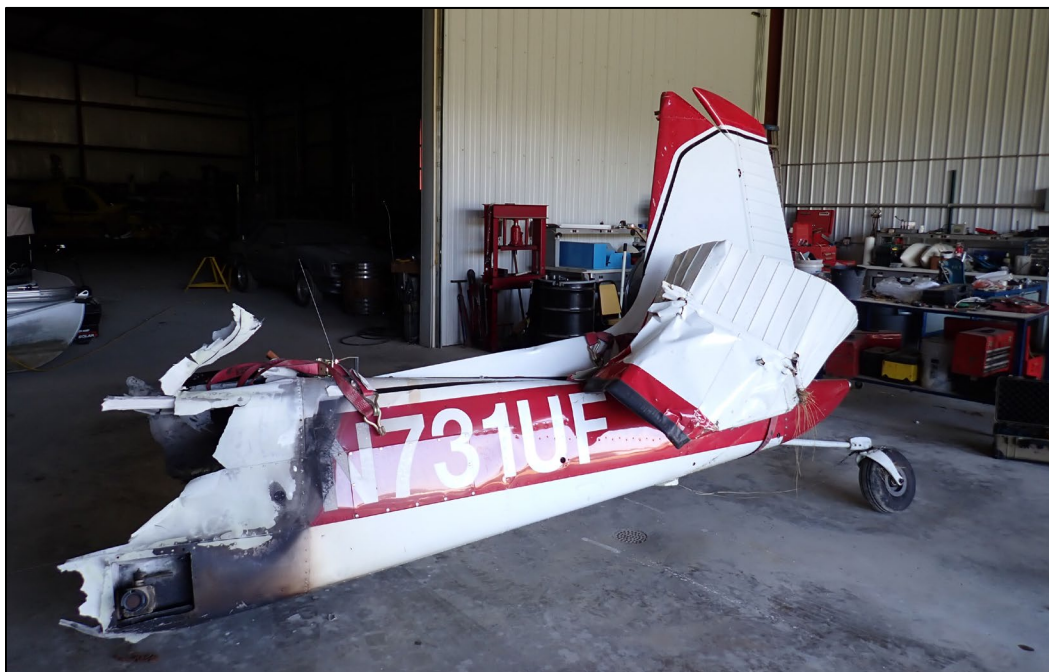
The empennage separated from the fuselage and was thermal damaged near the aft fuselage. The vertical stabilizer, horizontal stabilizer, rudder and elevator remained attached. No damage was observed to the right horizontal stabilizer, rudder and vertical stabilizer. Damage was observed to the trailing edge of the right elevator. The left horizontal stabilizer and elevator bent inward, crushing and bending was observed throughout. The rudder flight control cables and elevator flight control cables remained attached to their respective mounts.

**Figure 2: View of empennage damage (photo courtesy of Textron Aviation)**

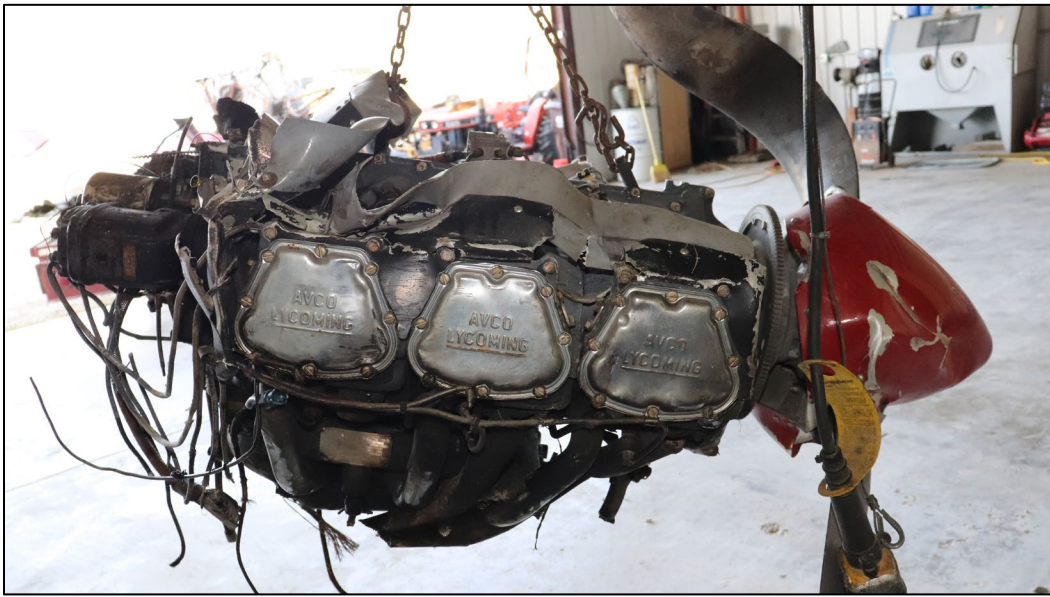
Examination of the recovered engine revealed that the engine separated from the engine mounts, impact and thermal damage was observed throughout. All six cylinders remained attached to the engine. Damage was observed to the oil sump and intake plenum. The fuel servo was separated from the intake flange. Damage was observed to the rocker box cover area of the number 4 cylinder. The propeller and propeller hub remained attached to the engine crankshaft. The exhaust remained attached, bending and crushing was observed throughout. The oil dip stick was not observed with the recovered wreckage.

**Figure 3: View of engine during examination**

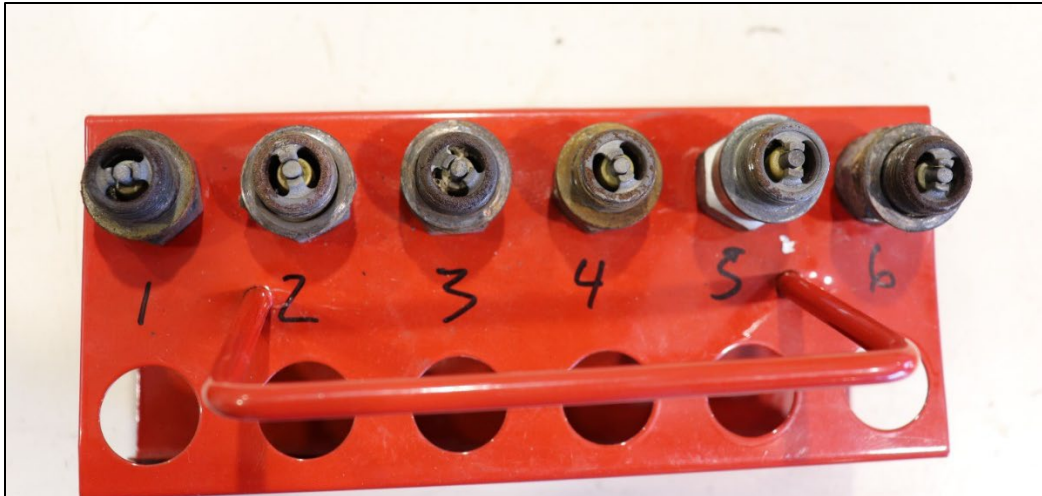
The upper spark plugs were removed from the engine, and they were the massive electrode type. All sparkplugs exhibited gray deposits within the electrode area. Very little gap was observed on the number 5 & 6 upper sparkplugs. All of spark plugs exhibited signatures consistent with worn-normal when compared to the Champion Check-A-Plug comparison chart.

**Figure 4: View of engine spark plugs during examination**

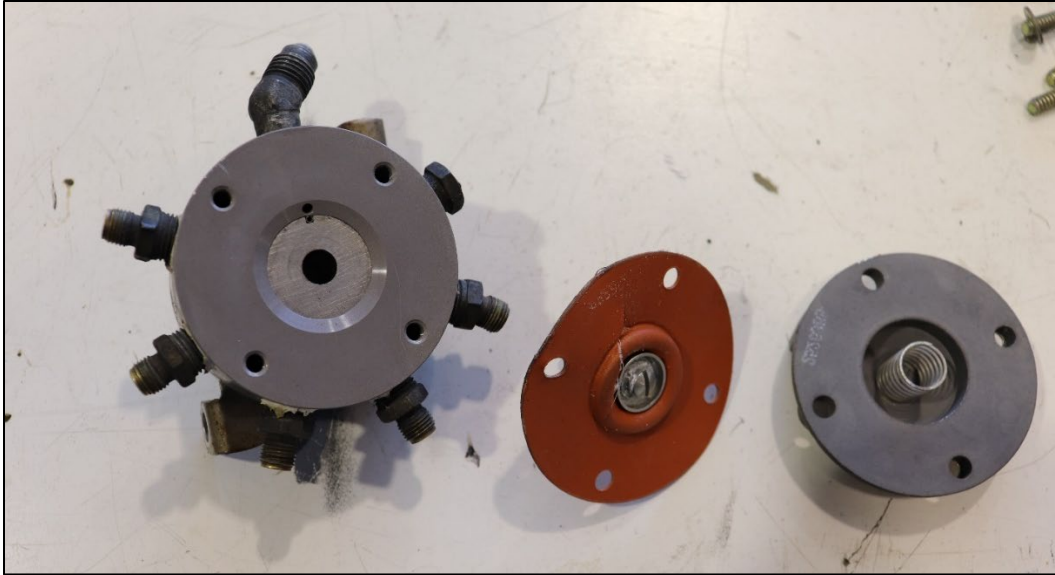
The fuel flow manifold remained attached to its respective mount and was undamaged. The number 6-cylinder fuel line and nozzle pressure gage fitting were fracture separated. The fuel manifold assembly was removed and subsequently disassembled. The internal diaphragm exhibited an approximate 1.1 inch long tear and the spring was undamaged. The fuel manifold was clear and free of debris.

**Figure 5: View of fuel manifold disassembled**

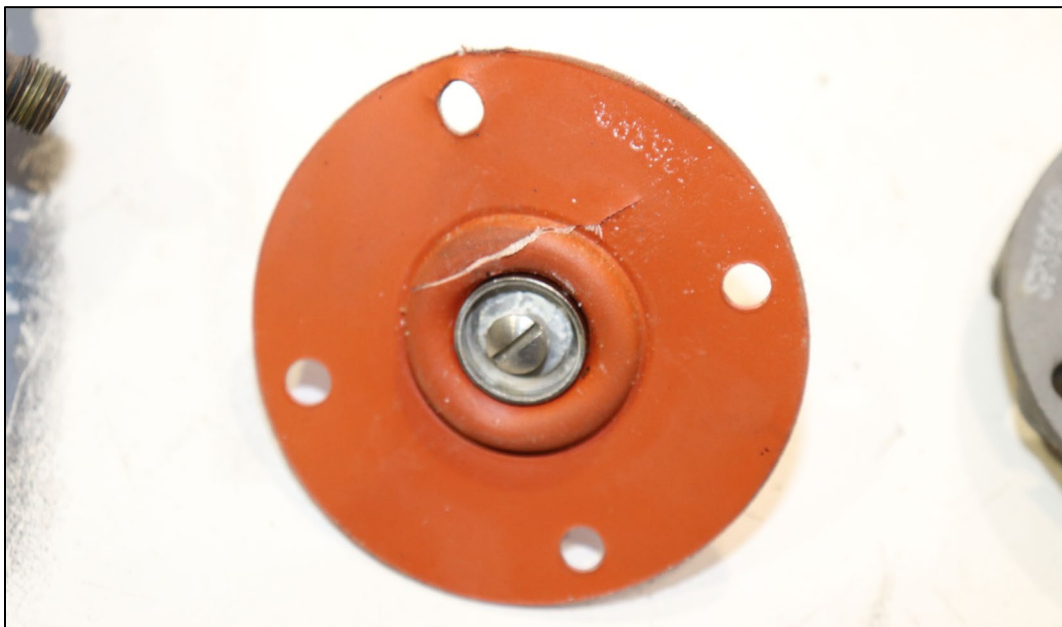
**Figure 6: View of fuel manifold diaphragm**

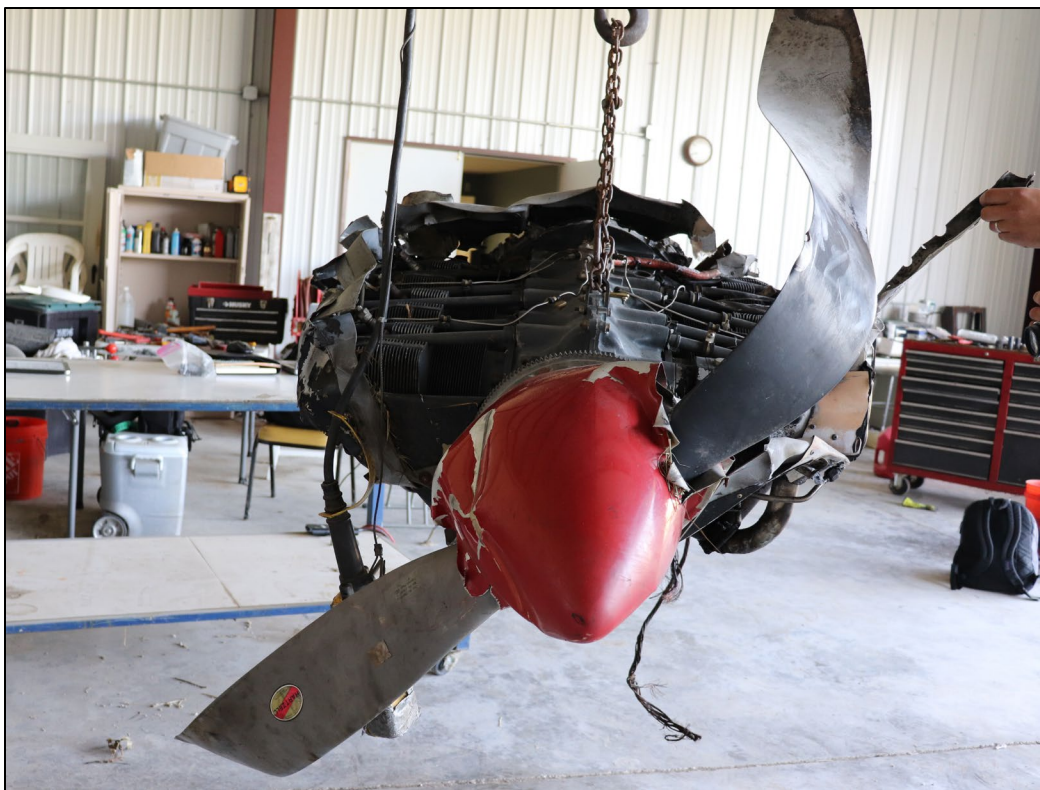
The airplane was equipped with a two blade Hartzell propeller; for the purposes of this report the propeller blades were labeled A & B. Propeller blade A exhibited S bending about mid span, with polishing along the leading edge, along with unidirectional striations on the cambered side of the blade. Blade B exhibited bending aft about mid span, with unidirectional striations on the cambered side of the blade. Additionally, about a 4-inch section of the propeller blade tip was fracture separated.

**Figure 7: View of airplane propeller during examination**
