# National Transportation Safety Board

WPR23LA220

## **FOLLOW UP EXAMINATION SUMMARY**

Location: Nephi, Utah  
Date: 6/8/2023  
Time: 12:19 Mountain daylight time  
Airplane: N7318Y

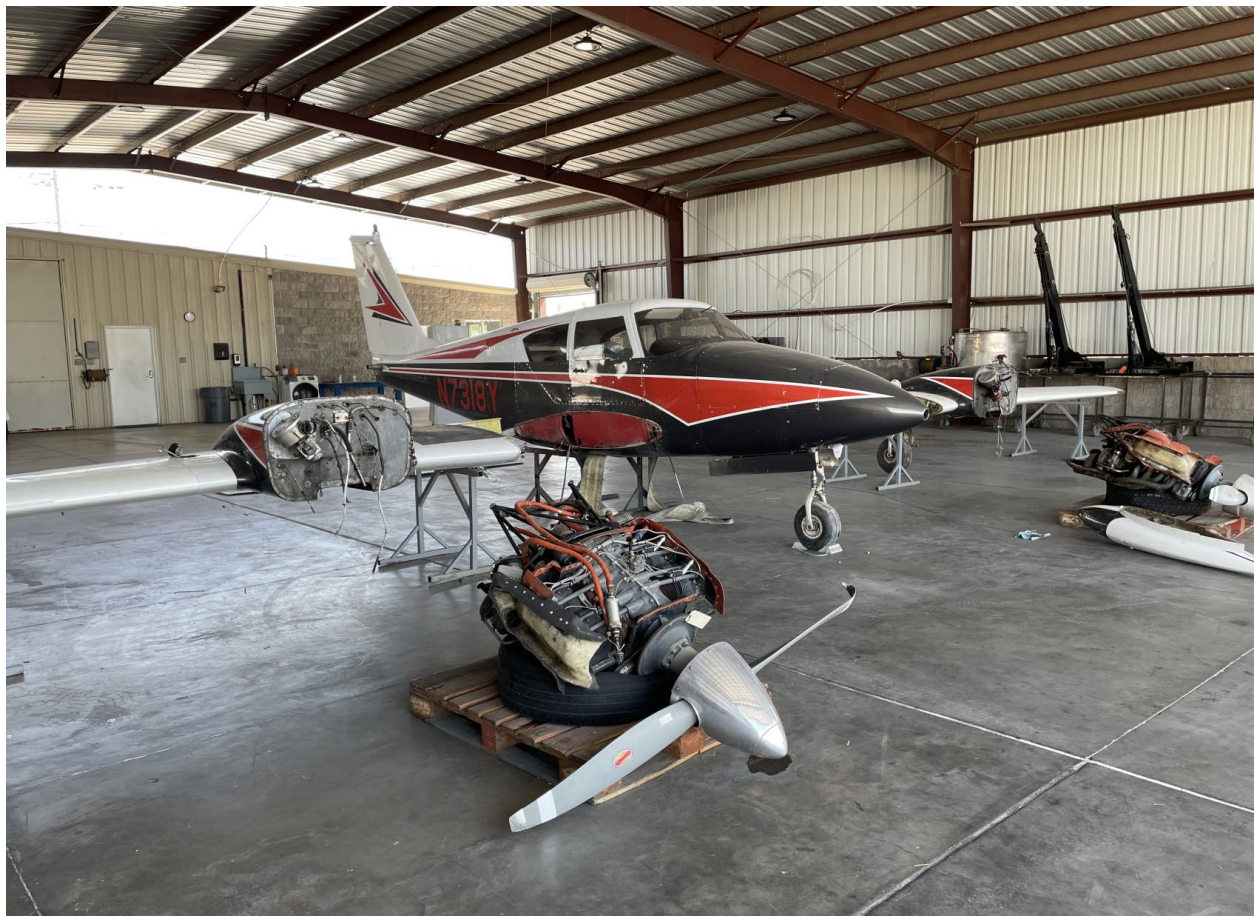
The aircraft had been disassembled, including the removal of both wings at the wing roots, and removal of both sides of the stabilator. During examination, the fuselage was propped up on stands. The fuselage sustained minor damage from the accident sequence (figure 1).

**Figure 1. View of accident airplane at wreckage layout**

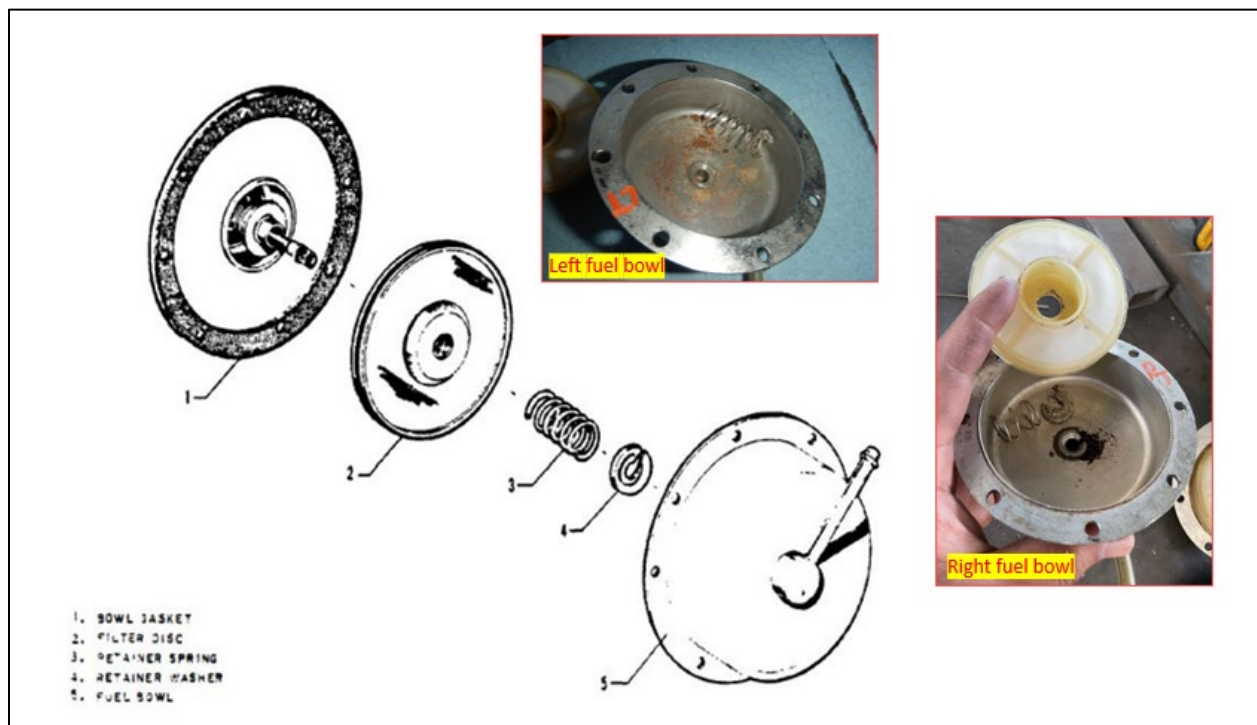
The left fuel selector handle was found positioned to the left main fuel tank position. When sumped, no fuel was released from the bowl. The bowl was removed and debris consistent with rust and dirt was found at the bottom of the bowl and in the plastic filter. The left fuel selector valve assembly was removed and tested with low air pressure; no defects in operation were noted. Rust and debris were found in the left main fuel tank port.

The right fuel selector handle was found positioned to the right main fuel tank position. When sumped, about 3 ounces of rusty fuel was released from the bowl. The bowl was removed and debris consistent with rust and dirt was found at the bottom of the bowl and in the plastic filter. When the selector valve handle and arm were turned, binding was felt, and the valve could not be moved to the crossfeed or off positions.

Fuel strained from the right strainer was tested with Sar-gel and revealed no water contamination. Removal of both the left and right fuel strainer bowls and filter discs revealed that the filter bowl and filter disc had contaminants consistent with rust/corrosion.

**Figure 3. Diagram of fuel filter bowl assembly with 2 embedded photos of the left and right fuel bowl disassembled**

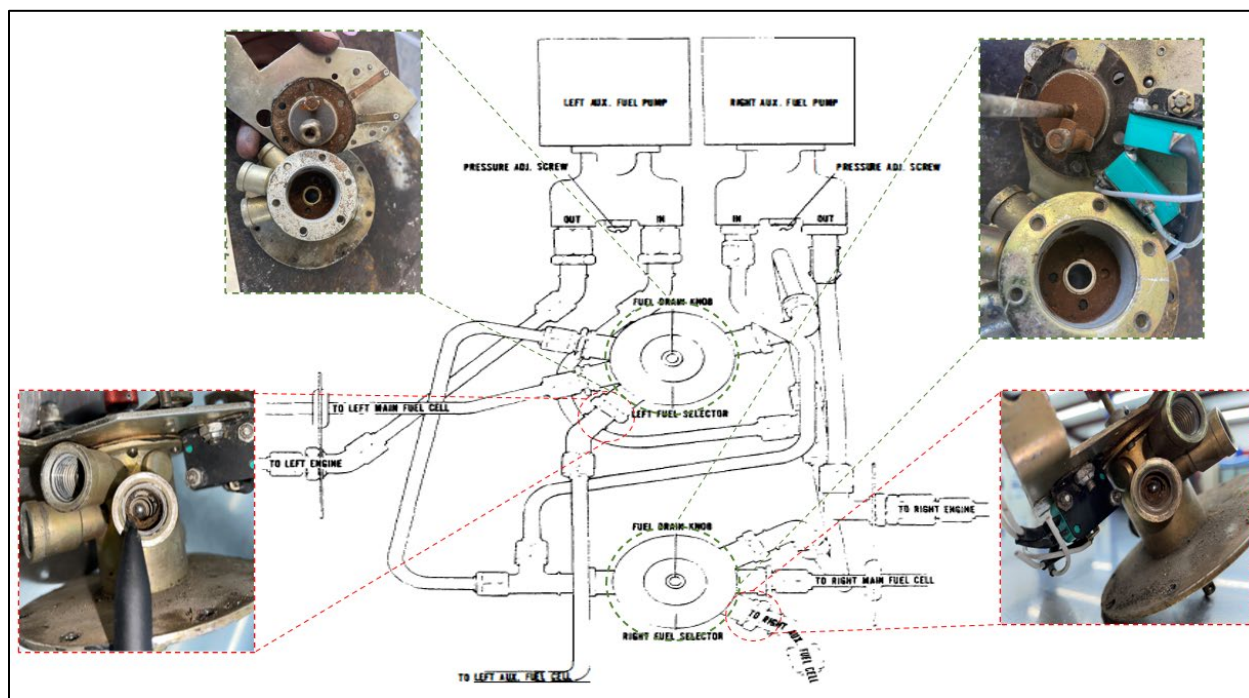
The left and right fuel strainer knob assembly was removed, and corrosion was found in the cavity walls and cover plate. The left and right fuel selector valves were removed from the airframe and corrosion was found in the threads of the left and right fuel line auxiliary outlet unions (see figure 4).

**Figure 4. View of fuel selector valve diagram with embedded photos of removed left and right valves**
