# National Transportation Safety Board

WPR23LA226

## **MATERIALS LABORATORY**

Factual Report 23-096

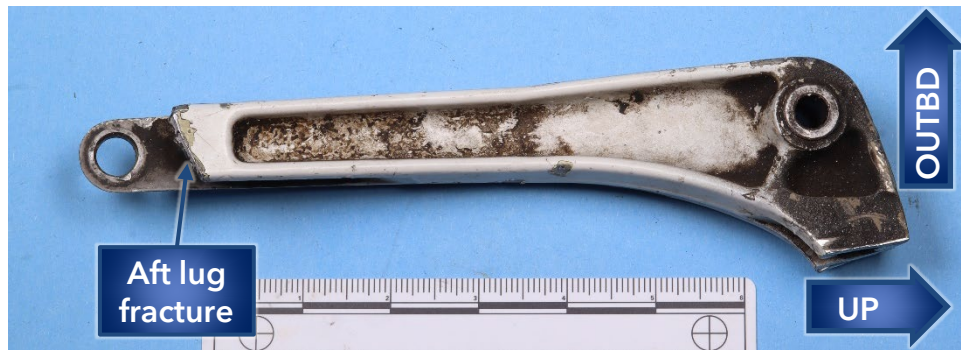
The submitted bellcrank from the right main landing gear side brace lock assembly is shown in figure 1. The forward lug of the clevis at the lower end of the bellcrank was fractured, and the other lug remained intact. The mating side of the fractured lug was missing and not recovered. Additionally, the flanged bearings and the pin for attaching the side brace lock link to the lower end of the bellcrank were missing and not recovered.

**Figure 1.** Overall view of the forward side of the submitted side brace lock bellcrank as received.

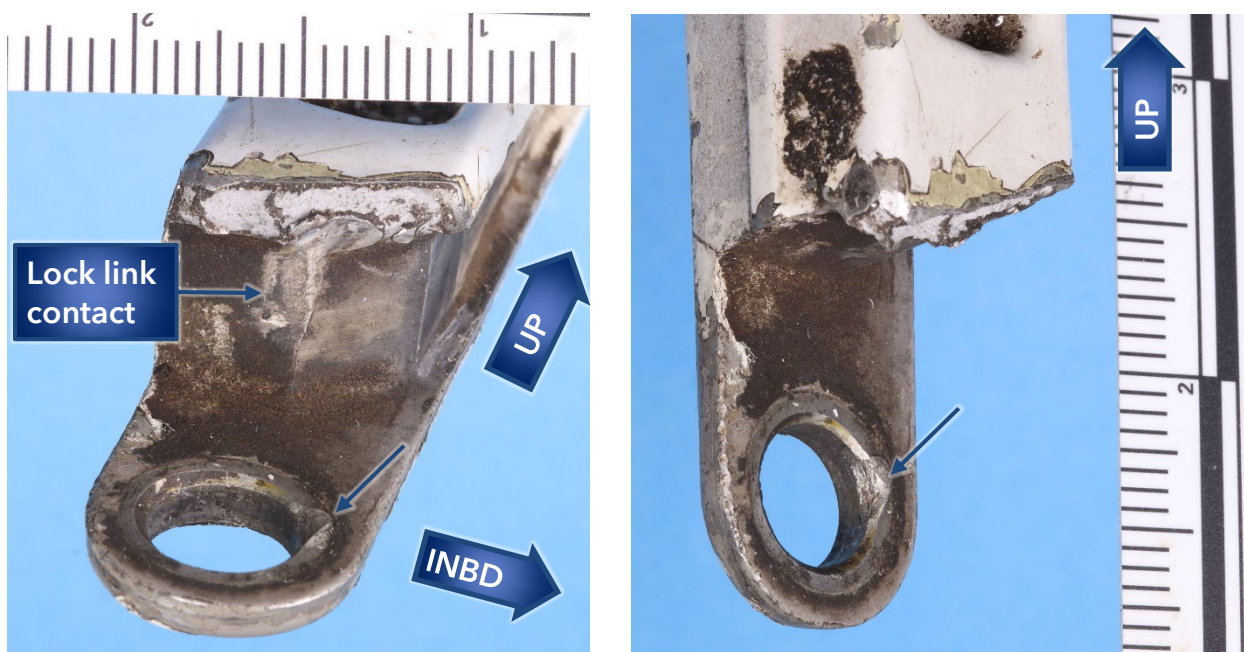
Closer views of the lower end of the bellcrank are shown in figure 2. The fracture surface had a rough matte gray appearance consistent with ductile overstress fracture. A portion of the fracture surface was obliterated by smearing damage on the aft side of the fracture consistent with sliding contact with the side brace lock link where the contacting face of the link slid forward and inboard relative to the bellcrank. On the intact lug, the inboard forward corner of the hole was deformed as indicated with arrows in figure 2. Contact marks associated with the deformation were limited to the forward half of the hole bore.

**Figure 2.** Views of the lower clevis lug fracture surface (left image) and heavy contact on the inside edge of the hole in the intact lower clevis lug (arrow in the right image).

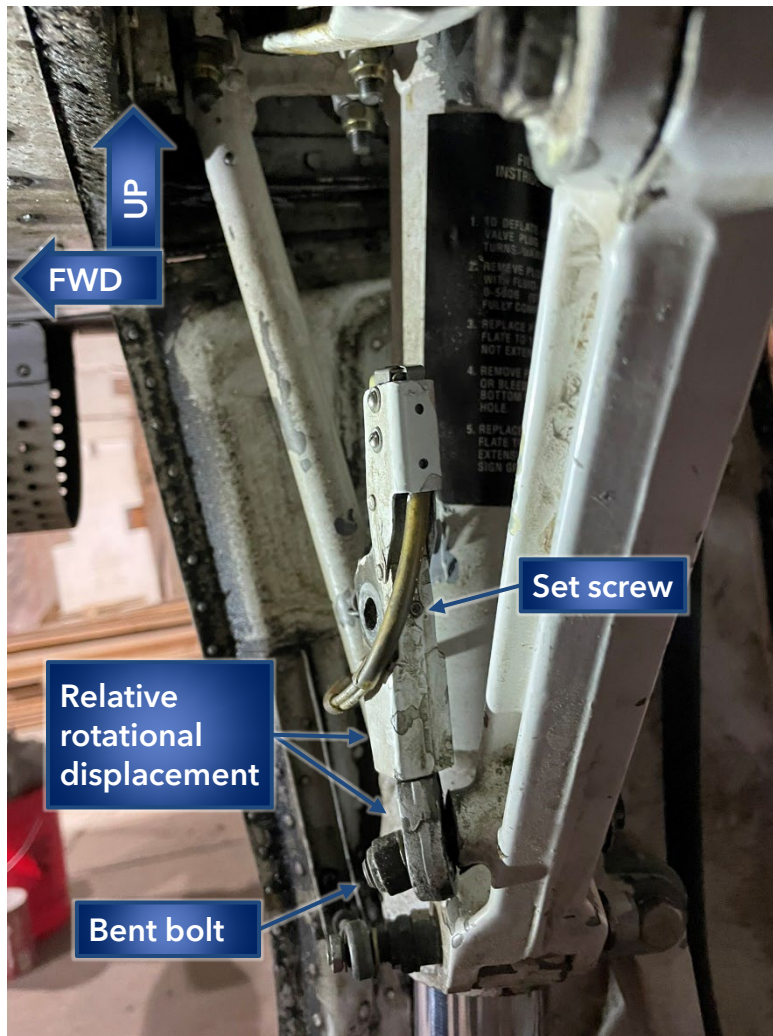
A view of the right main landing gear side brace lock link as photographed by a Federal Aviation Administration (FAA) investigator after the accident and before disassembly is shown in figure 3. As noted in figure 3, the attachment bolt at the lower end of the assembly was bent downward. Additionally, the view in figure 3 shows relative rotational displacement in the alignment between the lock link and the attached end fitting, where the lock link was rotated counterclockwise (as viewed from above) relative to the lock link.

**Figure 3.** Inboard side of the left main landing gear side brace lock link. (Photograph provided by the FAA.)

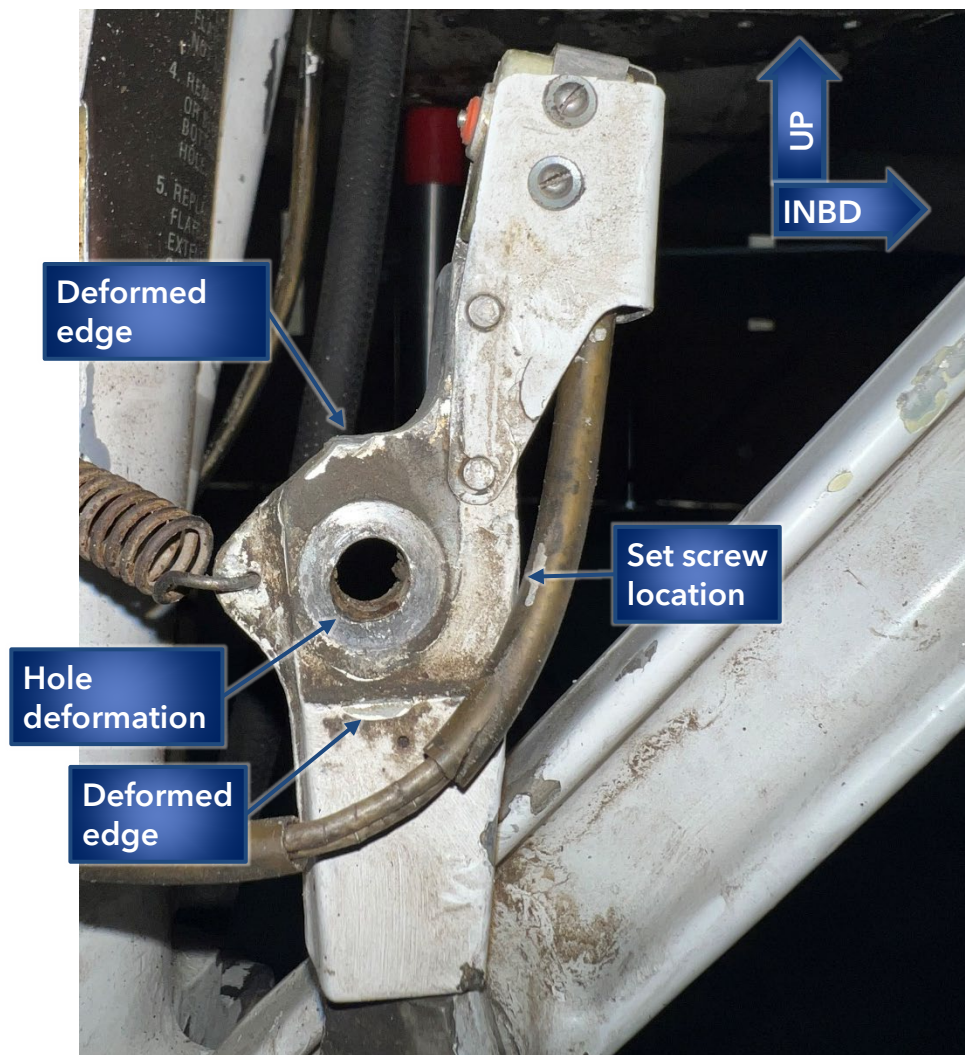
A close view of the forward side of the lock link as photographed by the pilot is shown in figure 4. A brownish black object was located at the inboard side of the

hole at a location consistent with the set screw for retaining the pin that attached the bellcrank to the lock link. The set screw, visible in figure 3, is adjusted from the inboard side of the lock link as indicated in figure 4. The attachment pin hole through the lock link was deformed on the outboard lower quadrant as indicated in figure 4. Additionally, the area below the attachment pin hole was deformed with a curved shape consistent with contact with the lower end of the missing bellcrank flange after being displaced downward relative to the lock link. The forward edge of the flat area above the attachment pin hole was also deformed on the lock link as indicated in figure 4. The damage location on the upper forward side of the lock link corresponded to the sliding contact area on the bellcrank as indicated in figure 2, areas that are not normally in contact in the intact assembly.

**Figure 4.** Forward side of the left main landing gear side brace lock link. (Photograph provided by the pilot.)
