# National Transportation Safety Board

WPR23LA232/192406

**AIRWORTHINESS**

Location: Rochester, Nevada  
Date: June 16, 2023  
Time: 2257 Pacific Daylight Time  
Airplane: Piper PA-28-140, N3508K

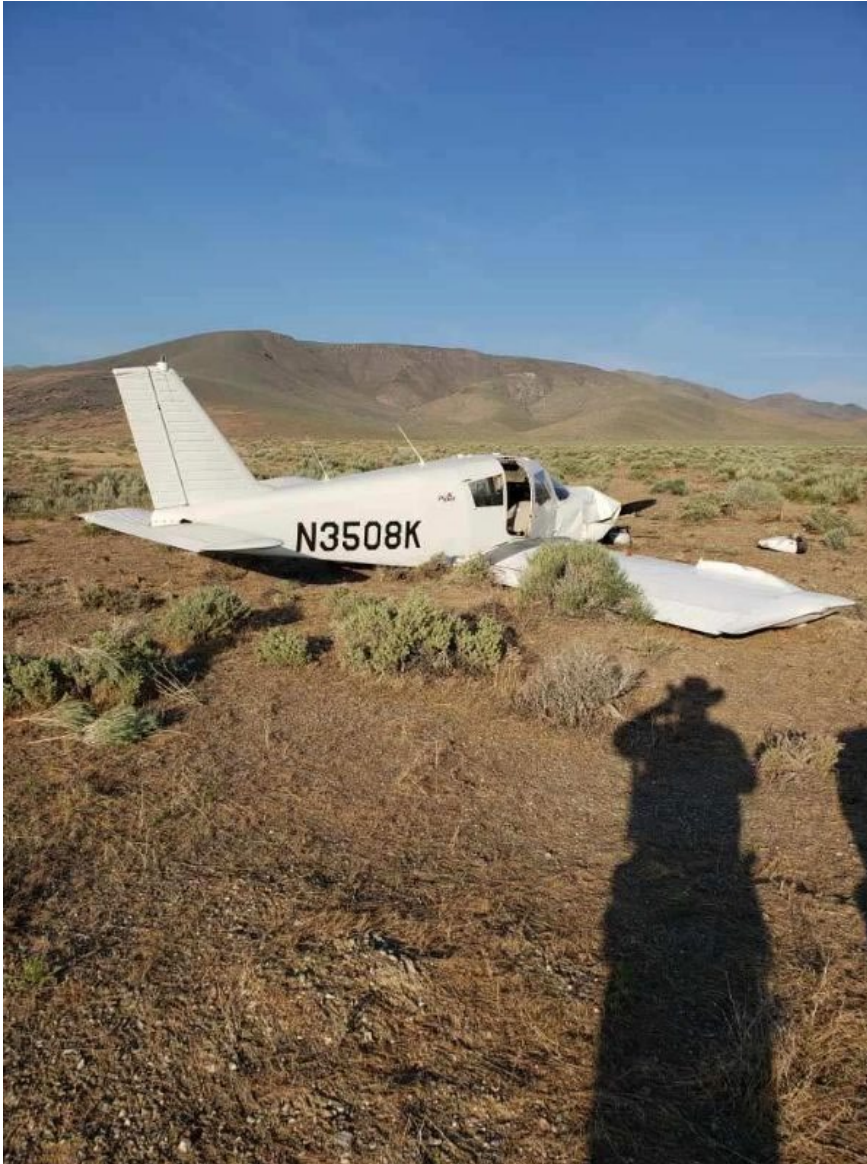
The pilot was able to land the airplane in relatively flat terrain. During the landing all three landing gear collapsed and both wings and the fuselage were substantially damaged (figure 1). The right wing fuel tank was breached. About 15 gallons of liquid consistent with 100LL AvGas was removed from the left wing fuel tank by recovery personnel following the accident.

Figure 1 - Airplane Accident Site

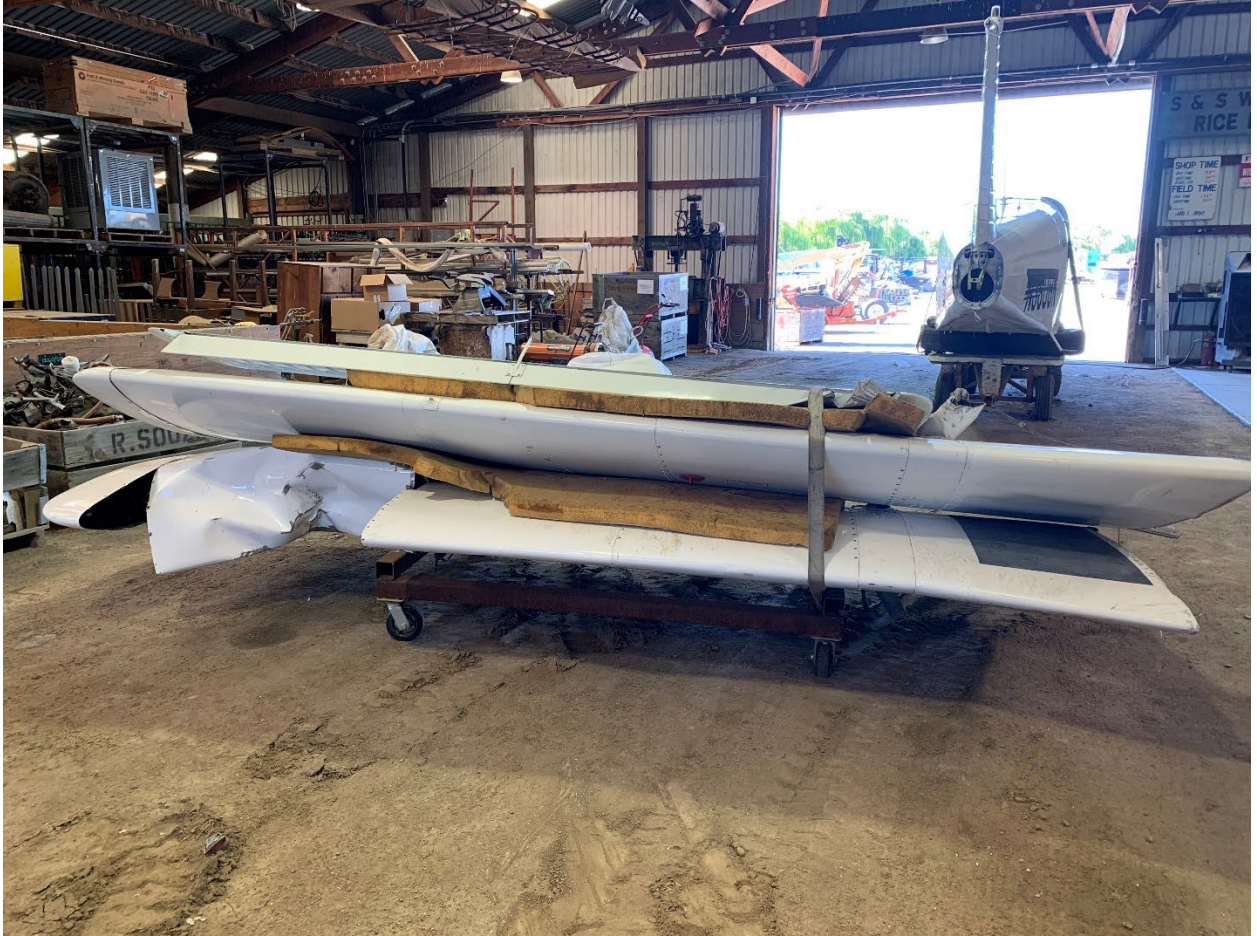
The wreckage was examined by the NTSB IIC July 12th, 2023, at a secure location near Sacramento CA. Both wings and horizontal stabilizers were separate from the fuselage. The engine remained attached to the airframe (figures 2 and 3).

Figure 2 - Wings and Horizontal Stabilizers

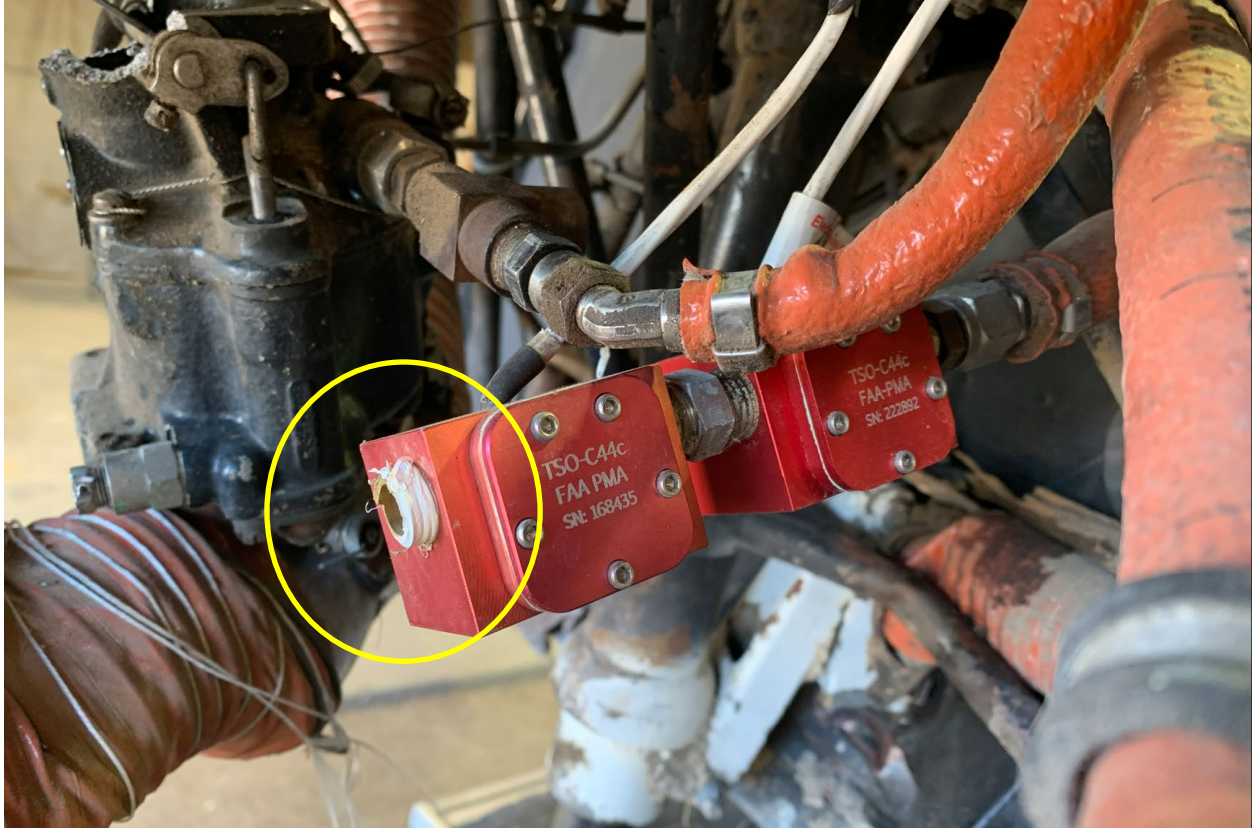
Both wings were removed and separated from the fuselage. The right wing fuel tank was impact damaged and compromised. The left wing fuel tank remained intact. The interior upholstery on the left side of the cockpit where the fuel selector valve was located had been removed during recovery and the fuel lines leading to the fuel selector valve had been disconnected. The fuel lines were intact from the fuel selector through both the electrical and mechanical fuel pumps. There were two Dynon Avionics fuel flow sensors installed in the fuel line immediately prior to the carburetor. Fuel line continuity was broken at the fuel line fitting between the second fuel flow sensor and the carburetor (figure 3).

Figure 3 - Broken Fuel Line at Fuel Flow Sensor

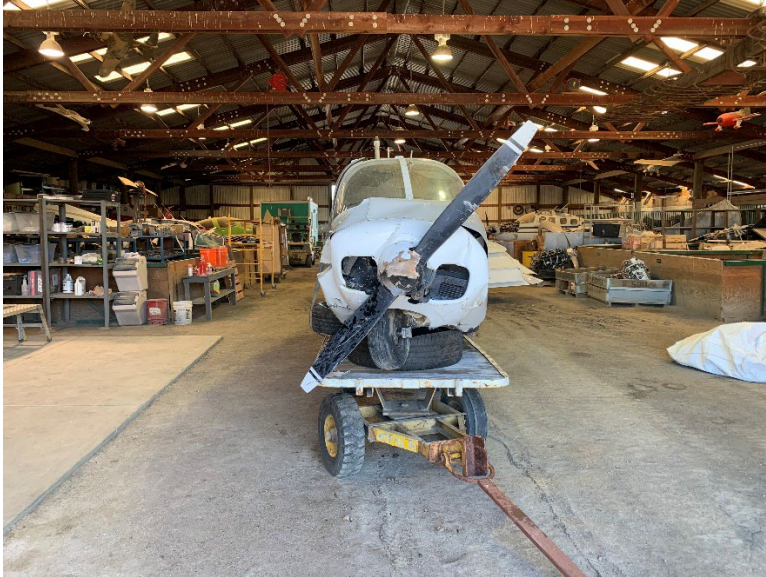
The propeller remained attached to the engine. Both propeller blades were generally straight. One blade exhibited length wise scratches along the length of the blade. The second blade exhibited some chordwise scratches.
