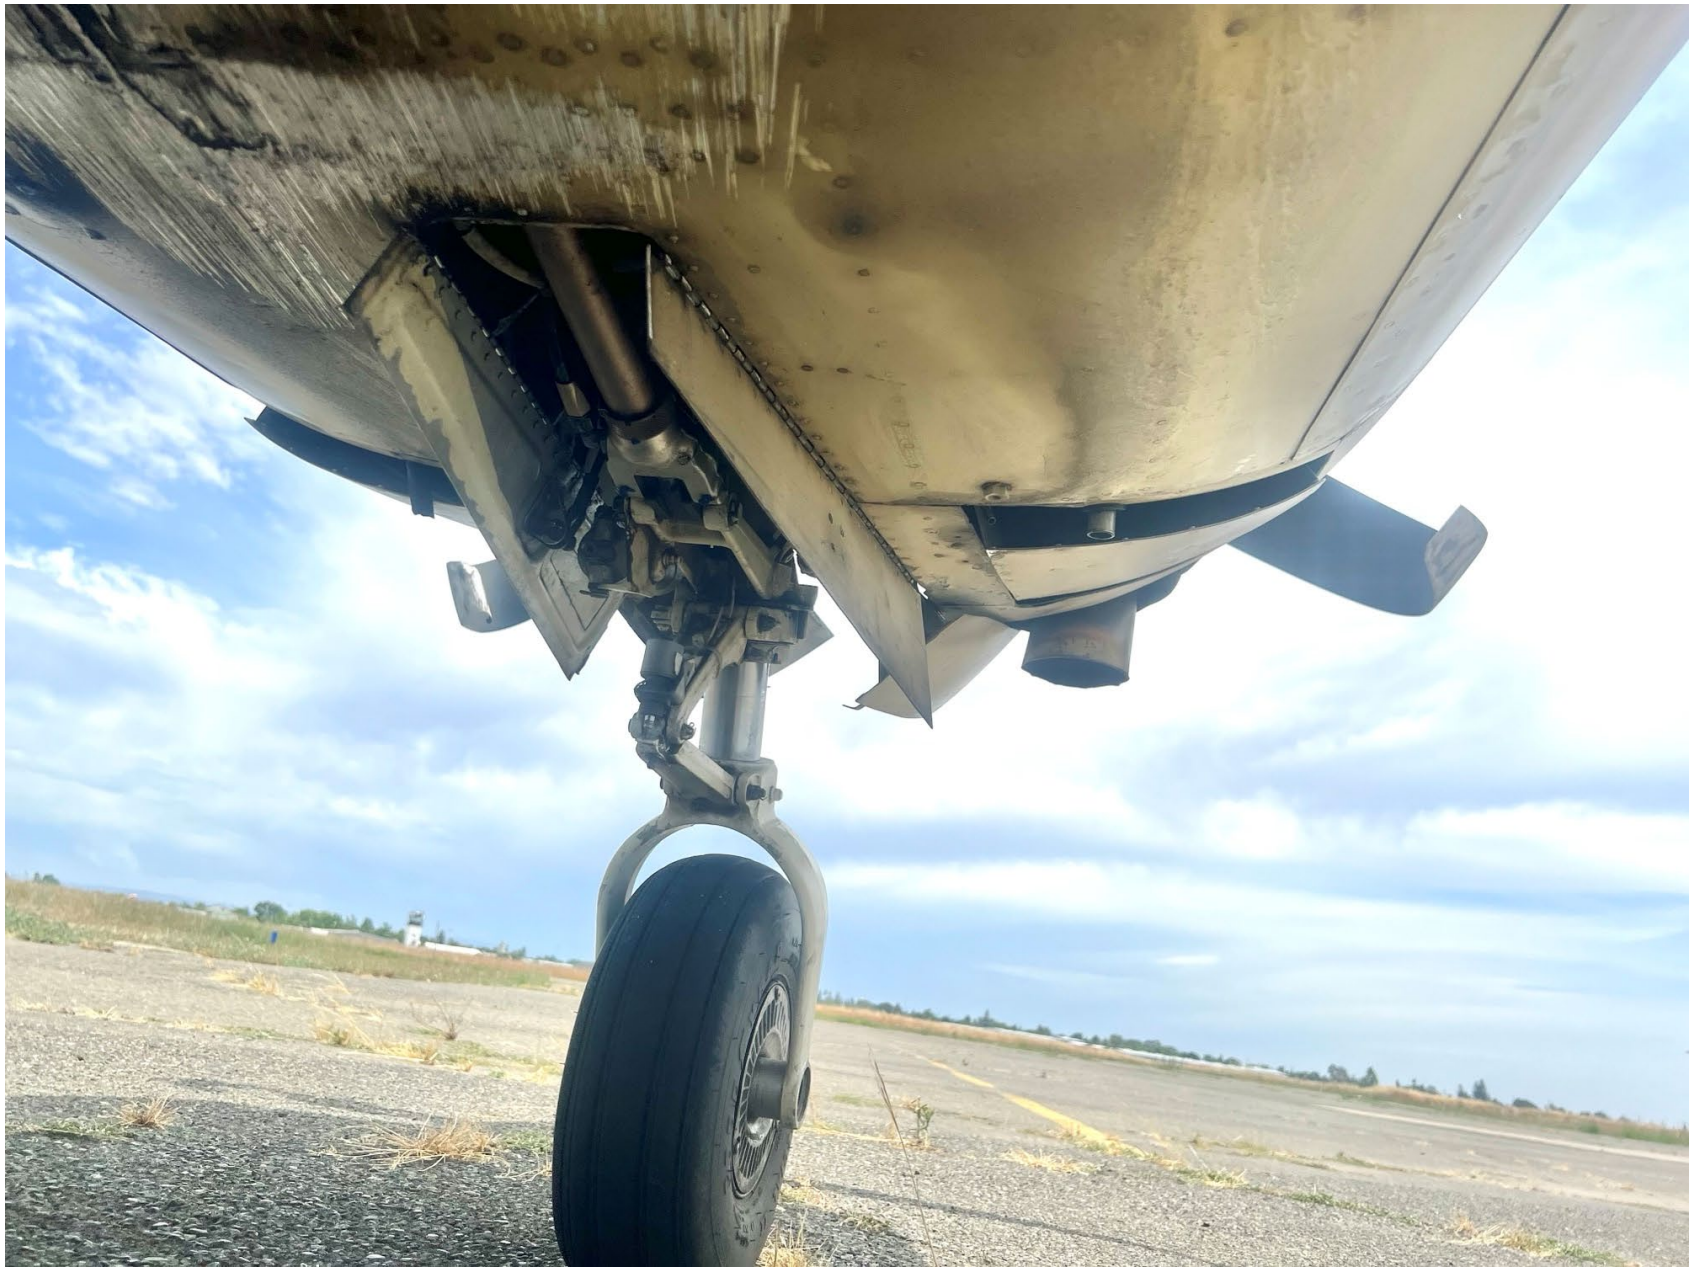
**Photo 1 –N4761A underside view. Photo courtesy of the pilot.**

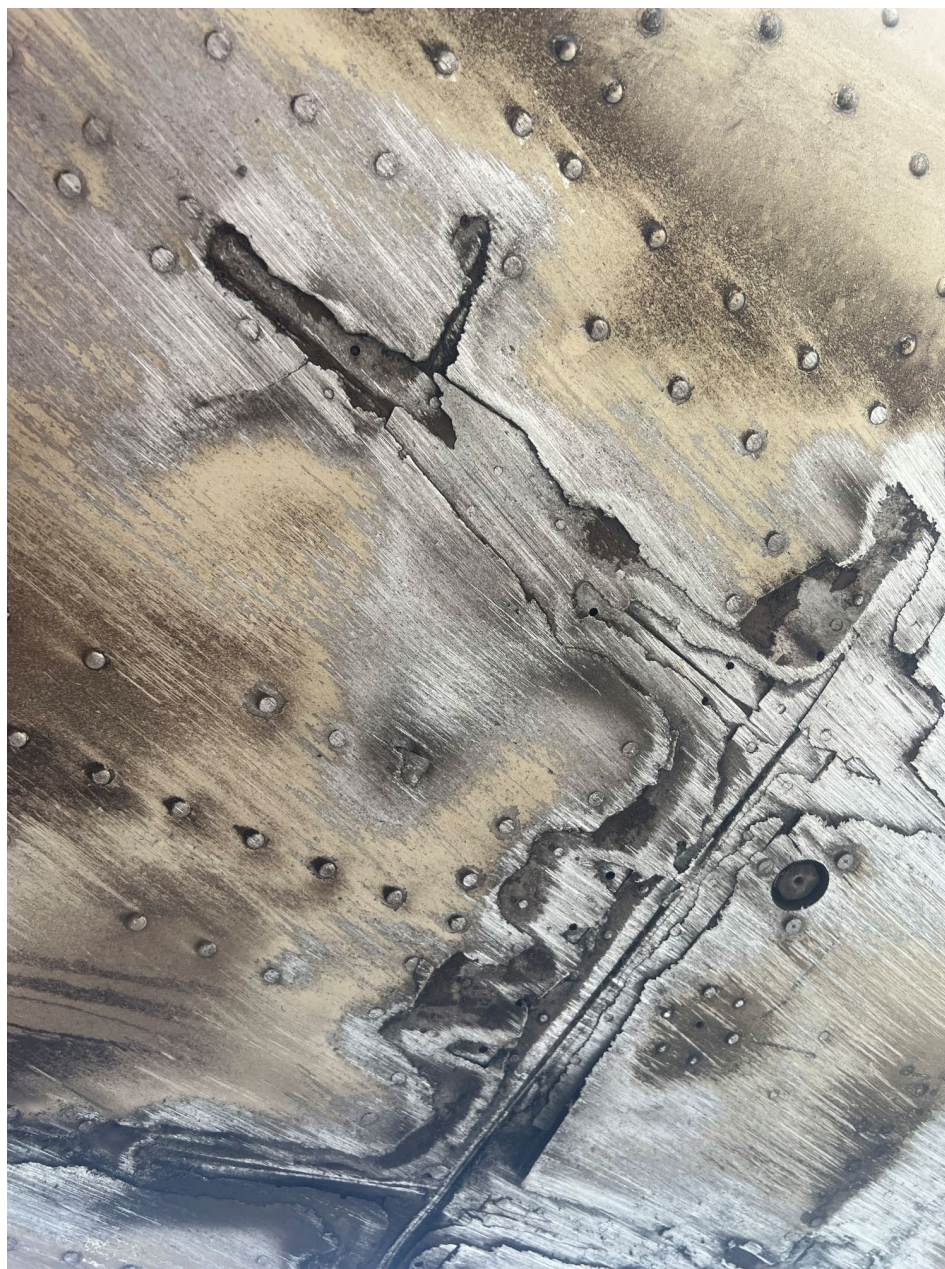
**Photo 2 – Underside view of damage to the left and right keel beams. Photo courtesy of the pilot.**
