# National Transportation Safety Board

WPR23LA241

## **AIRFRAME AND ENGINE EXAMINATION REPORT**

Location: Marana, Arizona  
Date: June 23, 2023  
Time: 03:55  
Airplane: Cessna 172K / N84385

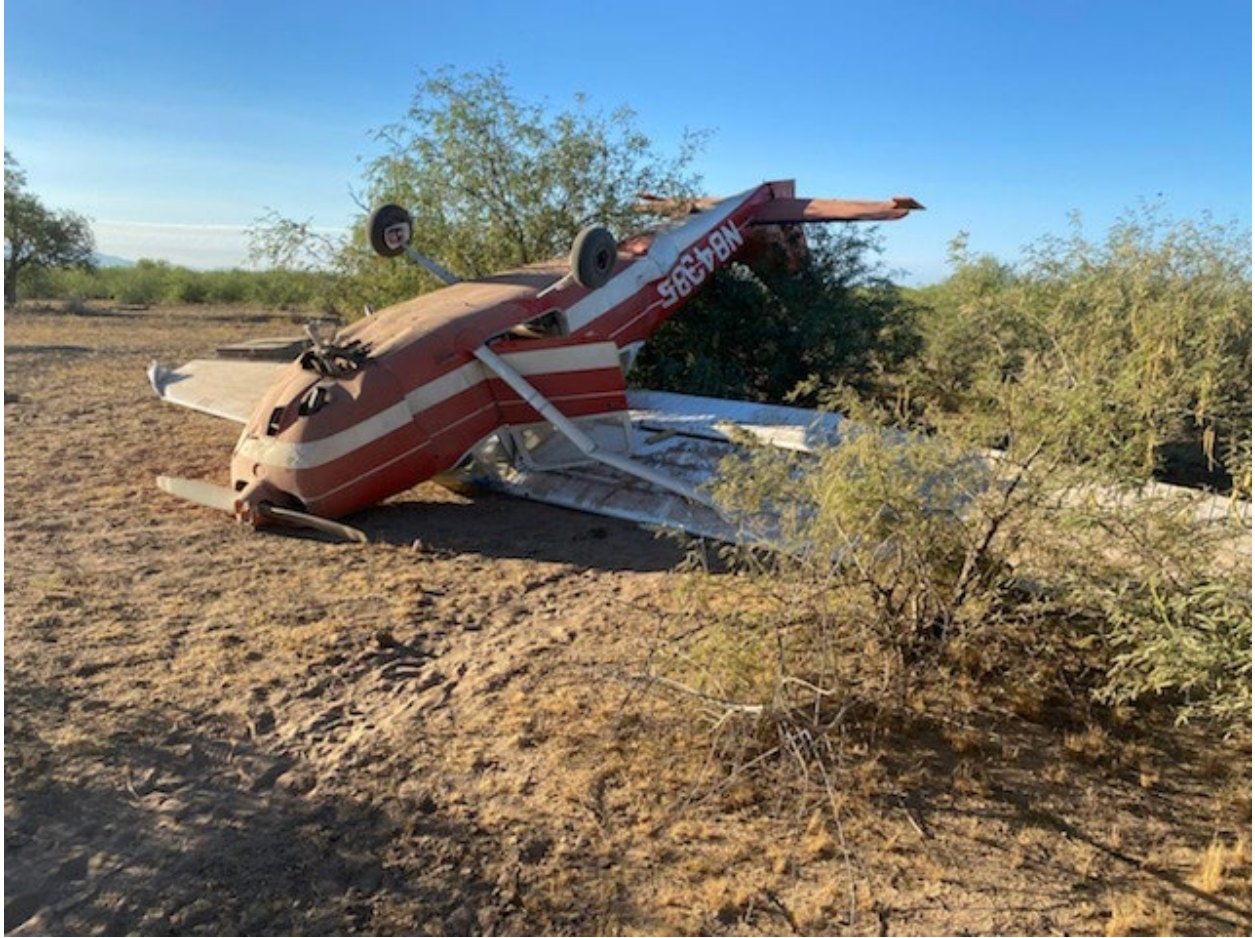
Review of photographs revealed substantial damage near the tail cone area. See figure 2 and 3.

**Figure 2. Photo of the accident airplane. Photo courtesy of the owner.**

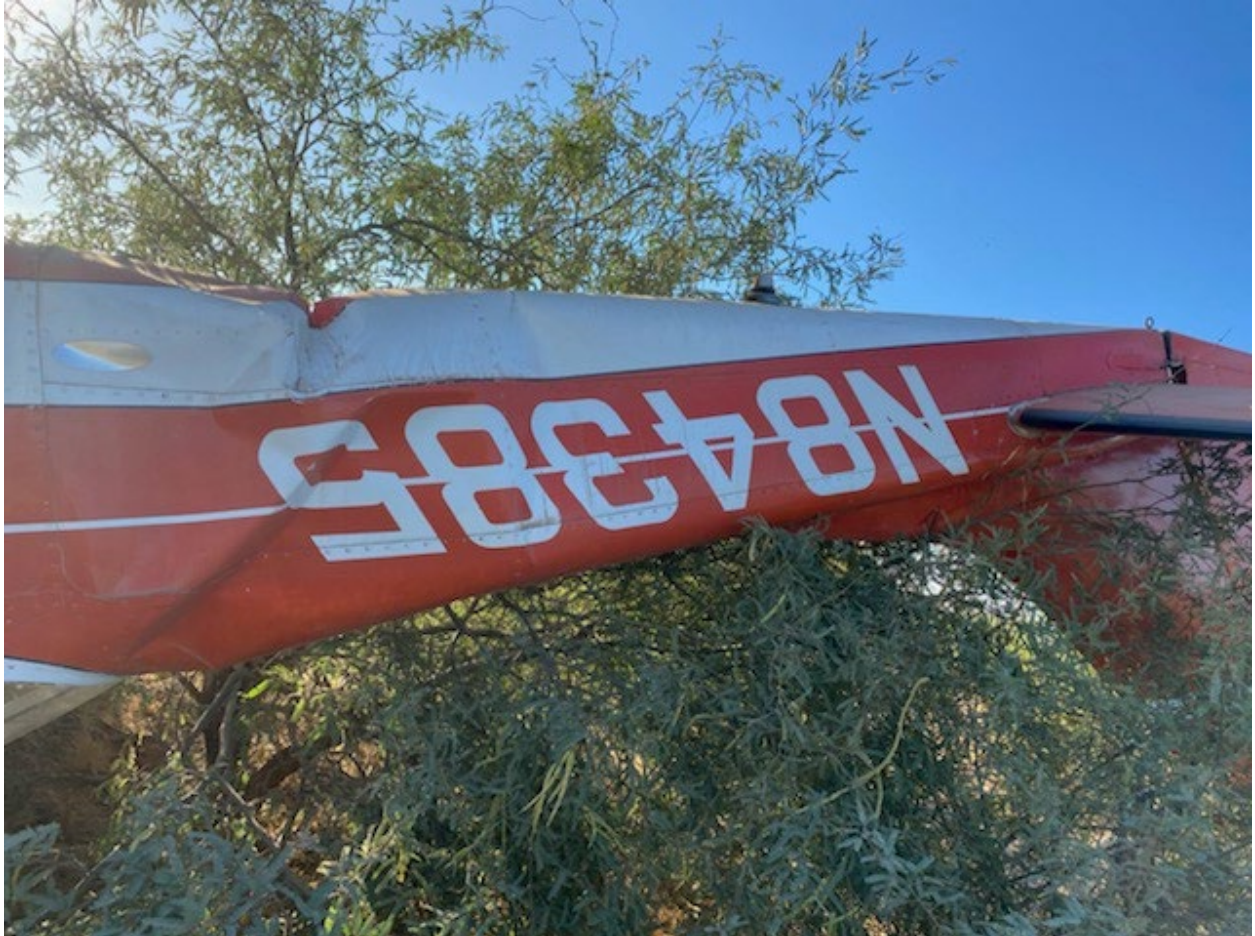
**Figure 3. Close up view of the substantial damage to the tail cone area of the fuselage. Photo courtesy of the owner.**

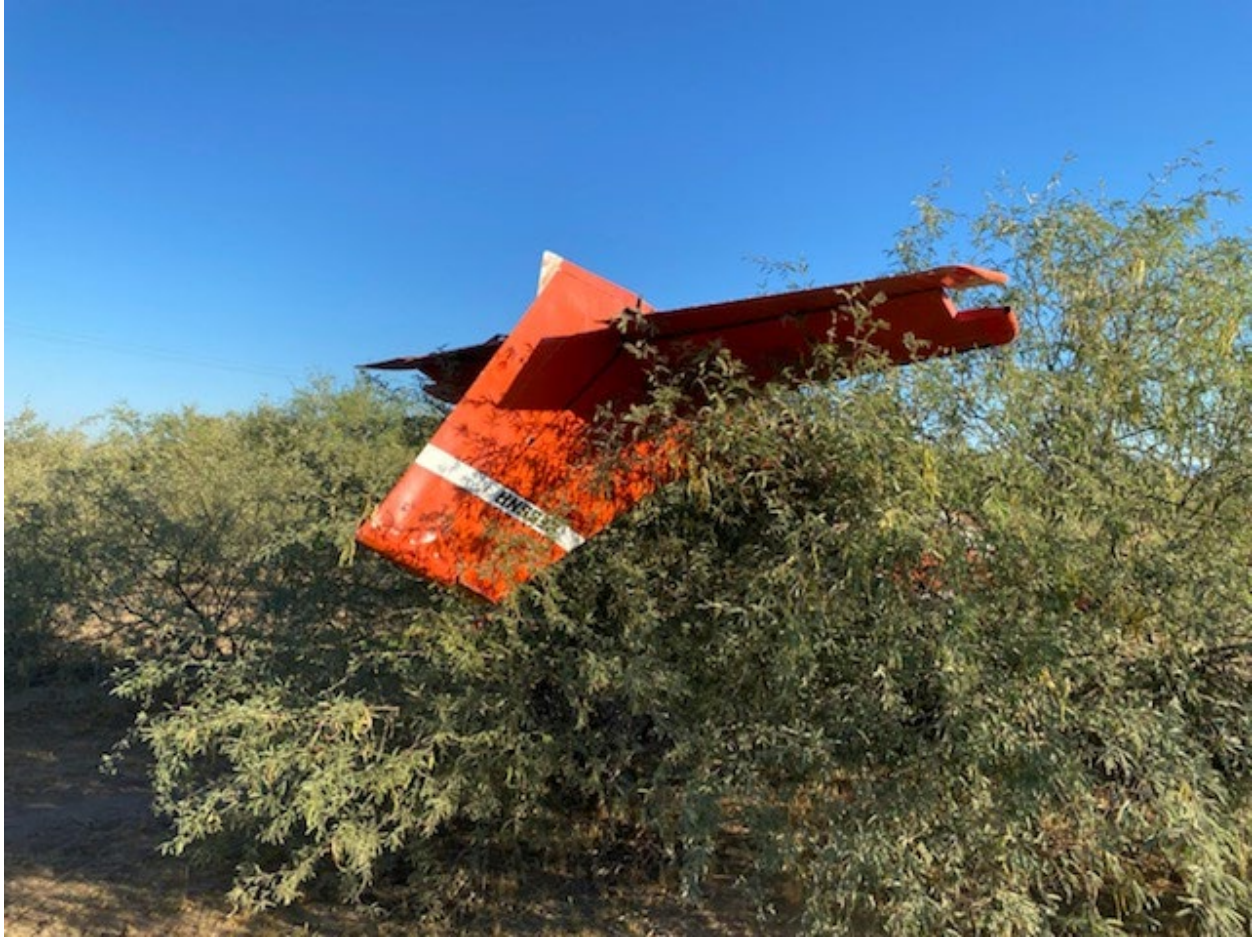
The empennage exhibited minor damage. See figure 4.

**Figure 4. Empennage. Photo courtesy of the owner.**

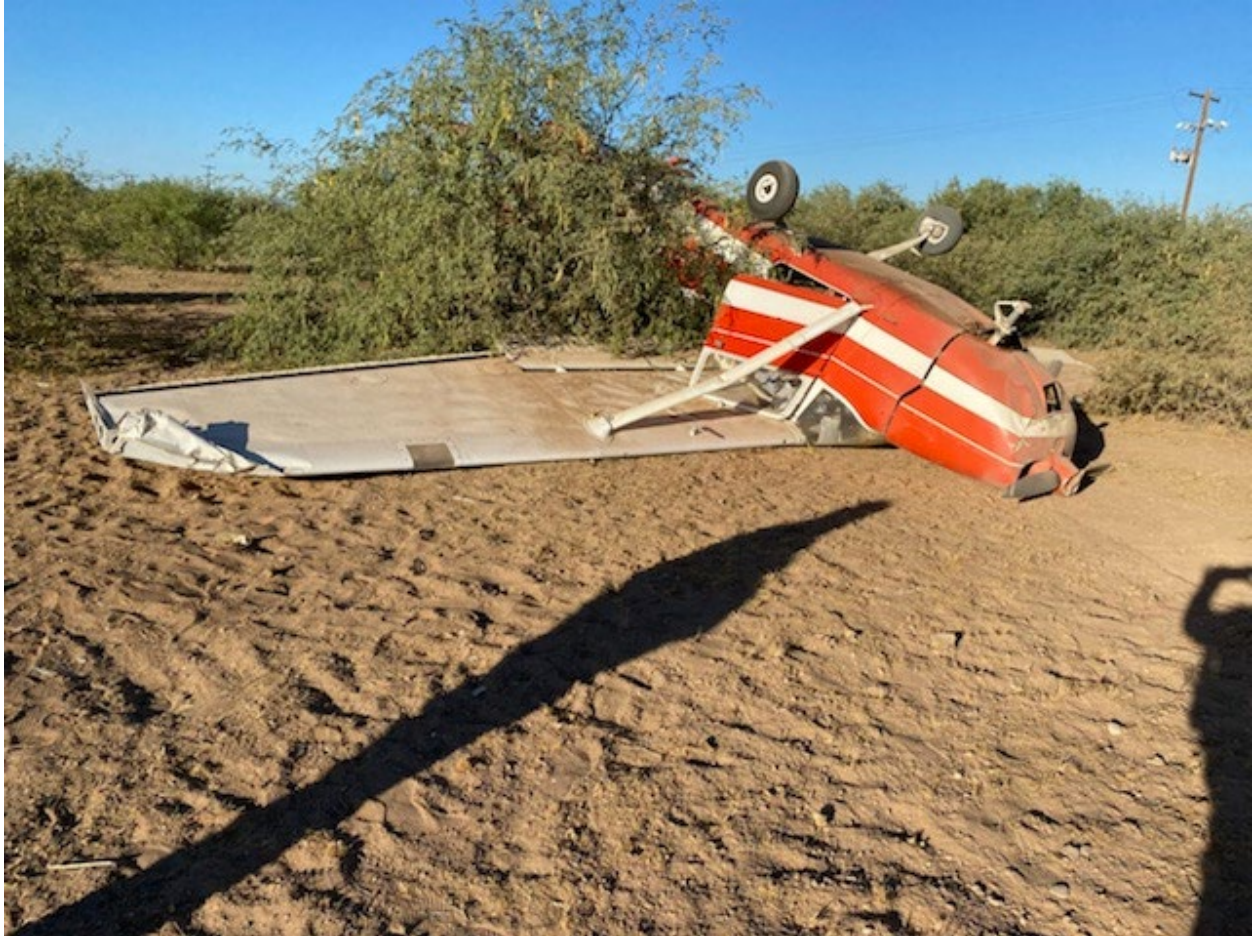
The left wing exhibited substantial damage to the left-wing strut. See figure 5.

**Figure 5. Left wing and wing strut damage. Photo courtesy of the owner.**
