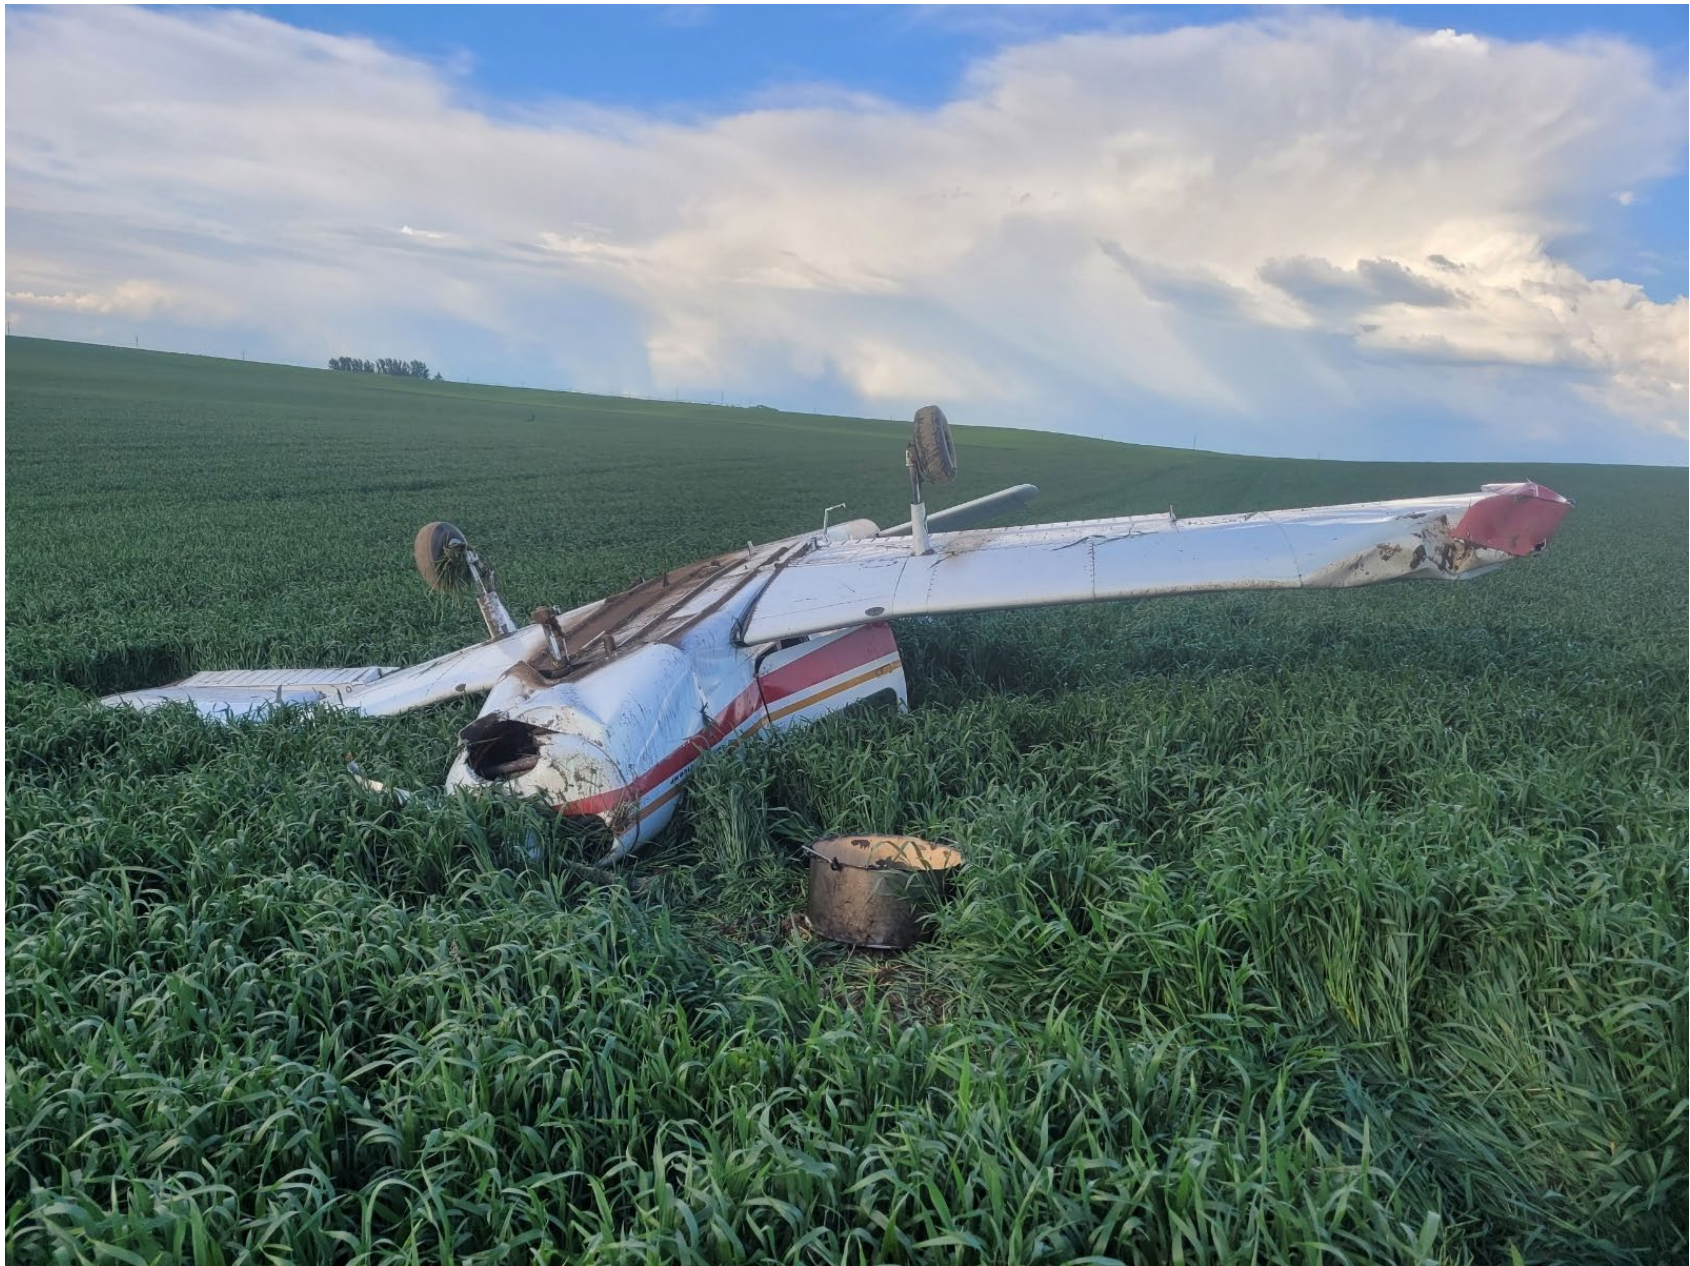
**Photo 1 – View of damage to both wings (courtesy of LEO on scene)**

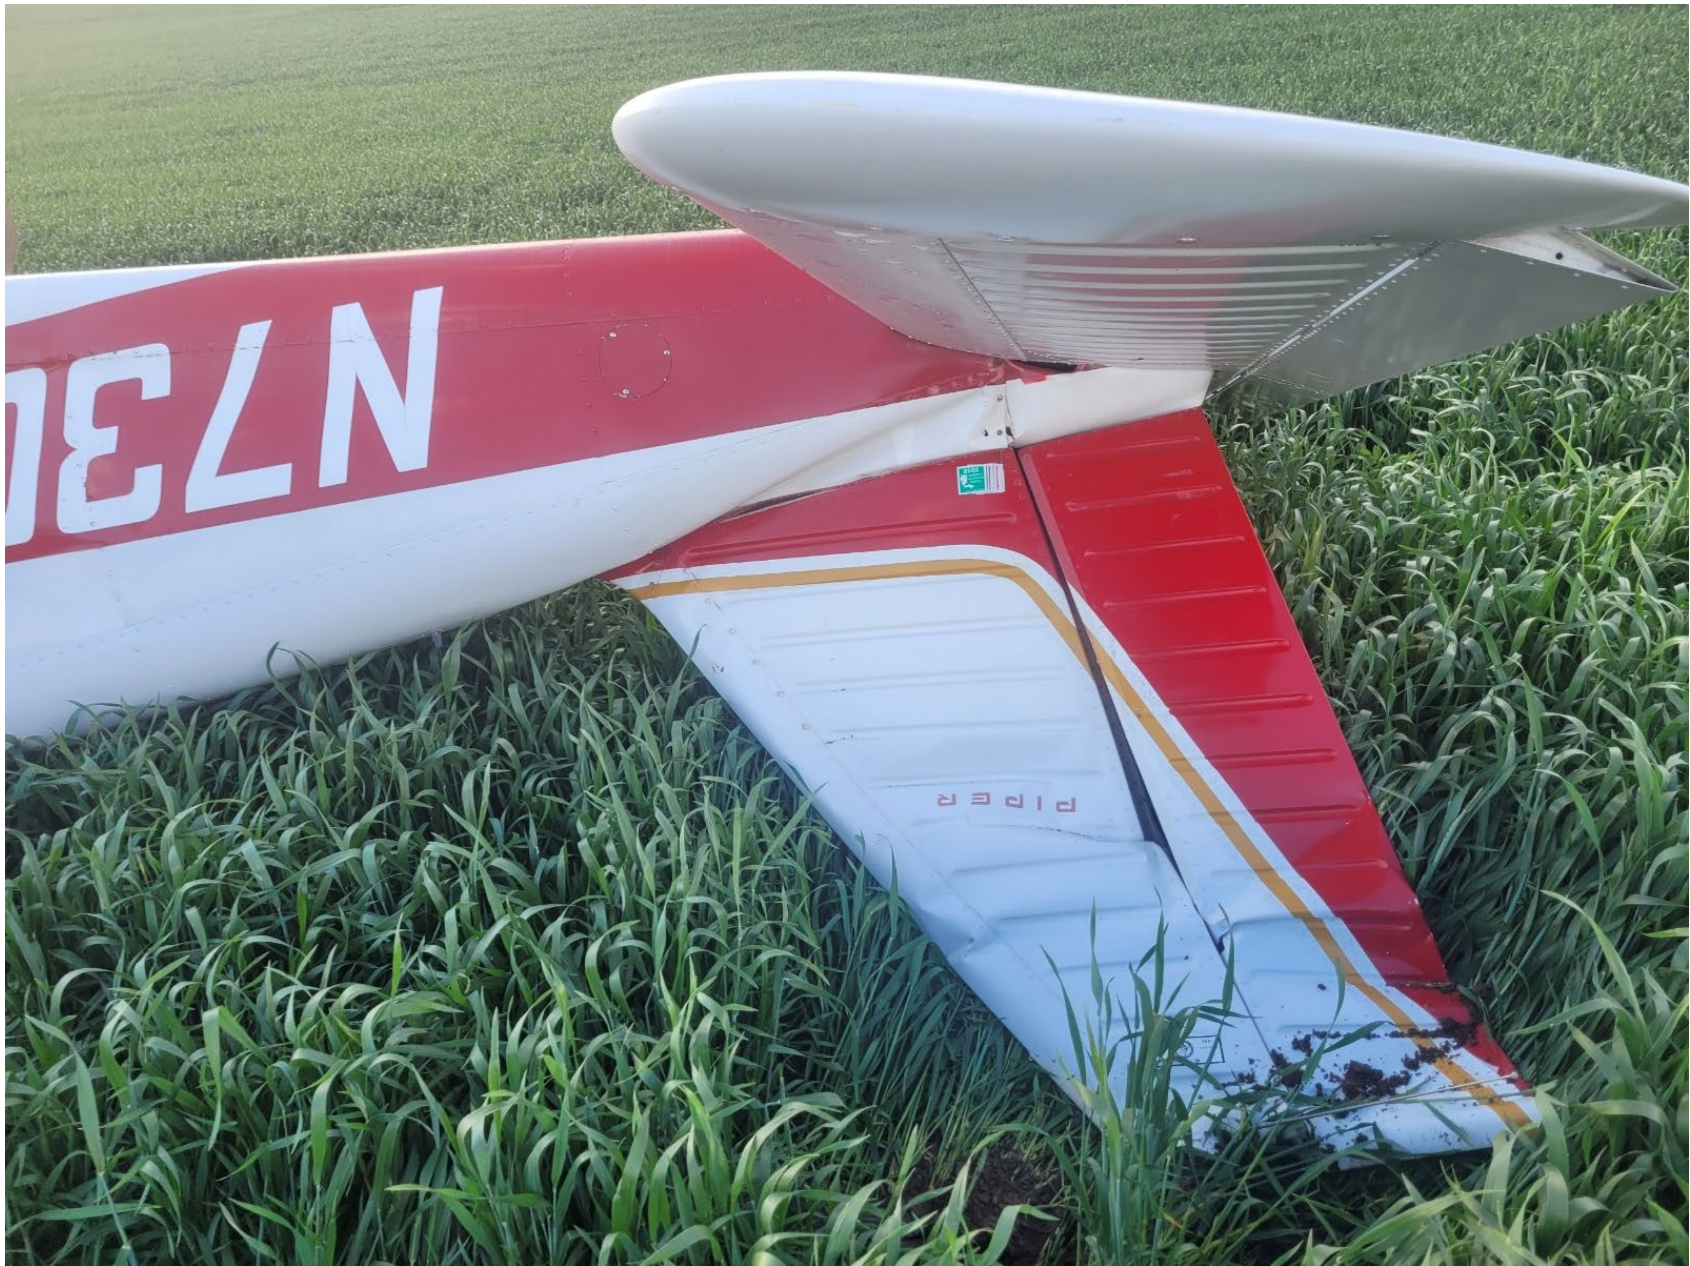
**Photo 2 – View of damage to fuselage, vertical stabilizer, and rudder (courtesy of LEO on scene)**
