WPR23LA255

## INVESTIGATION PHOTOGRAPHS

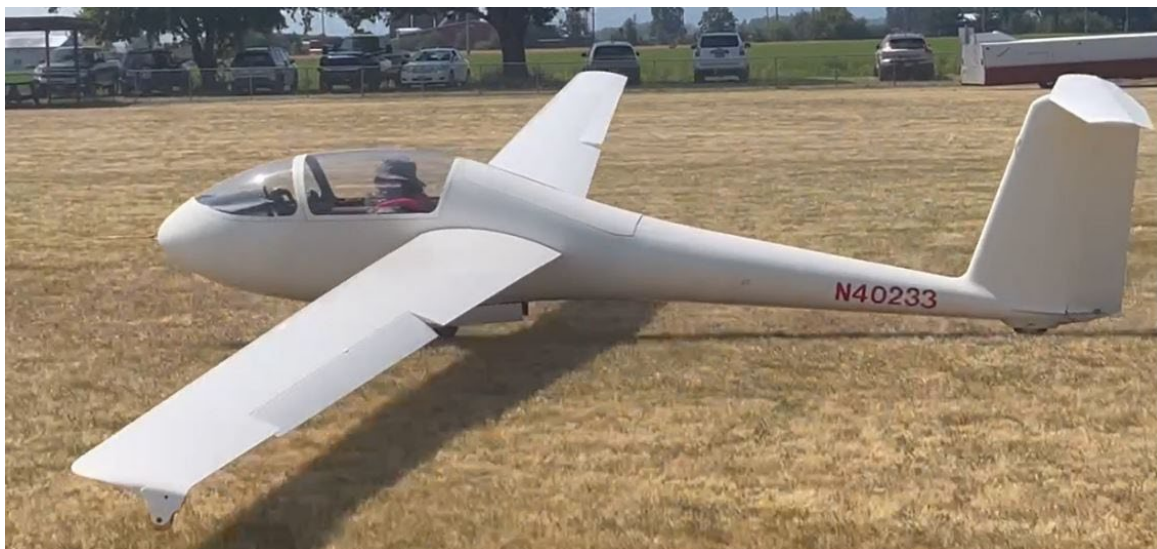
**Photograph 1 - View of motor-glider during aerotow ground roll (Courtesy of Flying Club)**

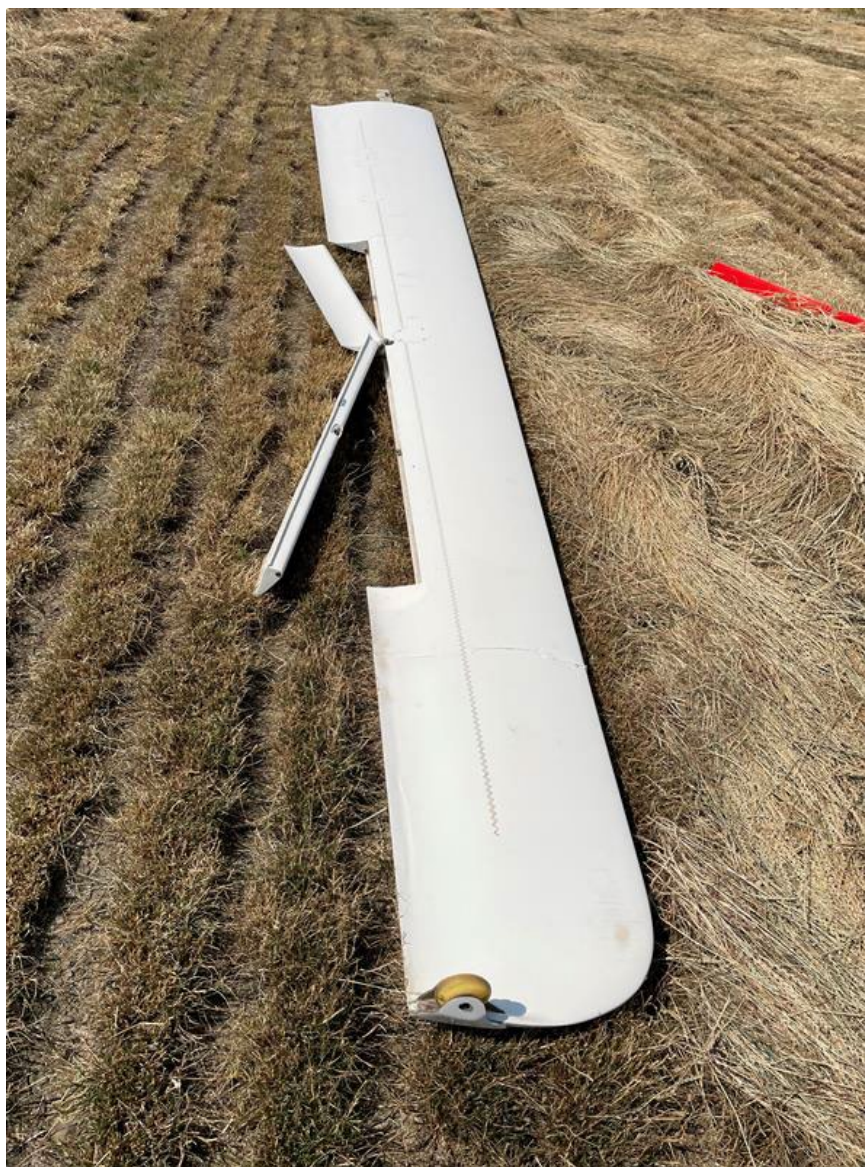
**Photograph 2 - View of separated left wing (Courtesy of FAA)**

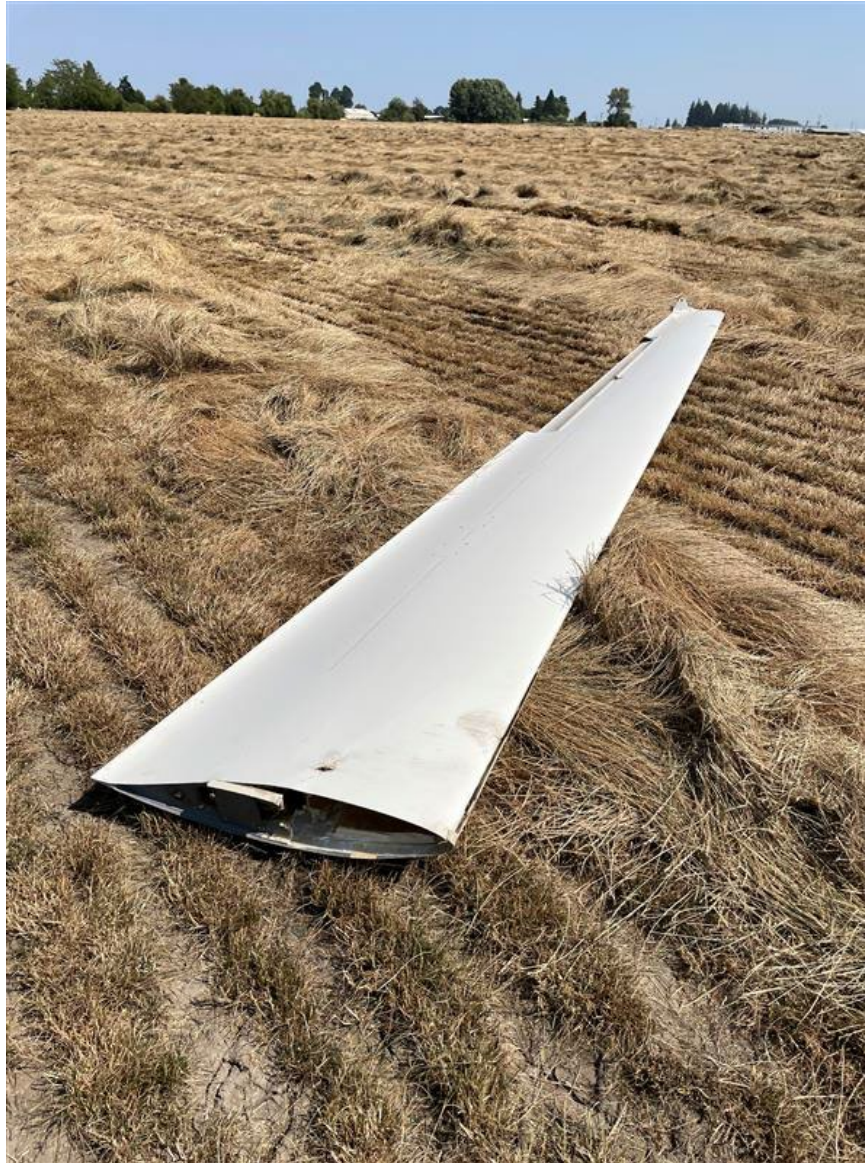
**Photograph 3 - View of separated right wing without wing root spar (Courtesy of FAA)**

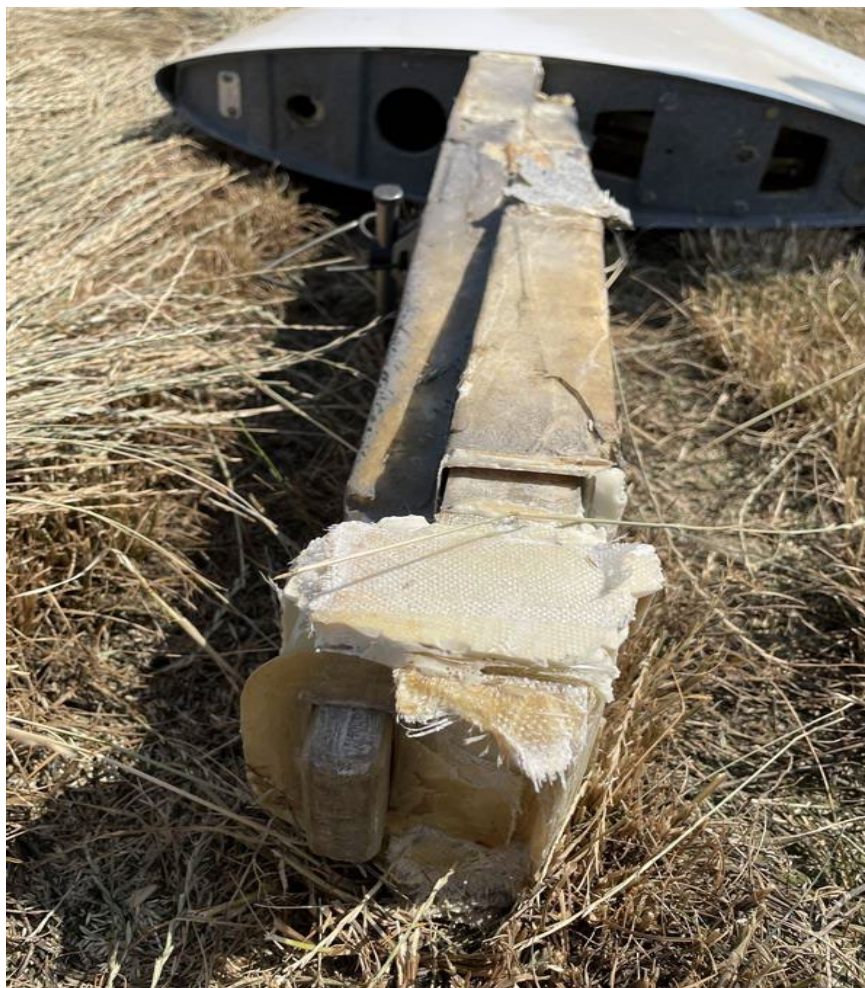
**Photograph 4 - View of left wing root and spar still affixed to right wing root spar, held together by spar pin (Courtesy of FAA)**

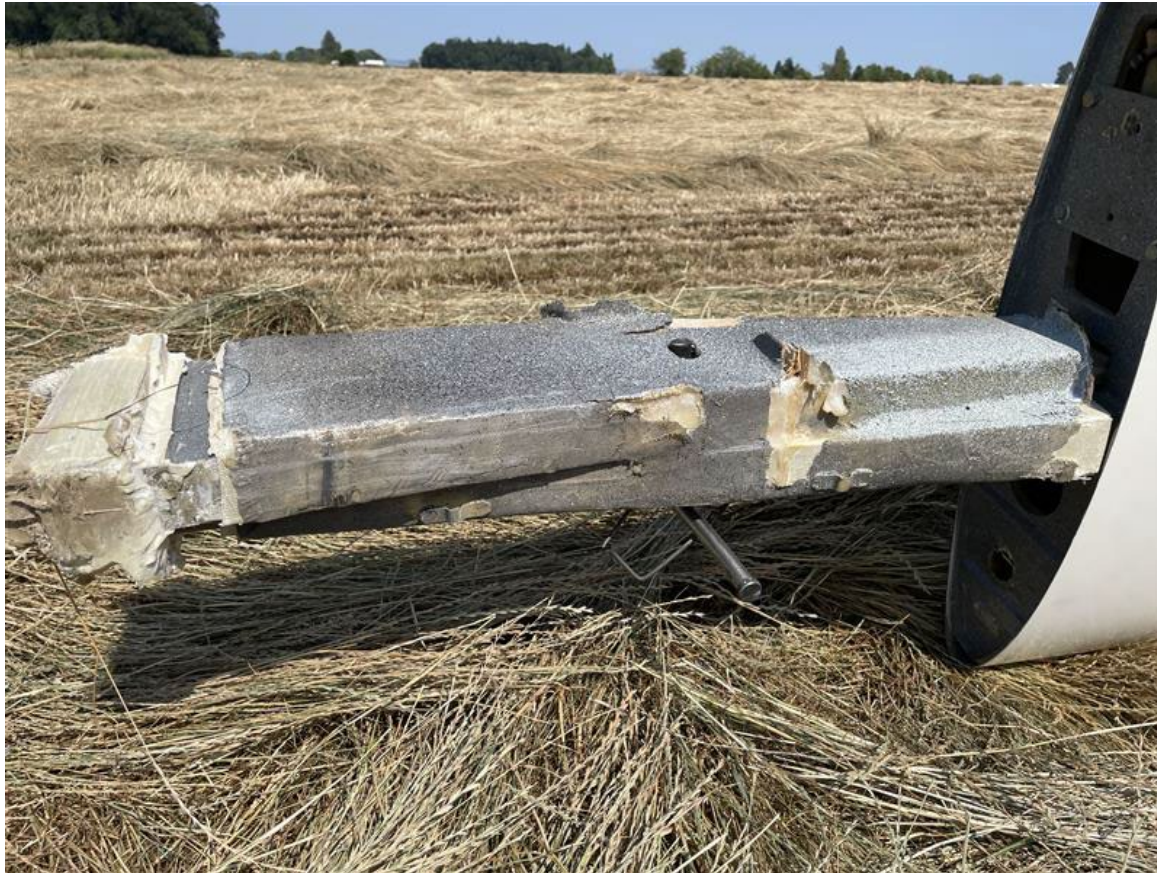
**Photograph 5 - View of left and right wing spar assembly, and failure surface (Courtesy of FAA)**

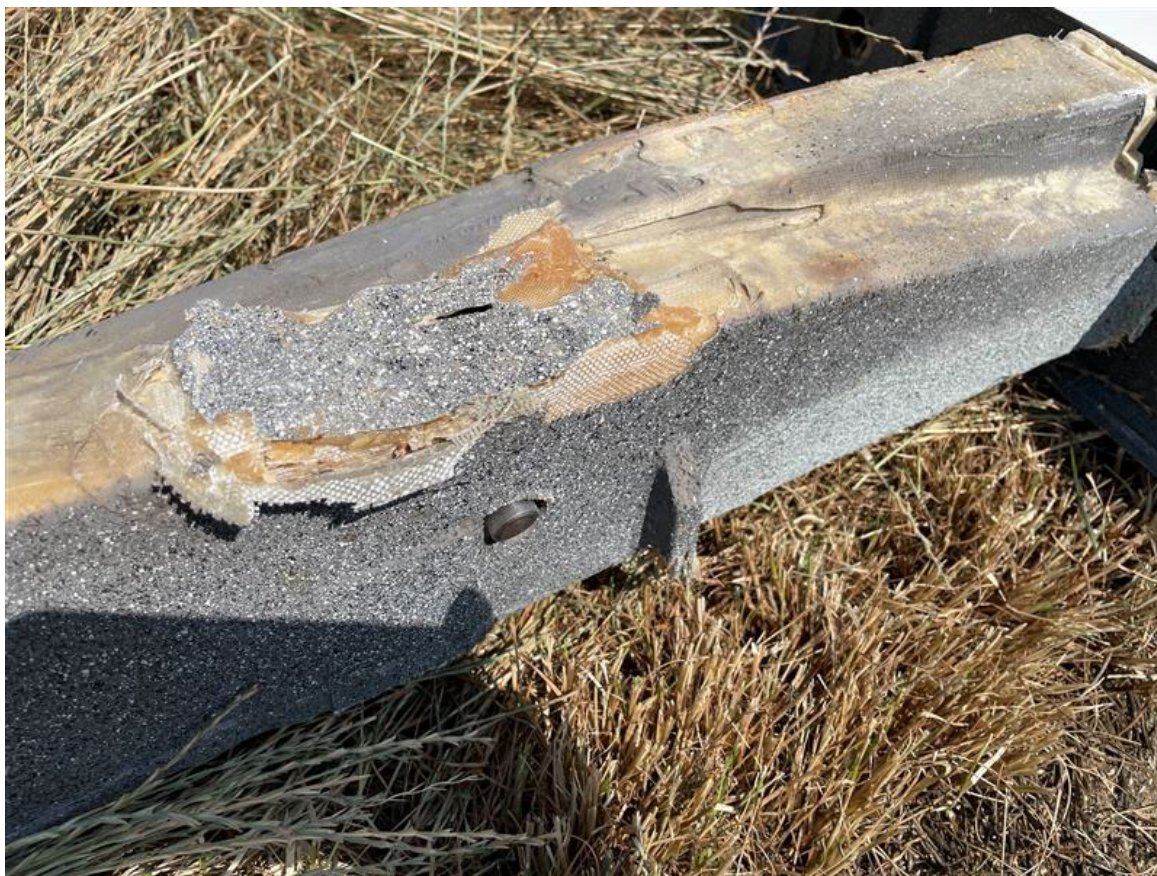
**Photograph 6 - Aft view of spar pin connected through spar orifice (Courtesy of FAA)**
