# National Transportation Safety Board

WPR23LA255

## **MATERIALS LABORATORY**

Factual Report 24-081

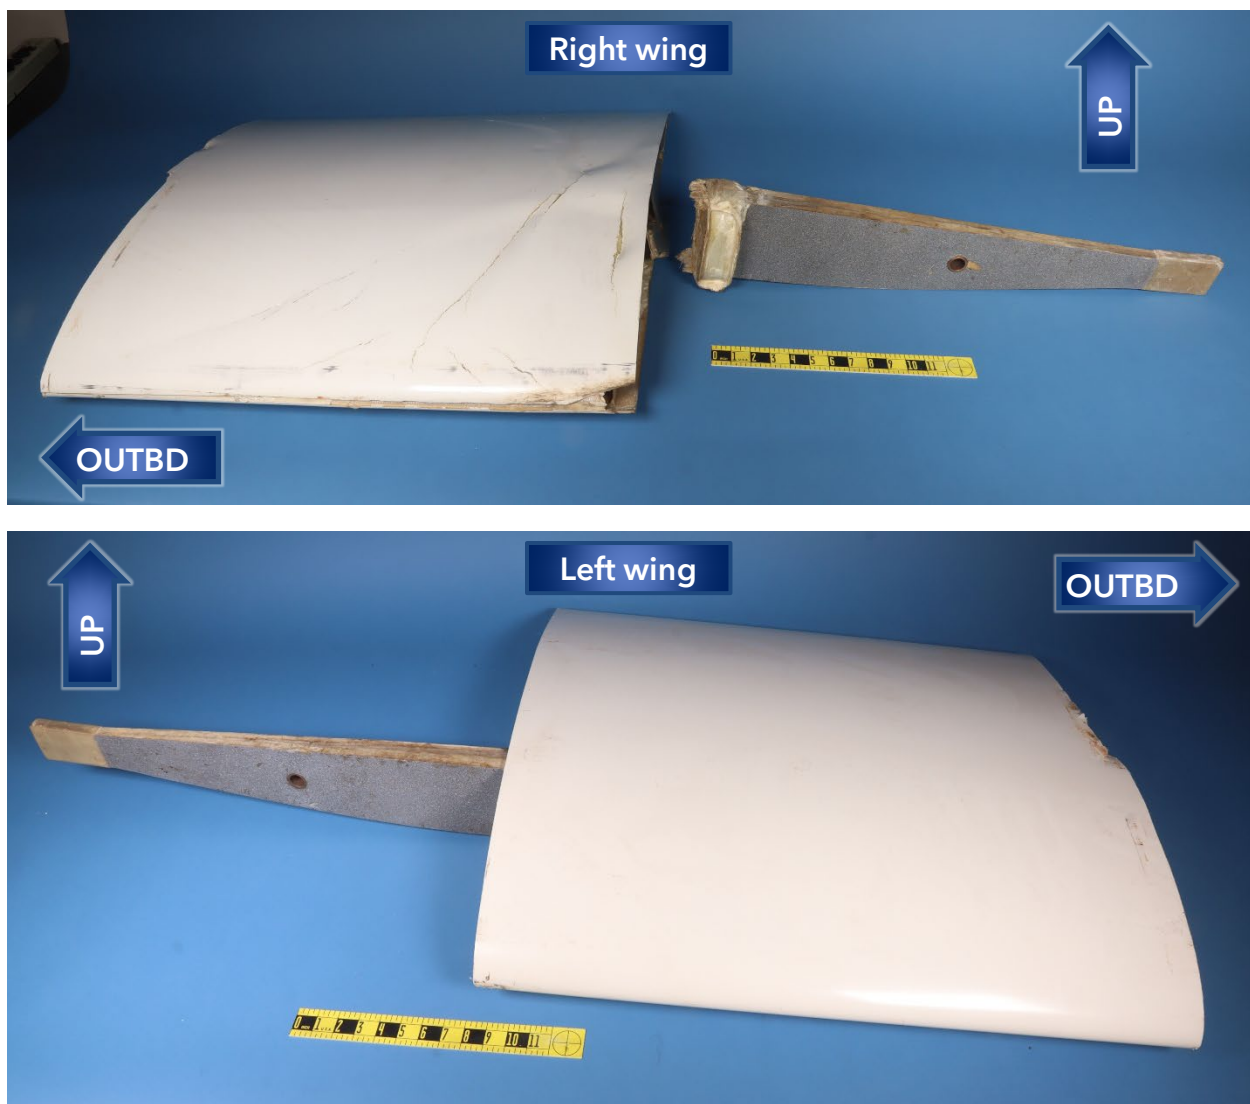
Overall views of the submitted wing and carrythrough beam pieces are shown as received in figure 1. Both wing pieces had chordwise cuts at the outboard ends to facilitate shipment to the NTSB Materials Laboratory. The right wing spar was fractured at the inboard end where it transitioned to the carrythrough beam, and the left wing piece was intact at the wing spar to carrythrough transition.

**Figure 1.** Overall views of the submitted wing and carrythrough beam pieces.

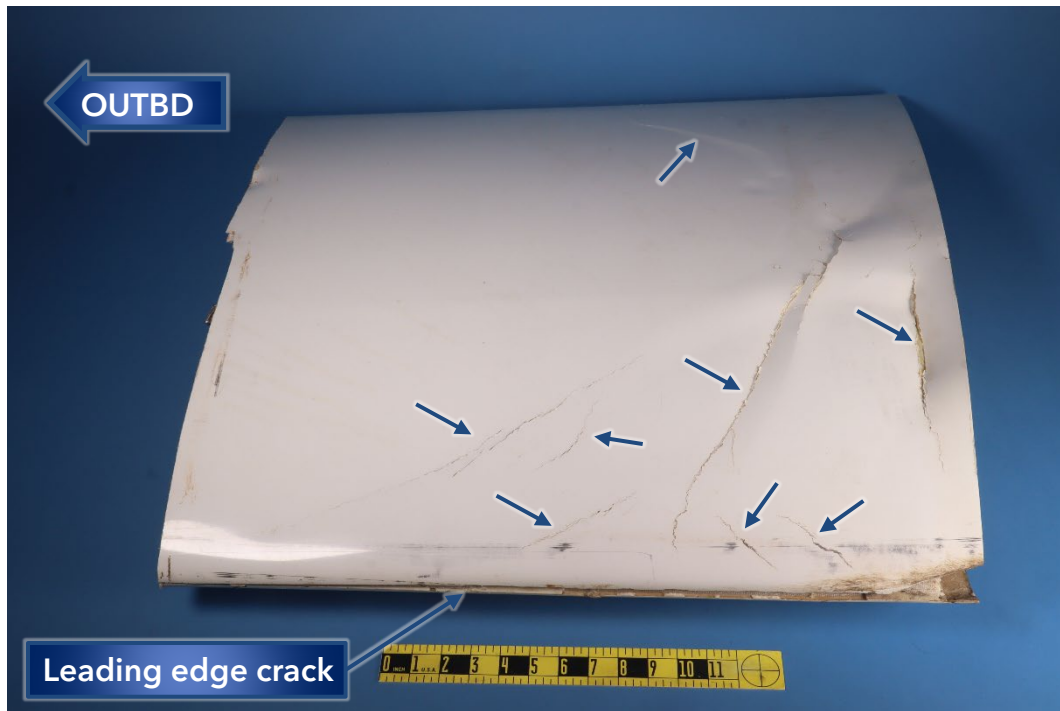
Views of the right wing upper and lower skins are shown in figures 2 and 3. The skins were mostly separated from each other at the leading edge but remained attached to the spar near mid chord and to each other along the trailing edge. Cracks and wrinkles were observed on the upper skin as indicated with unlabeled arrows in figure 2. The upper skin cracks and wrinkles were mostly located between the leading edge and the spar. A portion of the upper skin was missing at the inboard end of the leading edge. The upper skin at the edge of the missing portion

had a rubbed appearance, and surrounding areas on both the upper and lower skin had brown deposits that appeared to be consistent with soil.

**Figure 2.** Upper surface of the right wing piece.

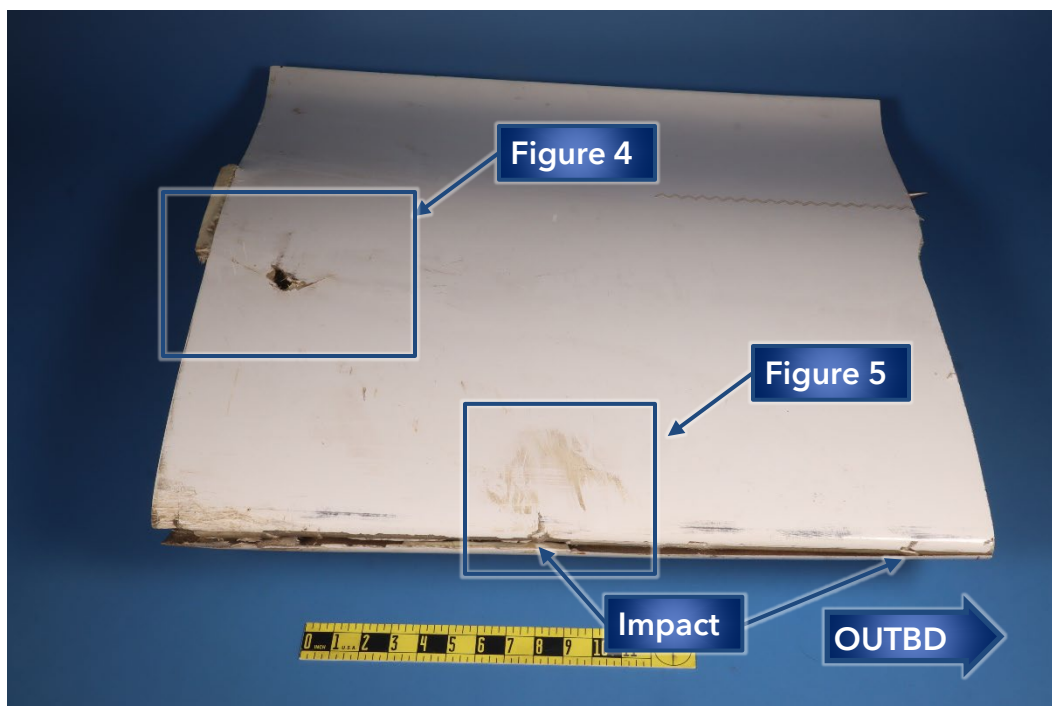
Impact damage was observed on the lower skin at two locations on the leading edge as indicated in figure 3. A closer view of the larger area of damage is shown in figure 5. Paint at the impact sites was fractured and missing, and paint cracks radiated from the impact location. The impact damage was isolated to the lower skin and was not observed on the mating upper skin across the leading edge separation. Longitudinally-oriented black deposits and sliding contact marks were observed on the upper and lower sides of the leading edge, and some of these marks and deposits can be seen intersecting the impact area shown in figure 5.

**Figure 3.** Lower surface of the right wing piece.

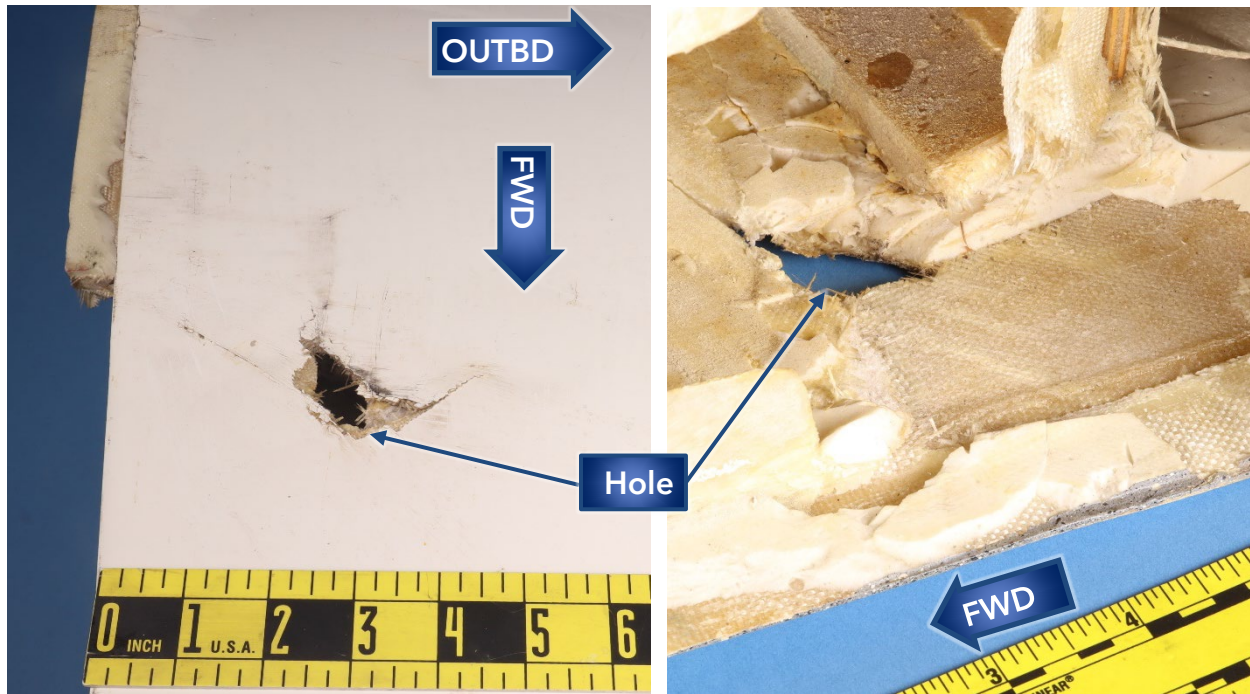
A hole was observed on the lower surface of the wing just forward of the spar approximately 2.5 inches outboard of the inboard edge as shown in figure 4. Cracks in the paint were observed emanating from the hole to the aft and both inboard and outboard of the hole. Sliding contact marks oriented in the spanwise direction were observed around the hole, and dark colored deposits were observed adjacent to the hole and on the adjacent fracture surface.

**Figure 4.** Inboard end of the right wing showing the hole in the lower skin forward of the spar fracture. Exterior and interior views are shown at the left and right, respectively.

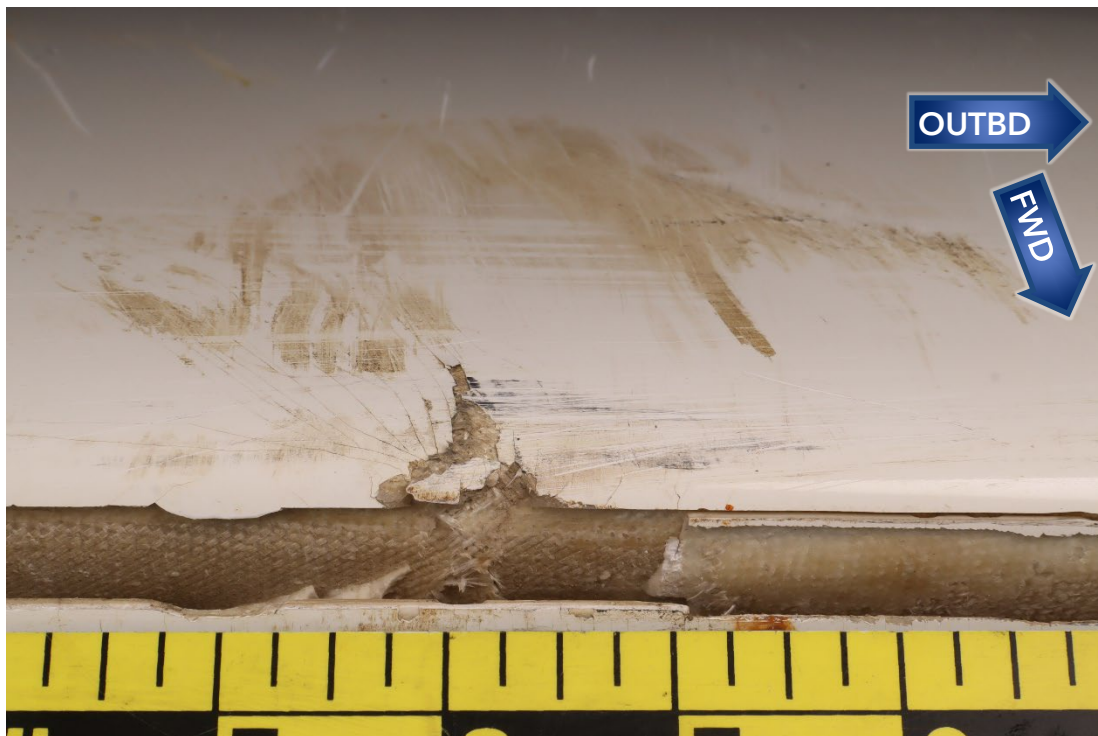
Reddish brown deposits were observed aft of the impact area shown in figure 5. Some of the deposits fluoresced when imaged using ultraviolet (UV) lighting. A view of the lower skin as photographed using a UV light is shown in figure 6. Trails of fluorescent material were observed extending between the hole near the spar and the two impact sites with a branching trail to the reddish brown deposit aft of the inboard impact site. Upon close inspection, the trails were associated with faint cracks in the paint.

**Figure 5.** Leading edge impact damage on the lower skin with black and brown deposits on the adjacent surfaces.

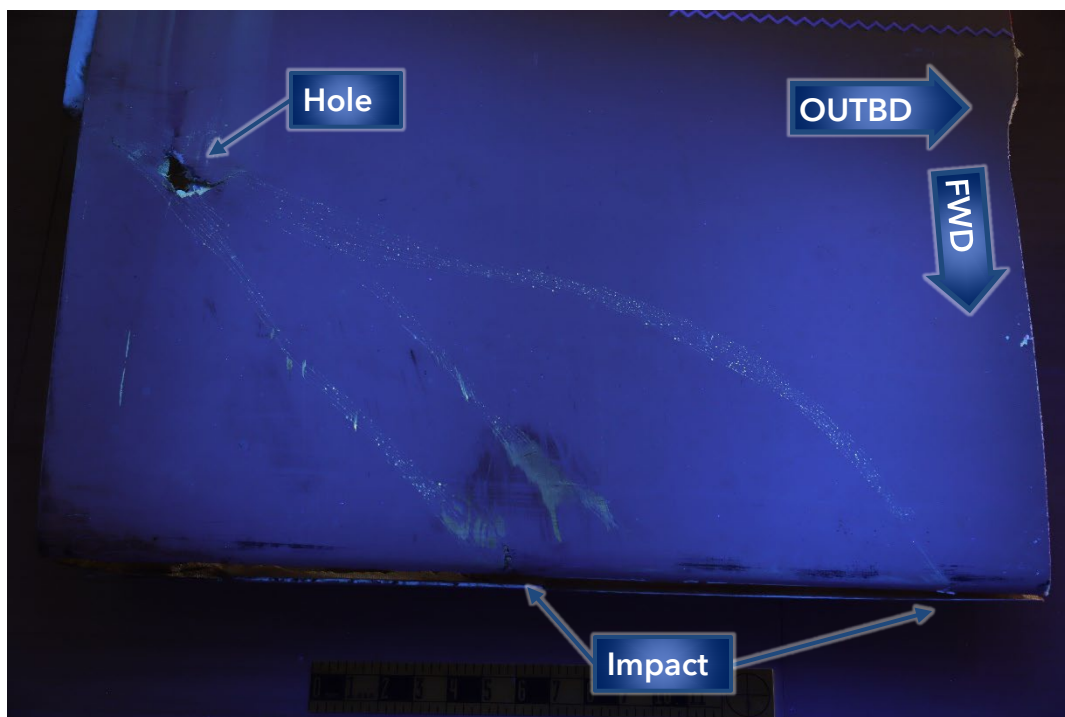
**Figure 6.** Lower skin under UV light showing fluorescing material between the hole and impact sites at the leading edge.

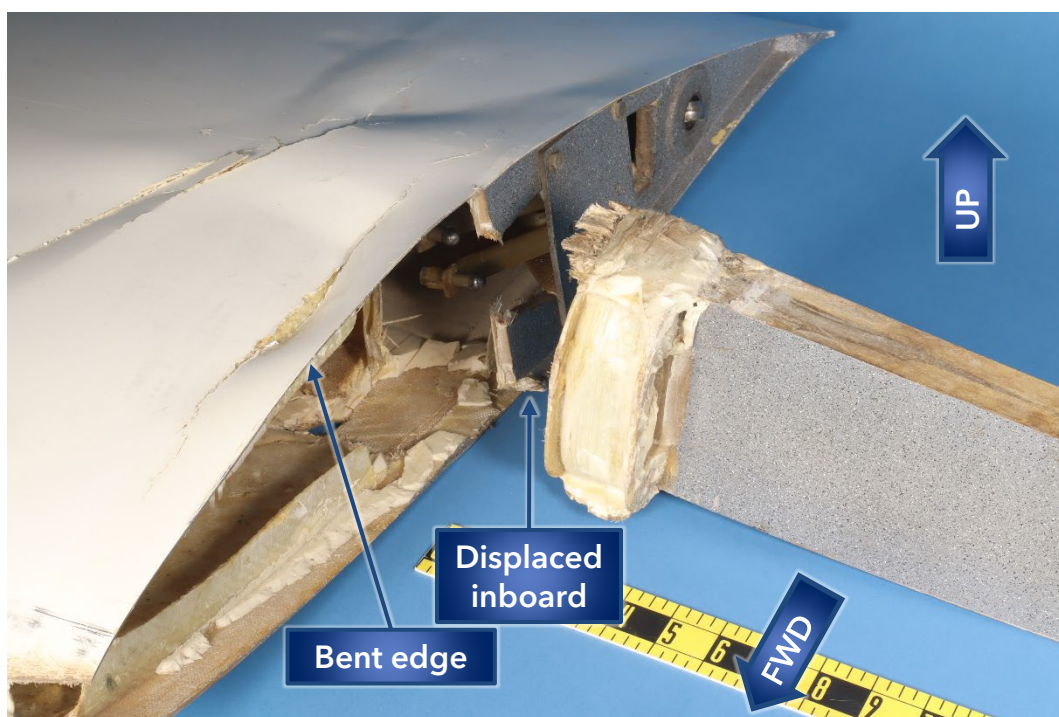
A view of the inboard end of the right wing with the mating side of the carrythrough beam is shown in figure 7. The close-out rib forward of the spar was fractured and missing. The inboard edge of the upper skin was bent upward

between the spar and the leading edge as indicated in figure 7. The upper skin was fractured and bent downward adjacent to the vertical flange for attaching the closeout rib. In contrast, the lower skin was not bent along the inboard edge where it had fractured from the close-out rib. The portion of the close-out rib aft of the spar remained attached to the wing. Adjacent to the aft side of the carrythrough beam, the lower flange of the close-out rib was fractured from the lower skin, and the upper flange was cracked. The closeout rib damage aft of the closeout beam was associated with inboard displacement of the lower end of the rib relative to the upper end as indicated in figure 7.

**Figure 7.** Inboard end of the right wing with separated carrythrough beam.

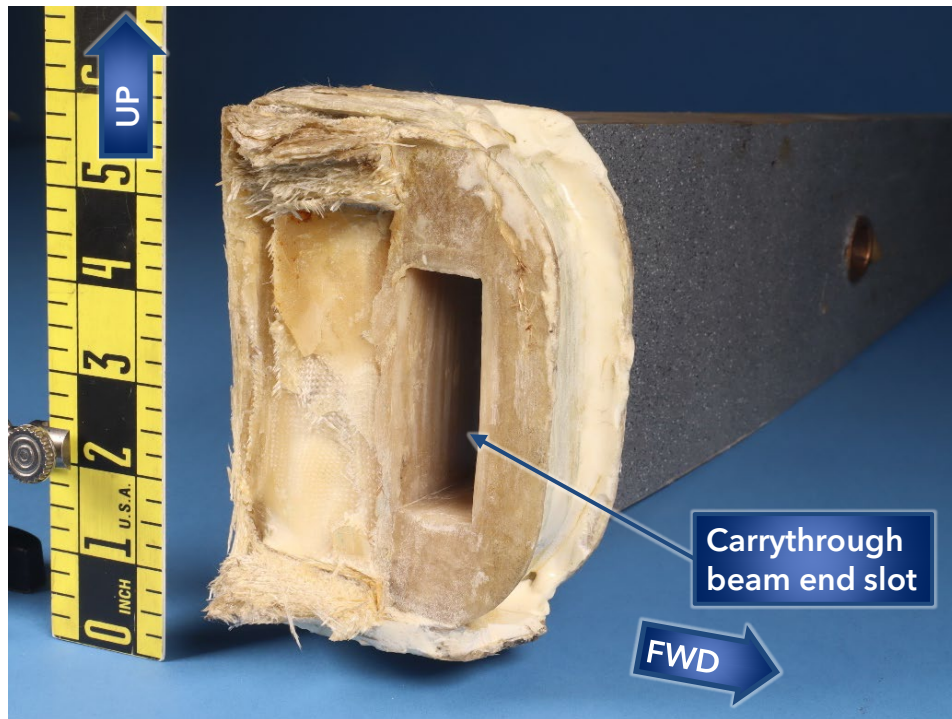
Views of the right wing spar fracture are shown in figures 8 and 9. The fracture occurred in the spar at the outboard side of the reinforced area of the closeout rib. The spar caps were constructed of a fiber-reinforced composite material separated by a web constructed of wood laminate.

**Figure 8.** Inboard side of the right wing spar fracture at the outboard end of the carrythrough beam.

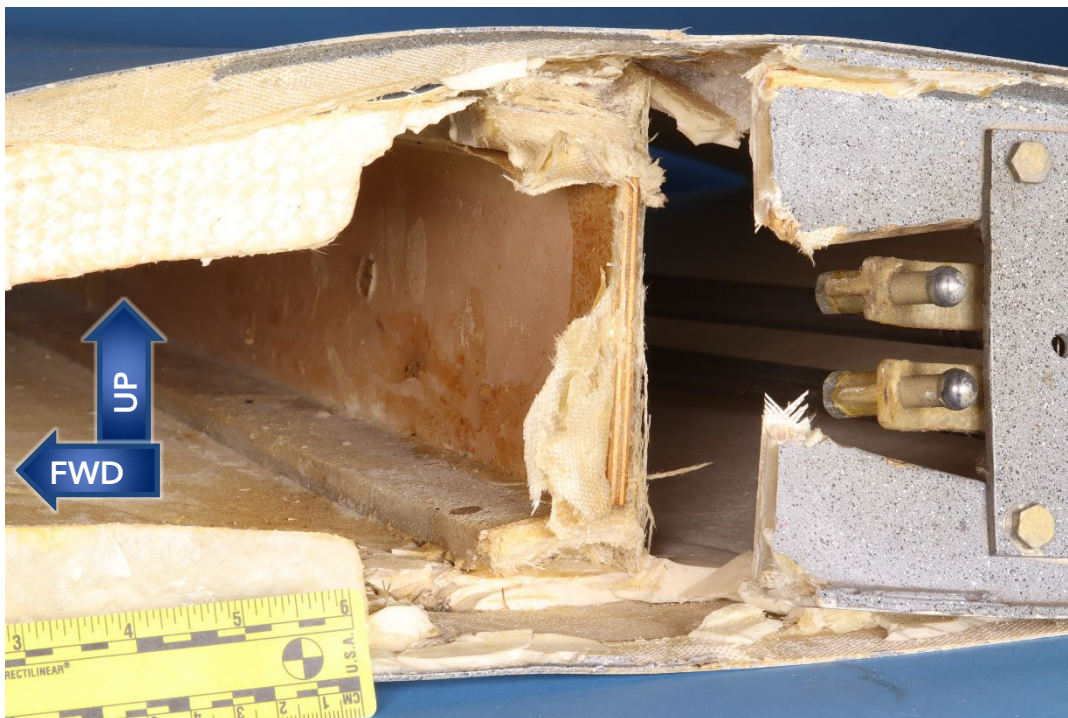
**Figure 9.** Outboard side of the right wing spar fracture at the inboard end of the wing.

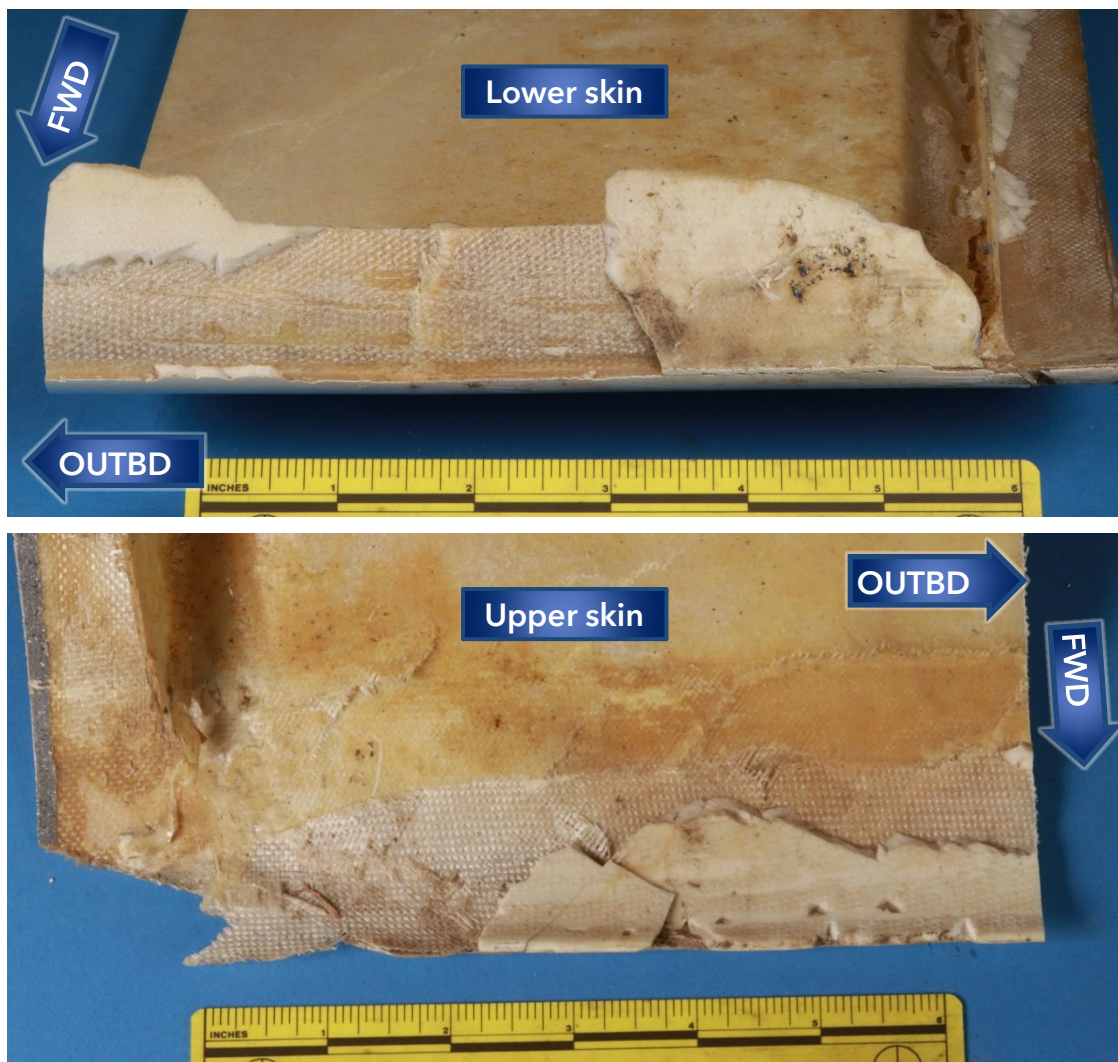
With the upper skin separated from the lower skin and spar, the fracture surfaces at the leading edge were exposed for examination as shown in figure 11. A cream-colored filler was observed between the skin layers, and the fracture path varied between interfaces at either side of the filler. No evidence of preexisting or progressive fracture such as arrest lines or rubbing damage from mating surfaces was observed.

**Figure 11.** Sectioned right wing lower skin (upper image) and upper skin (lower image) after the upper skin was separated from the spar and lower skin showing mating fracture surfaces at the inboard end of the leading edge bond line.

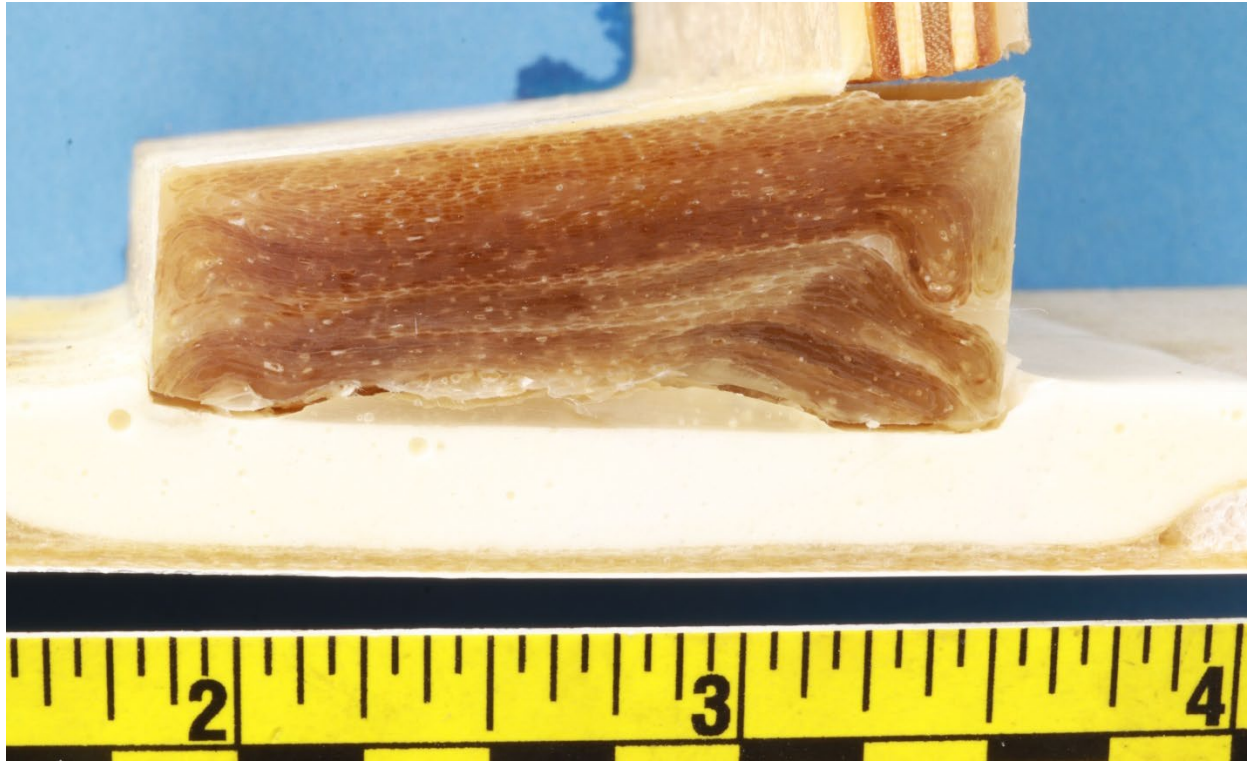
After the lower cap was cut, the surface on the outboard side of the cut was polished with abrasive paper up to 600 grit and was wiped with a damp paper towel to reveal the reinforcement layers. The resulting transverse cross-section through the right wing spar lower cap is shown in figure 12. The spar cap reinforcement appeared to consist of folded layers of glass-fiber fabric that were laid into a form in the shape of the spar cap and were likely assembled with other spar and carrythrough components, filled with resin, and cured. The fabric had been

sequentially folded along the forward and aft sides of the spar to place the reinforcement layers.

**Figure 12.** Transverse section through the right wing spar lower cap.

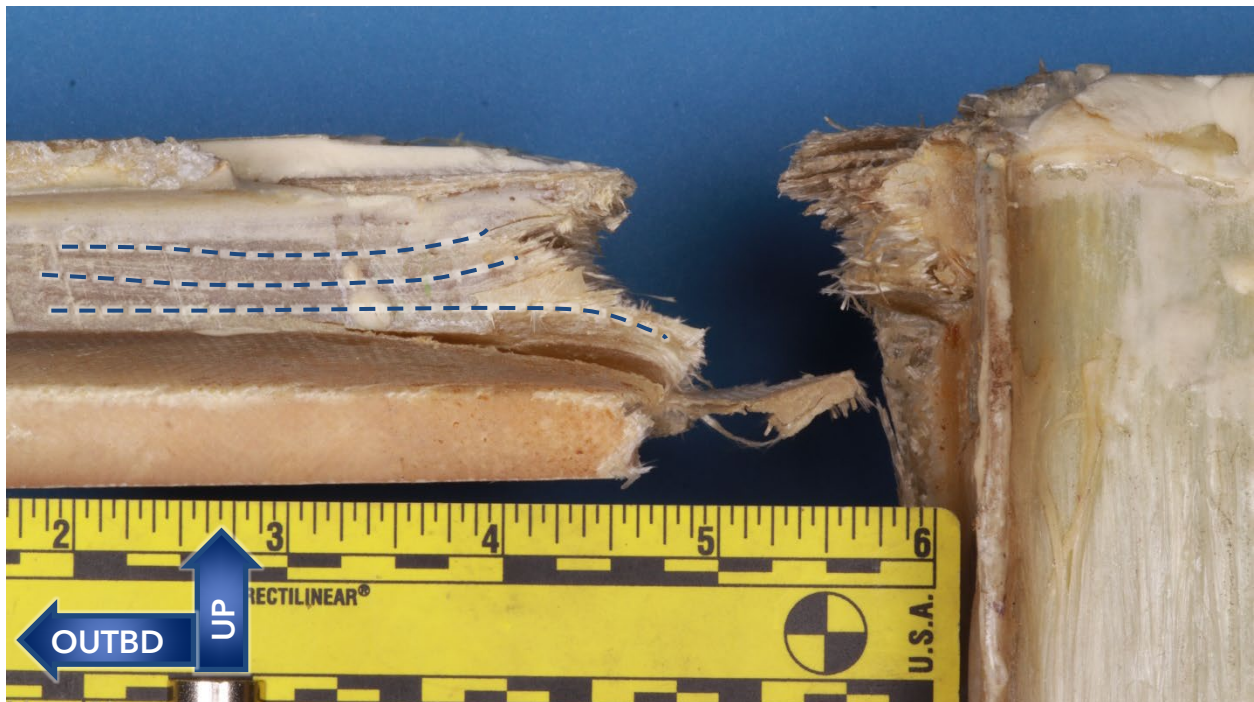
Mating sides of the fracture through the right wing spar upper cap are shown in figures 13 and 14. Fiber reinforcement layers were visible at the forward side of the upper spar cap, and the longitudinal reinforcement layers appeared to deviate from the spanwise direction outboard of the fracture surface. Dashed lines in figure 13 trace several of the reinforcement layers visible on the forward face of the upper cap showing observed variations in fiber alignment.

**Figure 13.** Mating sides of the right wing spar upper cap fracture after the outboard side was separated from the upper skin. Dashed lines indicate the orientation of reinforcement layers visible on the surface.

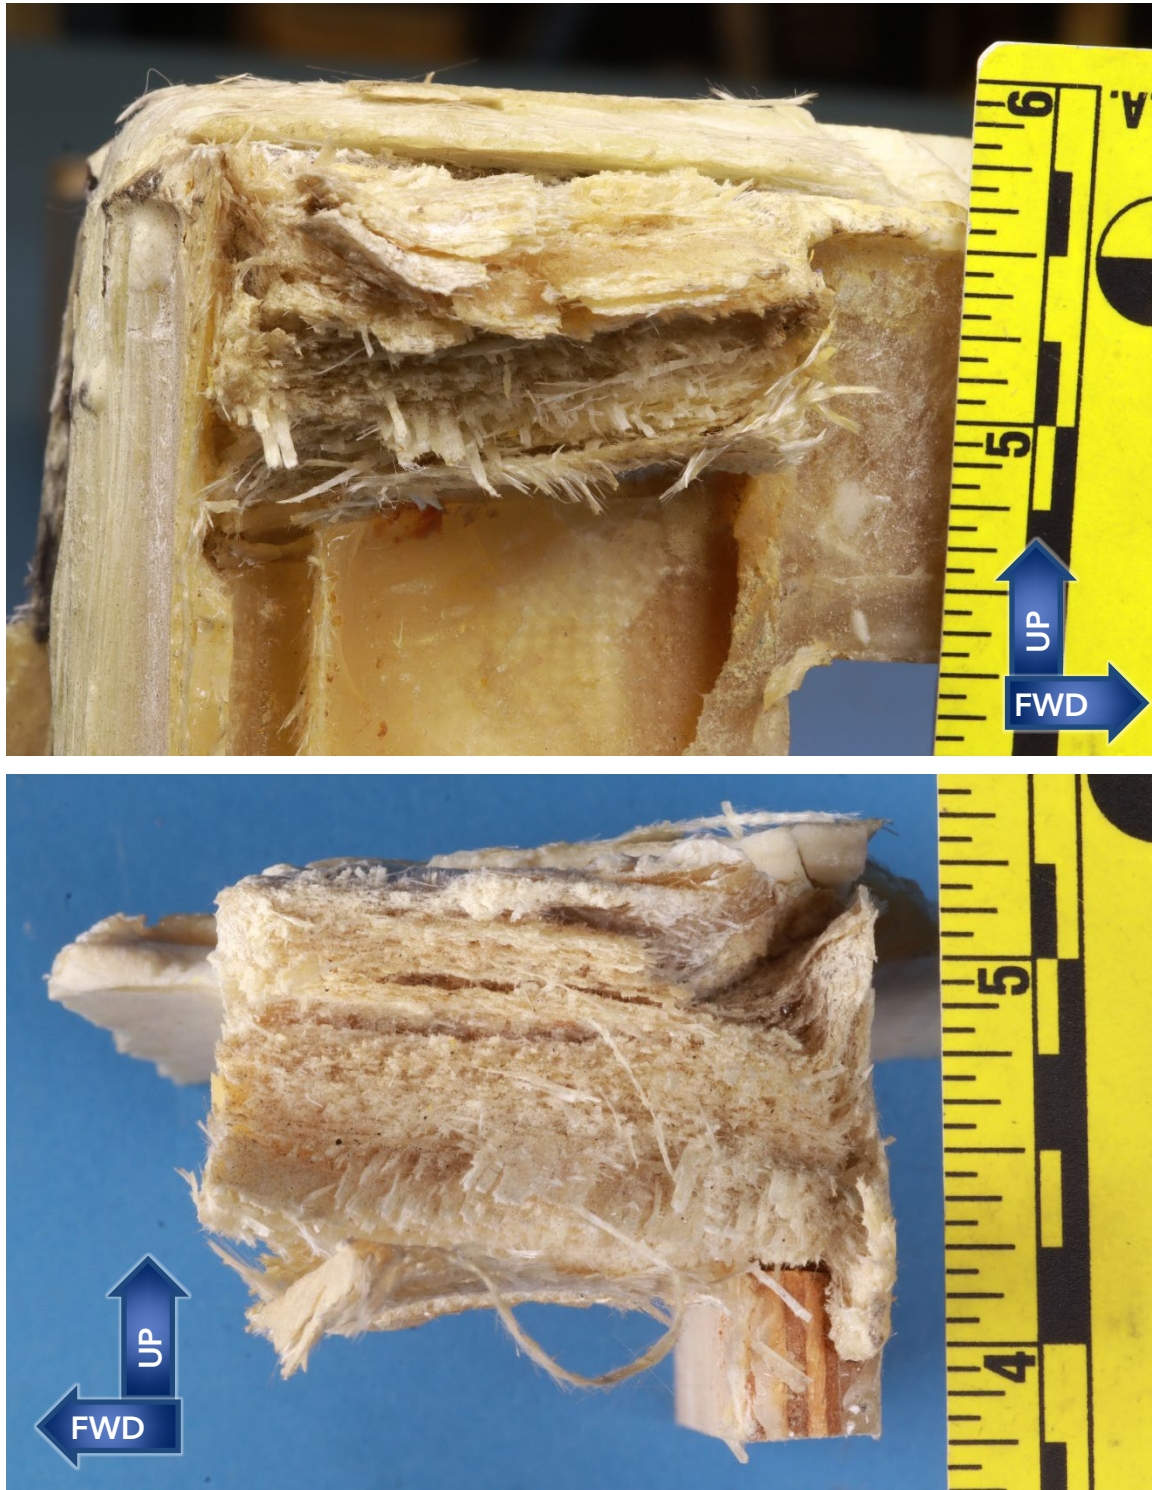
As shown in figure 14, fracture surface on the inboard side of the upper cap fracture appeared to have sustained post-fracture damage, but the surface on the outboard side appeared to be intact and mostly free of damage. As viewed on the outboard side, the fracture surface mostly had a rough fibrous appearance consistent with tensile overstress fracture. A small portion of the surface at the upper side of the fracture had a whiter flattened appearance consistent with compression failure. At the lower quarter of the fracture, the exposed longitudinal fibers were angled downward relative to the spanwise direction.

**Figure 14.** Inboard side (upper image) and outboard side (lower image) of the right wing spar upper cap fracture.

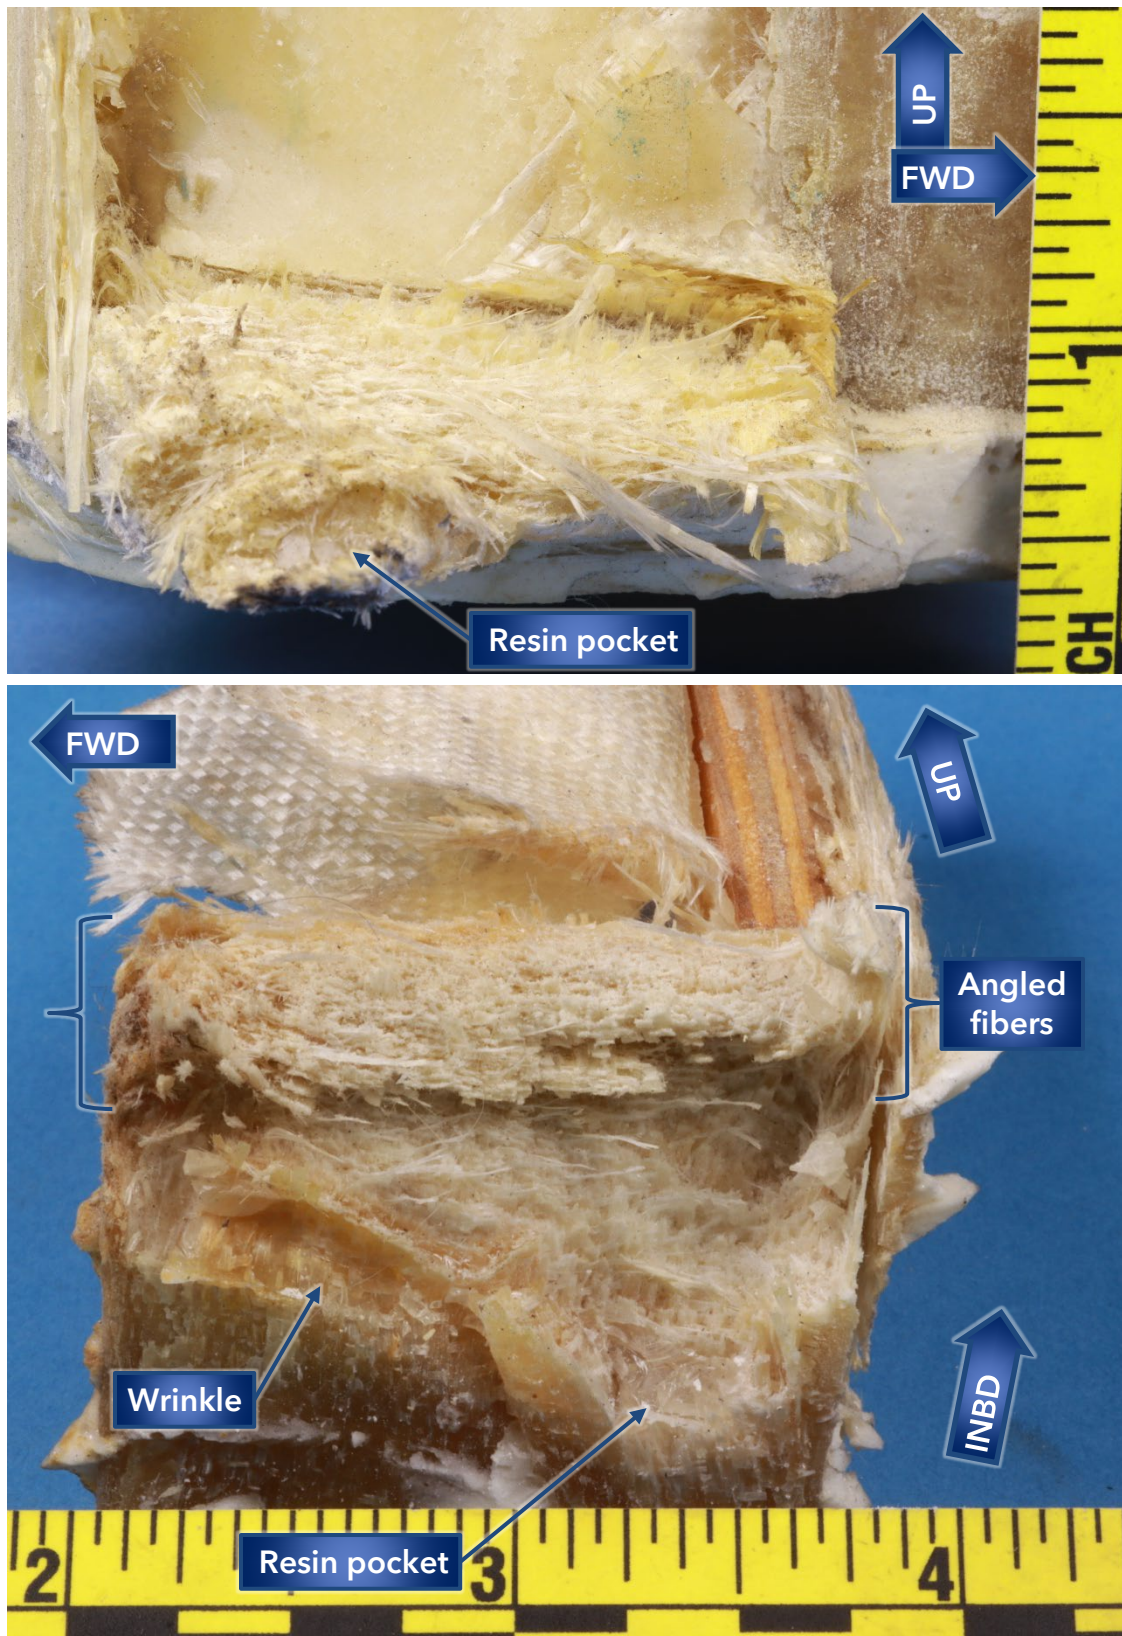
Mating sides of the right wing spar fracture through the lower cap are shown in figure 15. The fracture surfaces had a rough fibrous appearance consistent with tensile overstress fracture. A relatively large pocket of fractured resin was observed at the lower aft side of the fracture, and that portion of the fracture was the furthest outboard. A wrinkle was observed in the fibers at the lower surface forward of the resin pocket as indicated in figure 15. Additionally, brackets in figure 15 indicate fibers in the upper half of the fracture that were angled significantly downward relative to the spanwise direction.

**Figure 15.** Inboard side (upper image) and oblique view of the outboard side (lower image) of the right wing main spar lower cap fracture.

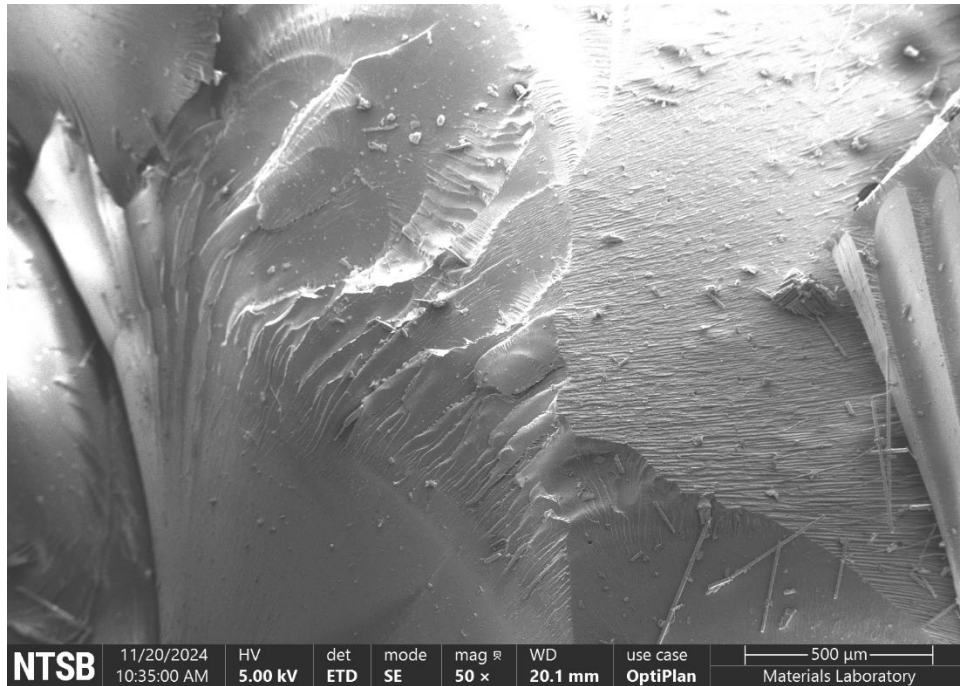
An SEM image of fracture features within the relatively large resin pocket is shown in figure 16. Smooth fracture features with Wallner lines and river patterns were observed consistent with overstress fracture.

**Figure 16.** SEM image of fracture features in the resin pocket on the outboard side of the fracture through the right wing spar lower cap.

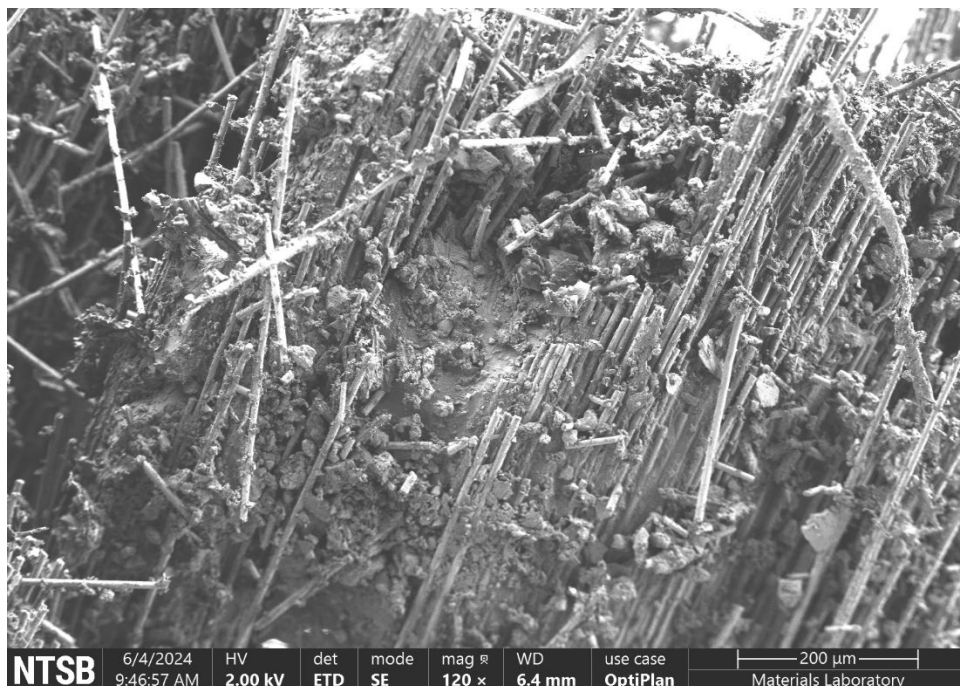
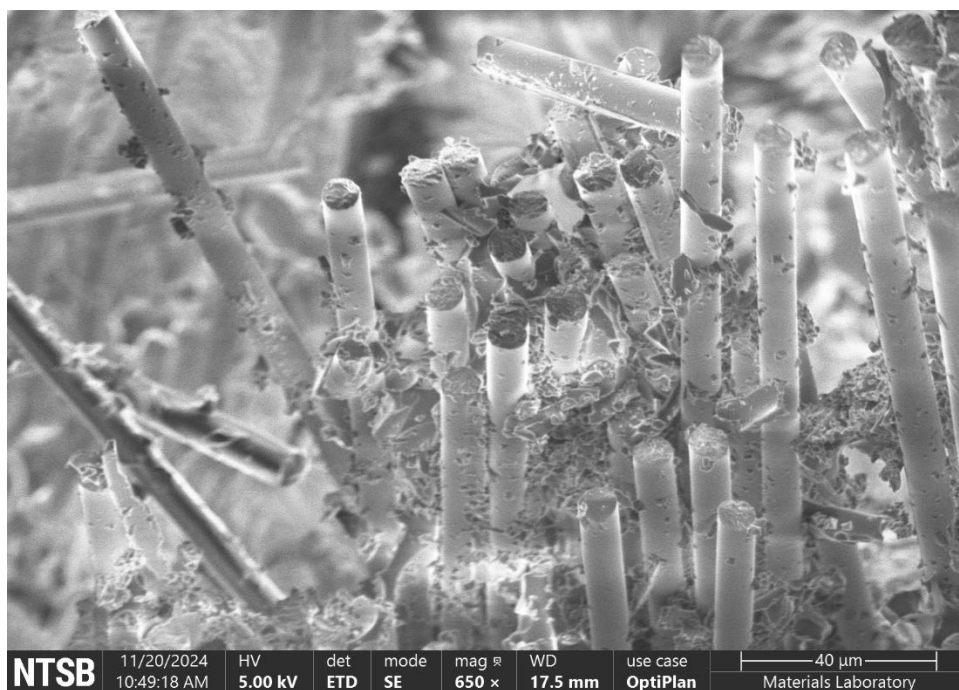
SEM images of fiber fractures in areas above the relatively large resin pocket are shown in figures 17 and 18. Fibers were fractured in variable locations and had rough features consistent with tensile overstress fracture. No evidence of progressive fracture was observed in resin features between fibers or in fiber-resin interfaces.

**Figure 17.** SEM image of fracture features above the resin pocket on the outboard side of the fracture through the right wing spar lower cap.

**Figure 18.** SEM image of fractured fibers in an area above the resin pocket on the outboard side of the fracture through the right wing spar lower cap.

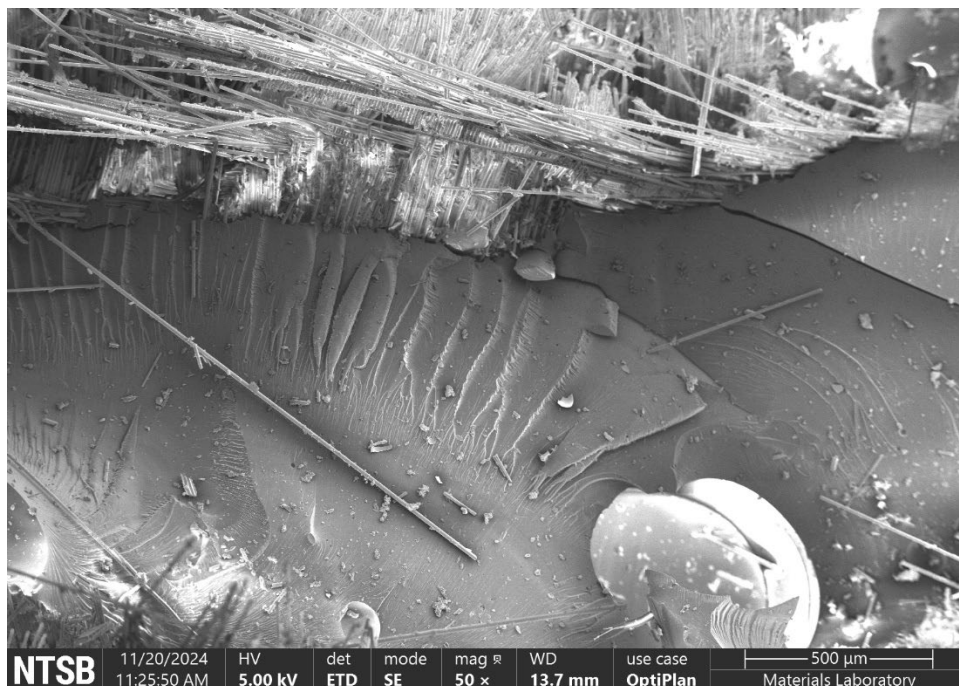
Figure 19 shows fracture features through a resin-rich area forward of the relatively large resin pocket. Smooth features with Wallner lines and river patterns were observed consistent with overstress fracture.

**Figure 19.** SEM image of a resin rich area above the wrinkle forward of the resin pocket on the outboard side of the fracture through the right wing spar lower cap.

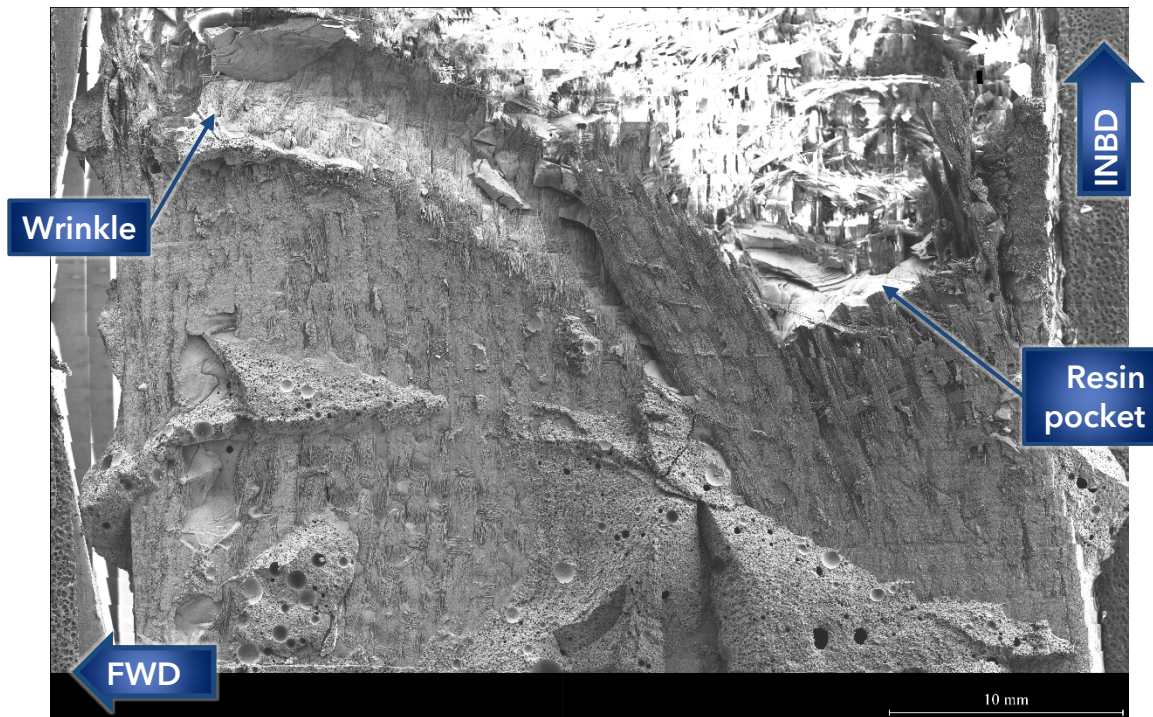
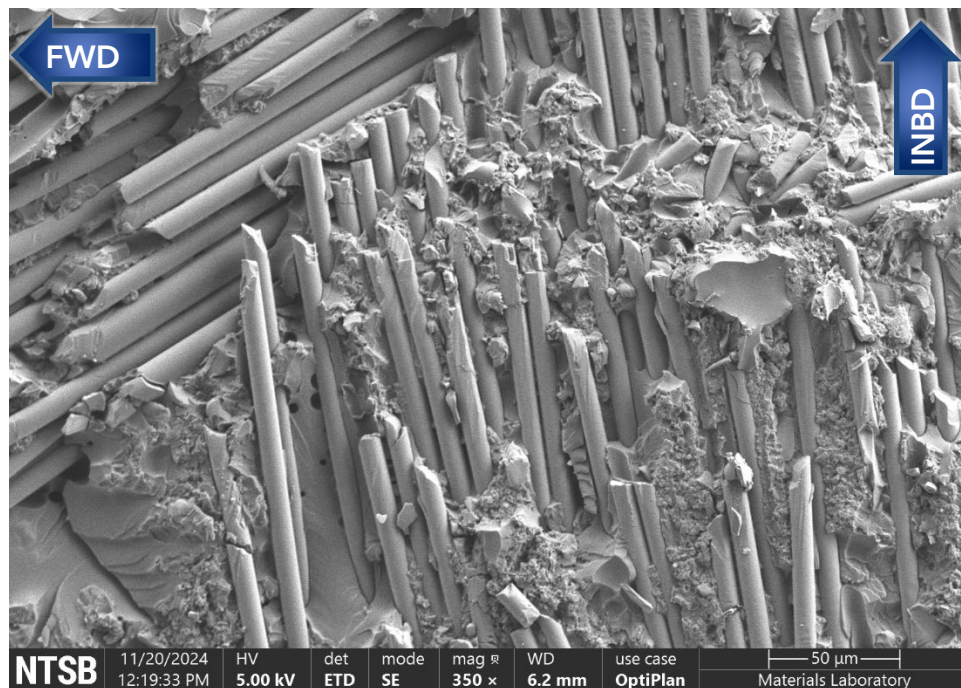
Fracture features at the lower surface of the lower cap are shown in figures 20 and 21. Reinforcement layers at the lower surface were wrinkled in an area forward of the relatively large resin pocket as indicated in figure 20. A closer view of the lower surface outboard of the indicated resin pocket is shown in figure 21. No evidence of preexisting or progressive separation, including features such as extensive rubbed surfaces or rolled matrix material, was observed on the lower surfaces.

**Figure 20.** Montage of SEM images stitched together to show fracture features at the lower surface of the right wing spar lower cap outboard of the fracture.

**Figure 21.** SEM image of the lower surface of the right wing spar lower cap showing fracture features outboard of the fracture through the resin pocket.
