# National Transportation Safety Board

WPR23LA255

## **MATERIALS LABORATORY**

Factual Report 24-081

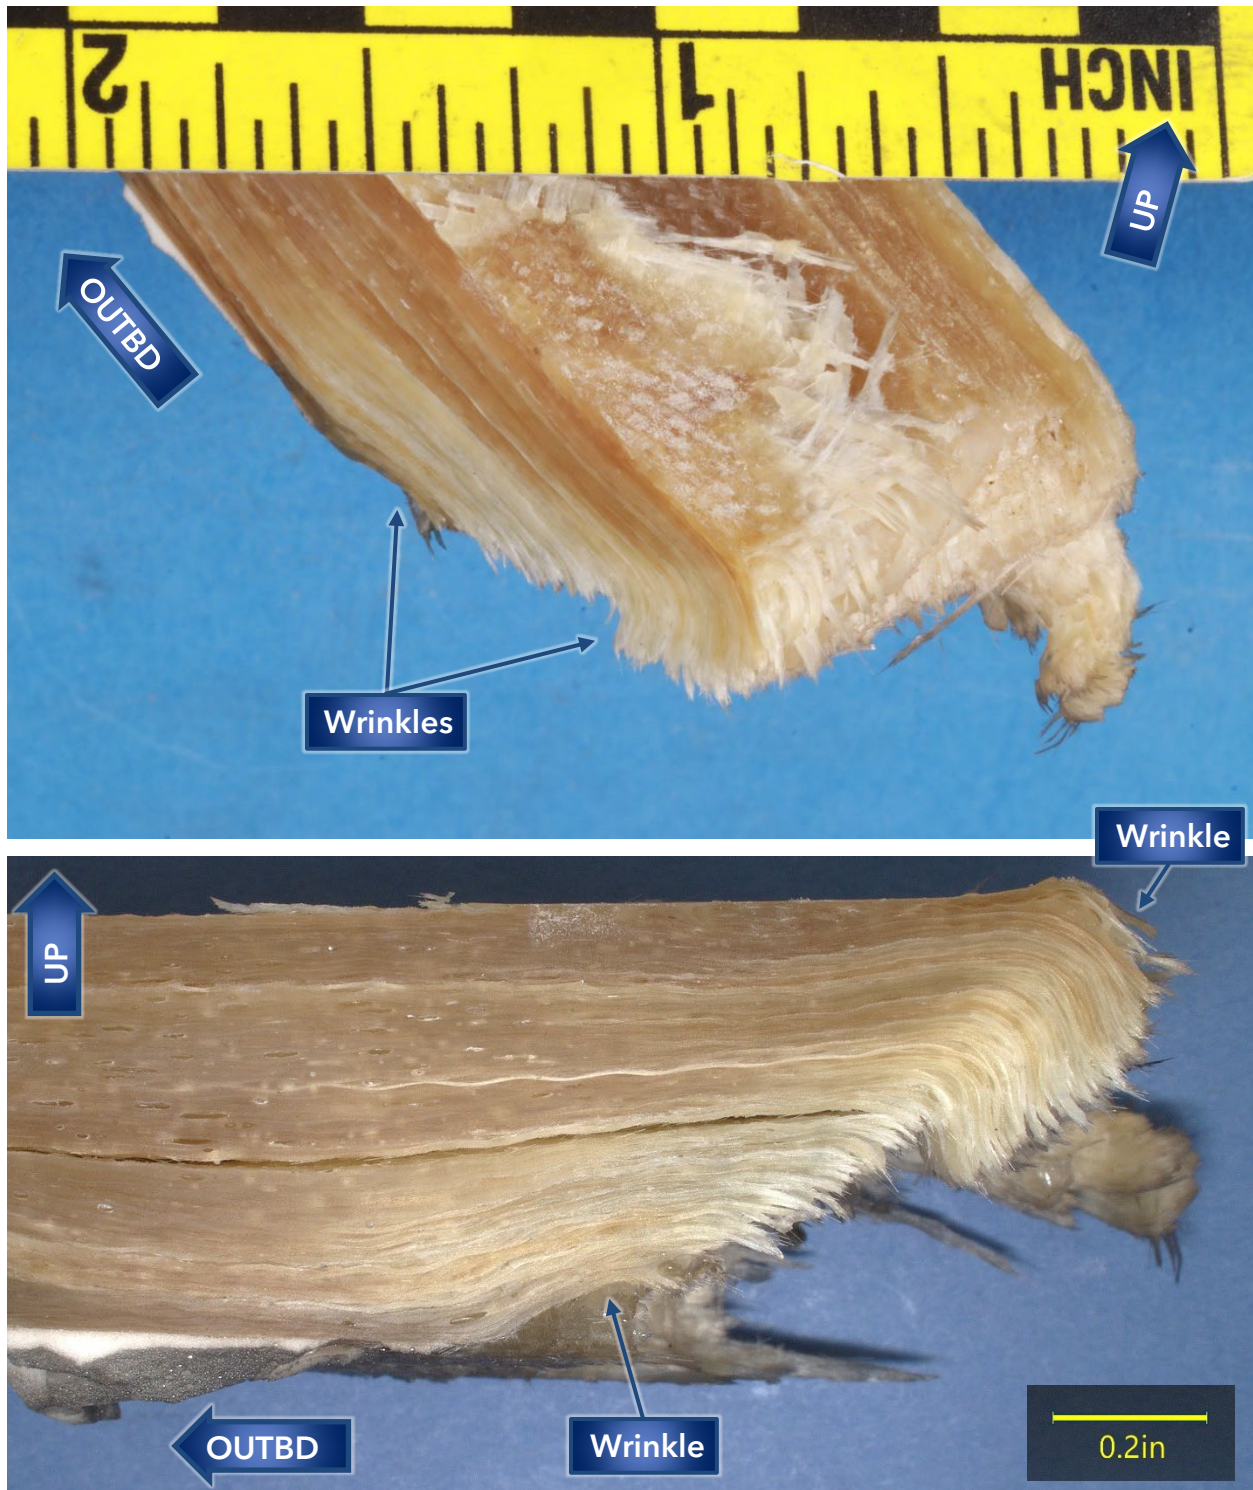
After the fractographic examination was complete, a vertical spanwise cut was made through the lower cap piece with the outboard fracture surface. The aft side of the longitudinal section through the lower cap was polished and wetted similar to the previously described transverse section to reveal the reinforcement layers, and views of the sectioned and polished piece are shown in figure 22. The fracture intersected wrinkles in the reinforcement layers at the upper and lower sides of the lower cap. On the upper half of the lower cap, the longitudinal fibers in the fabric were bent nearly 90 degrees relative to the spanwise direction. The bend had intact resin and showed no evidence of kinked fibers from compressive buckling, features consistent with an as-fabricated wrinkle.

**Figure 22.** Spanwise cross-section through the right wing spar lower cap piece showing composite layers outboard of the fracture surface.

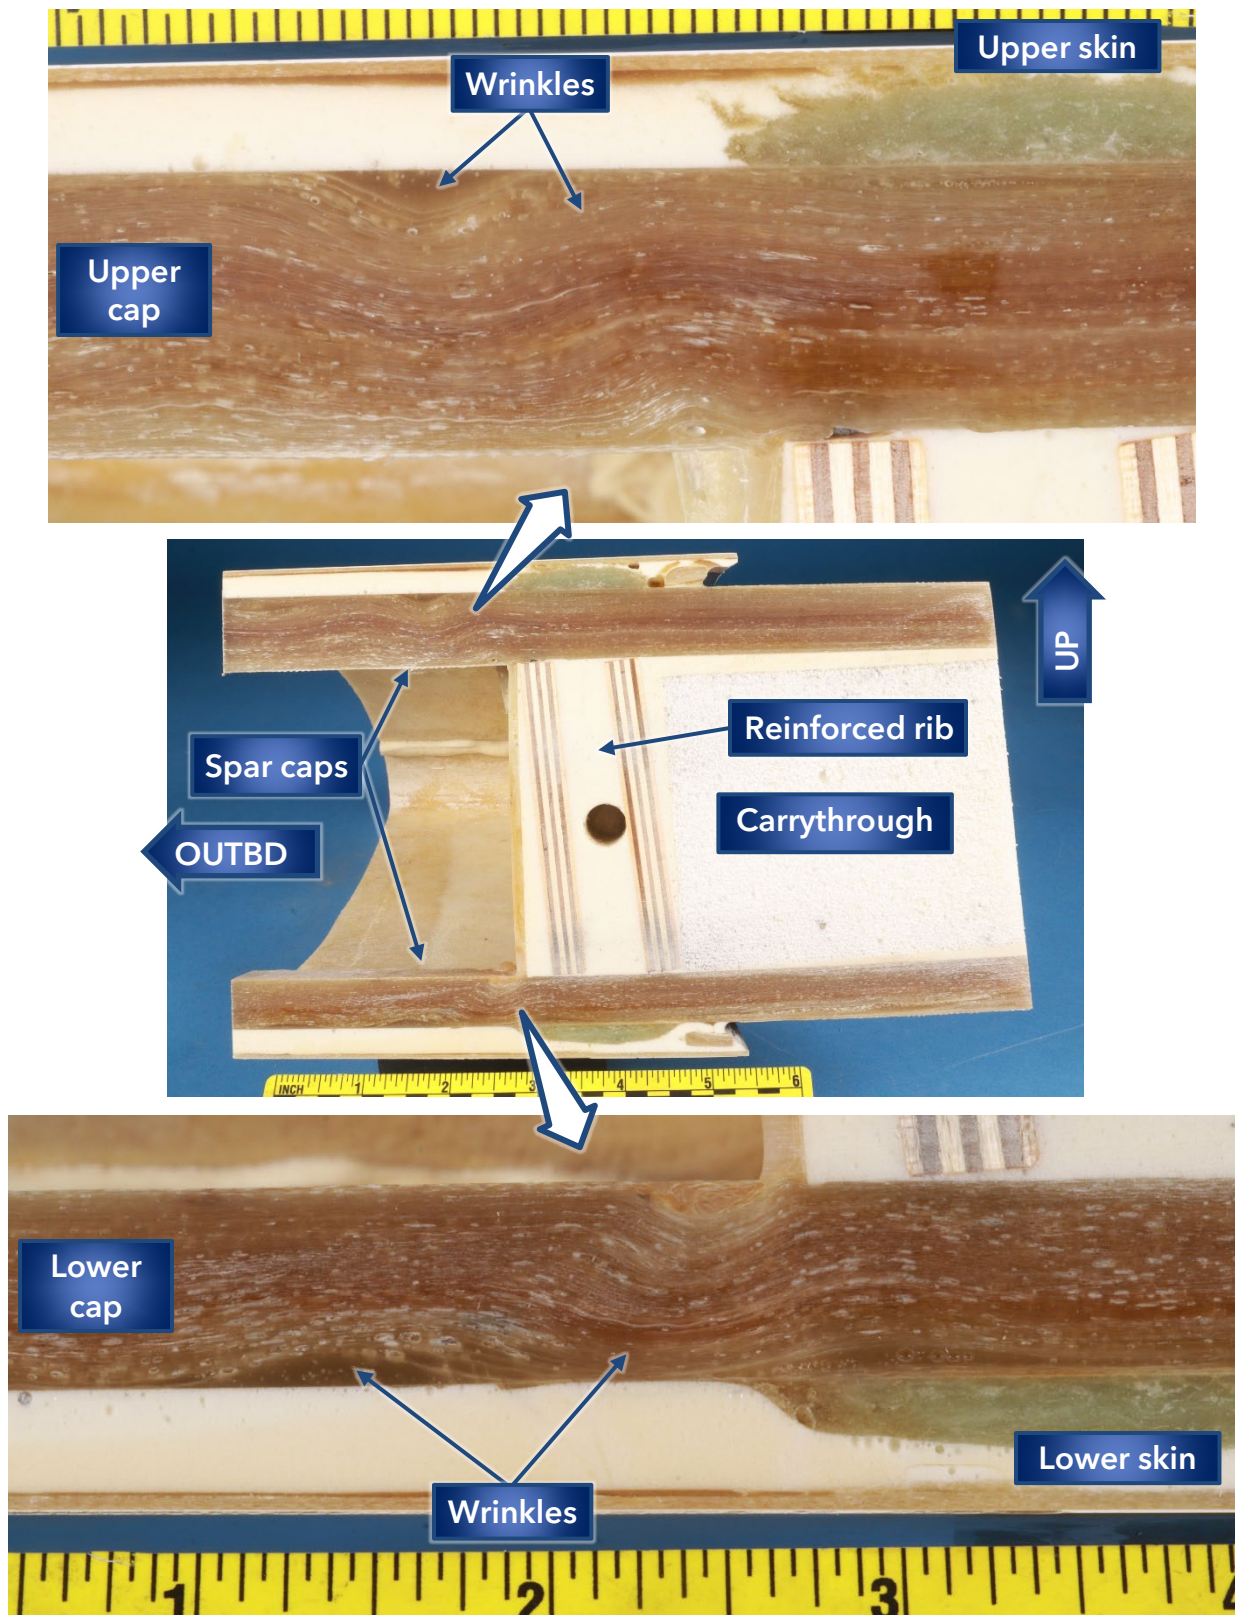
A vertical spanwise cut was made through the middle of the spar and carrythrough beam on the left wing piece shown in figure 10. The forward side of the cut was then polished and prepared similar to the previous sections to reveal the reinforcement layers in the upper and lower cap. An overall view of the section through the left wing spar caps, reinforced rib segment, and carrythrough beam is shown in figure 23 with closer views of the spar caps where they intersected the reinforced rib area. The reinforcement layers were continuous from the spar caps, through the reinforced rib area, and into the carrythrough beam. In the reinforced rib area, the caps were separated by two laminated wood panels, and in the carrythrough beam section, the caps were separated by a stiff foam core.

The fabric reinforcement layers in both the upper and lower caps for the left wing spar had wrinkles at the inboard end of the spar adjacent to the reinforced rib as indicated in figure 23. The inboard wrinkle in each cap was associated with rolled fabric at the interior corner between the spar cap and the vertical face of the reinforced rib, which locally interrupted the spanwise orientation of the fibers at that location. Further outboard, the outside layers deviated inward at another wrinkle, leaving a resin-rich area at the outside surface of each cap. In the region between the

wrinkles, the spanwise fibers in the fabric deviated substantially from the longitudinal direction. On the upper cap, longitudinal fibers angled between 16 and 28 degrees from the longitudinal direction in the area between the wrinkle peaks. On the lower cap, longitudinal fibers angled between 22 and 30 degrees from the longitudinal direction in the area between the wrinkle peaks.

**Figure 23.** Views of the spanwise cut through the left wing spar and carrythrough structure at the closeout rib showing wrinkles in the fiber reinforcement layers outboard of the rib in the spar upper and lower caps.
