Michael Hicks  
Air Safety Investigator  
OAS-WPR

**Date:** July 5<sup>th</sup>, 2023

**Subject:** WPR23LA255

**Contact:** FAA Inspector Ruconich

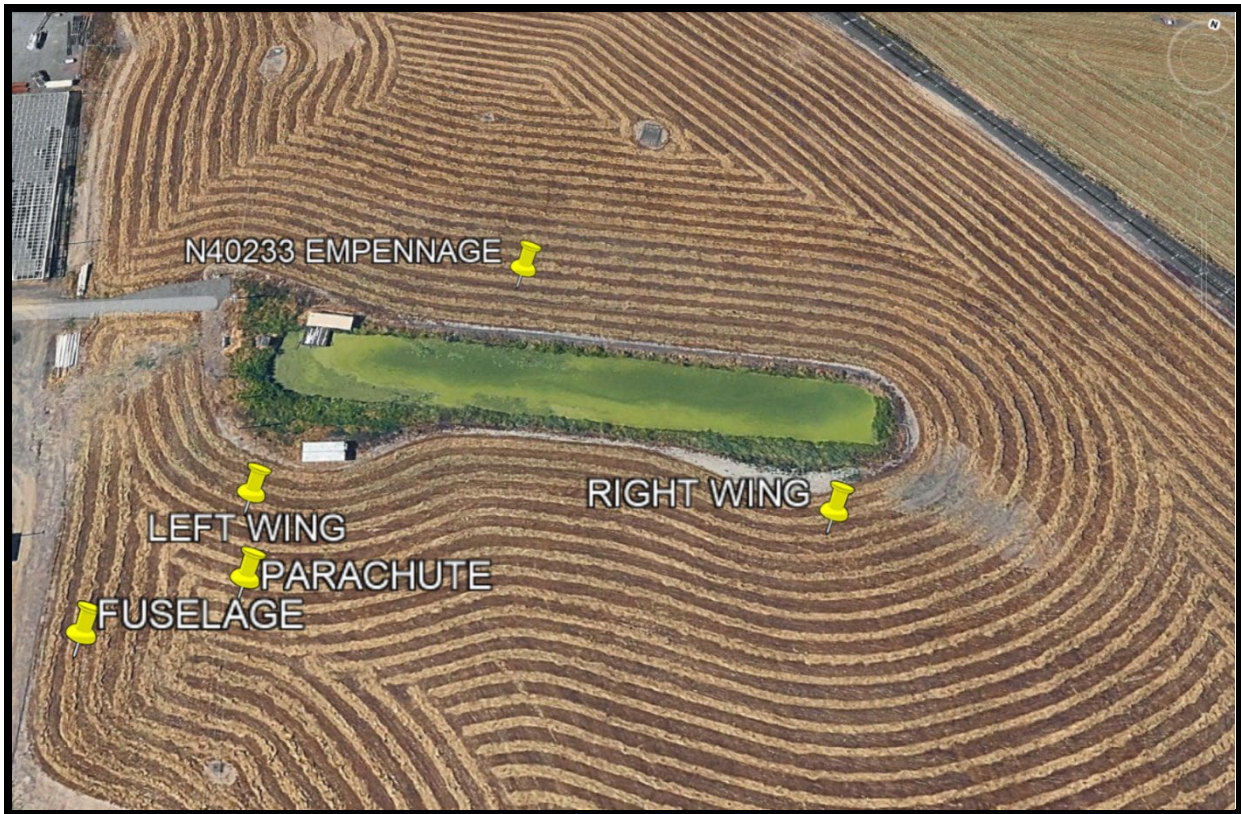
**Figure 1:** Wreckage Diagram

The approximate coordinates were: 45.575599, -123.056265 (fuselage), 45.575769, -123.055981 (parachute), 45.575935, -123.056065 (left wing), 45.576178, -123.054741 (right wing), 45.576602, -123.055661 (empennage). See Figure 1 below for the wreckage diagram.
