# National Transportation Safety Board

WPR23LA264

## ENGINE EXAMINATION SUMMARY

Location: La Mesa, California  
Date: July 9, 2023  
Time: 1500 Pacific standard time  
Airplane: N1839R

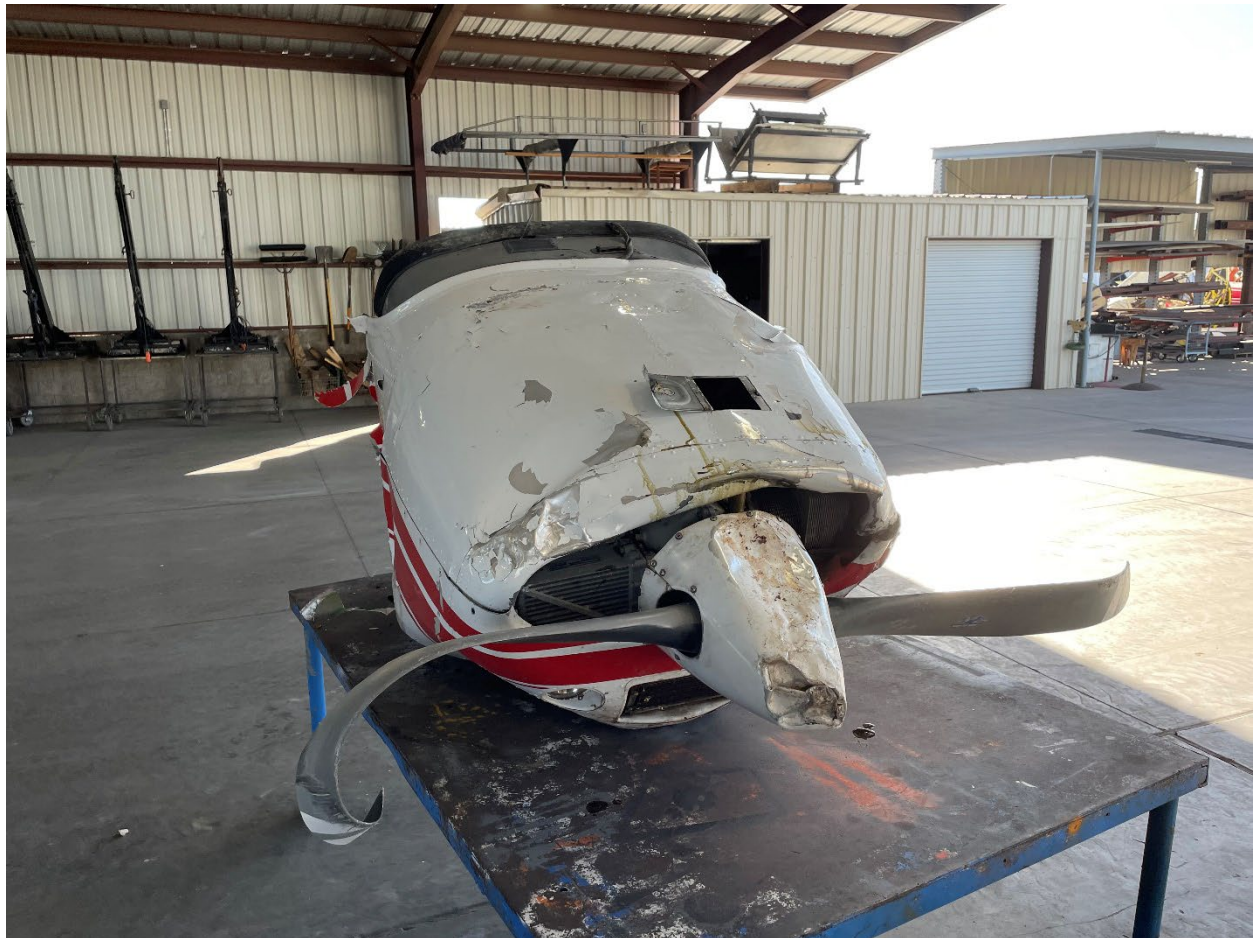
Examination of the engine took place on February 20-21, 2024, at Air Transport in Pheonix, Arizona. The engine remained within the cowling and was found attached to each engine mount with sustained damage consistent with impact to the lower engine truss. All engine accessories remained secured on its respective mounting pad. All fuel and oil lines were found secured. Continuity from the fuel tanks to the fuel selector valve was confirmed using compressed air. Continuity of the throttle, mixture, and propeller governor control was confirmed from the cockpit to the engine, with each control moving from minimum stop to maximum stop.
