WPR23LA264

## INVESTIGATION PHOTOGRAPHS

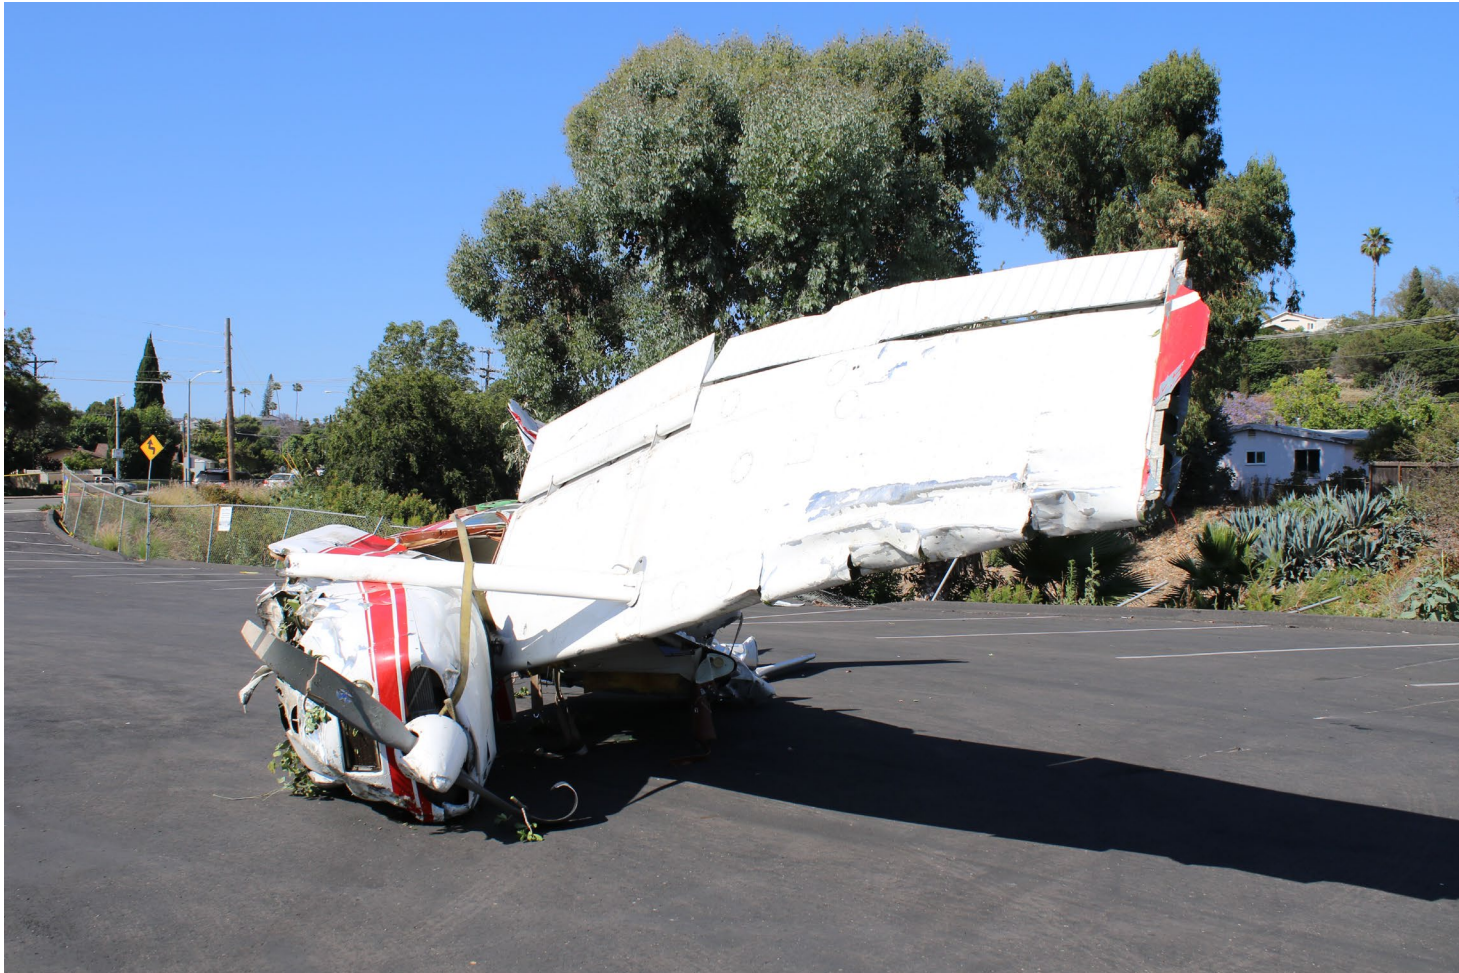
**Photograph 1 - View of recovered accident airplane with damage to right wing and fuselage  
(Courtesy of FAA)**

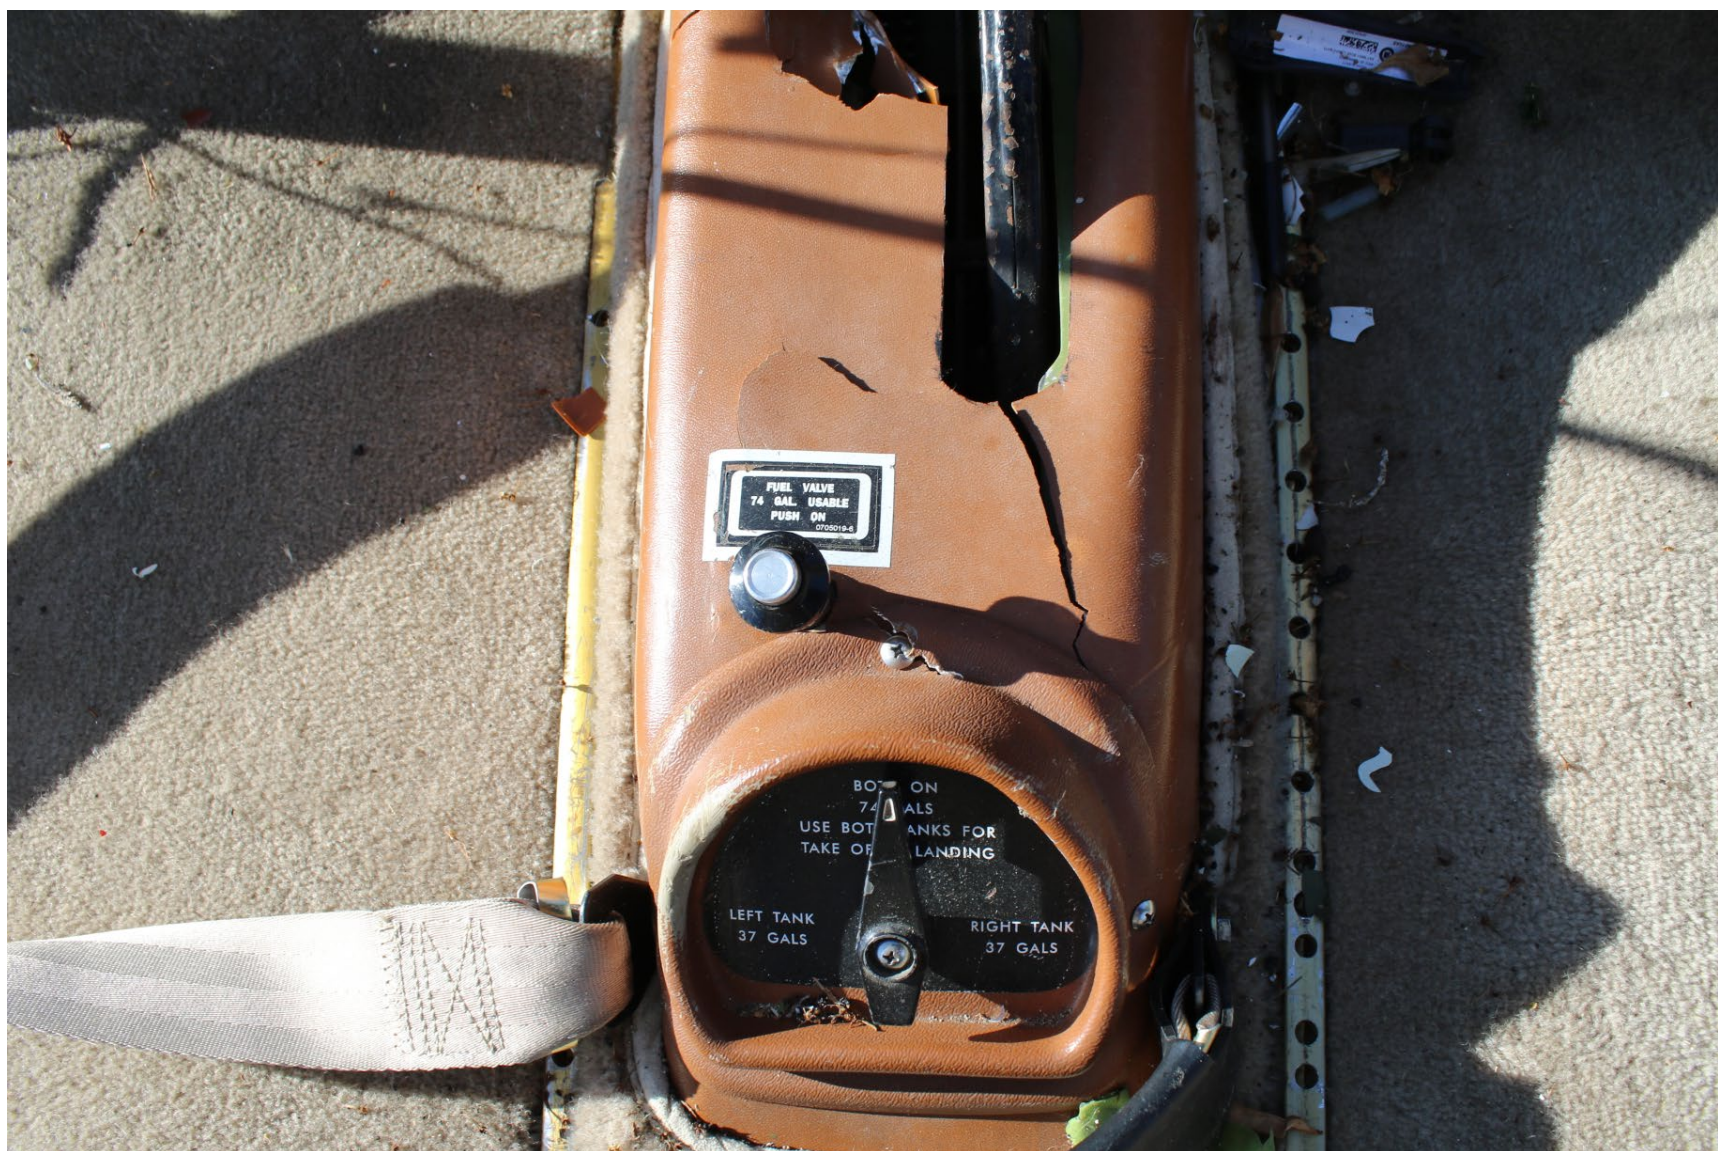
**Photograph 2 - View of fuel selector valve lever position set to BOTH ON at accident site  
(Courtesy of FAA)**

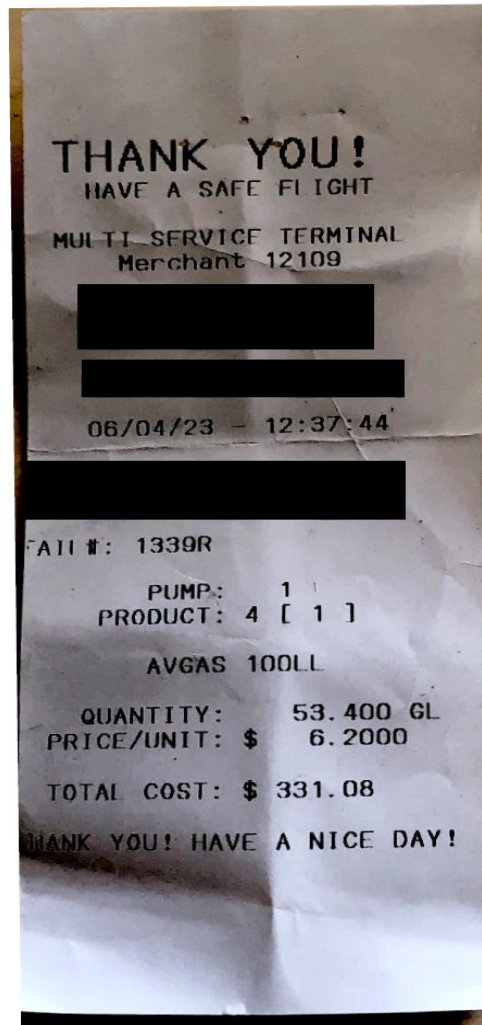
**Photograph 3 - View of last fuel receipt (Courtesy of pilot )**

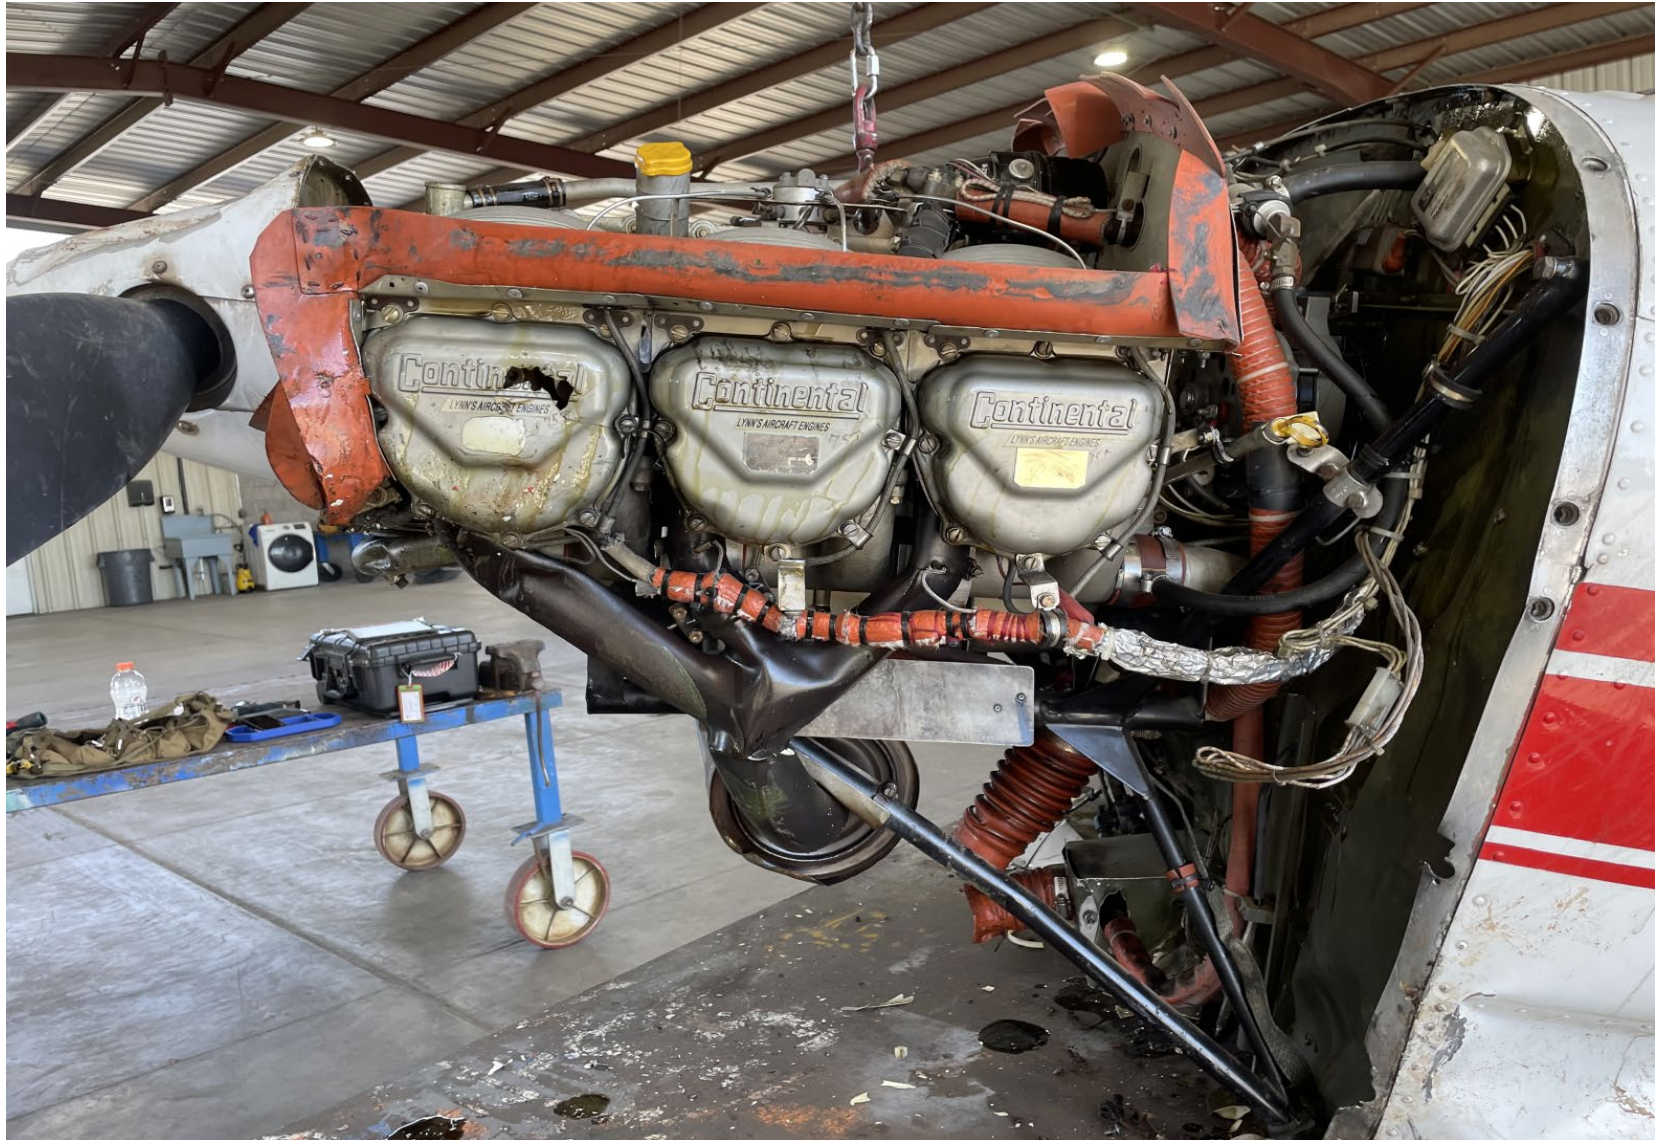
**Photograph 5 - View of left side of damaged engine**

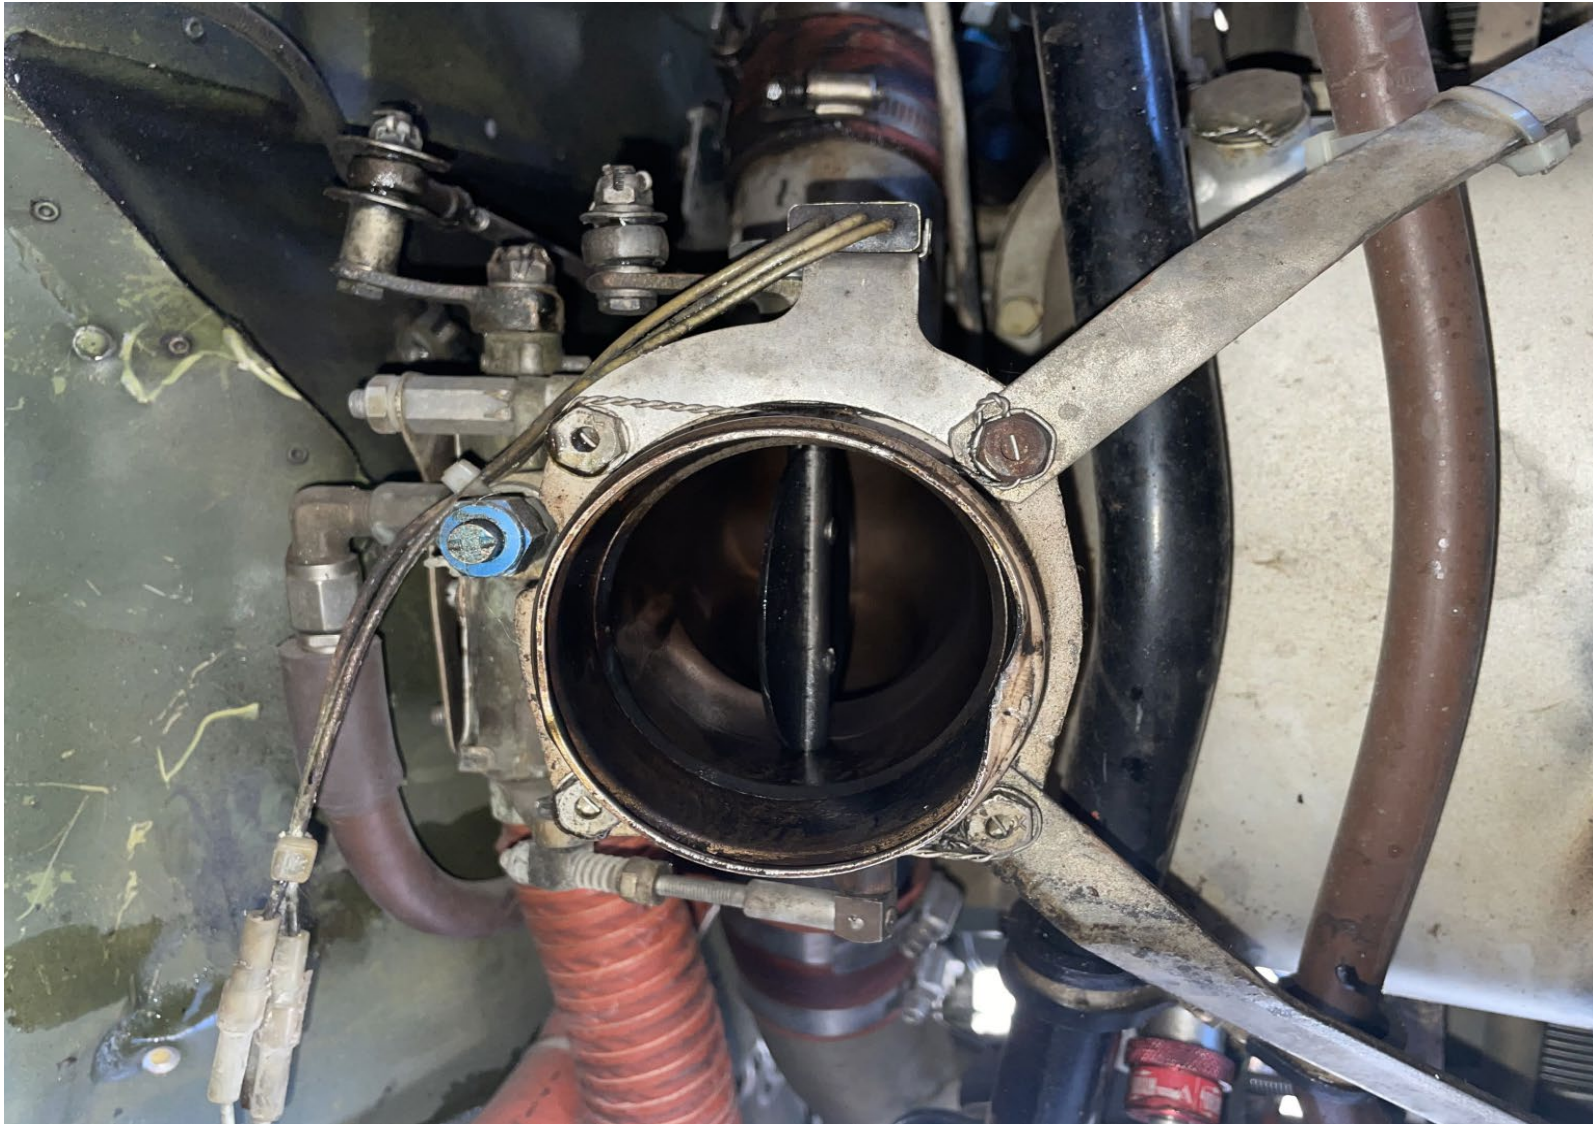
**Photograph 6 - View of fuel servo and butterfly valve**

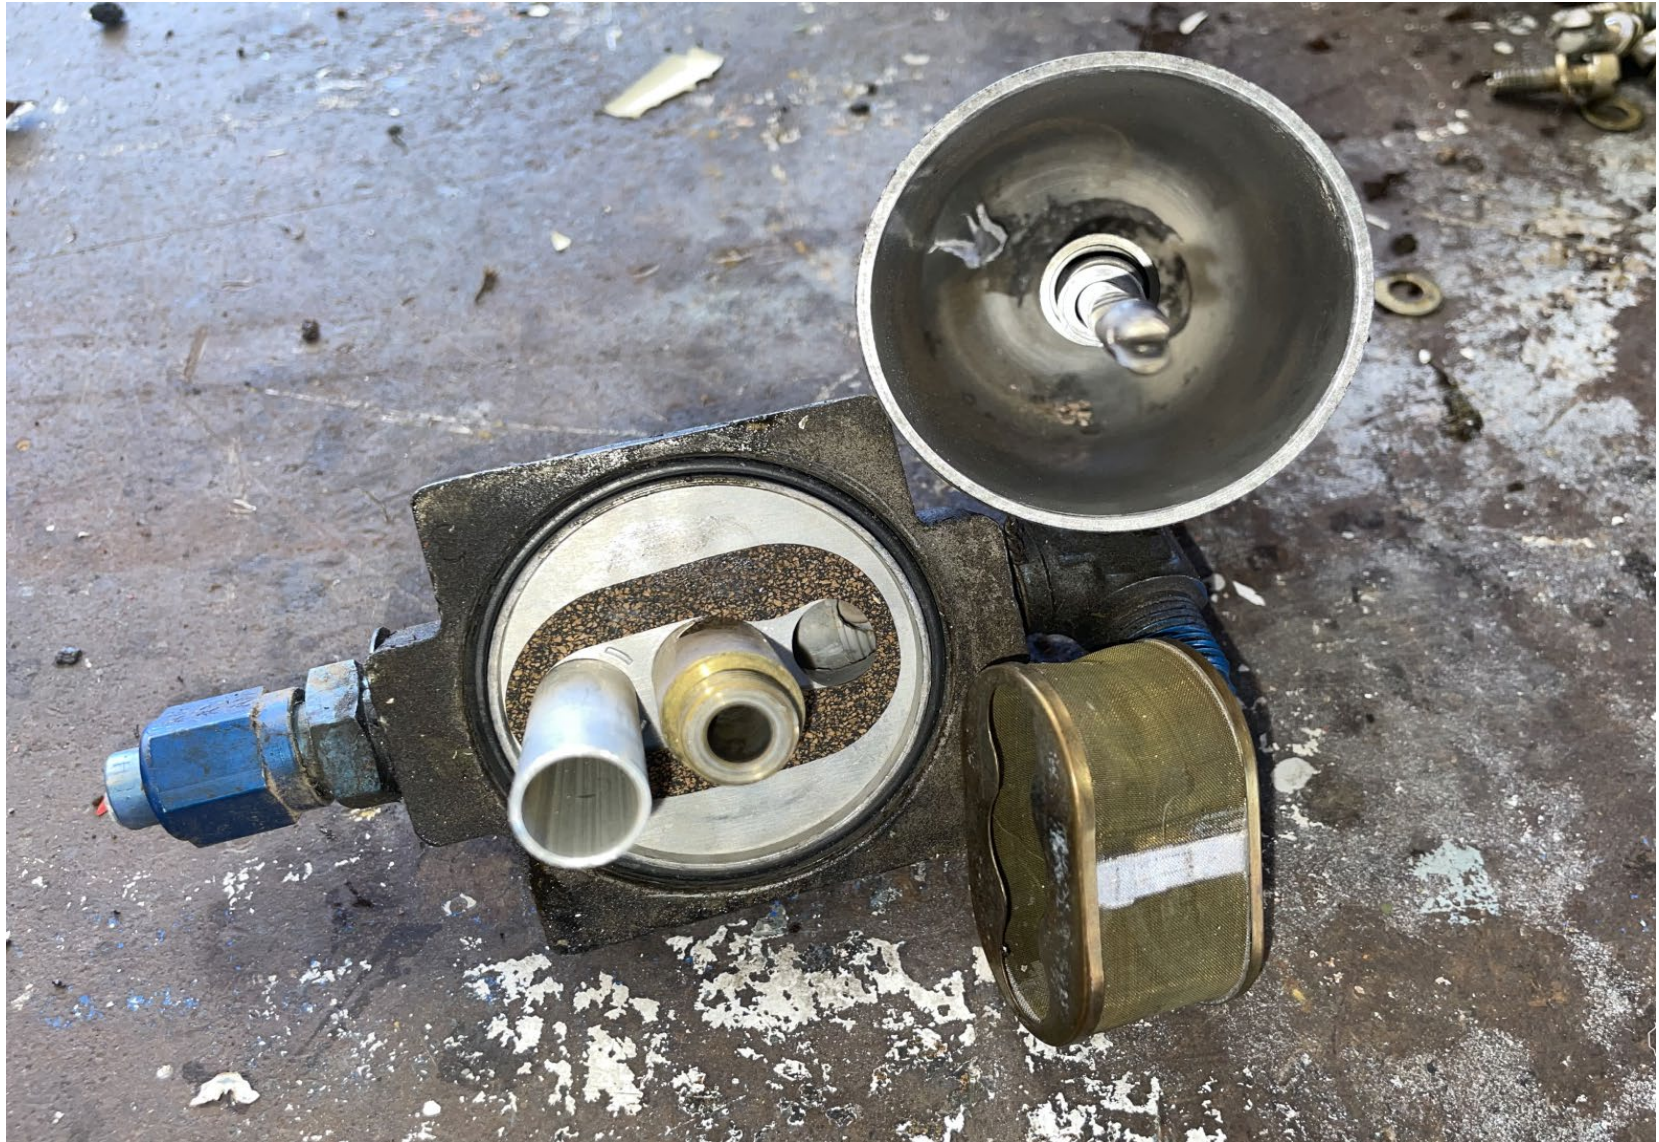
**Photograph 7 - View of removed damaged fuel filter bowl**

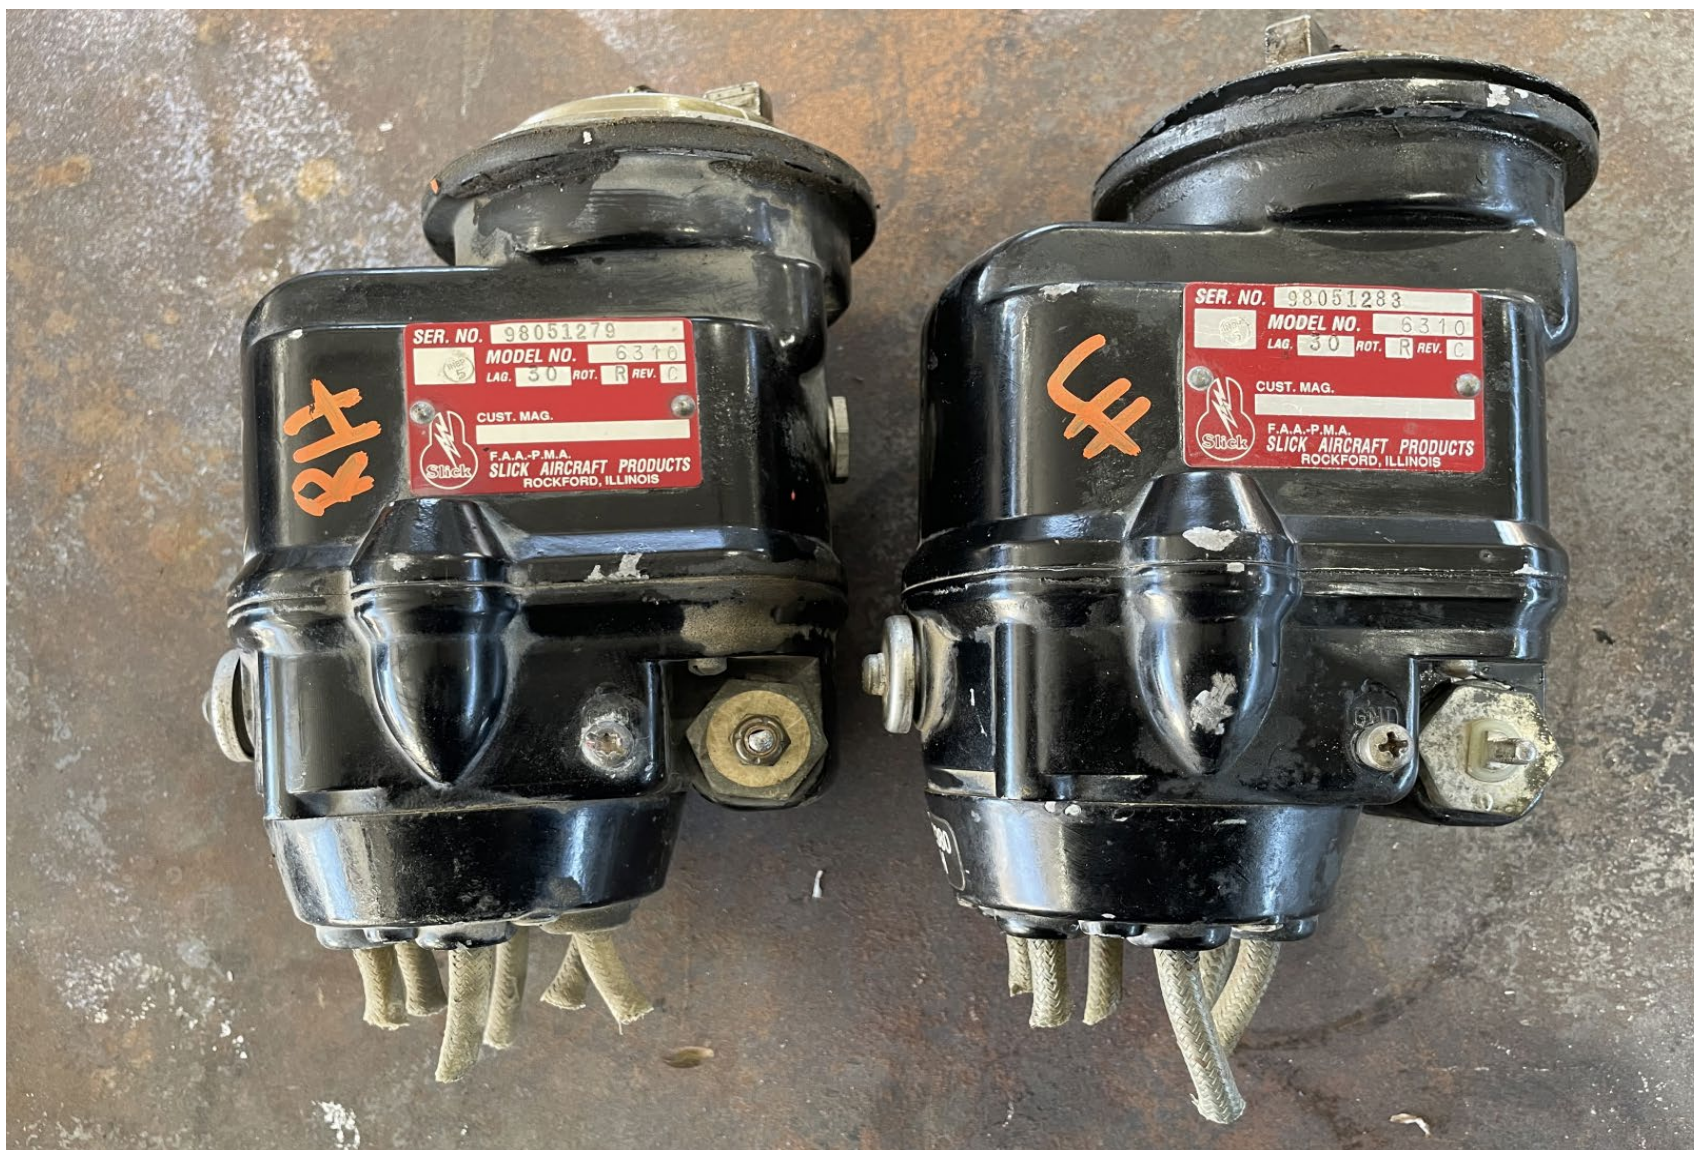
**Photograph 8 - View of removed damaged fuel filter bowl magnetos**
