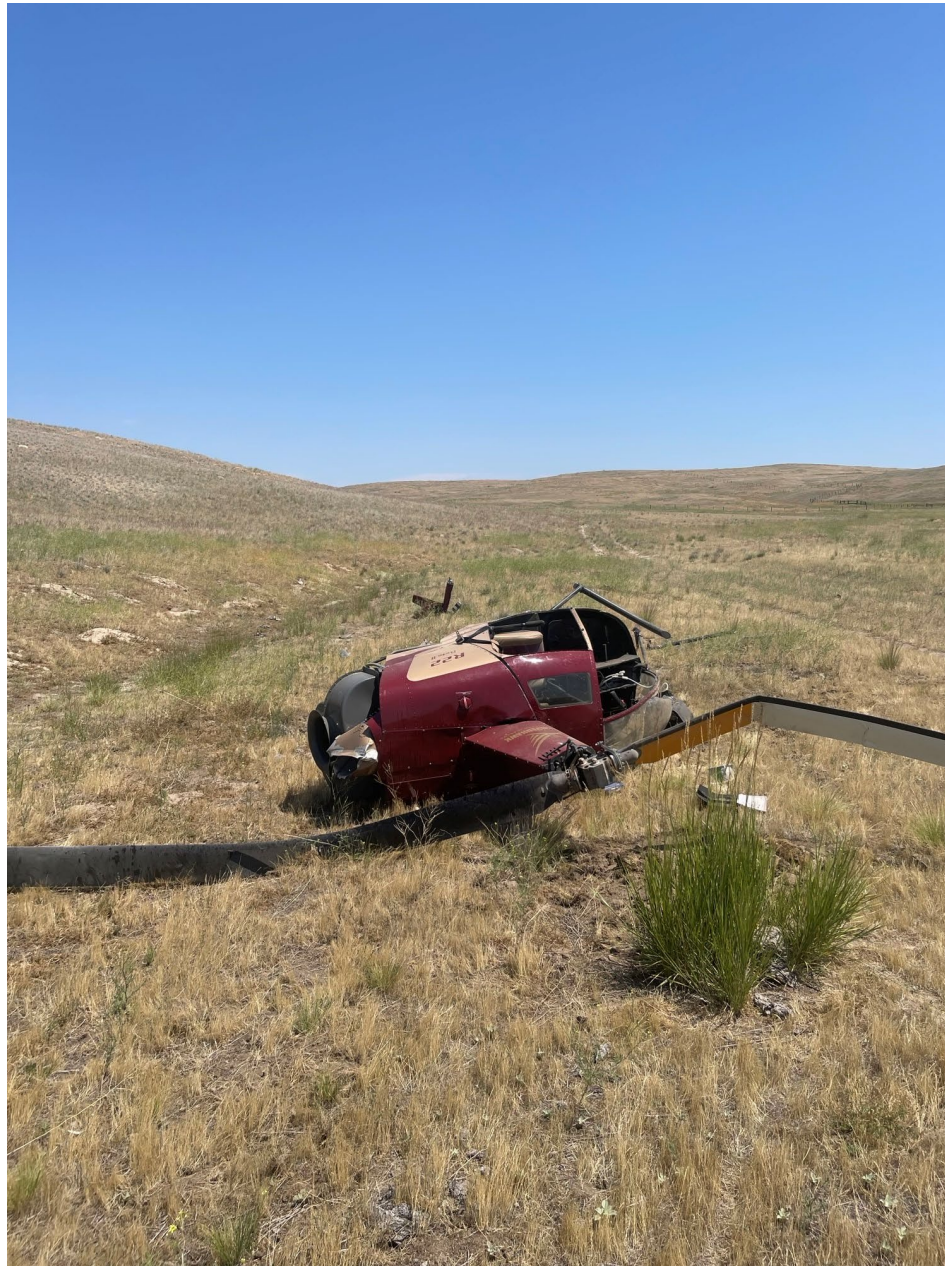
**Photo 1 – view of damage to tailboom and tail rotor assembly (pilot)**
