WPR23LA270

## INVESTIGATION PHOTOGRAPHS

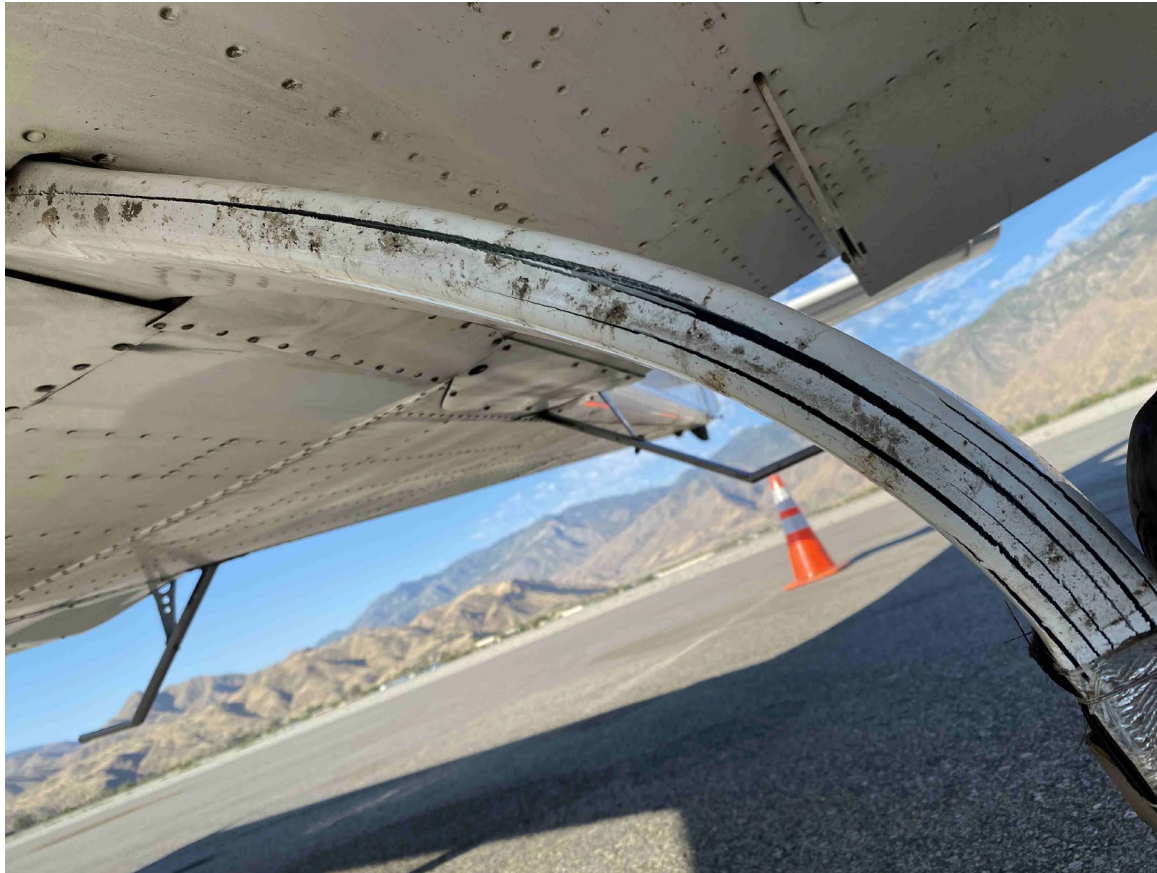
**Photograph 1 - Left leg damage**

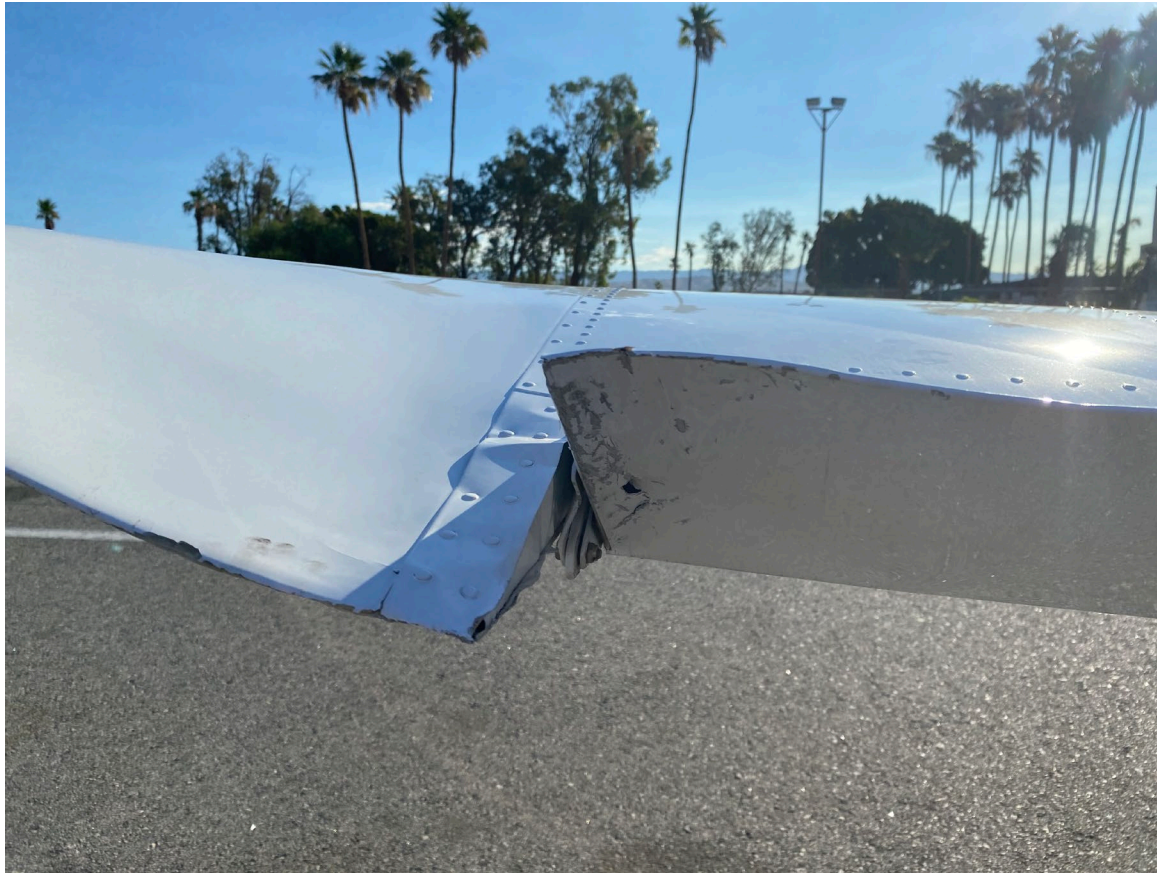
**Photograph 2 -Left wing damage**

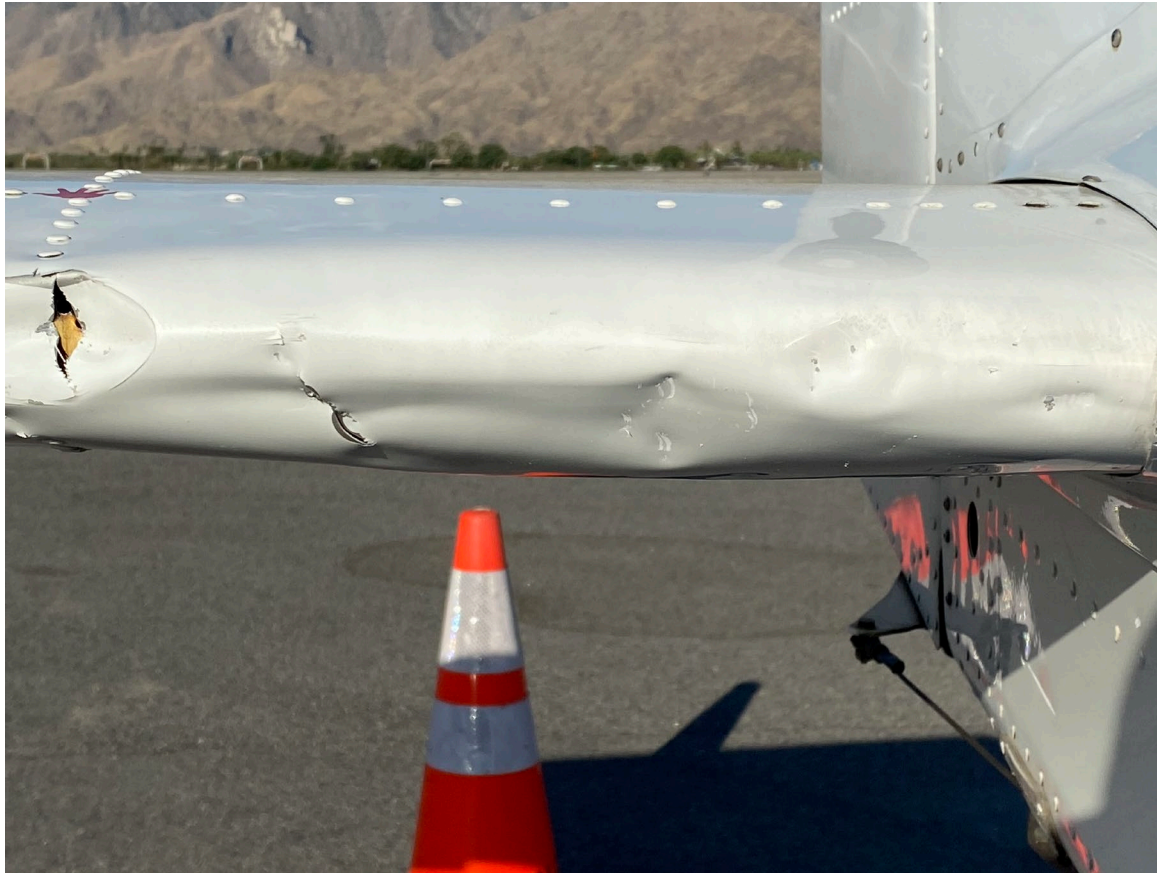
**Photograph 3 - Horizontal stabilizer damage**
